Inventory, Assessment, and Restoration Potential of Ephemeral Wetlands on FFWCC Wildlife Management Areas

Half Moon WMA Final Report

Submitted by: Rebecca P.M. Means¹, Ryan C. Means¹, Steven A. Johnson²

¹Coastal Plains Institute

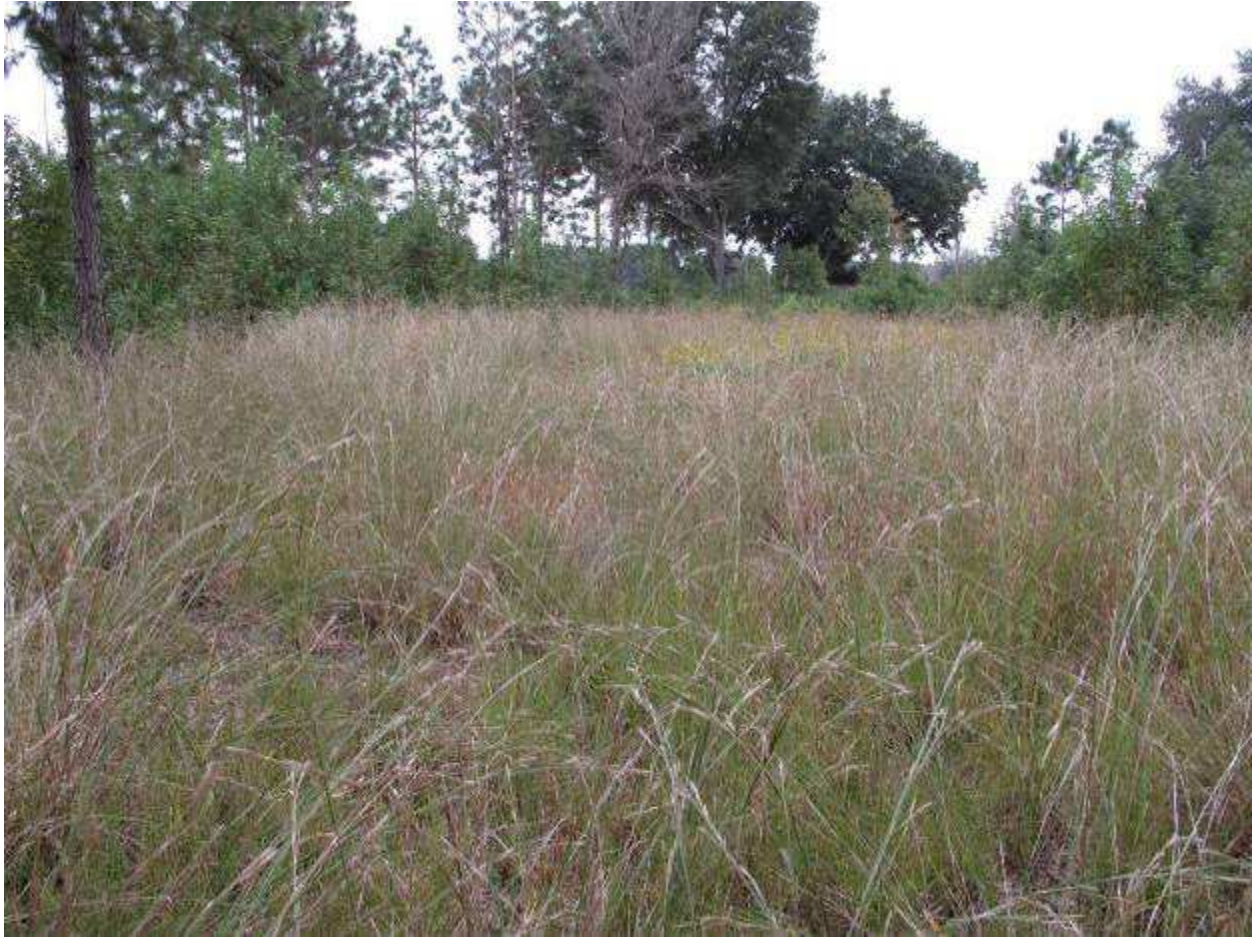
Wetland ID: 58-08

Description: This wetland is a 0.1 ha ephemeral marsh. There is no tree canopy cover. A patch of sweet gum saplings is beginning to encroach from the west edge of the wetland, and covers 5-25% of the wetland basin. Sedges/grasses grow throughout the wetland, and cover >75% of the basin. The wetland is surrounded by a dense brush and palmetto ring and oldfield with large longleaf pine trees.

Wetland Concerns: Upland condition, Woody encroachment

Restoration Action Recommended: Encourage fire to burn through the wetland basin to reduce sweet gum saplings. In order to restore the full ecological potential of the wetland, the uplands would have to be restored.

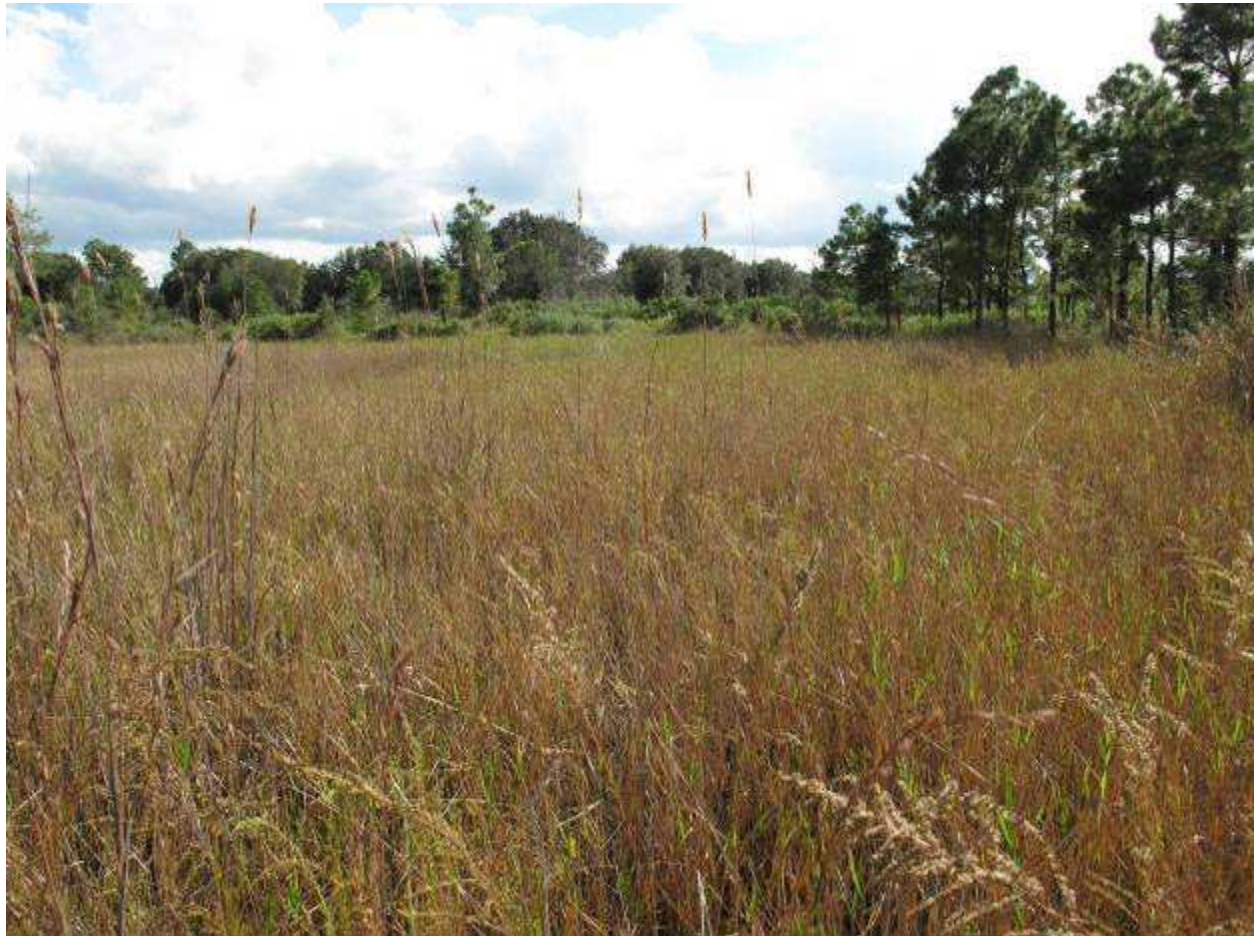
Wetland ID: 58-09

Description: This wetland is a 0.3 ha ephemeral marsh. There is no tree canopy or midstory cover. Maidencane and sedges/grasses grow throughout the wetland, and cover >75% of the basin. The wetland is surrounded by a dense gallberry ring and oldfield.

Wetland Concerns: Upland condition

Restoration Action Recommended: In order to restore the full ecological potential of the wetland, the uplands would have to be restored.

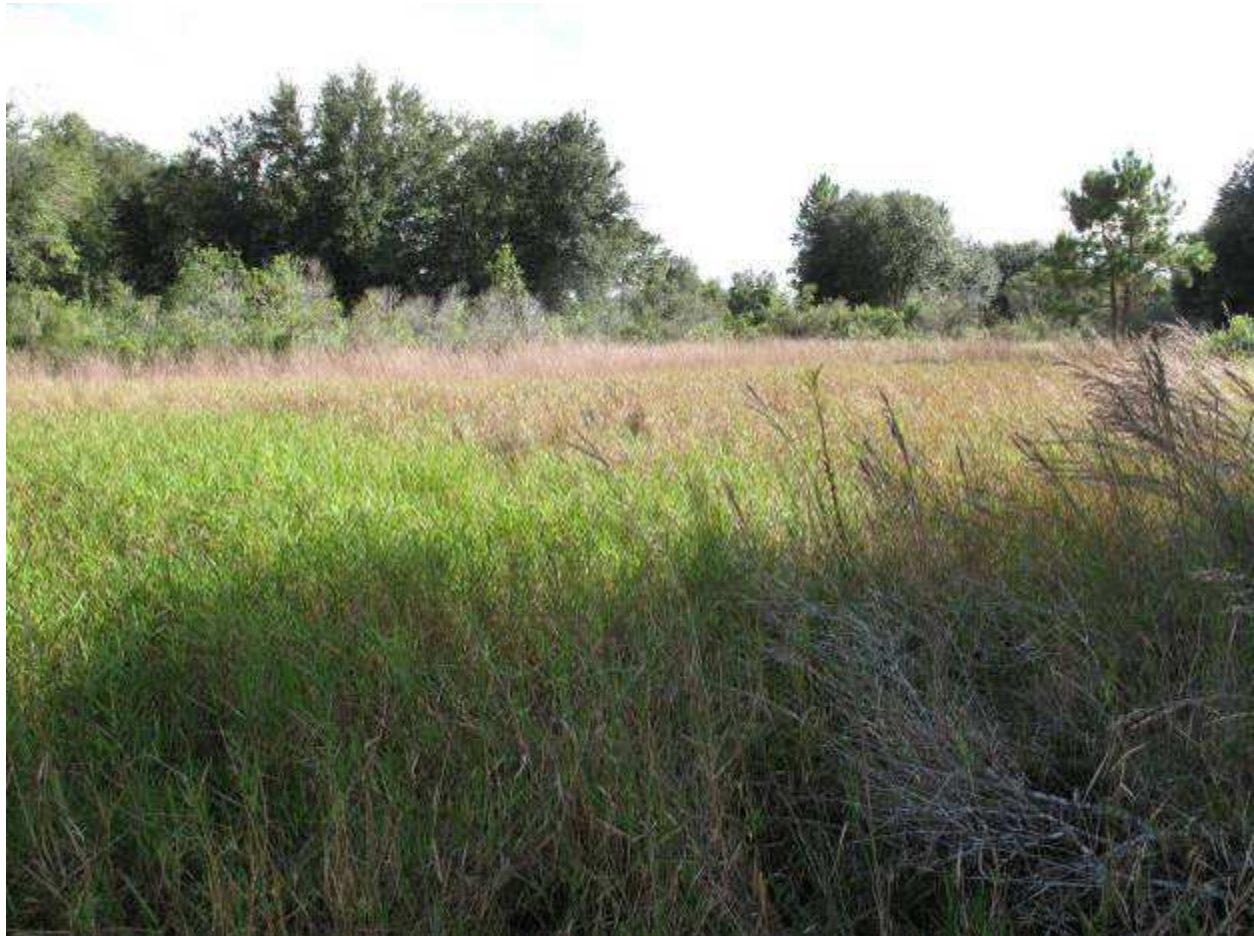
Wetland ID: 58-10

Description: This wetland is a 0.4 ha ephemeral marsh. There is no tree canopy or midstory cover. Maidencane and sedges/grasses grow throughout the wetland, and cover >75% of the basin. The wetland is surrounded by a brush ring and oldfield.

Wetland Concerns: Upland condition

Restoration Action Recommended: In order to restore the full ecological potential of the wetland, the uplands would have to be restored.

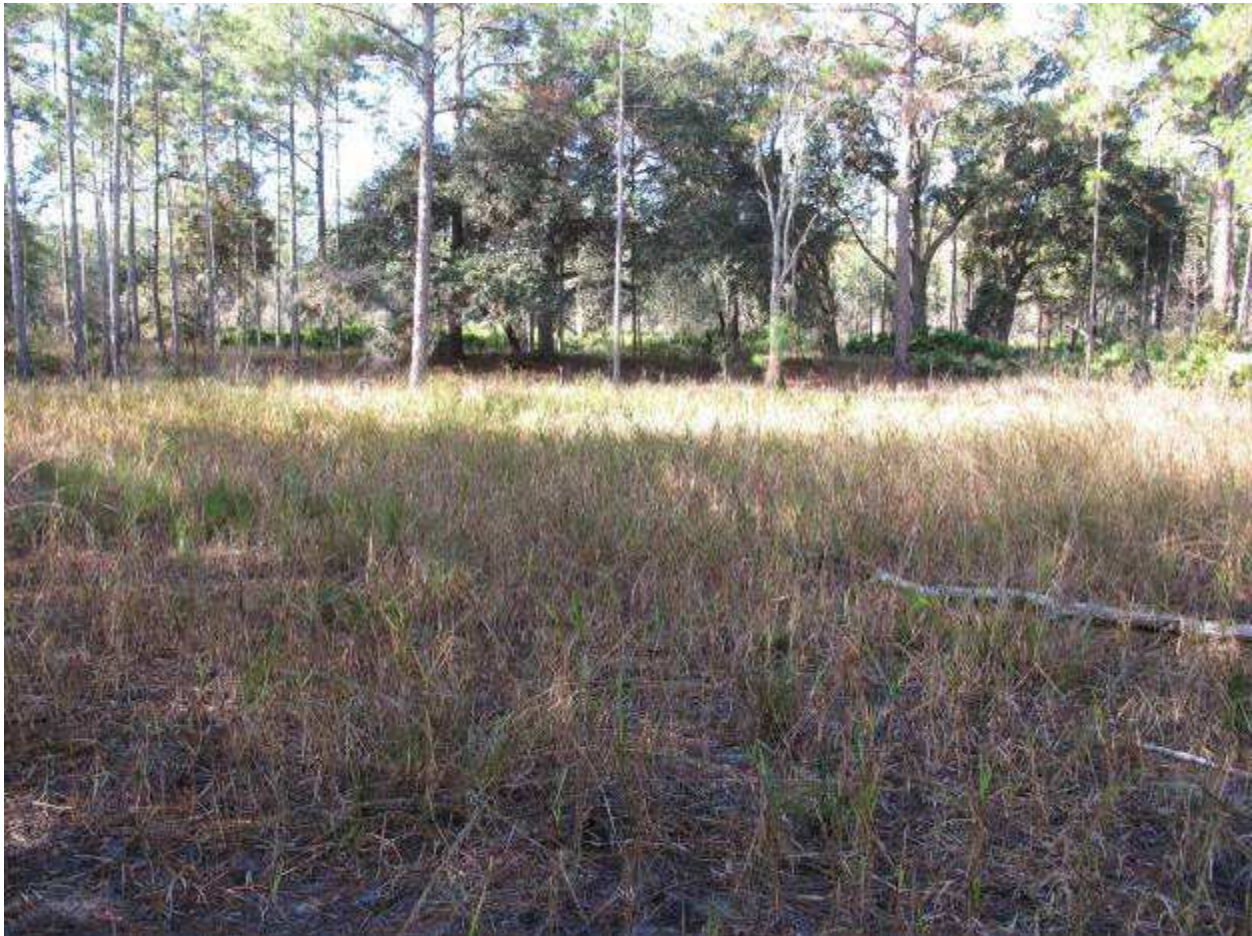
Wetland ID: 58-11

Description: This wetland is a 0.1 ha ephemeral marsh. Slash pine trees grow in a ring around the wetland, and cover 5-25% of the wetland basin. There is no midstory layer. Maidencane grows throughout the wetland, and covers 50-75% of the basin. This wetland is a potential striped newt breeding pond. The adjacent uplands are an upland pine forest community.

Wetland Concerns: Woody encroachment

Restoration Action Recommended: The perimeter pine trees could be thinned in order to reduce the shading effect and encourage the growth of more herbaceous vegetation.

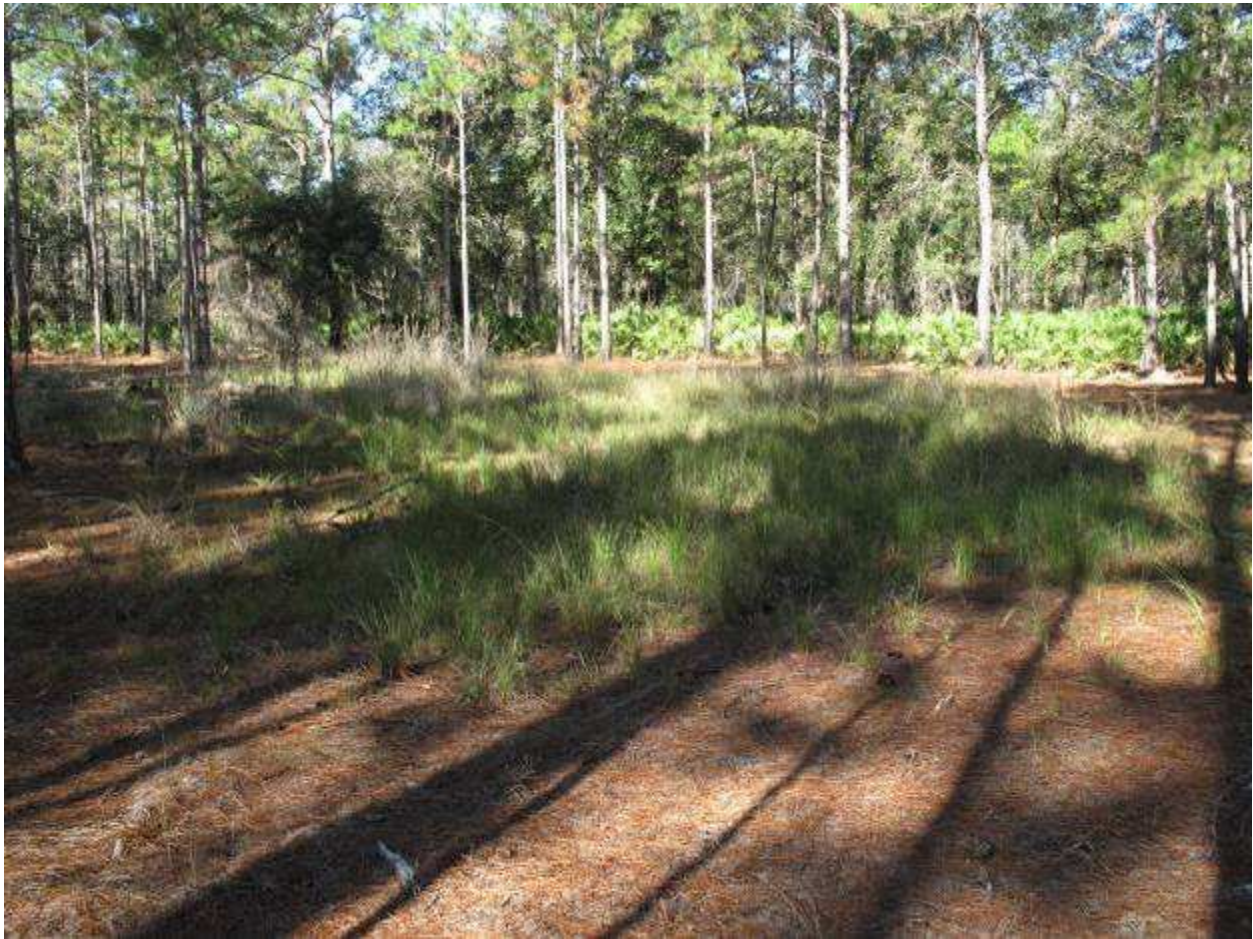
Wetland ID: 58-12

Description: This wetland is a <0.1 ha ephemeral marsh. Pine trees grow around the wetland edge, and cover 5-25% of the wetland. Needle duff is thick under the pine canopy. There is no midstory cover. Sedges/grasses grow in the wetland center, and covers 50-75% of the wetland basin. The wetland is a potential striped newt breeding pond. The adjacent uplands are an upland pine forest community.

Wetland Concerns: Woody encroachment

Restoration Action Recommended: The perimeter pine trees could be thinned in order to reduce the shading effect and encourage the growth of more herbaceous vegetation.

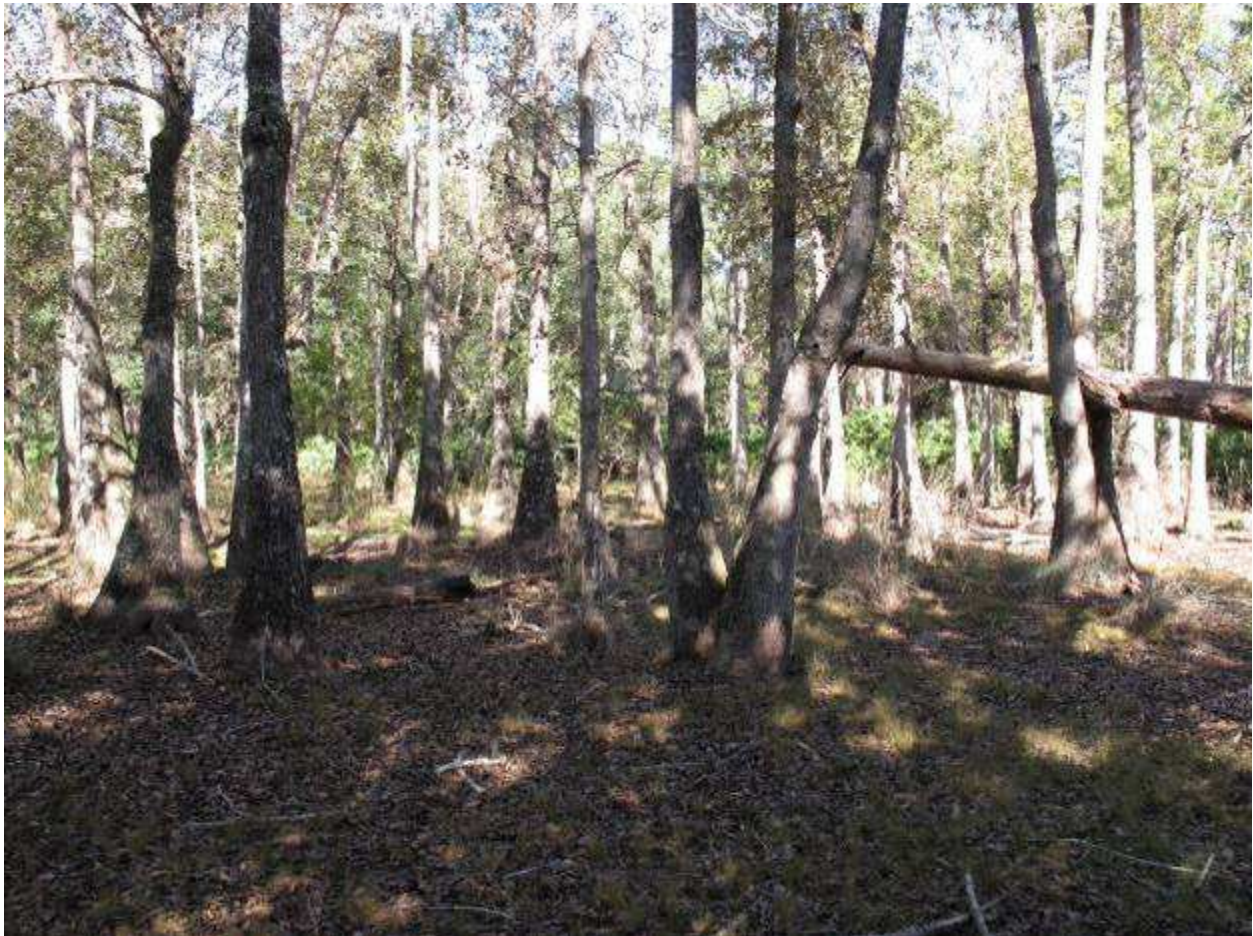
Wetland ID: 58-13

Description: This wetland is a 0.3 ha ephemeral forested swamp. Gum trees dominate the canopy, and cover >75% of the wetland basin. There is no midstory cover. Sedges/grasses grow in scattered patches, and cover 5-25% of the wetland basin. This wetland provides a perfect example of a depressional, isolated gum swamp. The adjacent uplands are pine/oak/palmetto thicket.

Wetland Concerns: None

Restoration Action Recommended: In order to restore the full ecological potential of the wetland, the uplands would have to be restored.

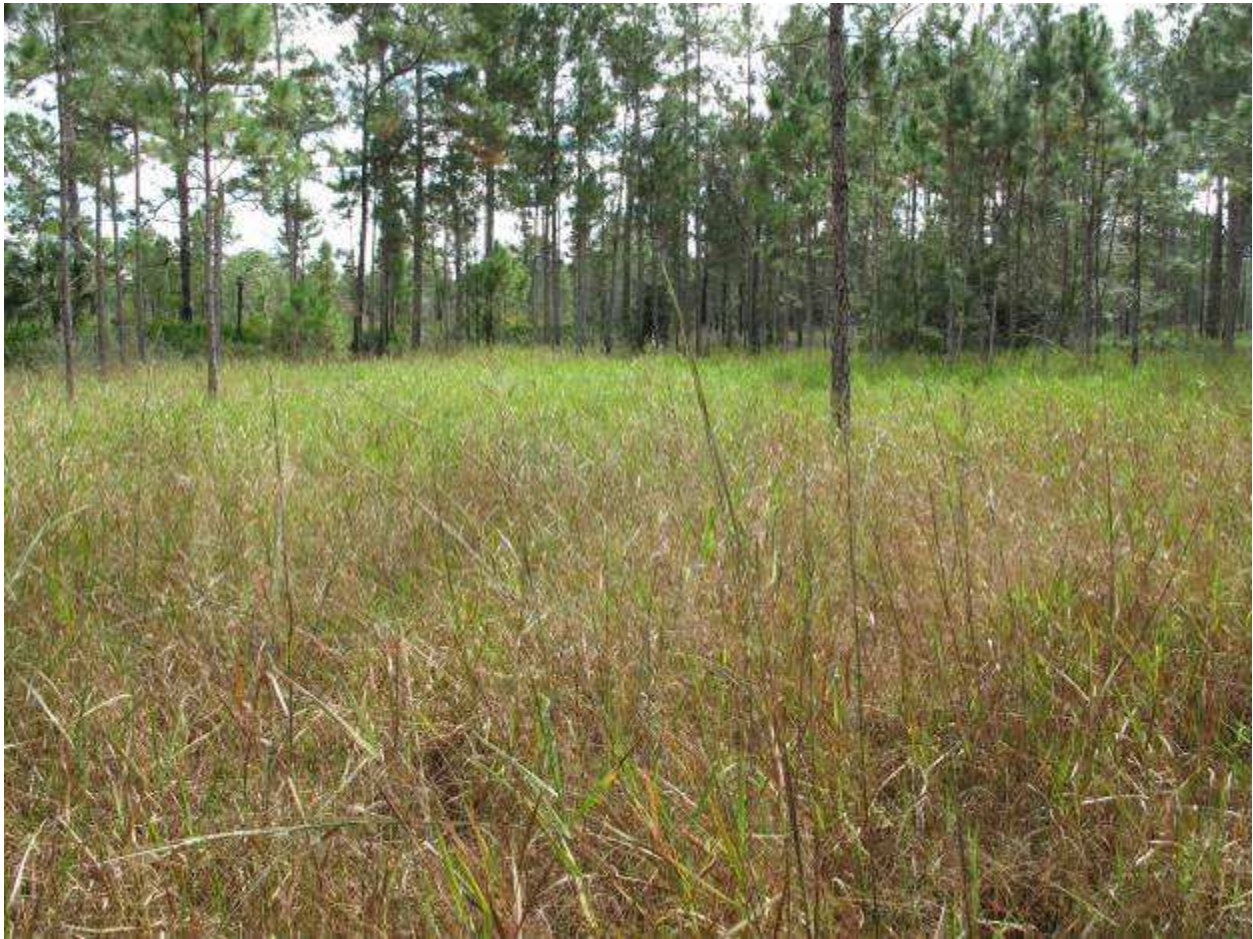
Wetland ID: 59-01

Description: This wetland is a 0.2 ha ephemeral marsh. Pine trees dominate the canopy, and cover 25-50% of the wetland basin. There is no midstory layer. Maidencane grows in the wetland center, and covers 50-75% of the wetland basin. A fireline/MU boundary was constructed adjacent to the wetland on the north side. The boundary separated this wetland from a larger wetland system (Wetland 10-01). The wetlands likely will connect during periods of high water. The adjacent uplands are scrubby flatwoods.

Wetland Concerns: Feral hog damage, Fireline/MU boundary, Woody encroachment

Restoration Action Recommended: In order to restore the hydrology of this wetland and the larger wetland system, the road would have to be removed. Recognizing that this road is now a permanent attribute to the property, we do not recommend any action relating to the road. Remove interior pine trees to reduce the shading effect and encourage the growth of more herbaceous vegetation.

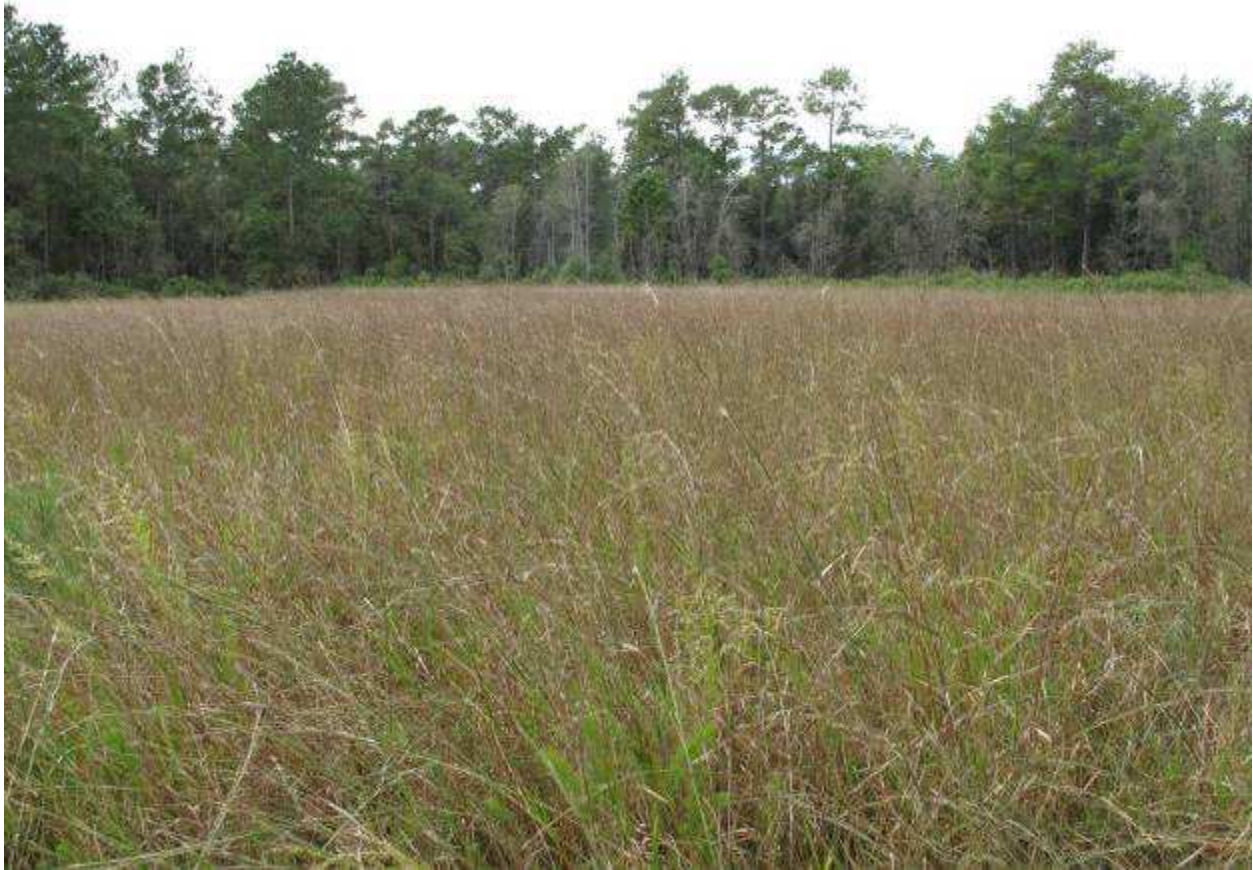
Wetland ID: 59-02

Description: This wetland is a 0.6 ha ephemeral marsh. There is no tree canopy or midstory cover. Maidencane and sedges/grasses grow throughout the wetland, and cover >75% of the basin. There is some minor feral hog damage. The adjacent uplands are an upland pine forest community.

Wetland Concerns: Feral hog damage

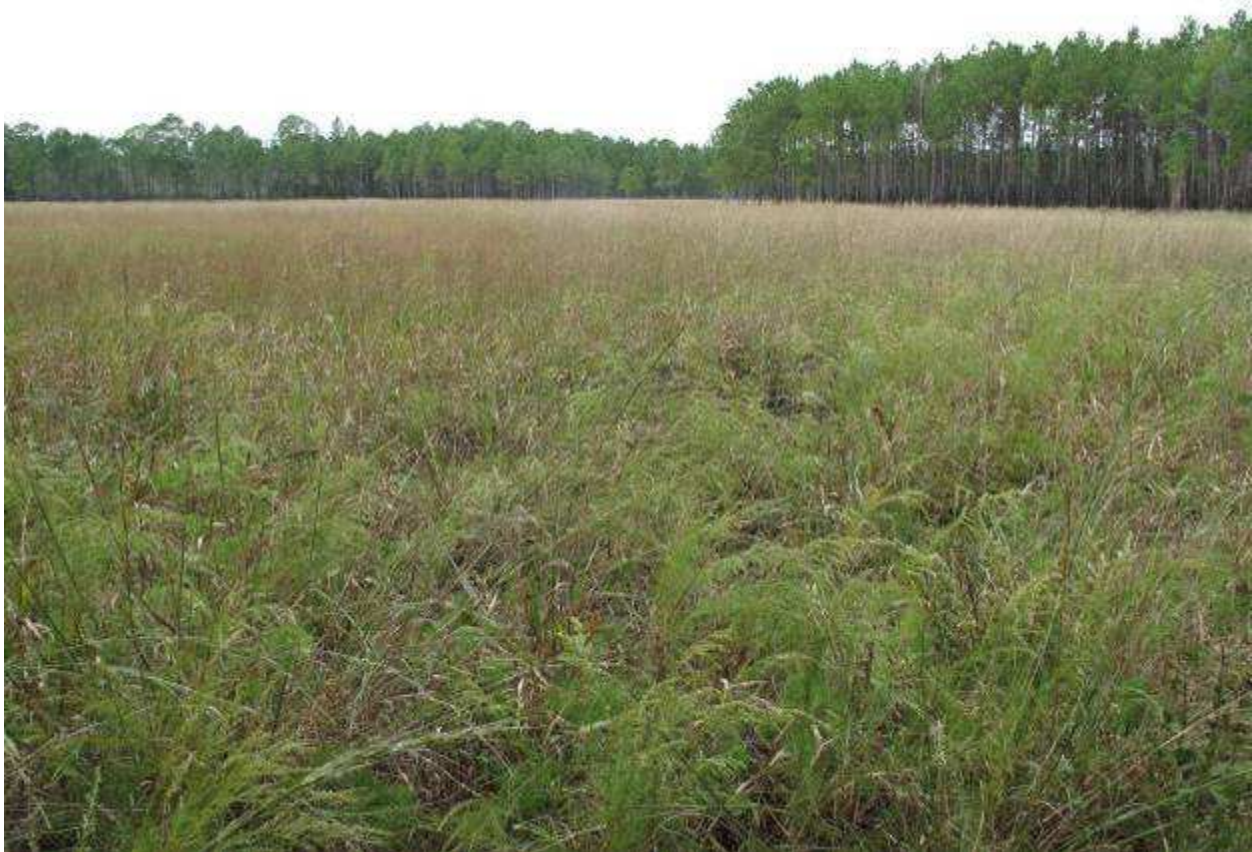
Wetland ID: 59-03

Description: This wetland is a 7.9 ha ephemeral marsh. Pine trees are encroaching from the wetland edge, especially in the northern half, and cover 5-25% of the wetland basin. There is no midstory cover. Maidencane and sedges/grasses grow throughout the wetland, and cover >75% of the basin. There is some minor feral hog damage. The adjacent uplands are mesic flatwoods.

Wetland Concerns: Feral hog damage, Woody encroachment

Restoration Action Recommended: Thin the perimeter pine trees.

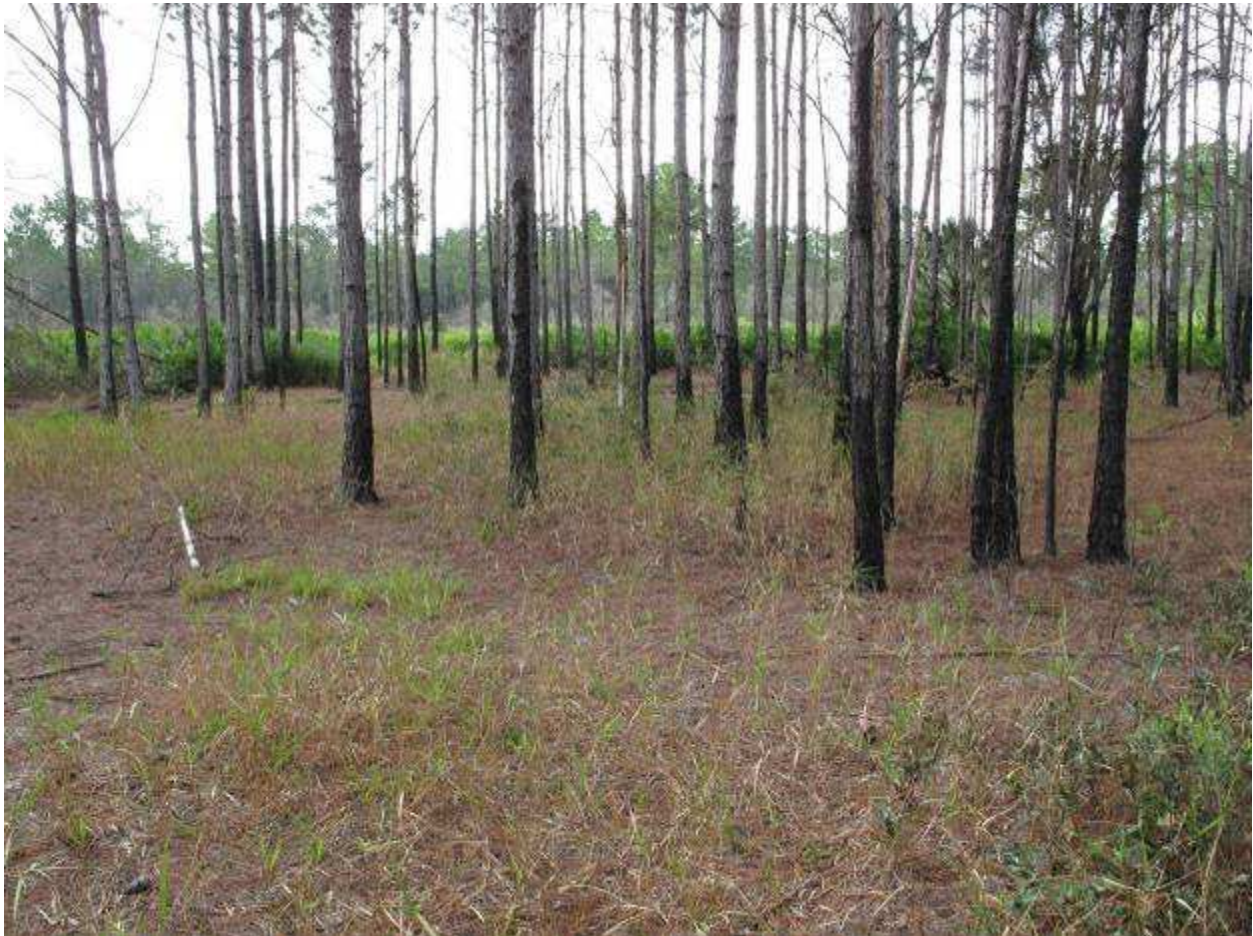
Wetland ID: 59-04

Description: This wetland is a 0.1 ha ephemeral marsh. Large pine trees grow throughout the wetland, and cover 25-50% of the basin. Needle duff is thick under the canopy. There is no midstory cover. Maidencane grows in scattered patches, covering 25-50% of the wetland basin. A recent fire burned through the wetland basin. This wetland provides a perfect example of pine (woody) encroachment. The adjacent uplands are scrubby flatwoods.

Wetland Concerns: Woody encroachment

Restoration Action Recommended: Remove interior pine trees.

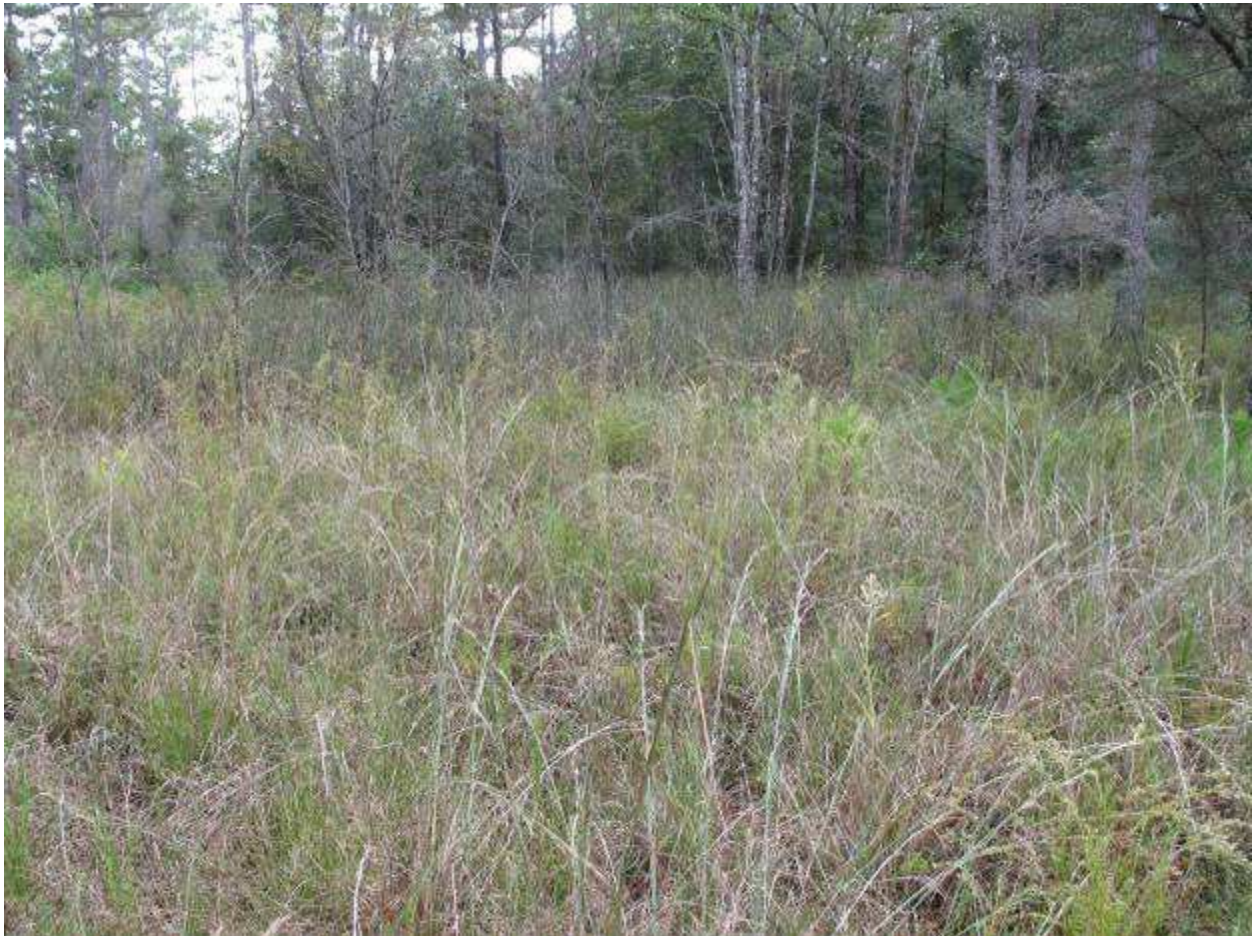
Wetland ID: 59-05

Description: This wetland is a 0.1 ha ephemeral marsh. Gum, pine, and maple trees are beginning to encroach, and cover 5-25% of the wetland basin. A needle duff layer is beginning to form under the pine trees. Sedges/grasses grow throughout the wetland, and cover >75% of the basin. The adjacent uplands are scrubby flatwoods.

Wetland Concerns: Woody encroachment

Restoration Action Recommended: Encourage periodic fire in the wetland basin to reduce the encroaching woody vegetation. Alternatively, the encroaching trees could be hand-removed now.

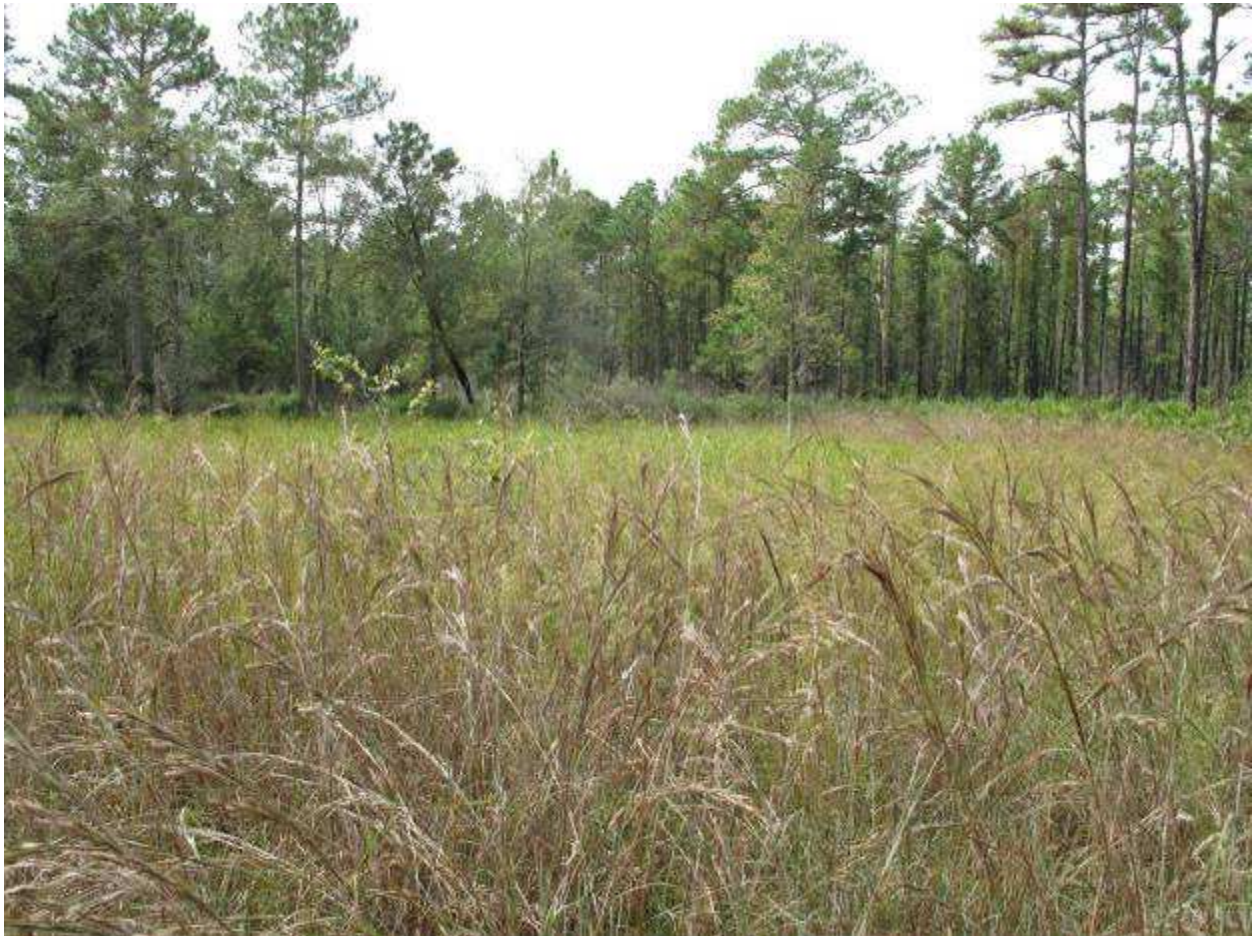
Wetland ID: 59-06

Description: This wetland is a 0.1 ha ephemeral marsh. There is no tree canopy or midstory cover. Sedges/grasses and maidencane grow throughout the wetland, and cover >75% of the basin. This wetland provides a good example of a small, isolated marsh in a pineland ecosystem. The adjacent uplands are scrubby flatwoods.

Wetland Concerns: None

Restoration Action Recommended: None

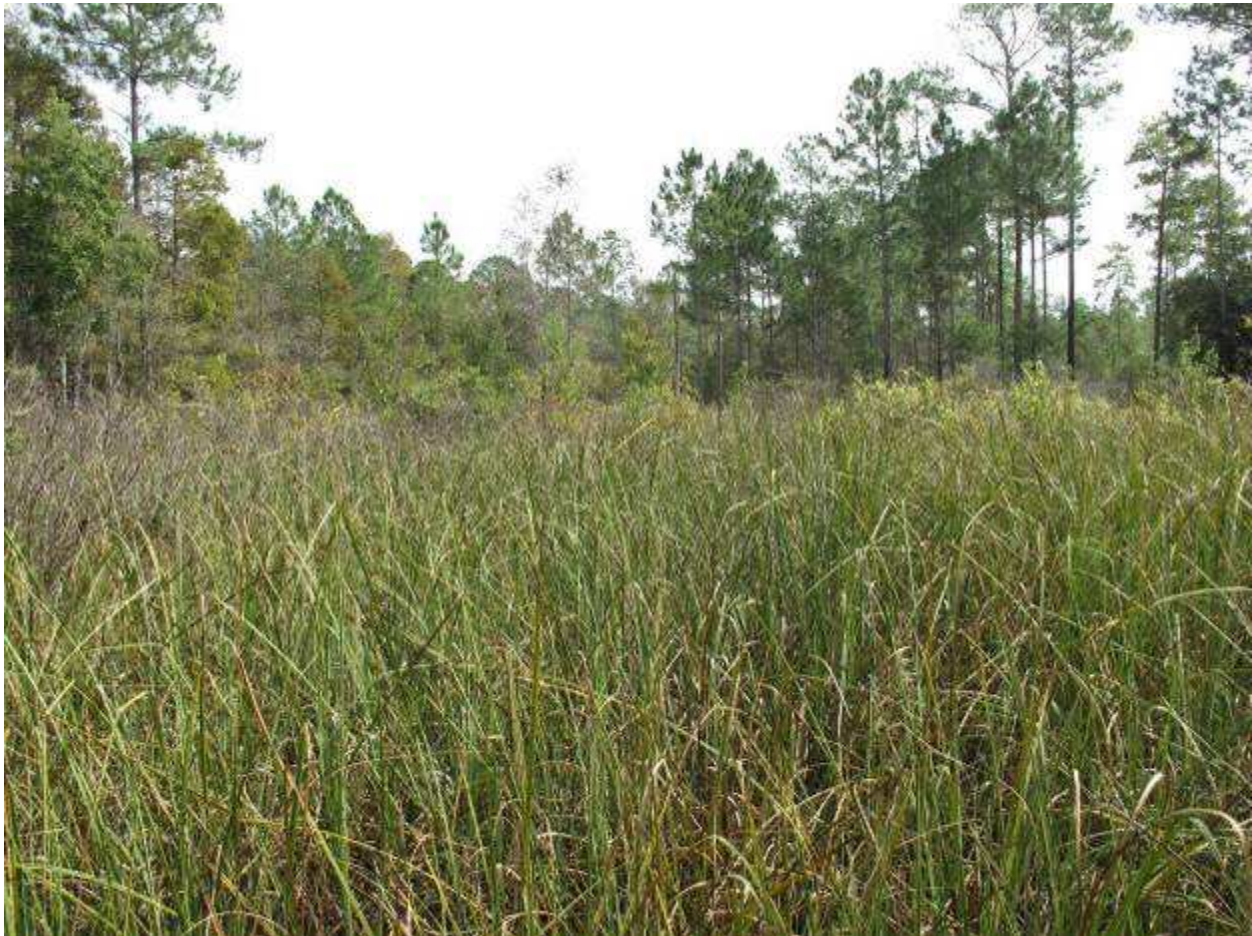
Wetland ID: 59-07

Description: This wetland is a 1.5 ha ephemeral mixed swamp. Cypress trees dominate the tree canopy, and cover 50-75% of the wetland basin. Buttonbush, fetterbush, and wax myrtle dominate the midstory, and cover 50-75% of the wetland. The south side of the wetland is marsh-like with dense sawgrass. Herbaceous vegetation covers 25-50% of the wetland. This wetland shows impacts from fire suppression. A recent fire recently burned through the wetland edges. Hummocks have formed over old tree stumps. The adjacent uplands are scrubby and mesic flatwoods.

Wetland Concerns: Woody encroachment

Restoration Action Recommended: Encourage fire through the wetland basin to reduce the dense interior brush.

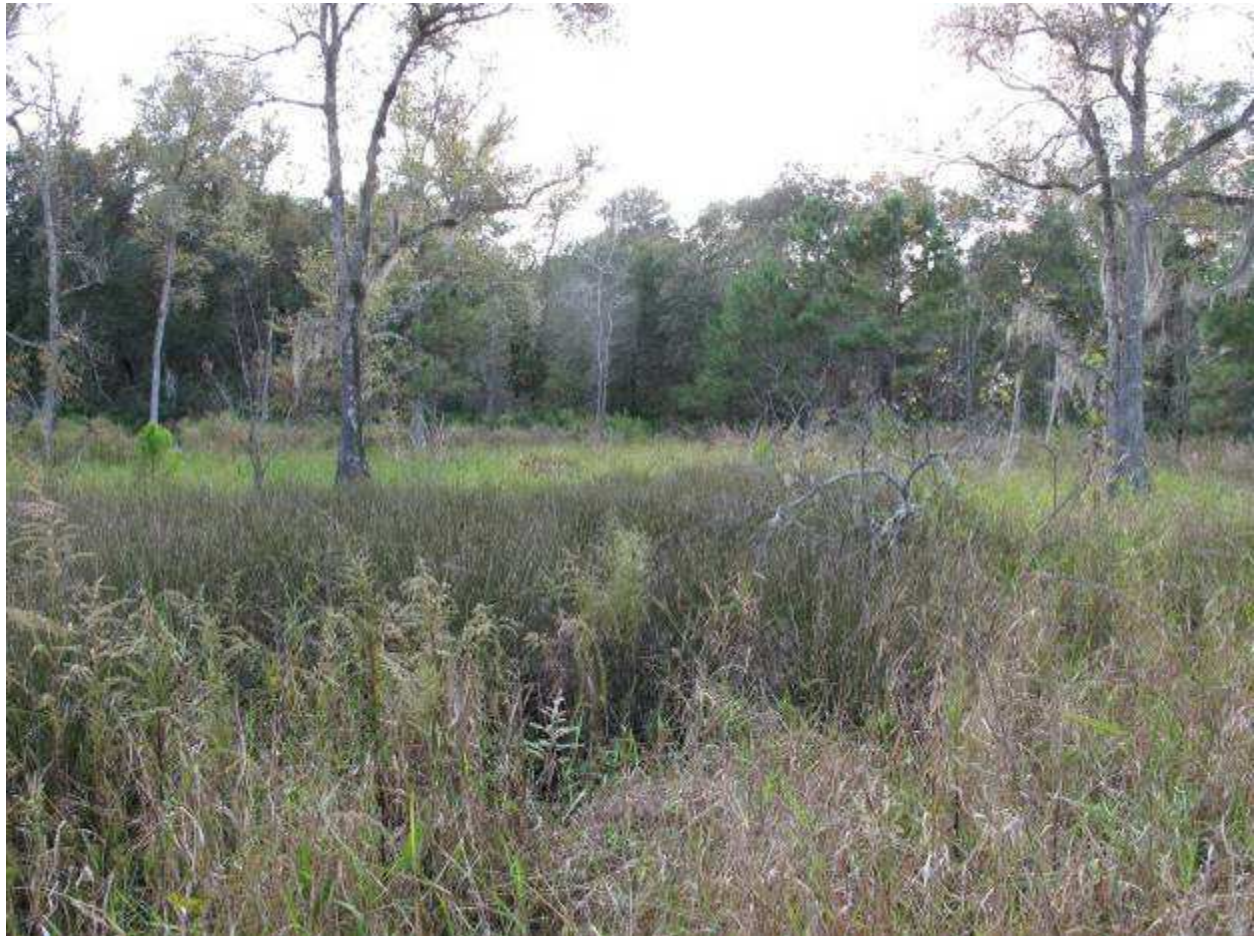
Wetland ID: 60-01

Description: This wetland is a 0.2 ha ephemeral marsh. Several gum trees grow throughout the wetland and pine trees are beginning to encroach. The tree canopy covers 5-25% of the wetland basin. There is no midstory cover. Sedges/grasses, rush, and maidencane grow throughout the wetland, and cover >75% of the basin. The adjacent uplands are fire-suppressed upland hammock.

Wetland Concerns: Woody encroachment

Restoration Action Recommended: Thin the pine trees in the wetland interior.

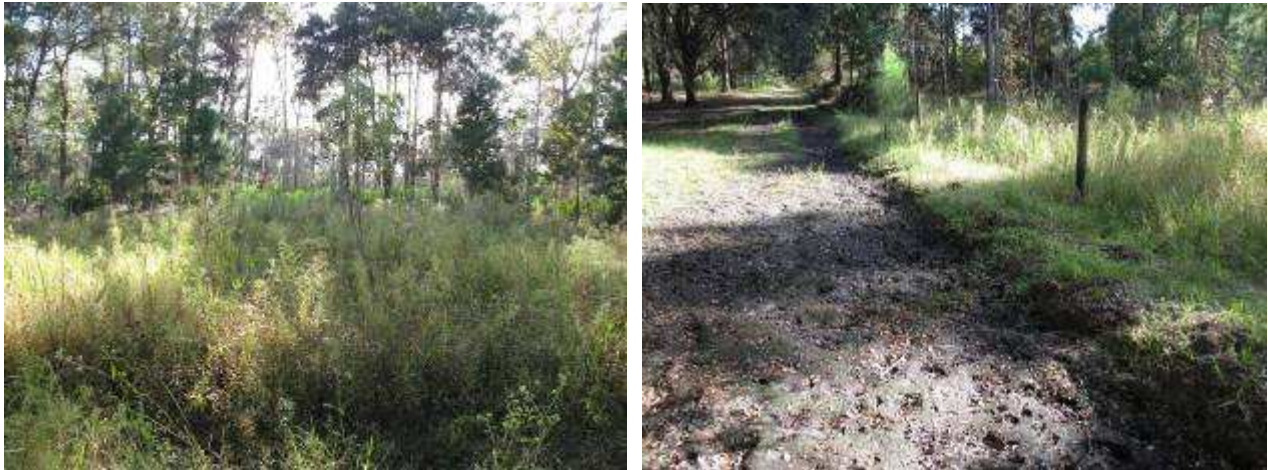
Wetland ID: 60-02

Description: This wetland is a 0.1 ha ephemeral marsh. A MU boundary that divides HMWMA with WMD-owned property bisects the wetland with a fence and firelines are both sides of the fence. The two halves of the wetland vary greatly in their character. Live oaks are shading out the herbaceous vegetation on the WMA side. The wetland basin is leaf-covered and grazed by cattle. The WMD side has encroaching pine vegetation and is choked with herbaceous vegetation. The adjacent uplands are grazed pasture and oak hammock on the WMA side and a fire-suppressed pine/oak community on the WMD side.

Wetland Concerns: Cattle, Fireline/MU boundary, Upland condition, Woody encroachment

Restoration Action Recommended: The fireline/MU boundary should be re-routed away from the wetland if feasible. If the boundary cannot be re-routed, monitor the wetland to ensure fire is not excluded. Maintain the fireline when the wetland is completely dry to prevent ruts from developing. The encroaching oak and pine trees could be thinned in order to reduce the shading effect and encourage the growth of more herbaceous vegetation. In order to restore the full ecological potential of the wetland, the cattle would need to be removed and the uplands restored.

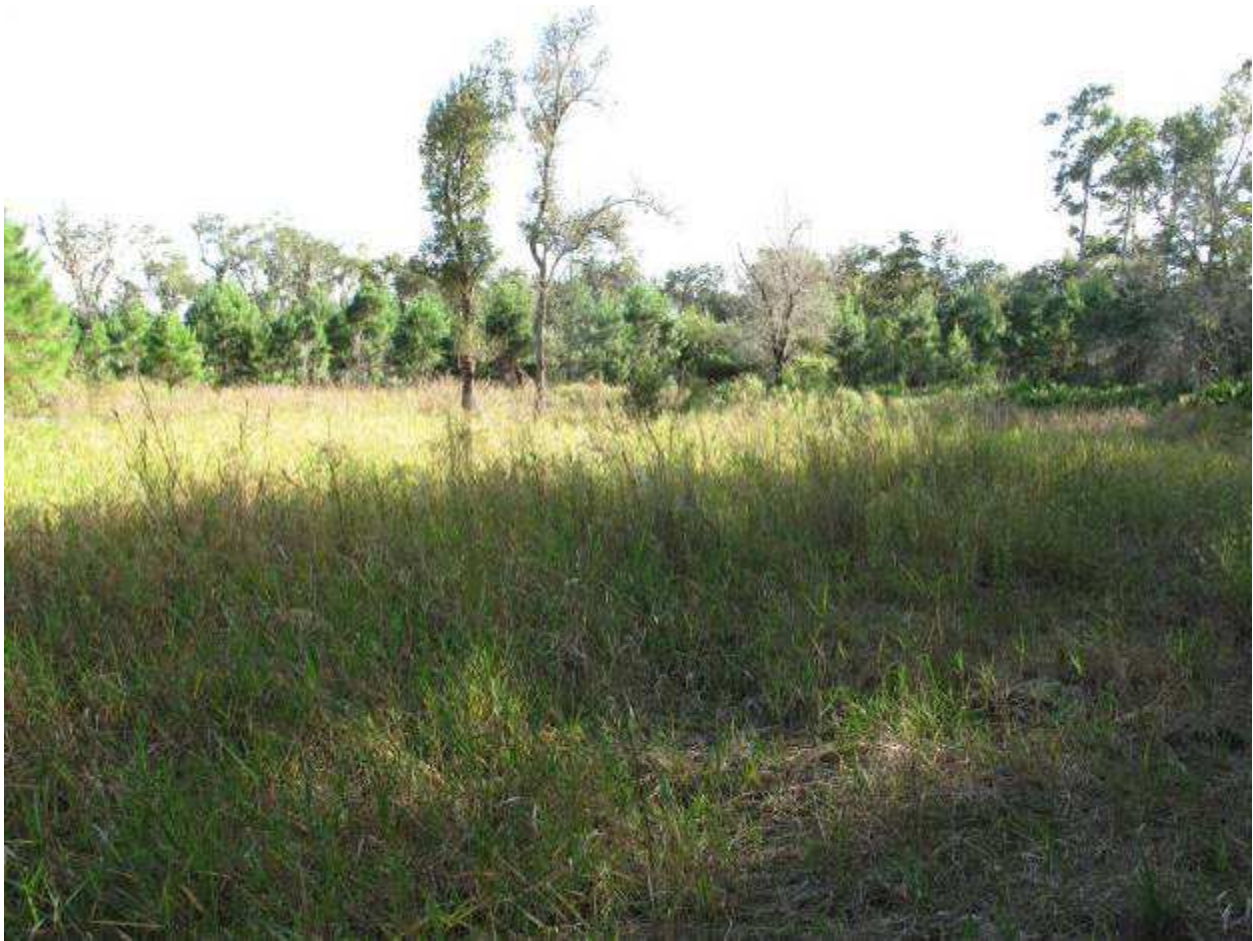
Wetland ID: 60-03

Description: This wetland is a 0.1 ha ephemeral marsh. Pine trees are encroaching from the wetland edge, and cover 5-25% of the wetland basin. There is no midstory cover. Maidencane grows densely throughout the wetland, and covers >75% of the basin. The adjacent uplands are fire-suppressed pine/oak/palmetto thicket.

Wetland Concerns: Woody encroachment

Restoration Action Recommended: Thin perimeter pine trees and encourage a fire to burn through the wetland basin to reduce herbaceous density.
