# **Inventory, Assessment, and Restoration Potential of Ephemeral Wetlands on FFWCC Wildlife Management Areas**

## **Triple N Ranch WMA Final Report**

Submitted by: Rebecca P.M. Means<sup>1</sup>, Ryan C. Means<sup>1</sup>, Steven A. Johnson<sup>2</sup>

15 May 2010 – 15 August 2010

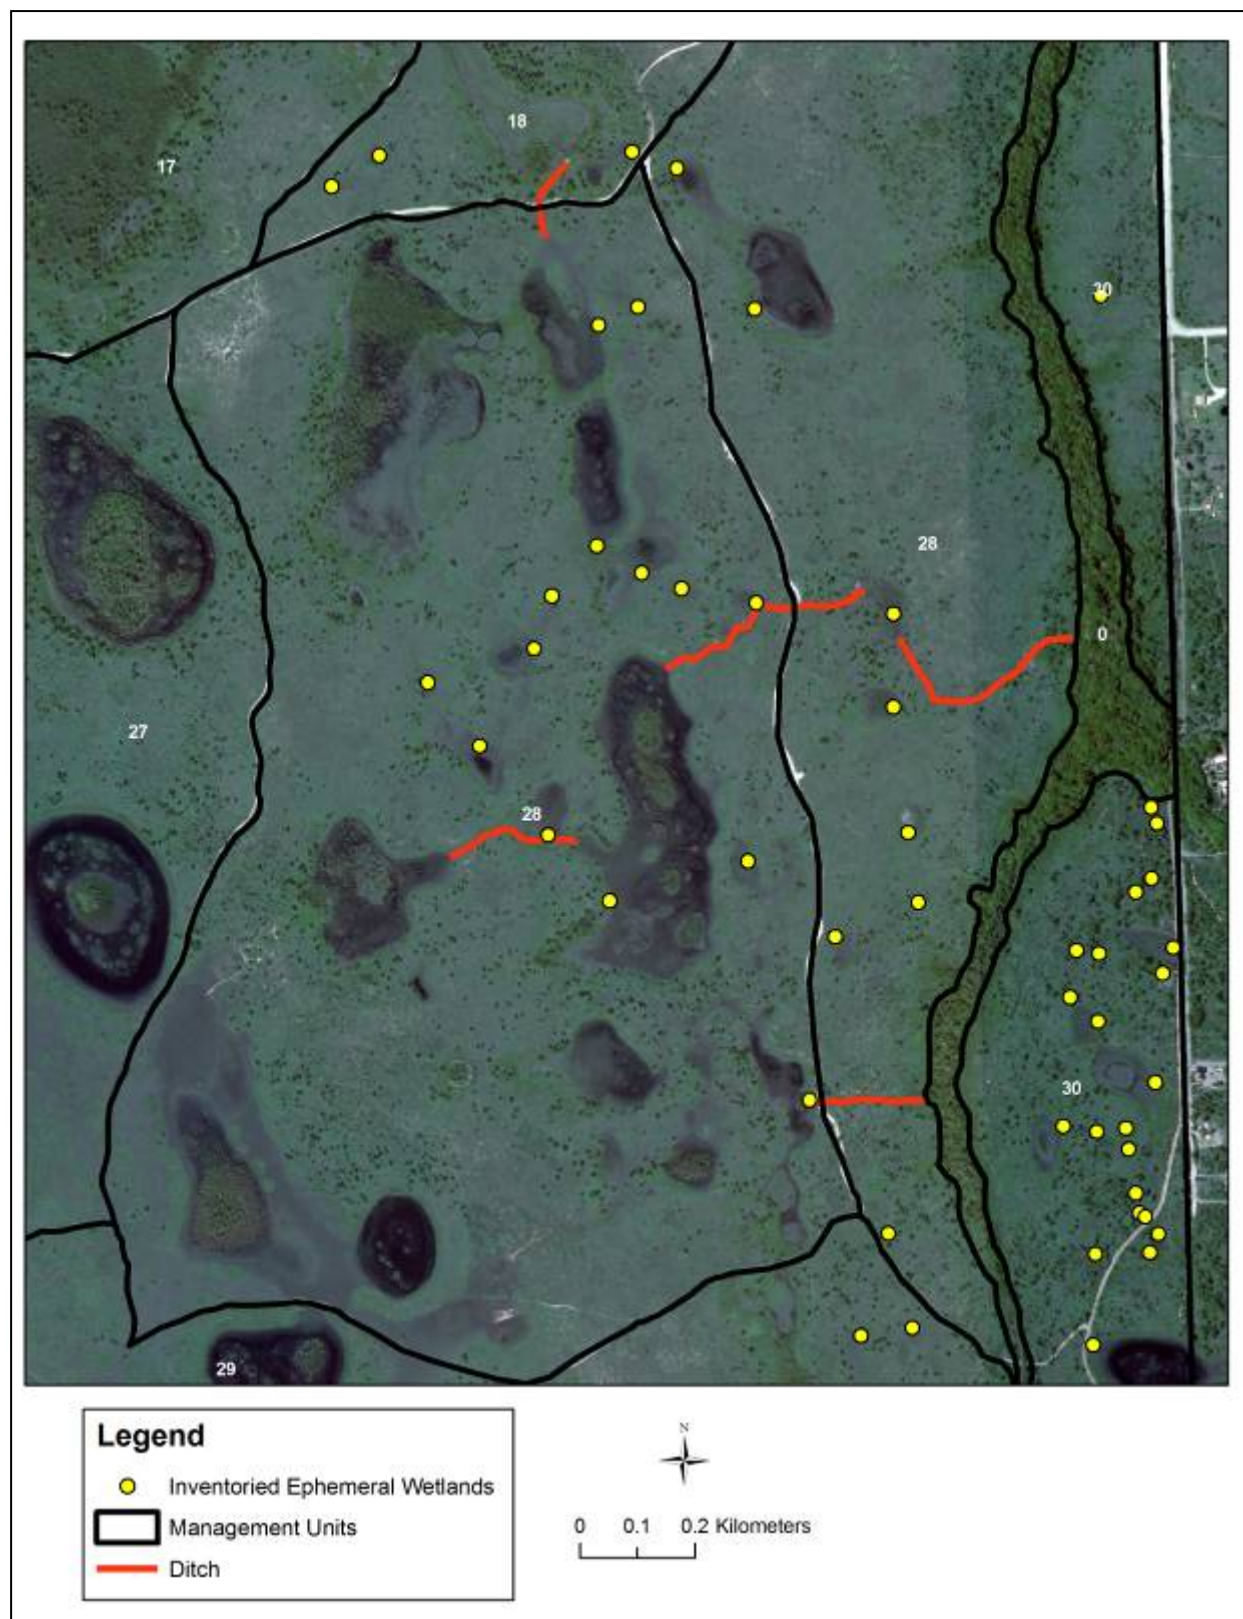
**Figure 4.** Map depicting a system of ditches impacting the hydrology of an area on TNRWMA.

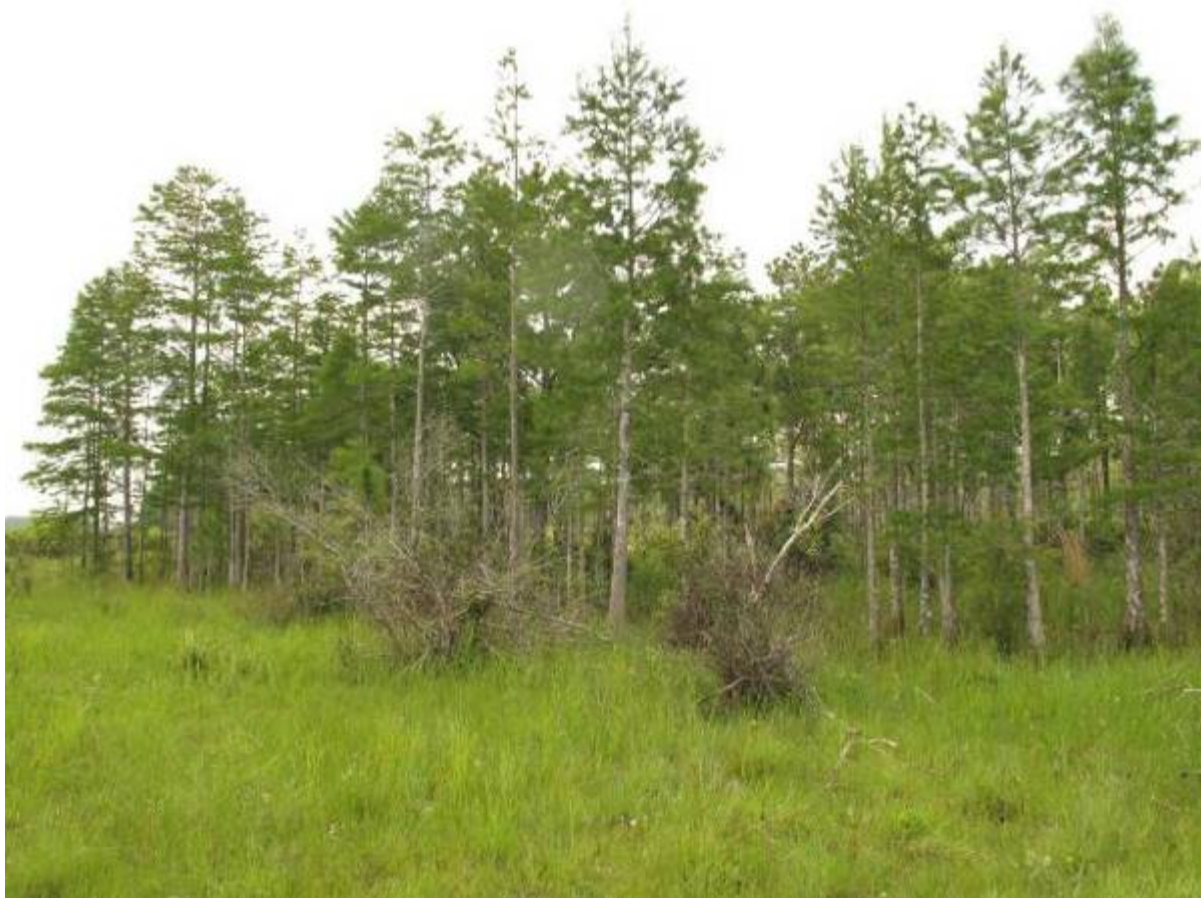
**Wetland ID: 01-01**

**Description:** This wetland is a 0.2 ha ephemeral forested swamp. This circular cypress dome is divided in half by a 1 m tall earthen berm. Cypress trees dominate the northern half of the wetland and a mix of cypress and pine trees dominate the southern half. The tree canopy covers >75% of the basin. Wax myrtle and other shrubs dominate the midstory, and cover 5-25% of the wetland. Sedges/grasses grow throughout the northern half of the wetland and fern grow throughout the southern half. The herbaceous vegetation covers >75% of the basin. There is a heavy presence of cattle in the wetland, including cattle feces. Past fires have burned through the wetland basin. The adjacent uplands are scrubby flatwoods that are managed with prescribed fire.

**Wetland Concerns:** Berm, Cattle

**Restoration Action Recommended:** When the wetland is completely dry, remove the berm and sculpt the area flat. The uplands in this MU are in good ecological condition, although we have observed some cattle-related effects in both wetlands and uplands in some areas. We recommend removing cattle from this unit to prevent destruction of the intact flatwoods community and the embedded wetlands.

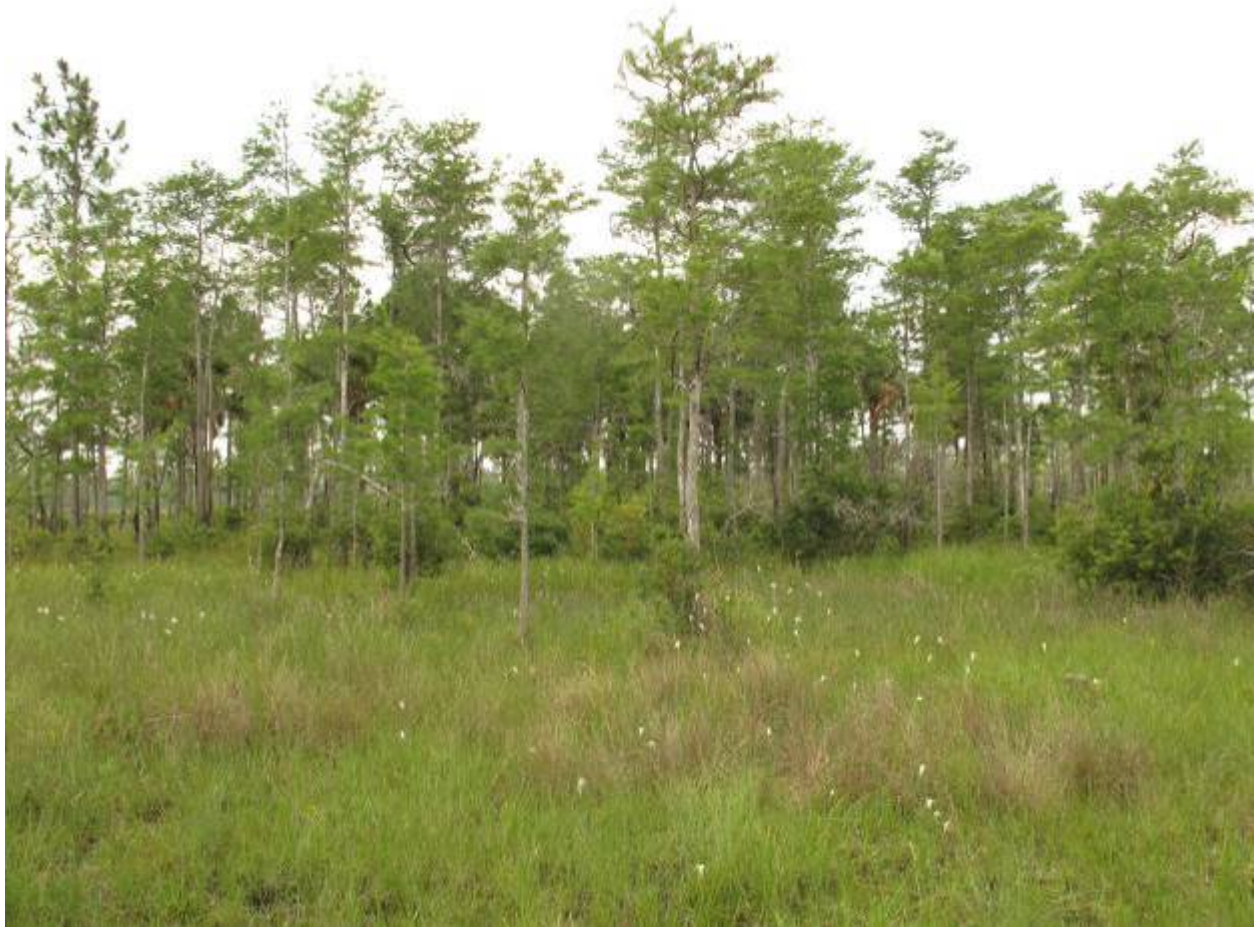
**Wetland ID: 01-02**

**Description:** This wetland is a 0.4 ha ephemeral forested swamp. Cypress, pine, and palm trees dominate the canopy, and cover 50-75% of the basin. There is an island of palmetto in the wetland center. Wax myrtle dominates the midstory, and covers 5-25% of the wetland. Sedges/grasses and fern grow throughout the wetland, and cover >75% of the basin. There is a heavy presence of cattle in the wetland, including cattle trails and feces. Past fires have burned through the wetland basin. The adjacent uplands are scrubby flatwoods that are managed with prescribed fire.

**Wetland Concerns:** Cattle

**Restoration Action Recommended:** The uplands in this MU are in good ecological condition, although we have observed some cattle-related effects in both wetlands and uplands in some areas. We recommend removing cattle from this unit to prevent destruction of the intact flatwoods community and the embedded wetlands.

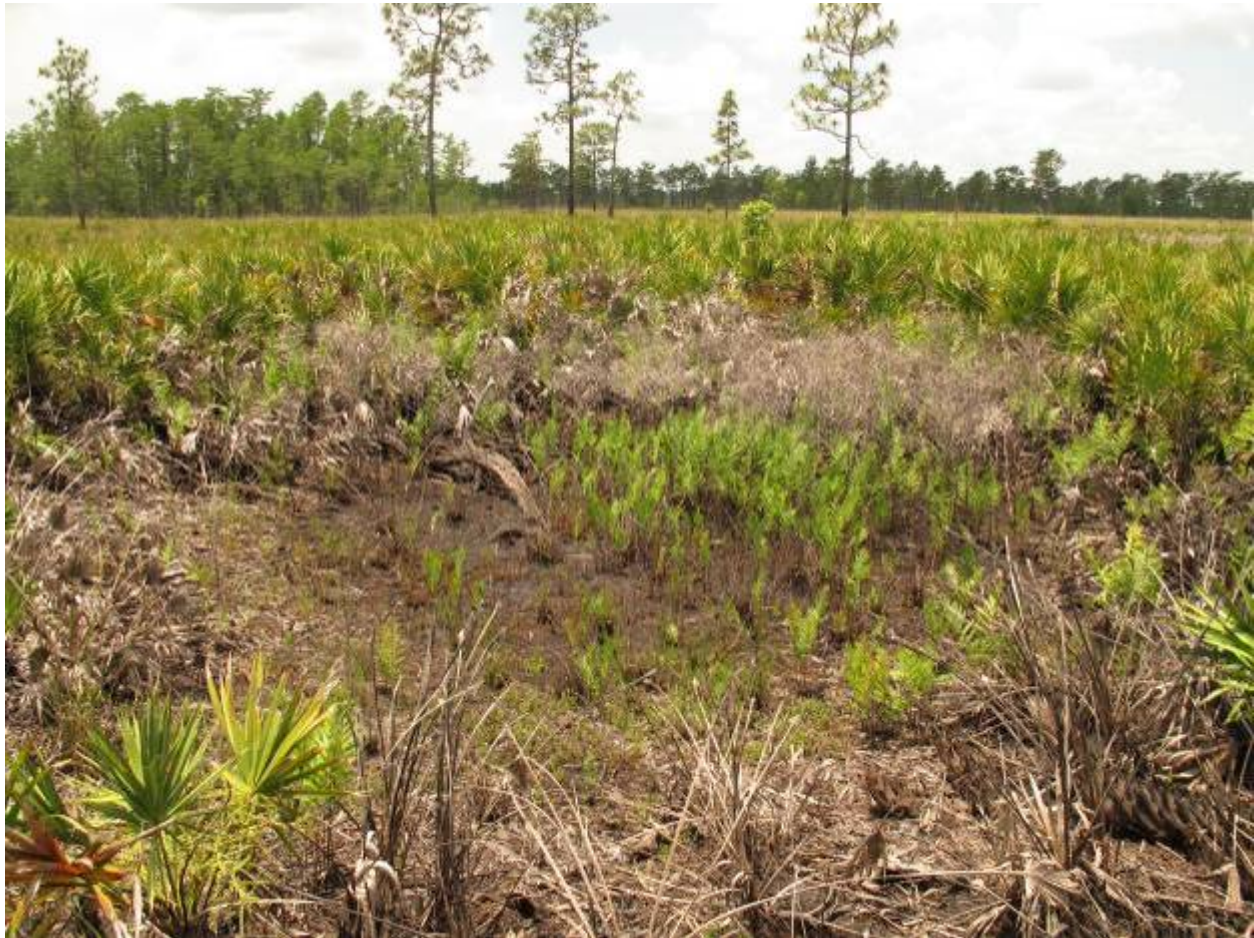
**Wetland ID: 02-01**

**Description:** This wetland is a <0.1 ha ephemeral marsh. There is no tree canopy or midstory cover. Fern grow in the wetland center and sedges/grasses predominately grow in a ring around the wetland edge. The herbaceous vegetation covers 50-75% of the basin. The wetland has steep sides and is a ‘pothole’ pond in a circular sink depression. The adjacent uplands are mesic flatwoods with some patches of scrubby flatwoods. The uplands are managed with prescribed fire. Cattle are allowed in this MU and animal trails are abundant in the uplands.

**Wetland Concerns:** None

**Restoration Action Recommended:** The uplands in this MU are in good ecological condition, although we have observed some cattle-related effects in both wetlands and uplands in some areas. We recommend removing cattle from this unit to prevent destruction of the intact flatwoods community and the embedded wetlands.

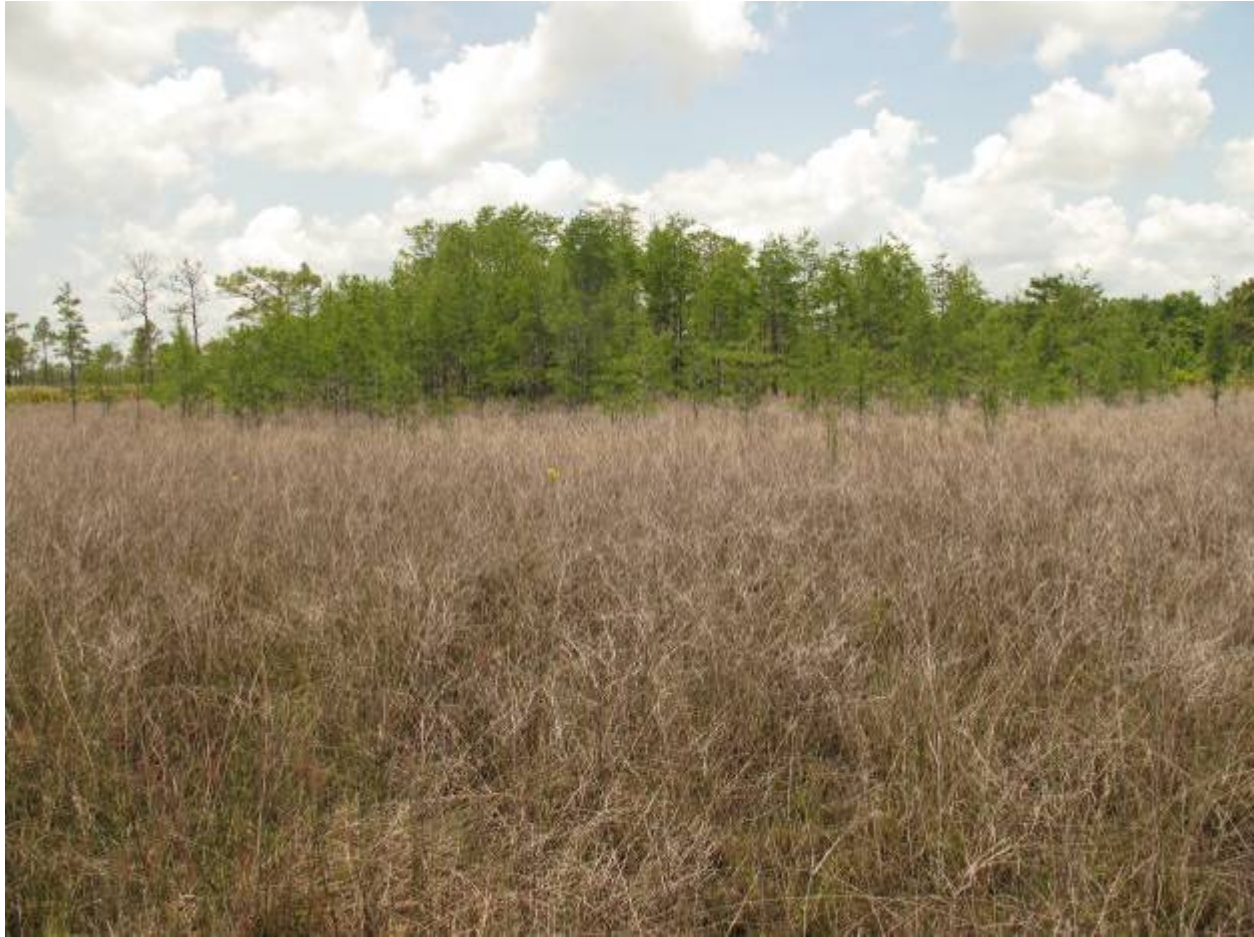
**Wetland ID: 02-02**

**Description:** This wetland is a 0.5 ha ephemeral marsh. A young cypress dome is forming in the center and covers 25-50% of the wetland. The rest of the wetland is open with abundant and recently killed stems of *Hypericum*. Sedges/grasses grow throughout the wetland, and cover 50-75% of the basin. The east end of the wetland has a sandy area denude of vegetation. This area may be a result of grazing pressure; there are cattle tracks and feces present. The adjacent uplands are mesic flatwoods with some patches of scrubby flatwoods. The uplands are managed with prescribed fire. Cattle are allowed in this MU and animal trails are abundant in the uplands.

**Wetland Concerns:** Cattle

**Restoration Action Recommended:** The uplands in this MU are in good ecological condition, although we have observed some cattle-related effects in both wetlands and uplands in some areas. We recommend removing cattle from this unit to prevent destruction of the intact flatwoods community and the embedded wetlands.

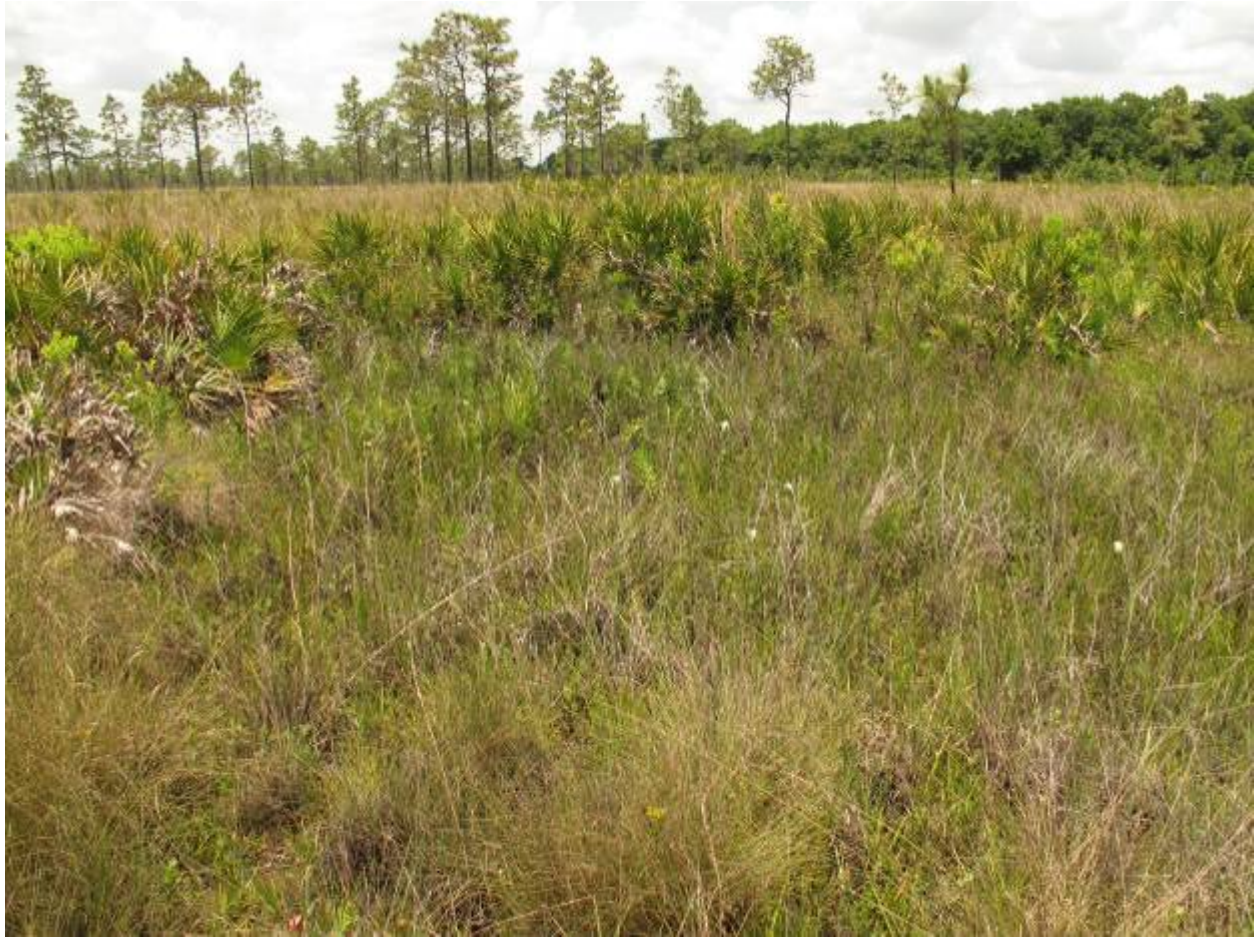
**Wetland ID: 02-03**

**Description:** This wetland is a <0.1 ha ephemeral marsh. There is no tree canopy or midstory cover. The herbaceous vegetation is diverse and covers >75% of the basin. We observed no evidence of cattle in the wetland, although cattle are allowed in this MU. The adjacent uplands are mesic flatwoods with some patches of scrubby flatwoods. The uplands are managed with prescribed fire.

**Wetland Concerns:** None

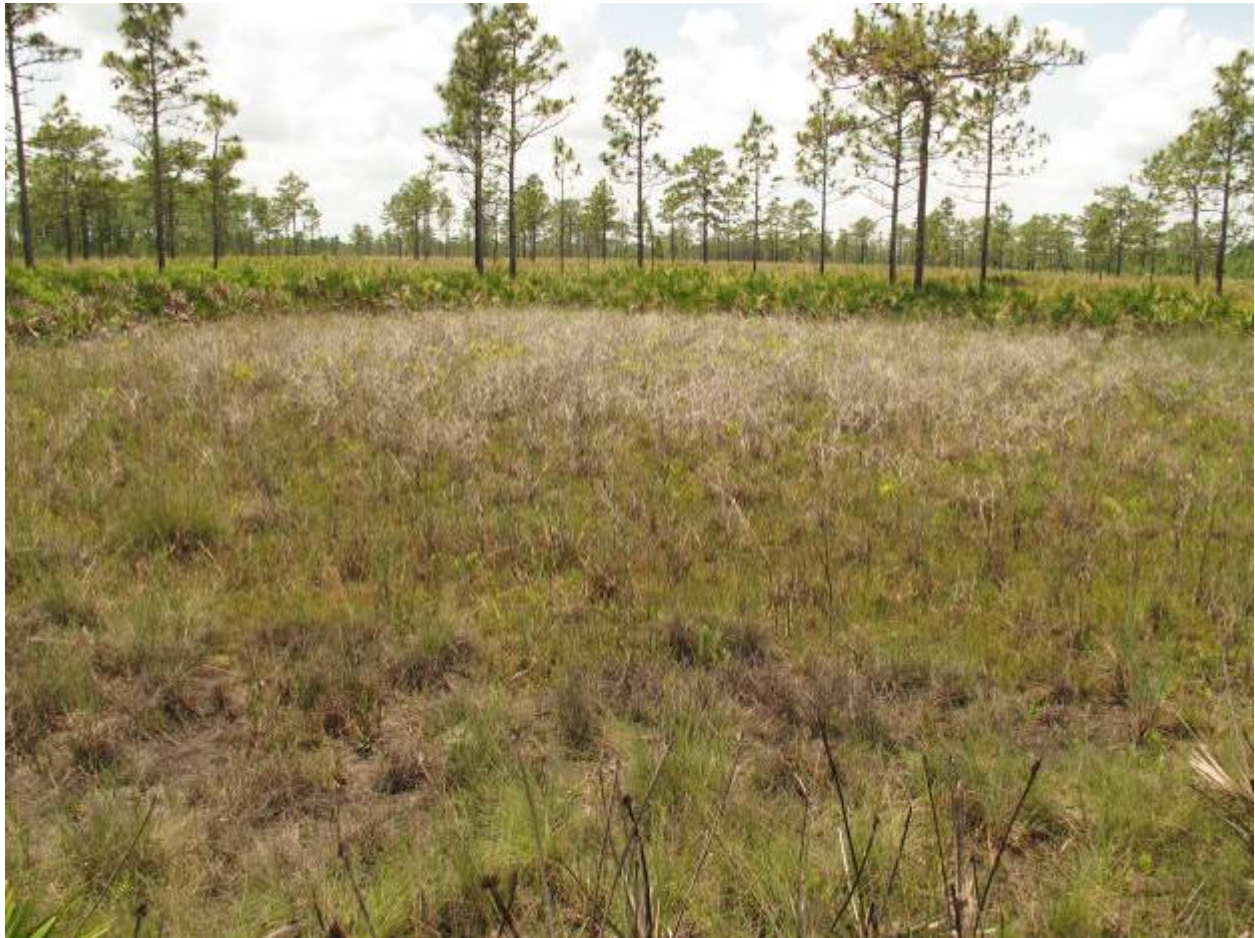
**Wetland ID: 02-04**

**Description:** This wetland is a <0.1 ha ephemeral marsh. There is no tree canopy or midstory cover. Dead *Hypericum* stems are abundant due to inundation, as are broomsedge and other herbaceous vegetation. The herbaceous vegetation covers >75% of the basin. There is evidence of cattle grazing in and around the wetland, including trails and cattle feces. The adjacent uplands are mesic flatwoods with some patches of scrubby flatwoods. The uplands are managed with prescribed fire.

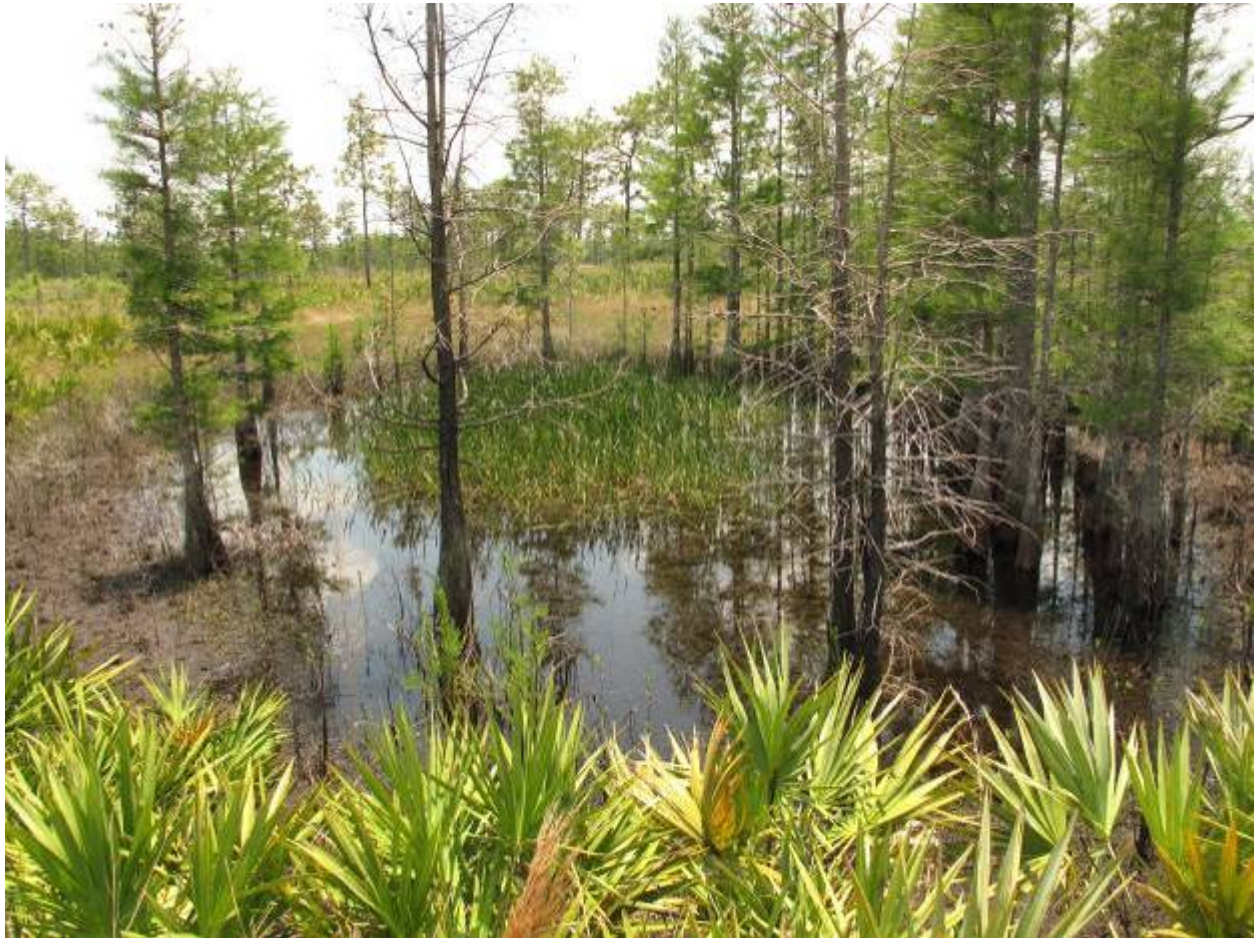
**Description:** This wetland is a <0.1 ha ephemeral marsh. Small cypress trees grow in a ring around the wetland, and cover 5-25% of the basin. There is no midstory cover. Emergent vegetation grows in the wetland center and sedges/grasses around the outer edge. The herbaceous vegetation covers 50-75% of the basin. Small fish (*Gambusia*) were present on the day of our visit. We observed no evidence of cattle in the wetland, although cattle are allowed in this MU. The adjacent uplands are a mix of scrubby and mesic flatwoods that are managed with prescribed fire.

**Wetland Concerns:** Cattle, Vehicular damage

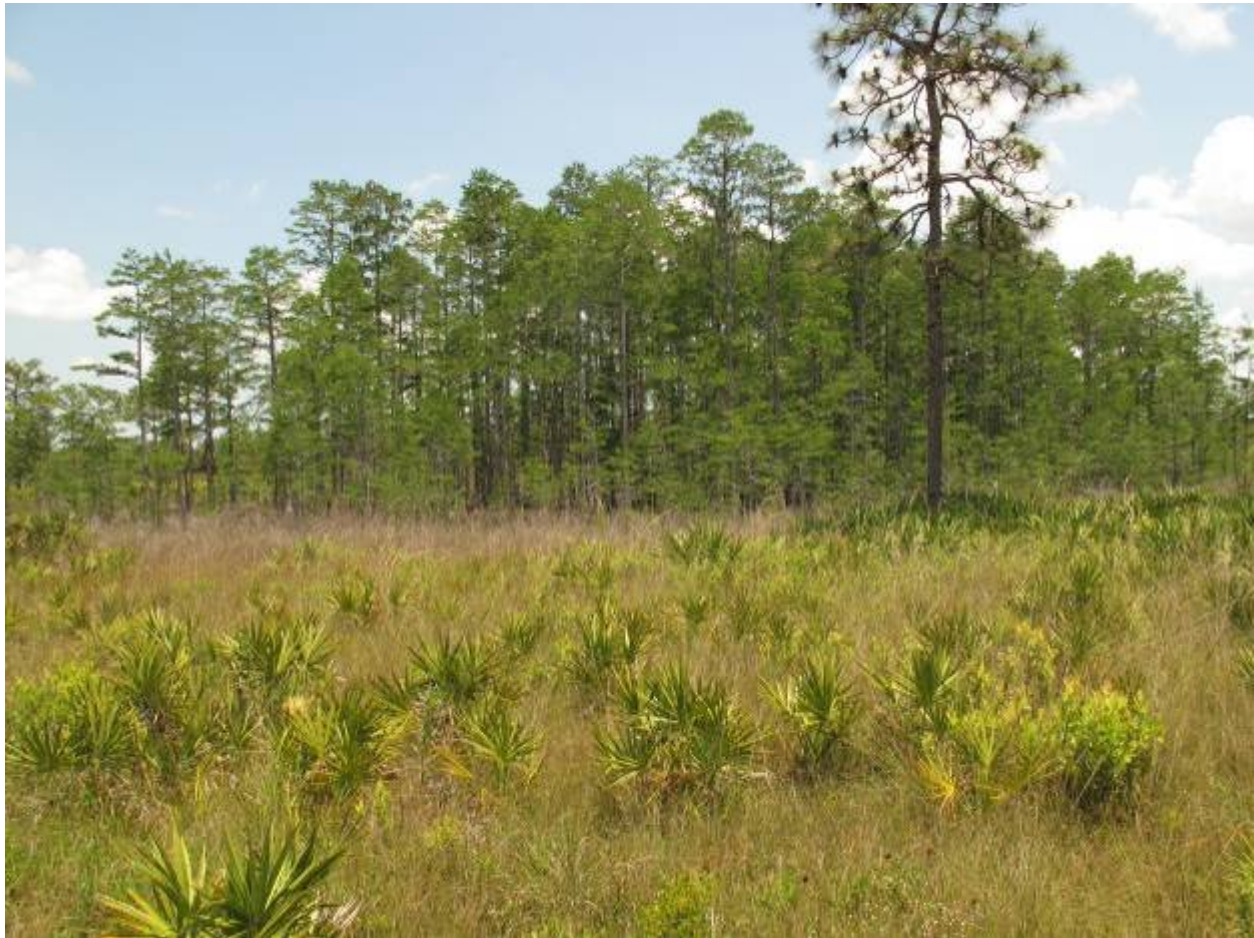
**Wetland ID: 02-06**

**Description:** This wetland is a 0.5 ha semi-permanent marsh likely succeeding to a cypress dome. Cypress trees grow in the wetland interior, and cover 50-75% of the basin. There is no midstory cover. The outer half of the wetland is an open grassy marsh with *Hypericum*. The herbaceous vegetation covers 50-75% of the basin. There are cattle tracks and feces in the wetland. Fresh ATV tracks are present around the wetland edge. The adjacent uplands are a mix of scrubby and mesic flatwoods that are managed with prescribed fire.

**Restoration Action Recommended:** The uplands in this MU are in good ecological condition, although we have observed some cattle-related effects in both wetlands and uplands in some areas. We recommend removing cattle from this unit to prevent destruction of the intact flatwoods community and the embedded wetlands. The ATV tracks are not severe and are likely a one-time occurrence. We mention it here to highlight a general concern about driving vehicles in and around wetlands.

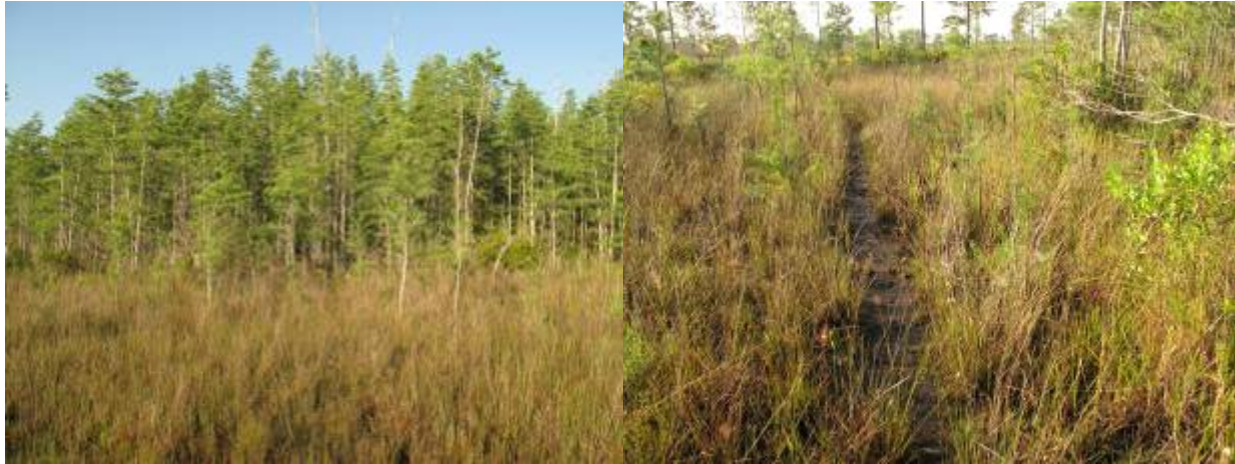
**Wetland ID: 02-07**

**Description:** This wetland is a 0.7 ha ephemeral forested swamp. The wetland was likely a marsh that has succeeded to a cypress dome. Cypress trees grow in the wetland interior, and cover 50-75% of the basin. There is no midstory cover. Sedges/grasses grow around the wetland edges, and cover 50-75% of the basin. There are animal trails, likely cattle, around the wetland edge. The adjacent uplands are mesic flatwoods that are managed with prescribed fire.

**Wetland Concerns:** Cattle

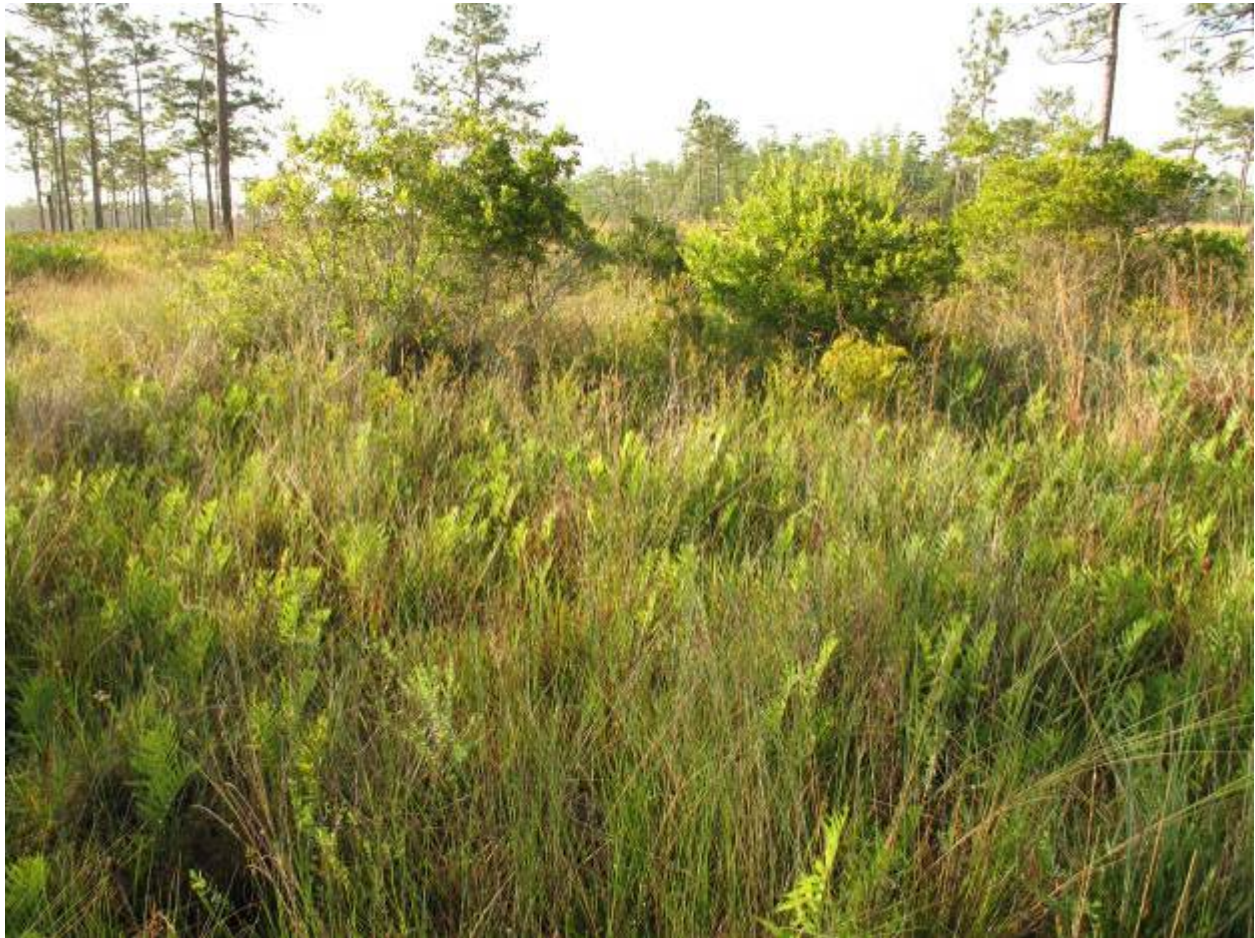
**Description:** This wetland is a 0.1 ha highly ephemeral marsh. There is no tree canopy cover. A small patch of wax myrtle grows in the wetland center, and covers 5-25% of the basin. There are several old dead wax myrtle shrubs as well, likely killed during the last fire. Fern and sedges/grasses grow throughout the wetland, and cover >75% of the basin. We observed no evidence of cattle in the wetland, although cattle are allowed in this MU. The adjacent uplands are a mix of scrubby and mesic flatwoods that are managed with prescribed fire.

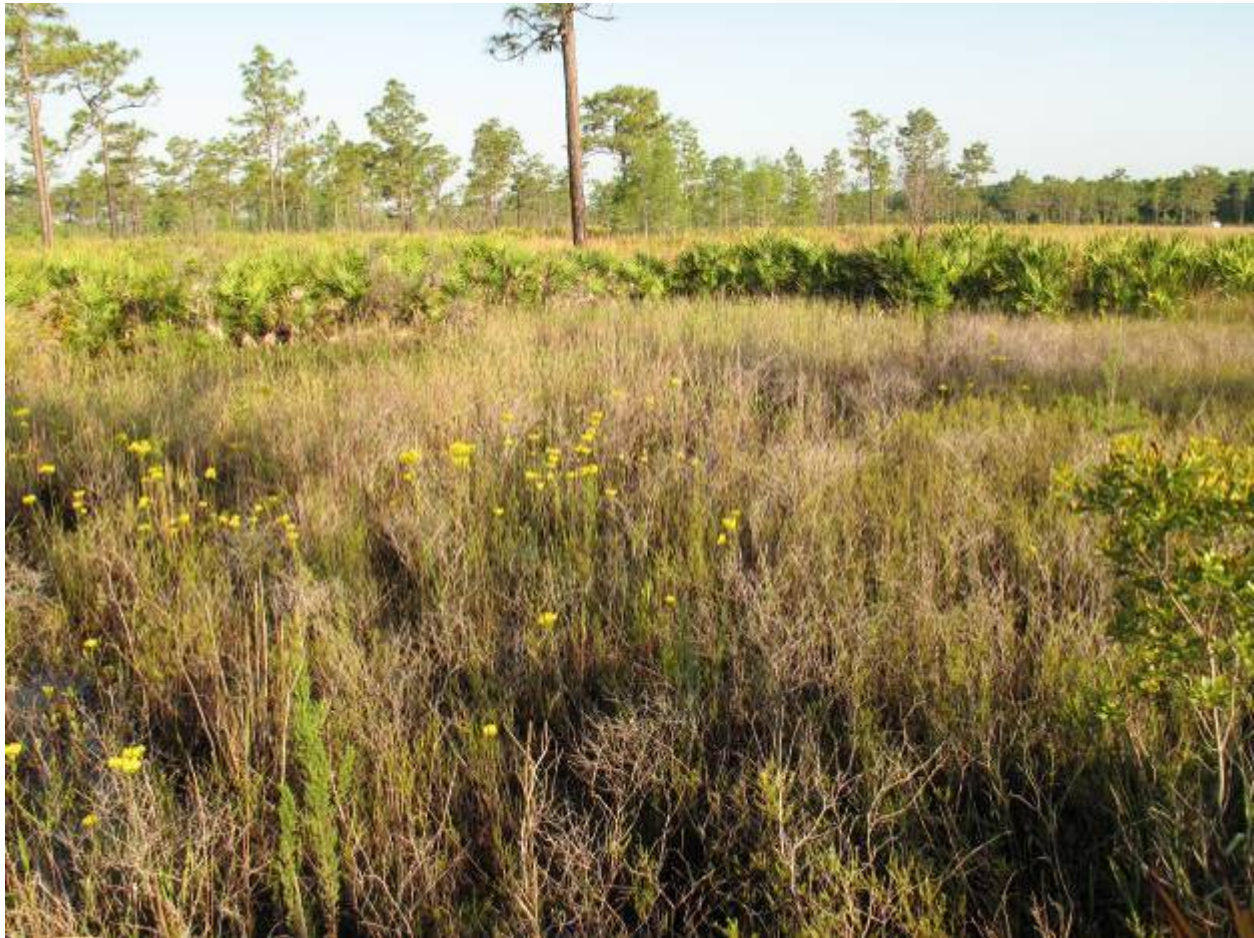
**Wetland ID: 02-09**

**Description:** This wetland is a <0.1 ha ephemeral marsh. There is no tree canopy or midstory cover. Maidencane grows in a patch on the deeper west side of the wetland, sedges/grasses grow throughout the wetland. The herbaceous vegetation covers >75% of the basin. Cattle trails are light on the east side of the wetland. The adjacent uplands are a mix of scrubby and mesic flatwoods that are managed with prescribed fire.

**Wetland Concerns:** Cattle

**Restoration Action Recommended:** The uplands in this MU are in good ecological condition, although we have observed some cattle-related effects in both wetlands and uplands in some areas. We recommend removing cattle from this unit to prevent destruction of the intact flatwoods community and the embedded wetlands.

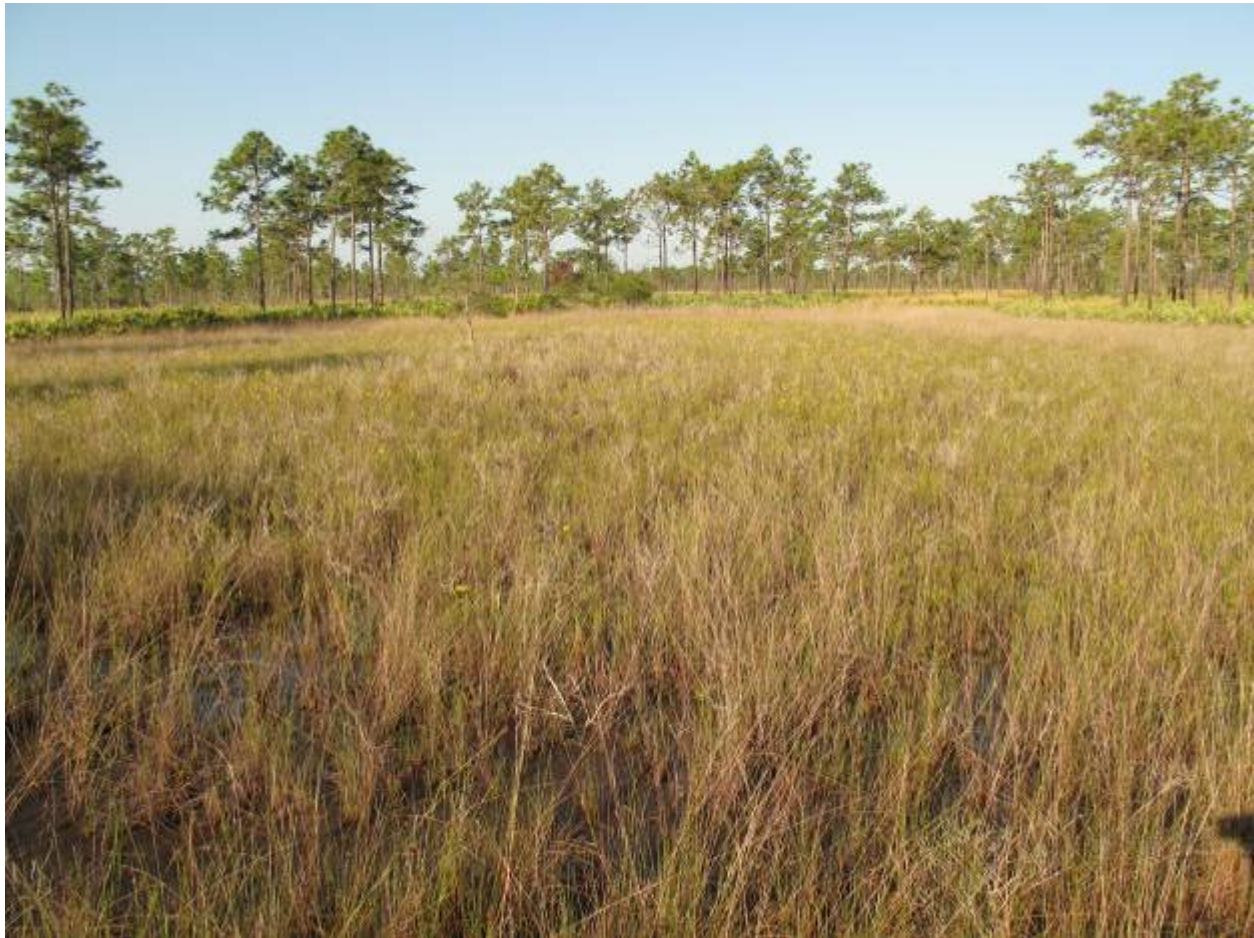
**Wetland ID: 02-10**

**Description:** This wetland is a 0.5 ha ephemeral marsh. There is no tree canopy or midstory cover. *Hypericum* is abundant in the wetland. Sedges/grasses grow throughout the wetland, and cover >75% of the basin. There are cattle trails around the wetland edge. The wetland appears to be healthy with diverse herbaceous vegetation, despite the presence of cattle. The adjacent uplands are a mix of scrubby and mesic flatwoods that are managed with prescribed fire.

**Wetland Concerns:** Cattle

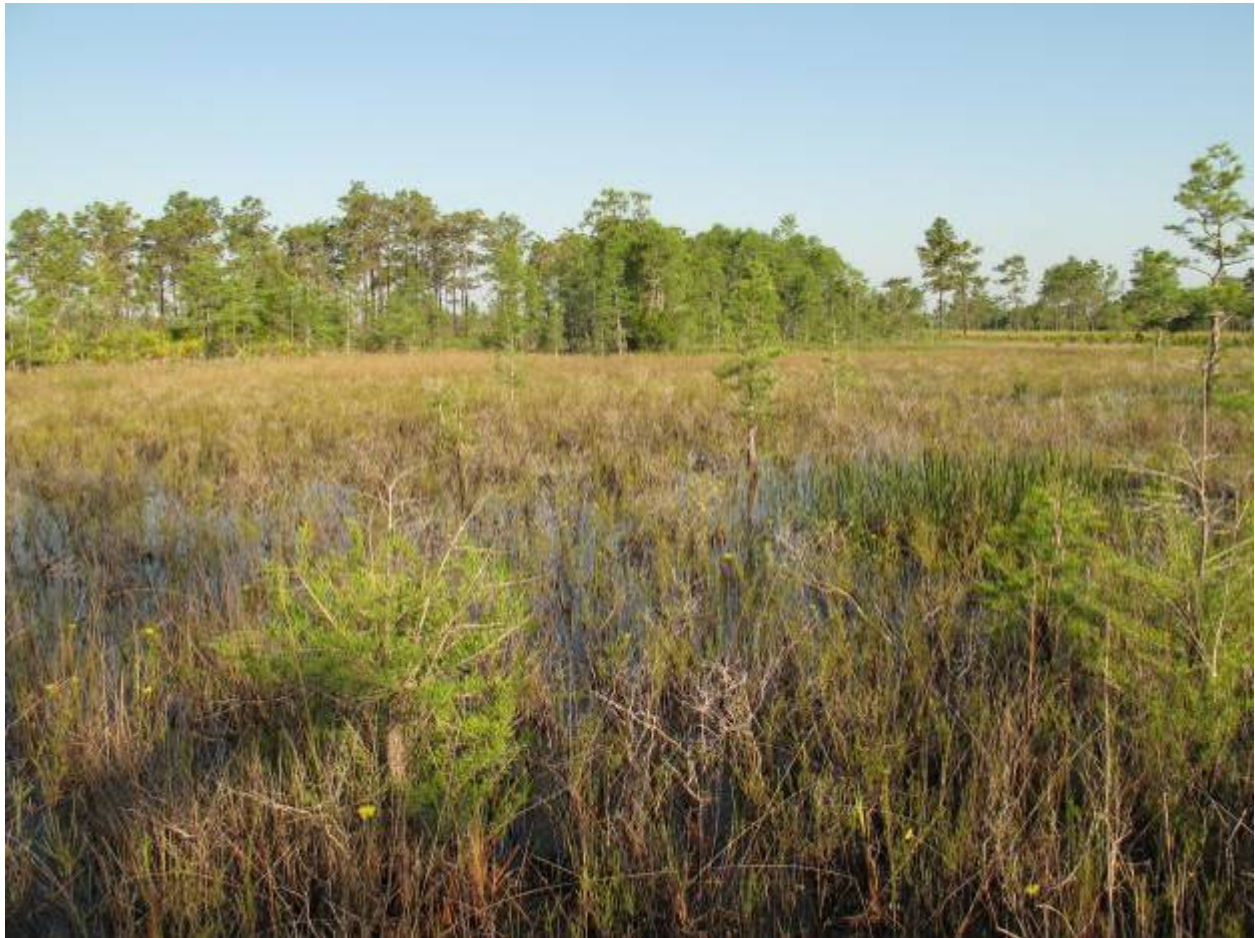
**Description:** This wetland is a 1.0 ha semi-permanent marsh. Two deeper holes on the north and west sides of the wetland have become cypress domes. Small cypress trees grow scattered across the whole wetland basin as well. The cypress trees cover 5-25% of the wetland. Sedges/grasses and maidencane grow throughout the wetland, and cover 50-75% of the basin. Cattle trails and grazing are evident around the wetland edge. Fish were present on the day of our visit. The adjacent uplands are a mix of scrubby and mesic flatwoods that are managed with prescribed fire.

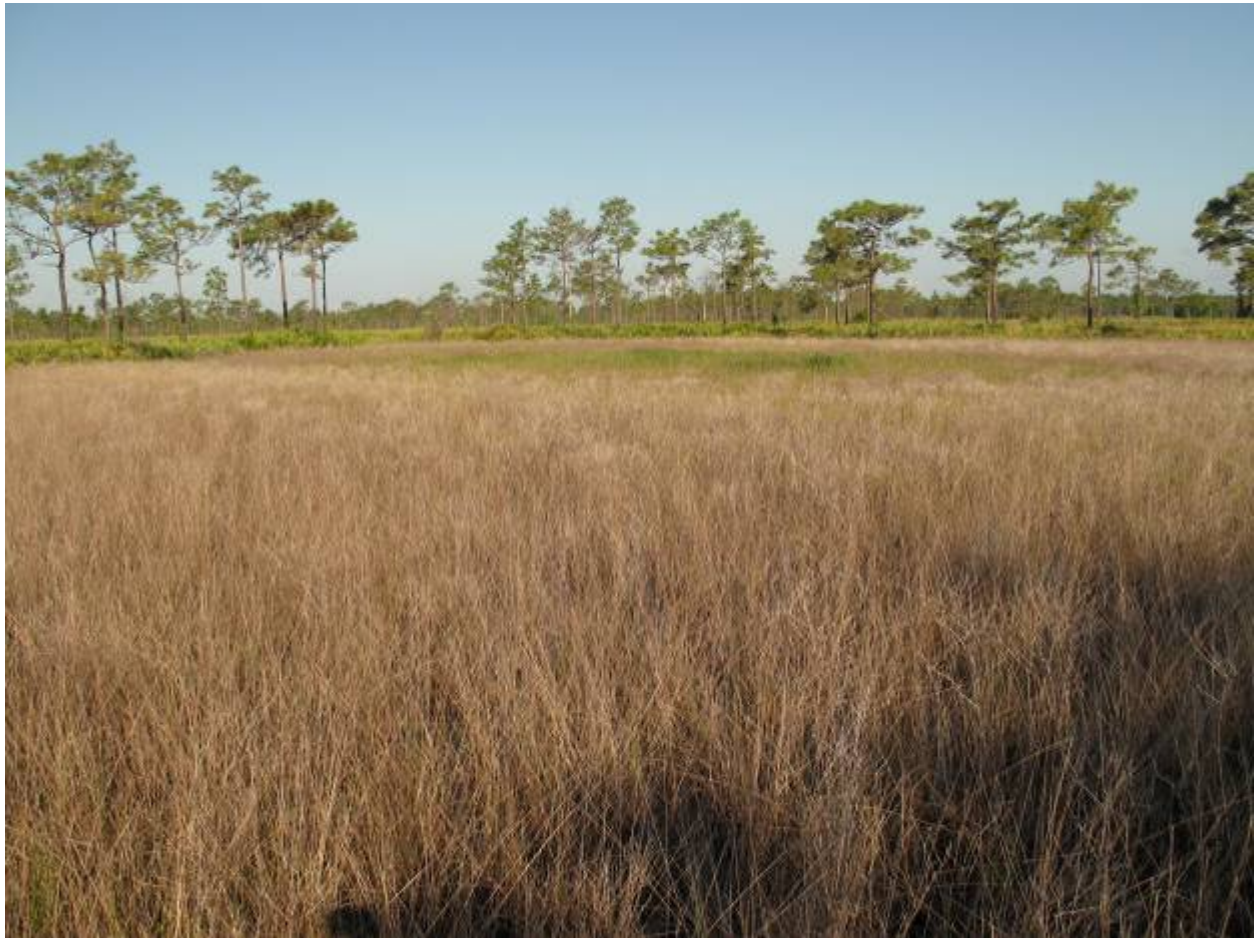
**Wetland ID: 02-12**

**Description:** This wetland is a 0.5 ha ephemeral marsh. There is no tree canopy or midstory cover. Emergent vegetation and maidencane grow in the wetland center and sedges/grasses grow throughout the wetland. The herbaceous vegetation covers >75% of the basin. There are cattle trails around the wetland edge. The wetland appears to be healthy despite the presence of cattle. The adjacent uplands are a mix of scrubby and mesic flatwoods that are managed with prescribed fire.

**Wetland Concerns:** Cattle

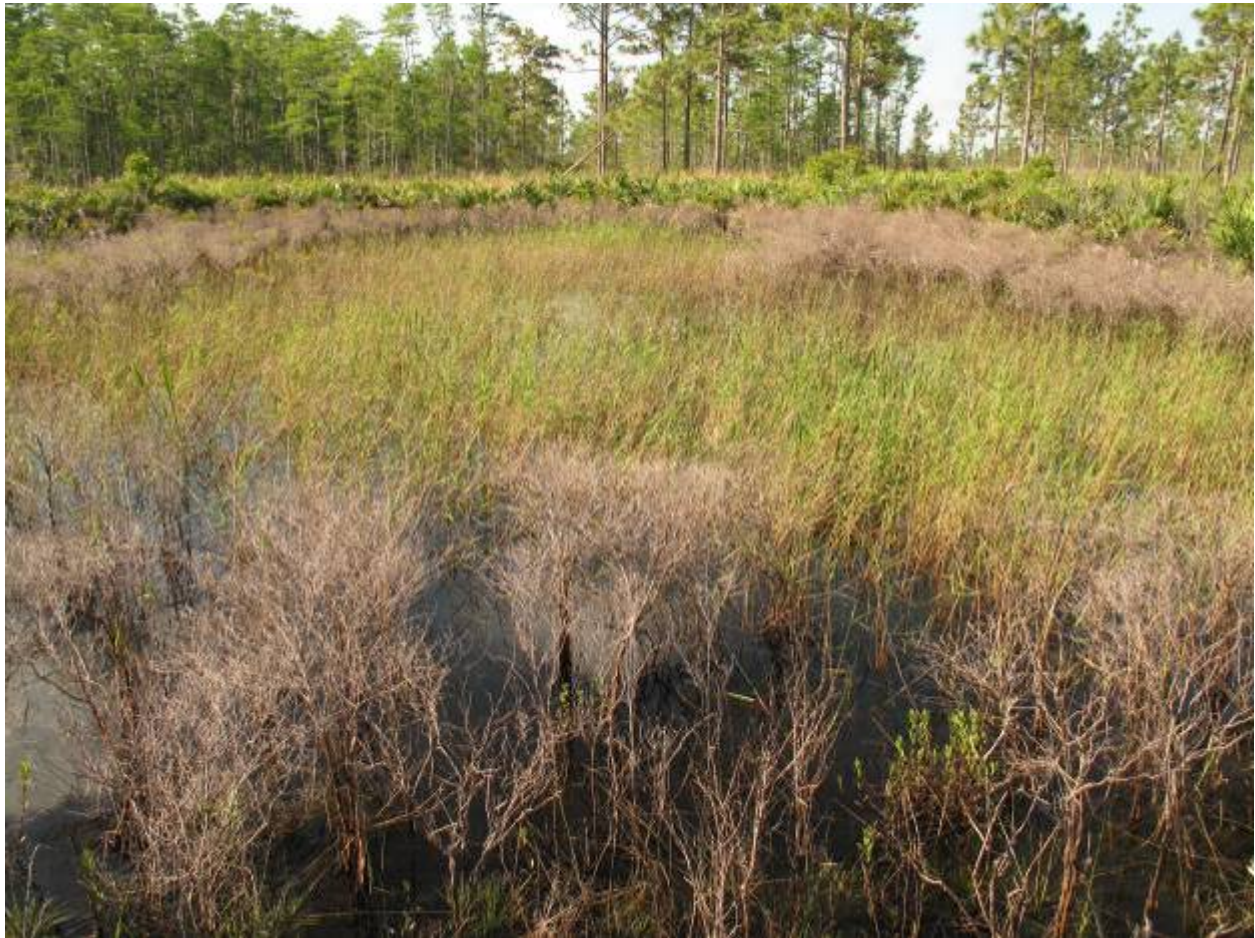
**Description:** This wetland is a 0.1 ha semi-permanent marsh. There is no tree canopy or midstory cover. Emergent vegetation and maidencane grow in the wetland center and sedges/grasses grow throughout the wetland. The herbaceous vegetation covers >75% of the basin. Small fish were present in the wetland on the day of our visit. We observed no evidence of cattle in the wetland, although cattle are allowed in this MU. The adjacent uplands are a mix of scrubby and mesic flatwoods that are managed with prescribed fire.
