# **Inventory, Assessment, and Restoration Potential of Ephemeral Wetlands on FFWCC Wildlife Management Areas**

## **Triple N Ranch WMA Final Report**

Submitted by: Rebecca P.M. Means<sup>1</sup>, Ryan C. Means<sup>1</sup>, Steven A. Johnson<sup>2</sup>

15 May 2010 – 15 August 2010

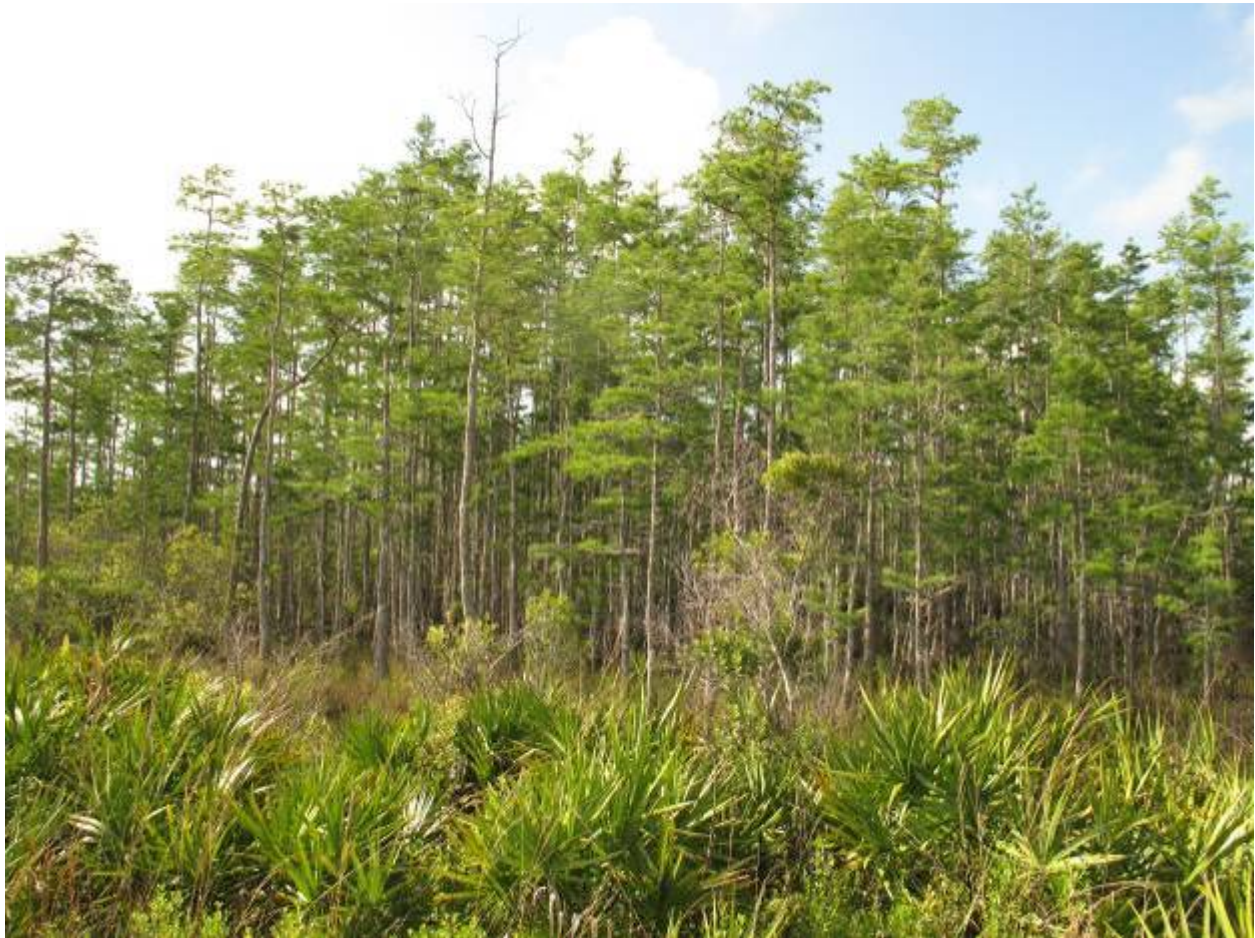
**Description:** This wetland is a 0.9 ha semi-permanent forested swamp. Cypress trees dominate the canopy, and cover >75% of the basin. Fetterbush grows in clumps in the wetland interior, and covers 5-25% of the wetland. A diverse array of herbaceous vegetation grows throughout the wetland, and covers 50-75% of the basin. Small fish were present in the wetland on the day of our visit. Cattle trails are light around the wetland edge. The adjacent uplands are a mix of scrubby and mesic flatwoods that are managed with prescribed fire.

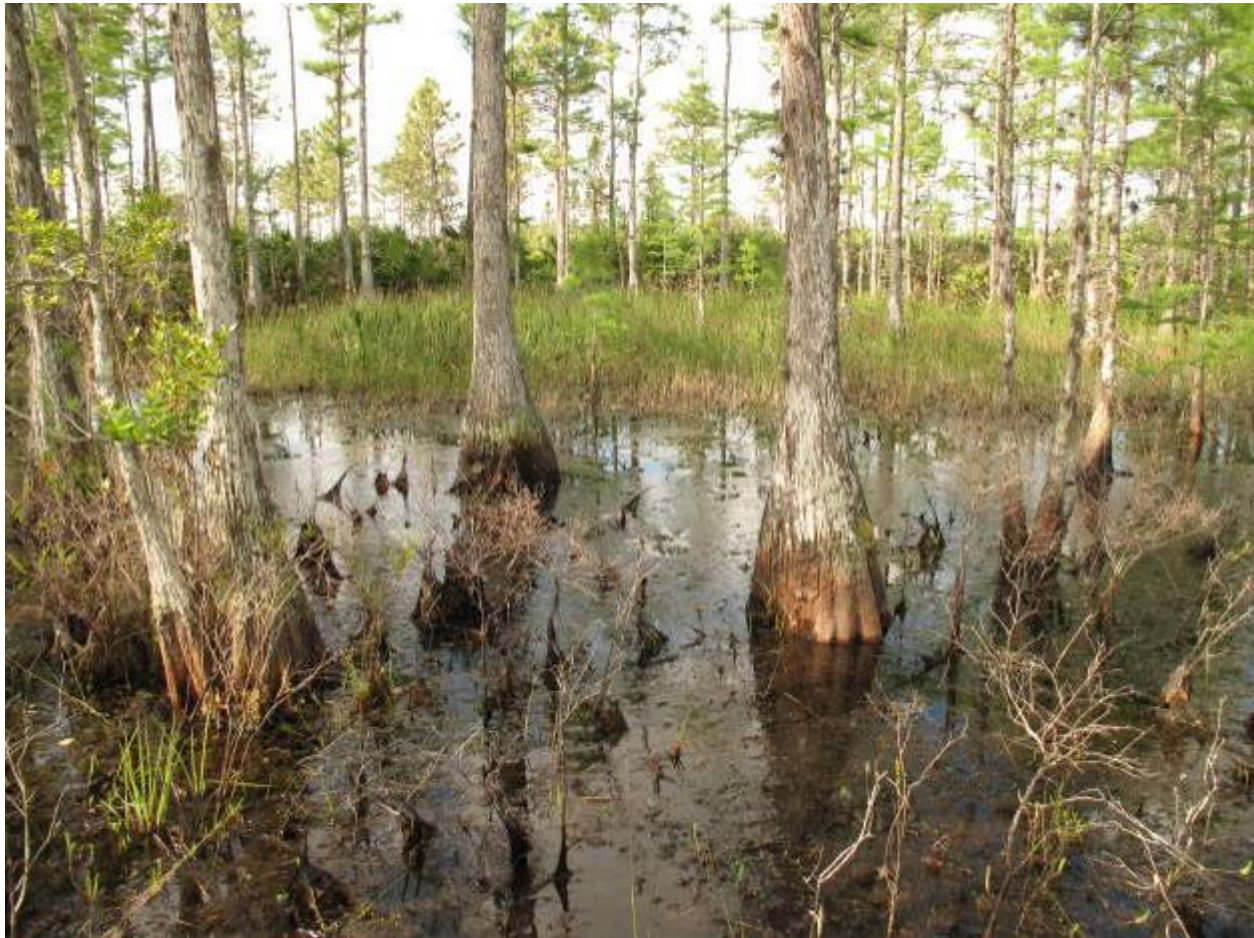
**Wetland ID: 02-15**

**Description:** This wetland is a 0.2 ha semi-permanent forested swamp. This wetland appears to be a marsh succeeding to a swamp. Cypress trees grow in a ring around the wetland, and cover 50-75% of the basin. There is no midstory cover. A diverse array of herbaceous vegetation grows throughout the wetland, and covers >75% of the basin. Small fish were present in the wetland on the day of our visit. Cattle trails are light around the wetland edge. The adjacent uplands are a mix of scrubby and mesic flatwoods that are managed with prescribed fire.

**Wetland Concerns:** Cattle

**Restoration Action Recommended:** The uplands in this MU are in good ecological condition, although we have observed some cattle-related effects in both wetlands and uplands in some areas. We recommend removing cattle from this unit to prevent destruction of the intact flatwoods community and the embedded wetlands.

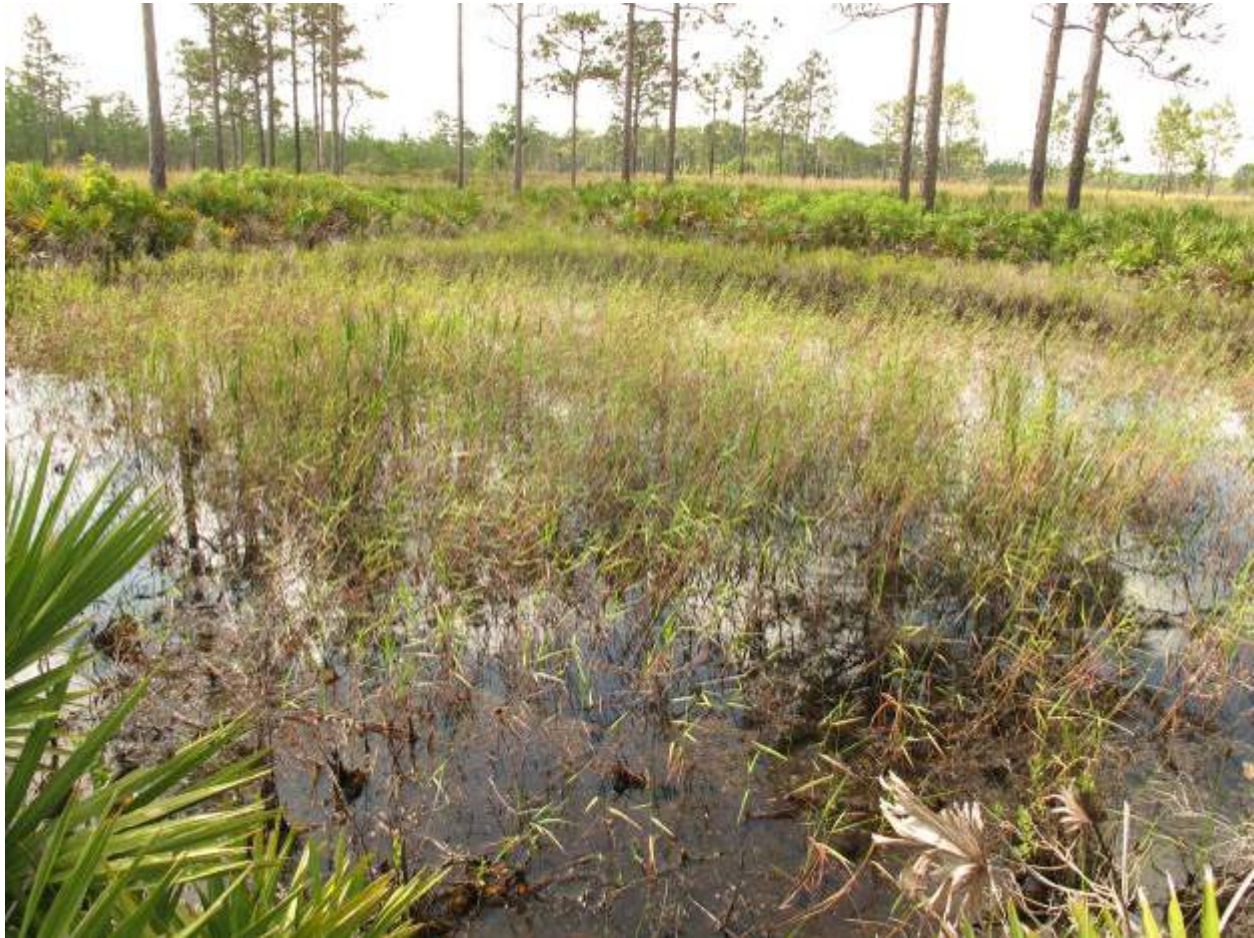
**Wetland ID: 02-16**

**Description:** This wetland is a <0.1 ha ephemeral marsh. There is no tree canopy or midstory cover. Maidencane grows throughout the wetland, and covers 50-75% of the basin. We observed no evidence of cattle in the wetland, although cattle are allowed in this MU. The adjacent uplands are a mix of scrubby and mesic flatwoods that are managed with prescribed fire.

**Wetland Concerns:** None

**Restoration Action Recommended:** The uplands in this MU are in good ecological condition, although we have observed some cattle-related effects in both wetlands and uplands in some areas. We recommend removing cattle from this unit to prevent destruction of the intact flatwoods community and the embedded wetlands.

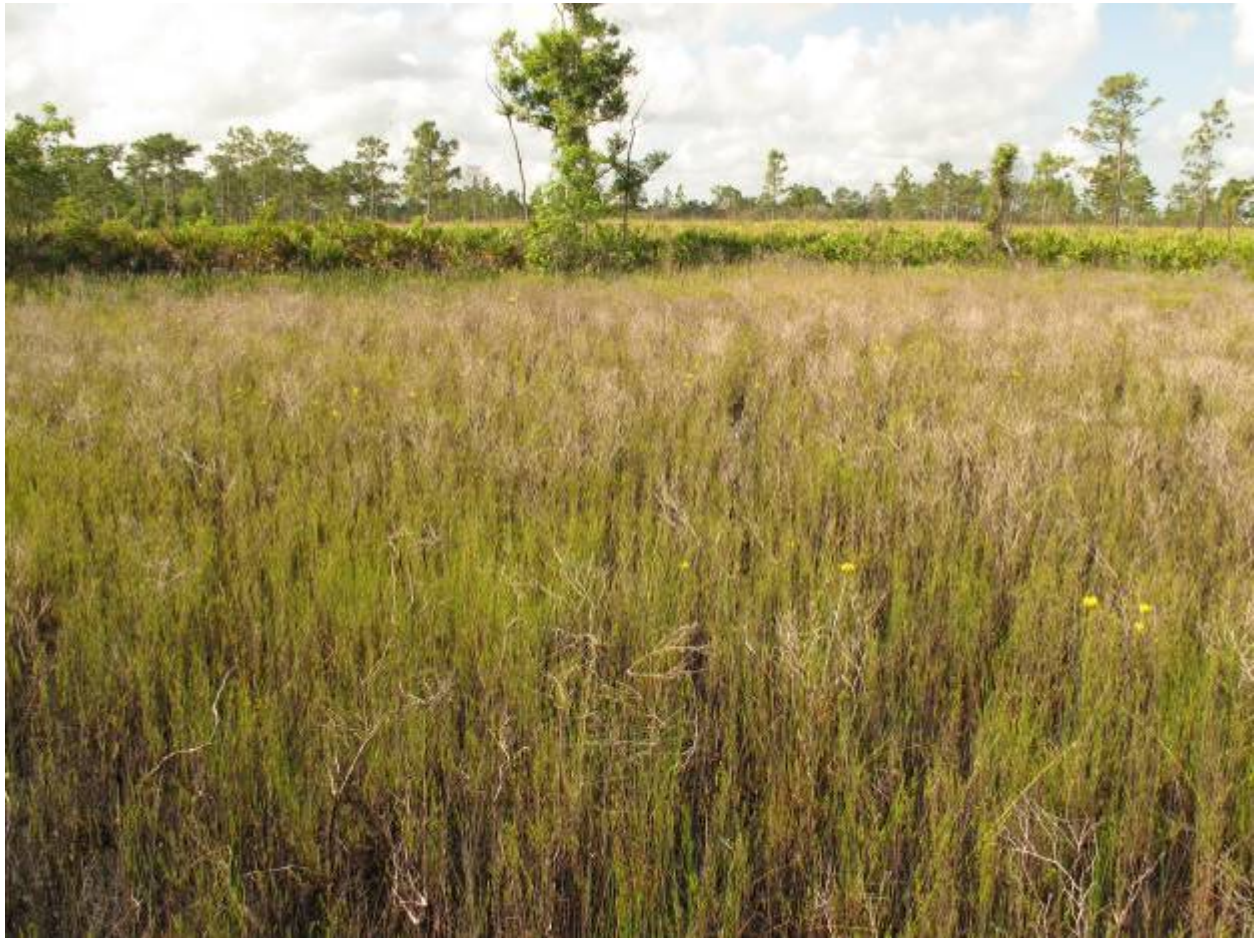
**Wetland ID: 02-17**

**Description:** This wetland is a 0.1 ha ephemeral marsh. There is no tree canopy. *Hypericum* is abundant within the wetland. Sedges/grasses grow throughout the wetland, and cover 25-50% of the basin. There are cattle trails around the wetland edge. The wetland appears to be healthy despite the presence of cattle. However, we do not know if the sedge/grass component was reduced, and the *Hypericum* increased, due to grazing. This wetland may connect to a large swamp to the east during times of high water. The adjacent uplands are a mix of scrubby and mesic flatwoods that are managed with prescribed fire.

**Wetland Concerns:** Cattle

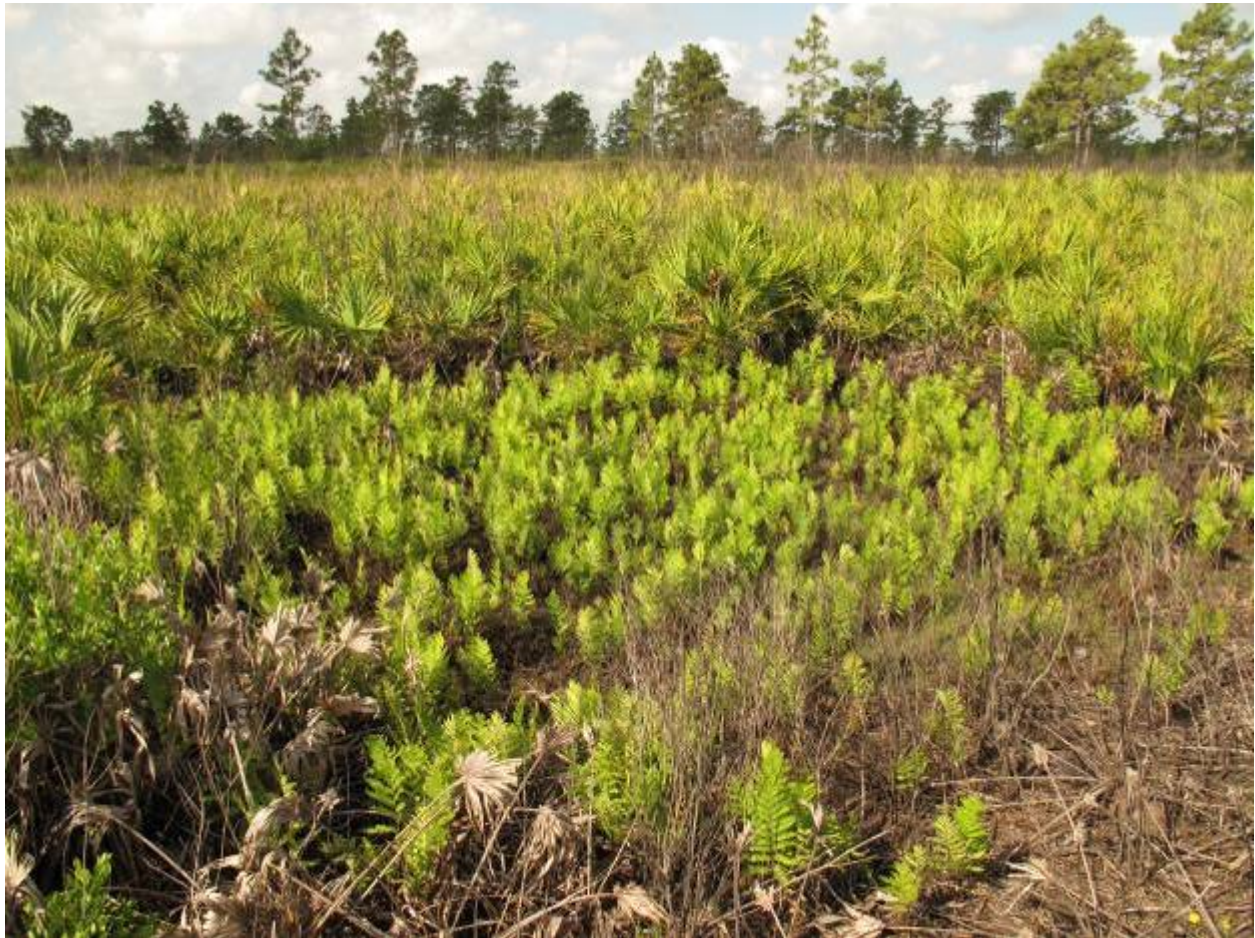
**Description:** This wetland is a <0.1 ha ephemeral marsh. There is no tree canopy or midstory cover. Sedges/grasses and fern grow throughout the wetland, and cover >75% of the basin. No evidence of cattle was observed in this sink depressional pond, although cattle are allowed in this MU. The adjacent uplands are a mix of scrubby and mesic flatwoods that are managed with prescribed fire.

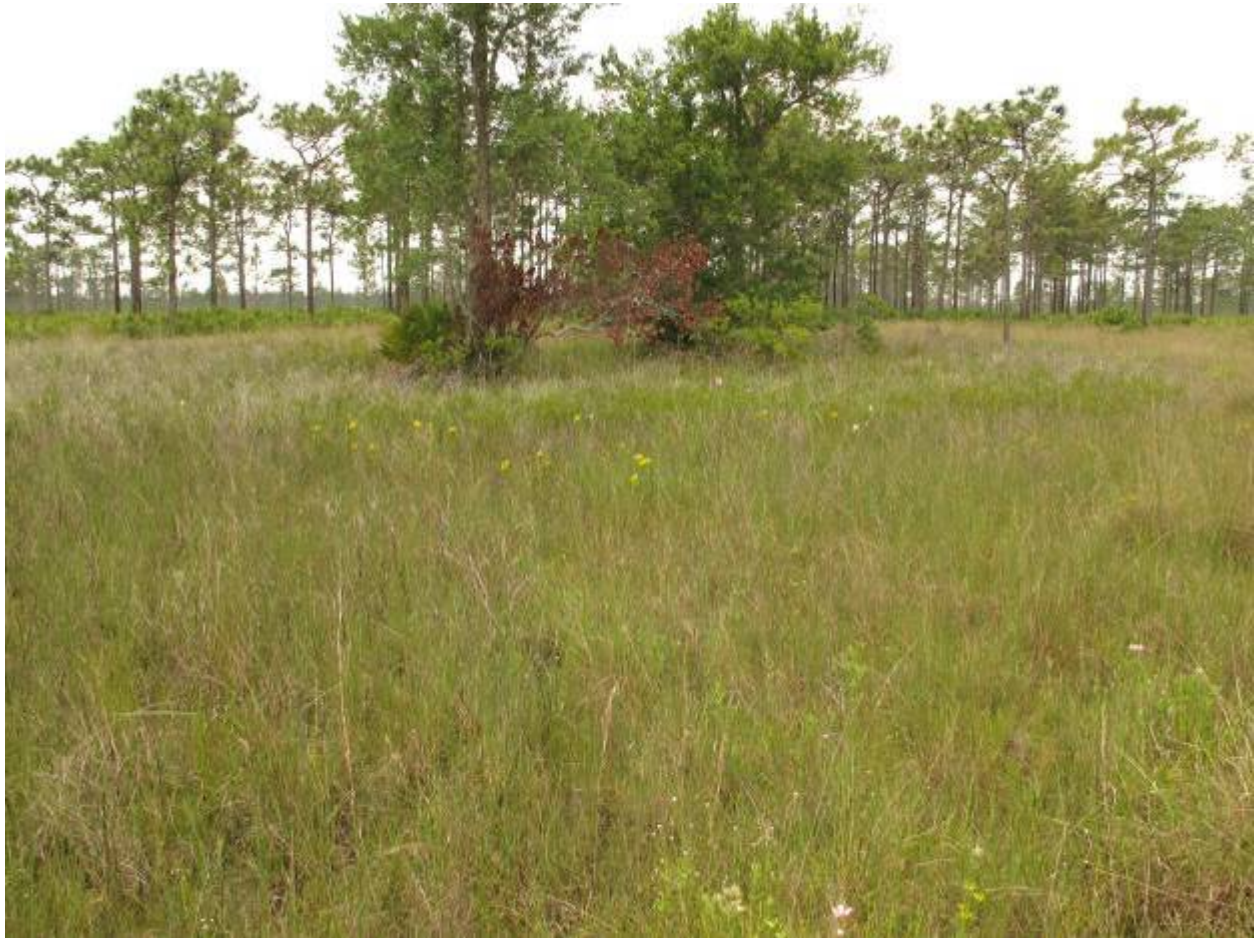
**Description:** This wetland is a 0.1 ha ephemeral marsh. Two small gum trees grow in the wetland center but provide <5% canopy cover. There is no midstory cover. This healthy marsh has diverse groundcover vegetation that covers >75% of the basin. No evidence of cattle was observed although cattle are allowed in this MU. The adjacent uplands are scrubby flatwoods that are managed with prescribed fire.

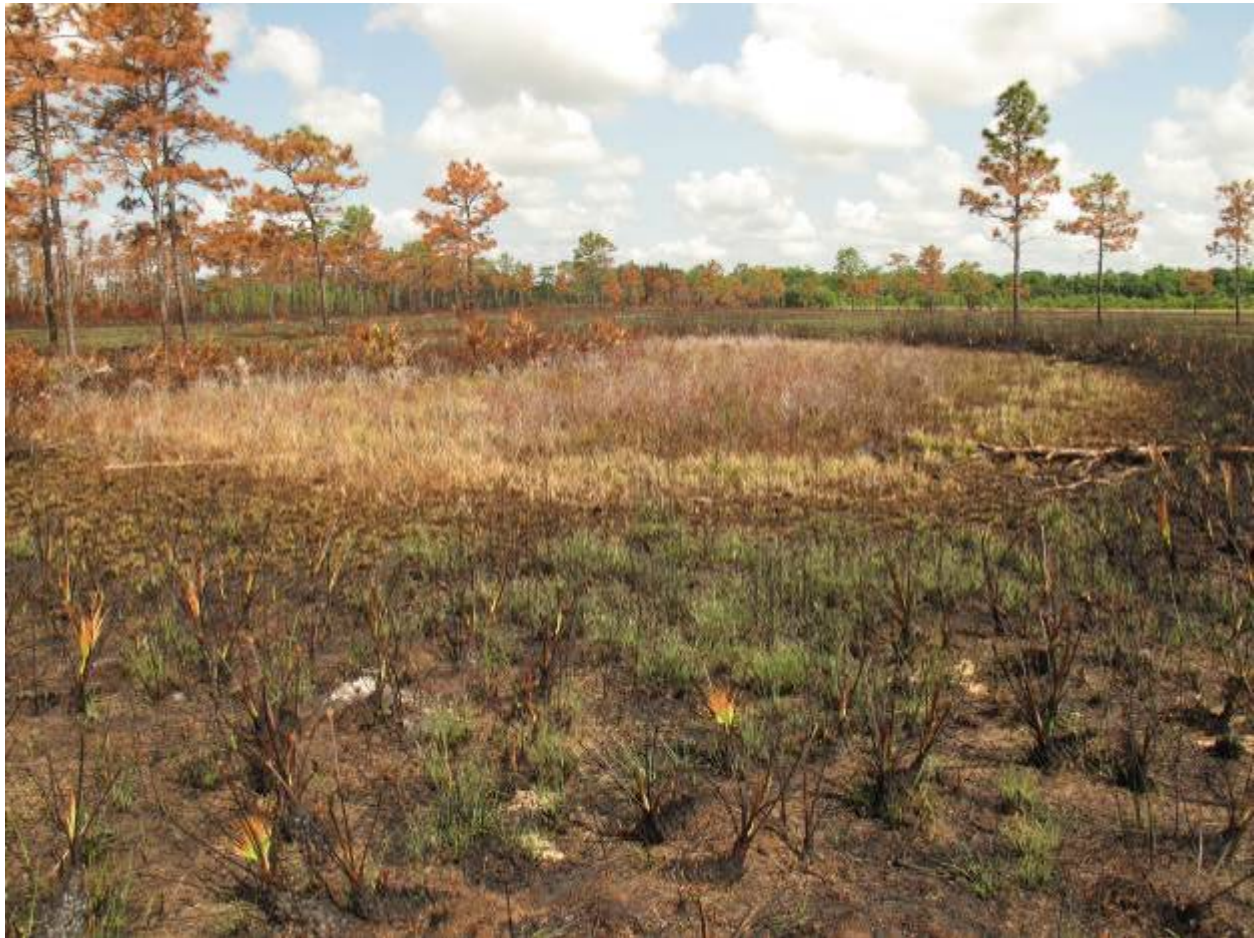
**Wetland ID: 03-01**

**Description:** This wetland is a 0.1 ha ephemeral marsh. There is no tree canopy or midstory cover. Sedges/grasses and short emergent vegetation grow throughout the wetland, and cover >75% of the basin. No evidence of cattle was observed in this wetland, although cattle are allowed in this MU. A recent fire burned through the entire wetland. The adjacent uplands are mesic flatwoods that are managed with prescribed fire and mechanical vegetation removal.

**Wetland Concerns:** None

**Restoration Action Recommended:** The uplands in this MU are in good ecological condition, although we have observed some cattle-related effects in both wetlands and uplands in some areas. We recommend removing cattle from this unit to prevent destruction of the intact flatwoods community and the embedded wetlands.

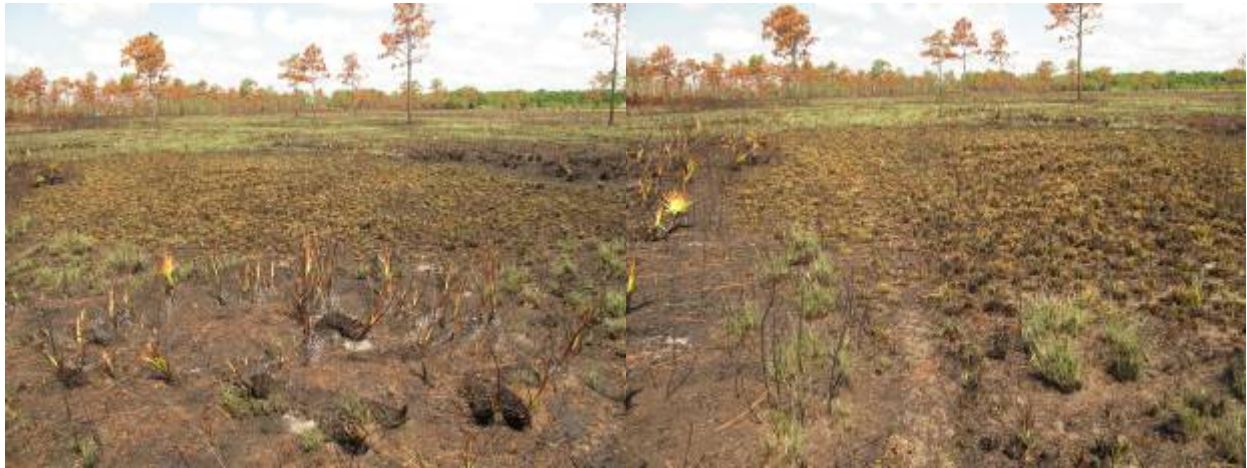
**Wetland ID: 03-02**

**Description:** This wetland is a <0.1 ha highly ephemeral marsh. There is no tree canopy or midstory cover. Sedges/grasses grow throughout the wetland, and cover >75% of the basin. A recent fire burned through the entire wetland basin. There is a cattle trail through the south side of the wetland. The adjacent uplands are mesic flatwoods that are managed with prescribed fire and mechanical vegetation removal.

**Wetland Concerns:** Cattle

**Restoration Action Recommended:** The uplands in this MU are in good ecological condition, although we have observed some cattle-related effects in both wetlands and uplands in some areas. We recommend removing cattle from this unit to prevent destruction of the intact flatwoods community and the embedded wetlands.

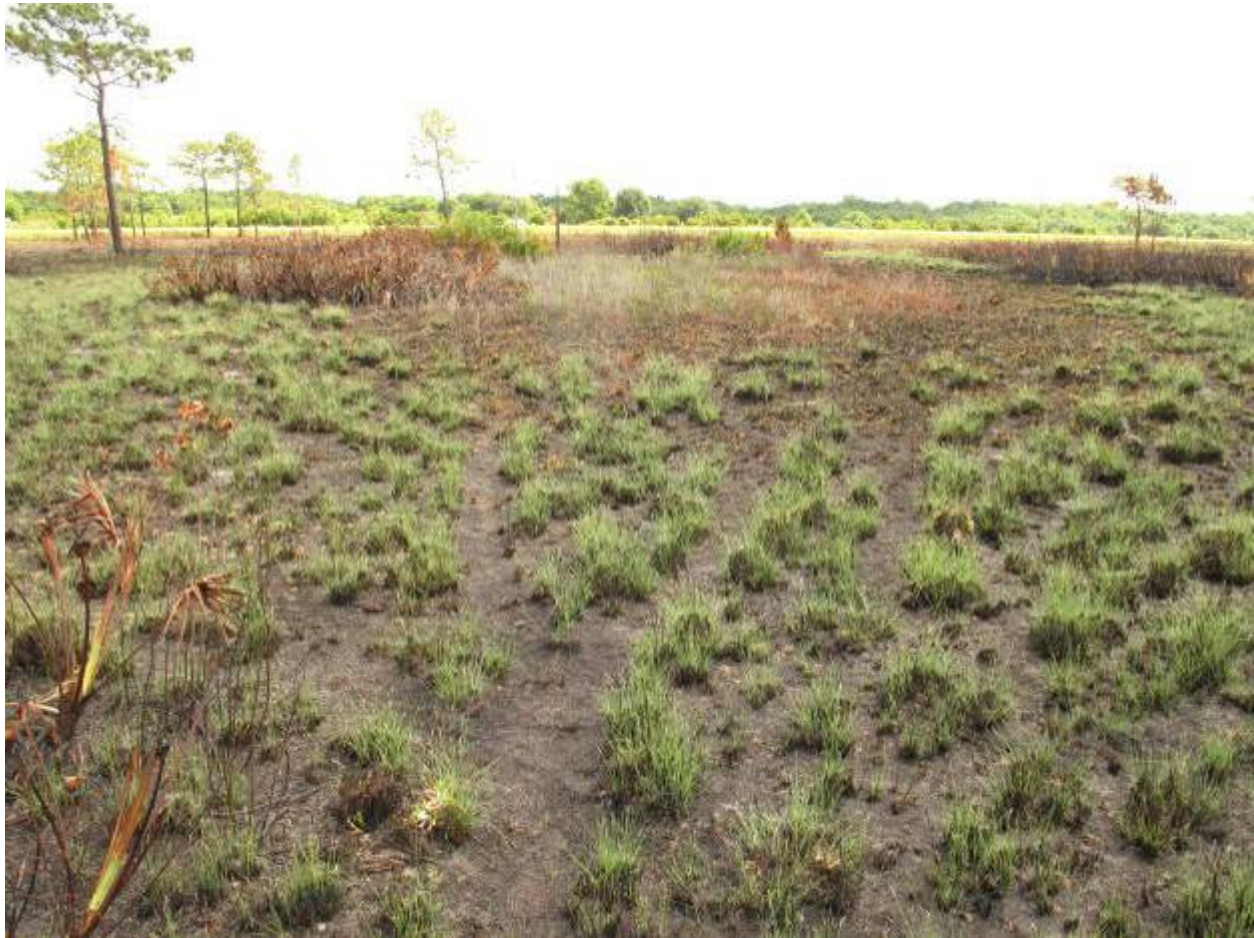
**Wetland ID: 03-03**

**Description:** This wetland is a <0.1 ha highly ephemeral marsh. There is no tree canopy or midstory cover. Sedges/grasses grow throughout the wetland, and cover >75% of the basin. A cattle trail leads into the wetland. A fire recently burned into the wetland edges. Feral hog damage is old and recovering. The adjacent uplands are mesic flatwoods that are managed with prescribed fire and mechanical vegetation removal.

**Wetland Concerns:** Feral hog damage, Cattle

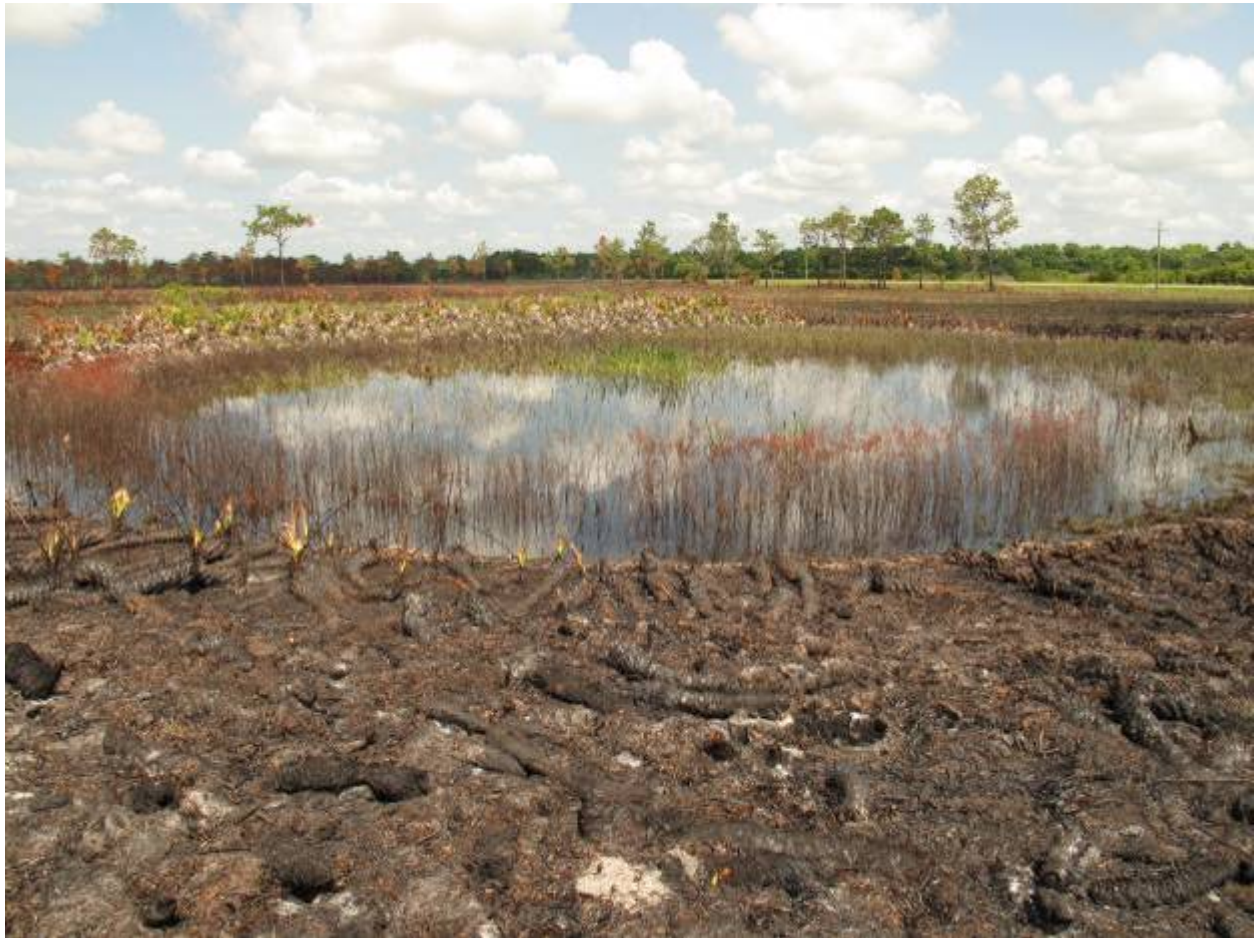
**Wetland ID: 03-04**

**Description:** This wetland is a 0.1 ha semi-permanent marsh. There is no tree canopy or midstory cover. Emergent vegetation grows in the deeper wetland center and sedges/grasses grow throughout. The herbaceous vegetation covers 5-25% of the basin. A recent fire burned into the wetland edges. This sink depressional marsh appears very healthy. No evidence of cattle was observed, although cattle are allowed in this MU. Fish were present on the day of our visit. The adjacent uplands are mesic flatwoods that are managed with prescribed fire and mechanical vegetation removal.

**Wetland Concerns:** None

**Restoration Action Recommended:** The uplands in this MU are in good ecological condition, although we have observed some cattle-related effects in both wetlands and uplands in some areas. We recommend removing cattle from this unit to prevent destruction of the intact flatwoods community and the embedded wetlands.

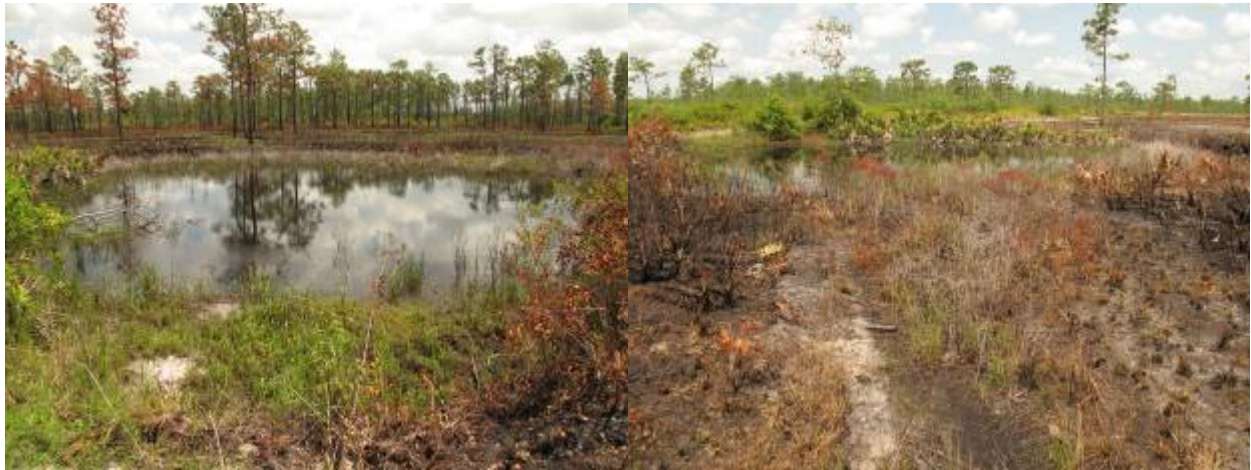
**Wetland ID: 03-05**

**Description:** This wetland is a 0.1 ha semi-permanent marsh. There is no tree canopy or midstory cover. This circular, sink depression has a deeper, open center with sedges/grasses and emergent vegetation growing around the shallower edges. The herbaceous vegetation covers 25-50% of the basin. A shallow fireline/ditch leads from the wetland's east side to a large swamp. There are cattle tracks in the fireline. Fish were present on the day of our visit. The adjacent uplands are mesic and scrubby flatwoods that are managed with prescribed fire and mechanical vegetation removal.

**Wetland Concerns:** Cattle, Fireline

**Restoration Action Recommended:** Although the fireline does not appear to function as a ditch draining the wetland, we recommend re-routing the fireline. Allow vegetation to regenerate along the fireline and move future firelines, if needed, into the uplands. The uplands in this MU are in good ecological condition, although we have observed some cattle-related effects in both wetlands and uplands in some areas. We recommend removing cattle from this unit to prevent destruction of the intact flatwoods community and the embedded wetlands.

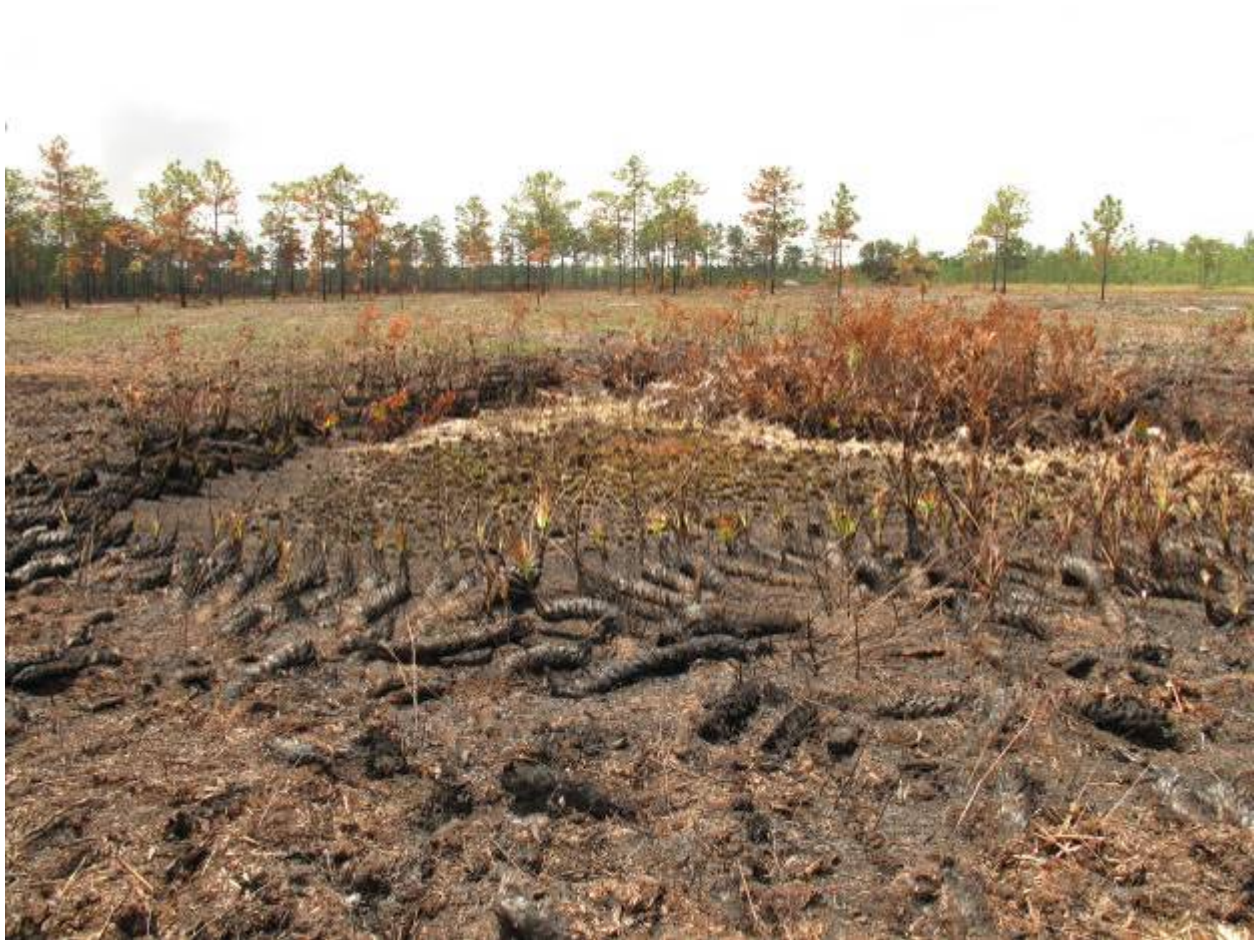
**Description:** This wetland is a <0.1 ha ephemeral marsh. There is no tree canopy or midstory cover. Sedges/grasses and *Sphagnum* grow throughout the wetland, and cover >75% of the basin. A fire recently burned through the wetland basin. No evidence of cattle was observed in this wetland, although cattle are allowed in this MU. The adjacent uplands are mesic flatwoods that are managed with prescribed fire and mechanical vegetation removal.

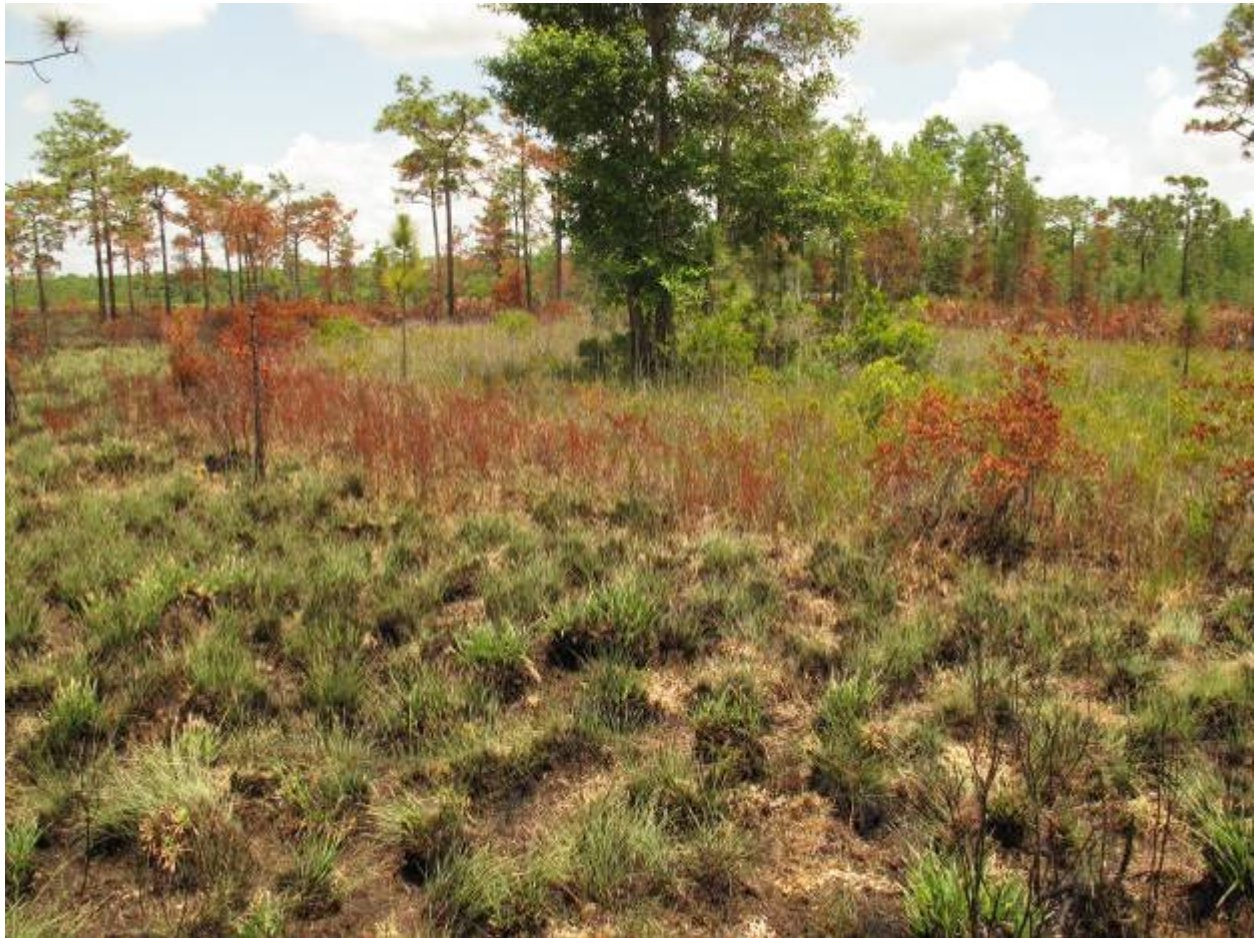
**Wetland ID: 03-07**

**Description:** This wetland is a 0.1 ha ephemeral marsh. Cypress trees grow in a strand on the north side of the wetland, and cover 5-25% of the basin. There is no midstory cover. Maidencane grows in the wetland center and a diverse array of sedges/grasses and other herbaceous vegetation grow throughout the wetland. The herbaceous vegetation covers >75% of the basin. A fire recently burned to the wetland edge. No evidence of cattle was observed in this wetland, although cattle are allowed in this MU. The adjacent uplands are mesic flatwoods that are managed with prescribed fire and mechanical vegetation removal.

**Wetland Concerns:** None

**Restoration Action Recommended:** The uplands in this MU are in good ecological condition, although we have observed some cattle-related effects in both wetlands and uplands in some areas. We recommend removing cattle from this unit to prevent destruction of the intact flatwoods community and the embedded wetlands.

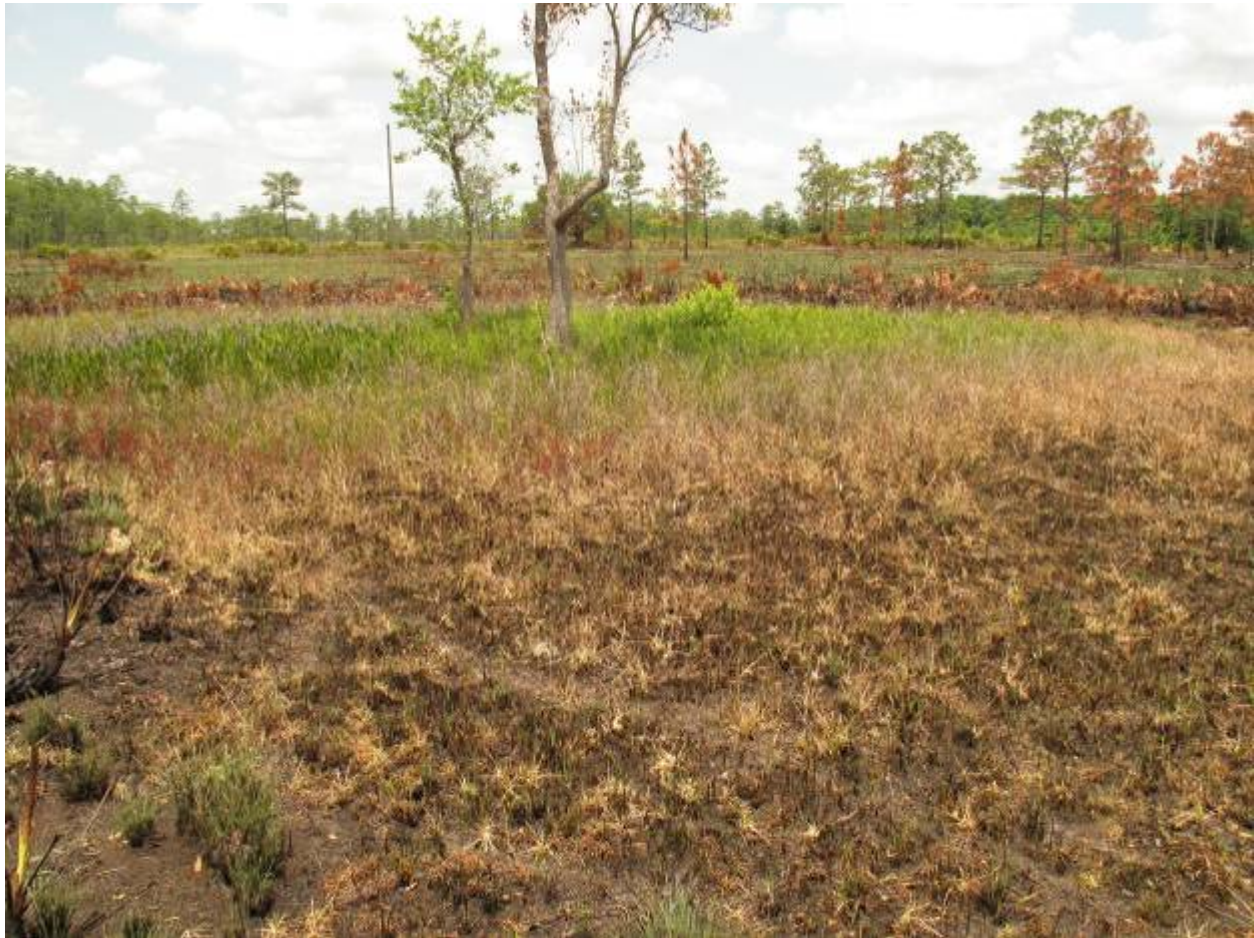
**Wetland ID: 03-08**

**Description:** This wetland is a <0.1 ha ephemeral marsh. There is no tree canopy or midstory cover. Fern grow in the wetland interior and sedges/grasses grow throughout the wetland. The herbaceous vegetation covers >75% of the basin. A fire recently burned into the wetland edges. Cattle trails are evident around the wetland edge. The adjacent uplands are mesic flatwoods that are managed with prescribed fire and mechanical vegetation removal.

**Wetland Concerns:** Cattle

**Restoration Action Recommended:** The uplands in this MU are in good ecological condition, although we have observed some cattle-related effects in both wetlands and uplands in some areas. We recommend removing cattle from this unit to prevent destruction of the intact flatwoods community and the embedded wetlands.

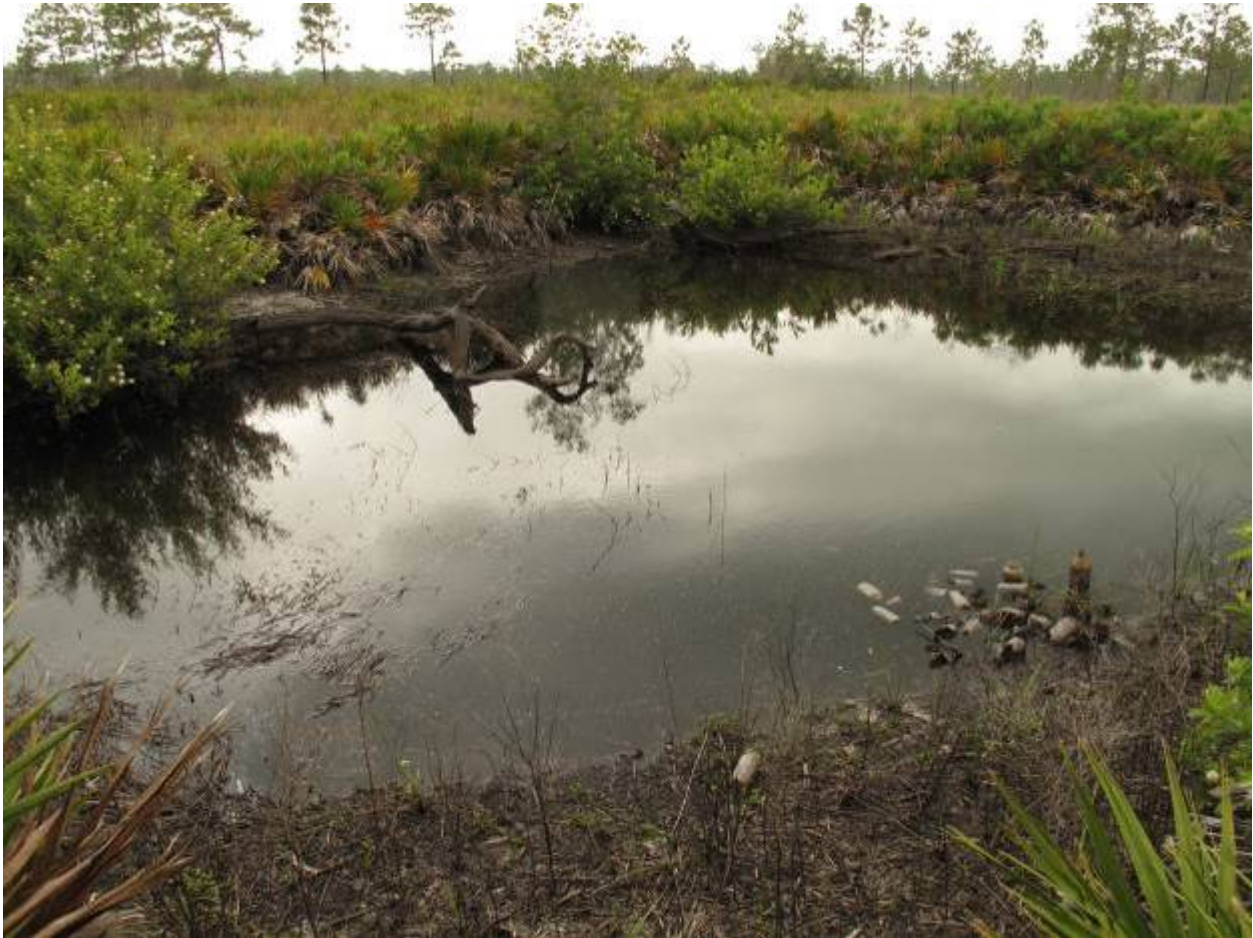
**Wetland ID: 06-01**

**Description:** This wetland is a <0.1 ha ephemeral marsh. There is no tree canopy or midstory cover. Cattle have trampled the herbaceous vegetation in this wetland. The vegetation is sparse and covers 5-25% of the basin. This wetland provides a good example of the damage cattle can do to a wetland. There are several piles of bottle trash in the wetland. The adjacent uplands are mesic and scrubby flatwoods that are managed with prescribed fire.

**Wetland Concerns:** Cattle, Trash

**Restoration Action Recommended:** Remove the trash from the wetland. The uplands in this MU are in good ecological condition, although we have observed some cattle-related effects in both wetlands and uplands in some areas. We recommend removing cattle from this unit to prevent destruction of the intact flatwoods community and the embedded wetlands.

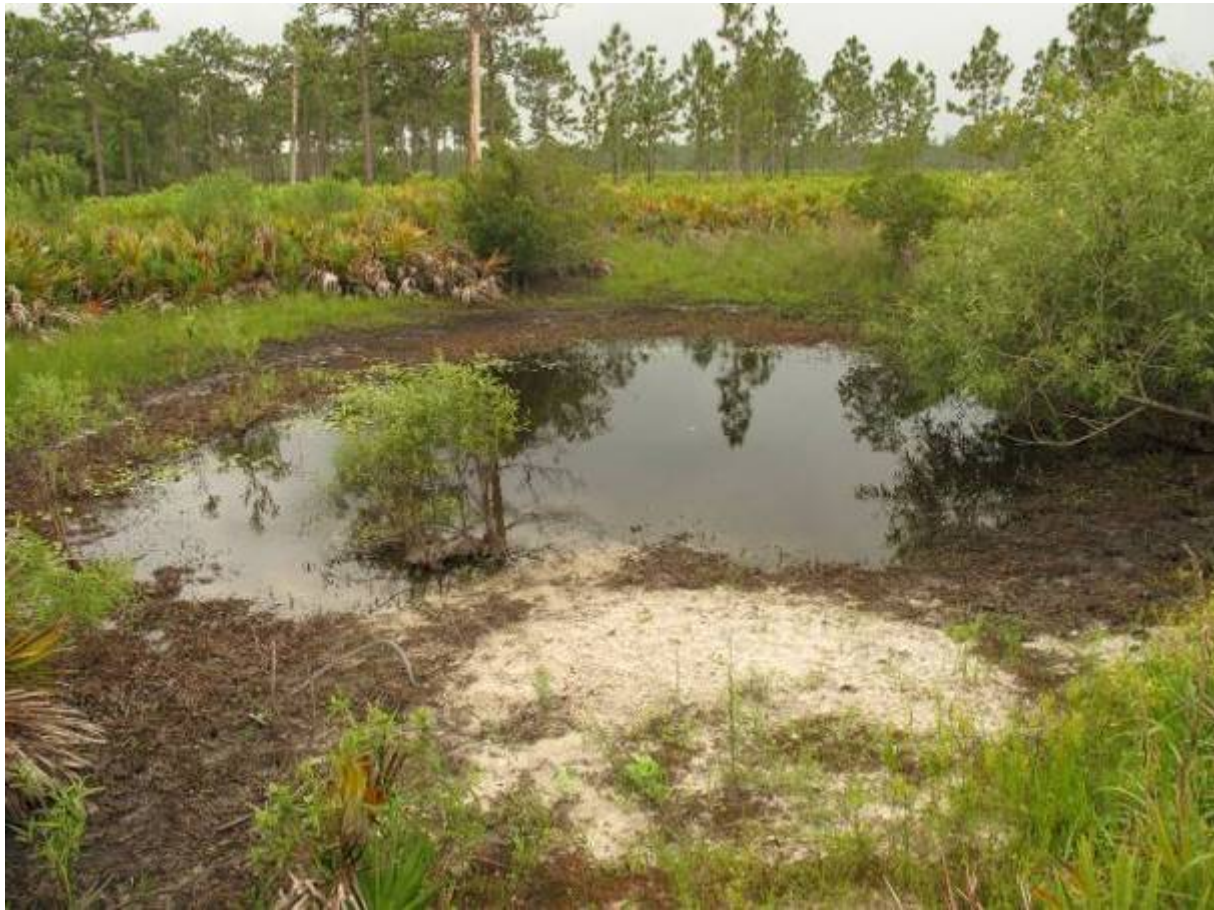
**Wetland ID: 07-01**

**Description:** This wetland is a <0.1 ha ephemeral marsh. There is no tree canopy or midstory cover. Emergent vegetation grows in scattered patches, and covers 25-50% of the basin. The wetland is heavily impacted by cattle. There is a persistent odor of feces and urine. Wetland vegetation is denuded presumably from cattle grazing. This wetland serves as an example of the negative effects that cattle can have on wetlands. There is some sediment build up due to run-off from a nearby road. The adjacent uplands are mesic flatwoods that are managed with prescribed fire.

**Wetland Concerns:** Cattle, Road

**Restoration Action Recommended:** If the road cannot be rerouted away from the wetland, consider maintaining a siltation fence to prevent sedimentation from impacting the wetland. The uplands in this MU are in good ecological condition, although we have observed some cattle-related effects in both wetlands and uplands in some areas. We recommend removing cattle from this unit to prevent destruction of the intact flatwoods community and the embedded wetlands.

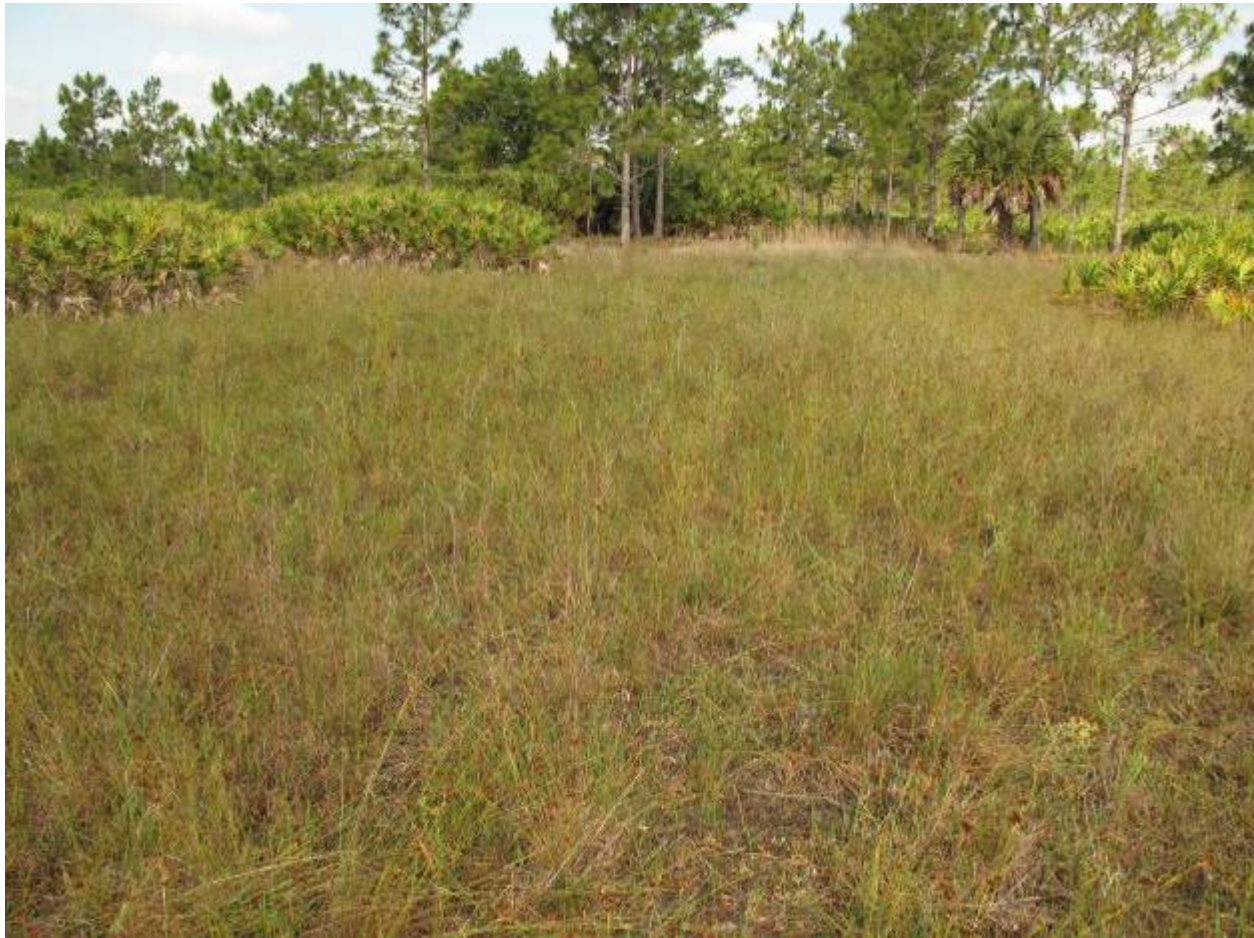
**Wetland ID: 08-01**

**Description:** This wetland is a 0.5 ha highly ephemeral marsh. There is no tree canopy or midstory cover. A high diversity of wetland grasses grow throughout the wetland, and cover >75% of the basin. There is evidence of cattle in the wetland, including cattle feces. The adjacent uplands are mesic flatwoods that are managed with prescribed fire.

**Wetland Concerns:** Cattle

**Restoration Action Recommended:** The uplands in this MU are in good ecological condition, although we have observed some cattle-related effects in both wetlands and uplands in some areas. We recommend removing cattle from this unit to prevent destruction of the intact flatwoods community and the embedded wetlands.
