# **Inventory, Assessment, and Restoration Potential of Ephemeral Wetlands on FFWCC Wildlife Management Areas**

## **Triple N Ranch WMA Final Report**

Submitted by: Rebecca P.M. Means<sup>1</sup>, Ryan C. Means<sup>1</sup>, Steven A. Johnson<sup>2</sup>

15 May 2010 – 15 August 2010

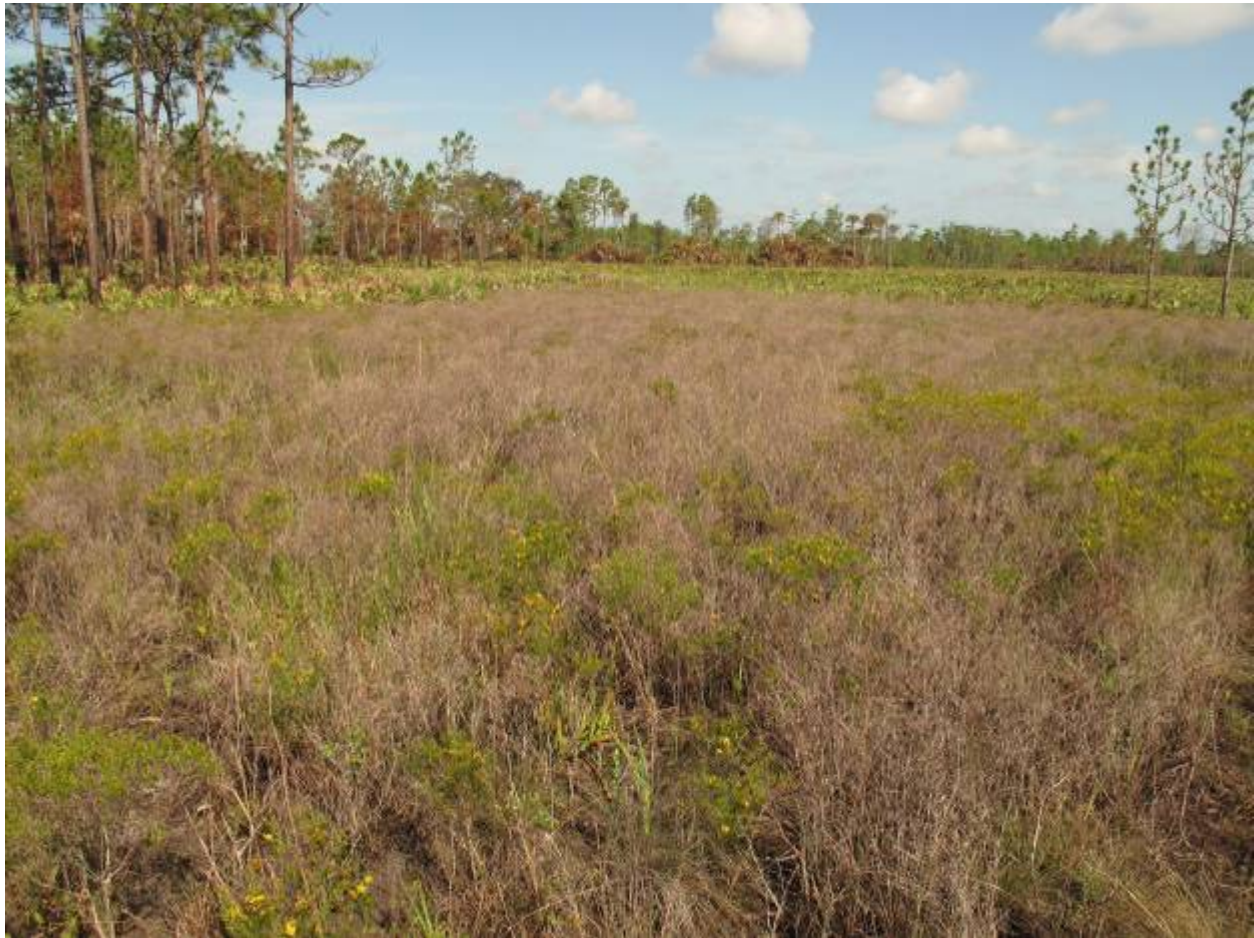
**Wetland ID: 09-01**

**Description:** This wetland is a <0.1 ha ephemeral marsh. There is no tree canopy or midstory cover. *Hypericum* and sedges/grasses grow throughout the wetland, and cover >75% of the basin. There is evidence of past fire and cattle in the wetland. The adjacent uplands are mesic flatwoods that are managed with prescribed fire and mechanical vegetation removal.

**Wetland Concerns:** Cattle

**Restoration Action Recommended:** The uplands in this MU are in good ecological condition, although we have observed some cattle-related effects in both wetlands and uplands in some areas. We recommend removing cattle from this unit to prevent destruction of the intact flatwoods community and the embedded wetlands.

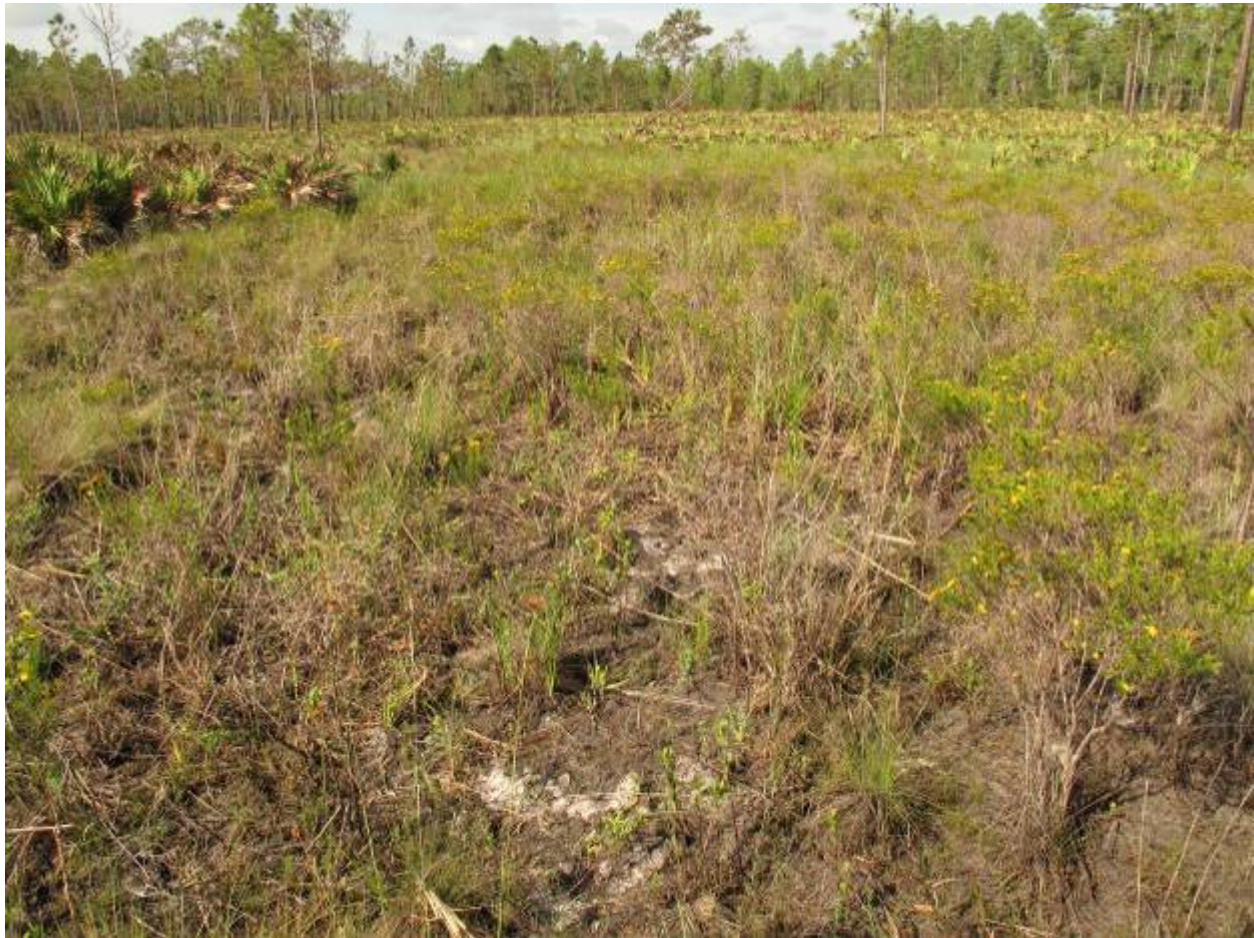
**Wetland ID: 09-02**

**Description:** This wetland is a <0.1 ha ephemeral marsh. There is no tree canopy or midstory cover. *Hypericum* and sedges/grasses grow throughout the wetland, and cover >75% of the basin. There is evidence cattle in the wetland, including tracks and feces. The adjacent uplands are mesic flatwoods that are managed with prescribed fire and mechanical vegetation removal.

**Wetland Concerns:** Cattle

**Restoration Action Recommended:** The uplands in this MU are in good ecological condition, although we have observed some cattle-related effects in both wetlands and uplands in some areas. We recommend removing cattle from this unit to prevent destruction of the intact flatwoods community and the embedded wetlands.

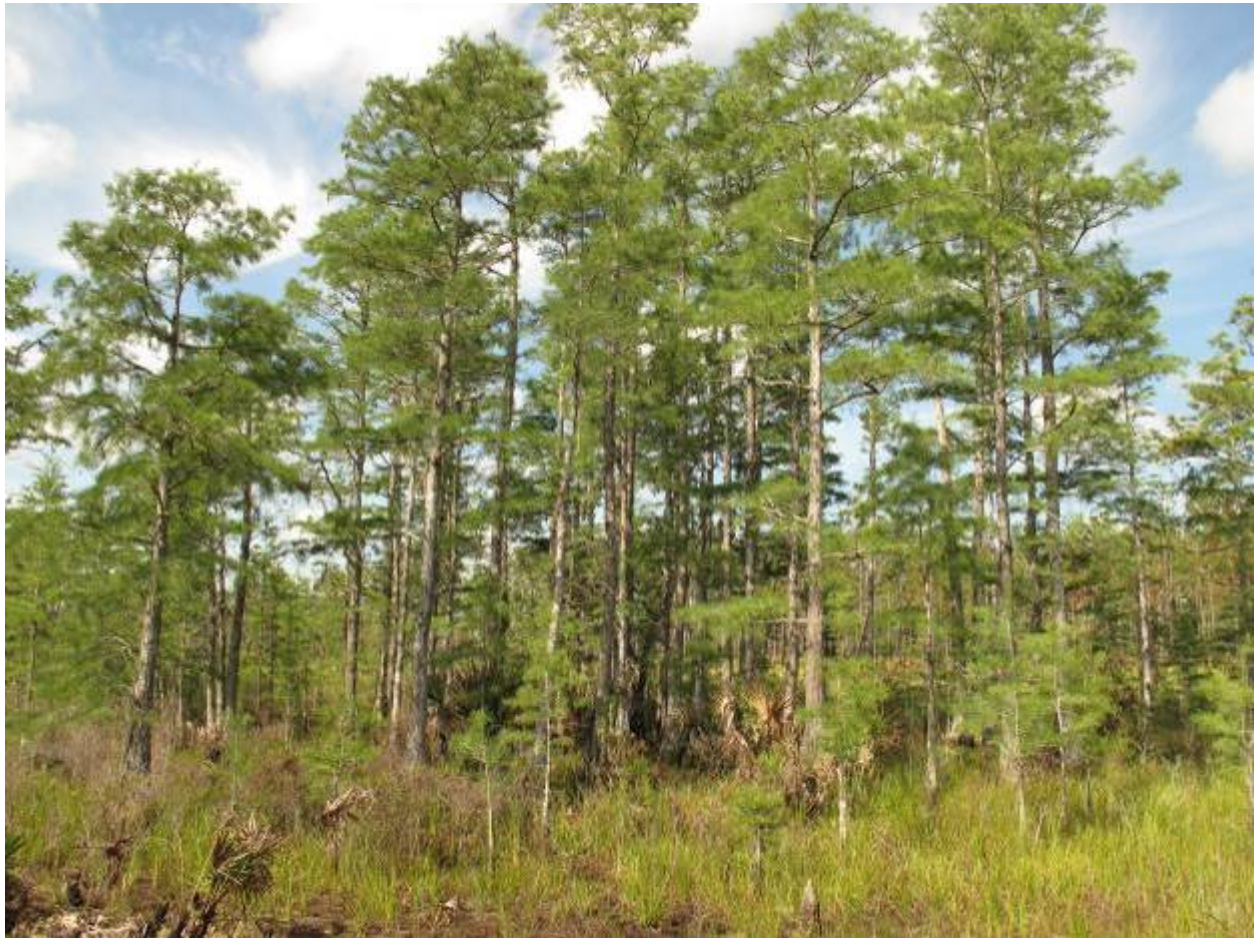
**Wetland ID: 09-03**

**Description:** This wetland is a <0.1 ha ephemeral forested swamp. Cypress trees dominate the canopy, and cover 50-75% of the wetland. There is no midstory cover. Sedges/grasses and emergent vegetation grow throughout the wetland, and cover >75% of the basin. There is evidence of cattle in the wetland, including feces. The adjacent uplands are mesic flatwoods that are managed with prescribed fire and mechanical vegetation removal.

**Wetland Concerns:** Cattle

**Restoration Action Recommended:** The uplands in this MU are in good ecological condition, although we have observed some cattle-related effects in both wetlands and uplands in some areas. We recommend removing cattle from this unit to prevent destruction of the intact flatwoods community and the embedded wetlands.

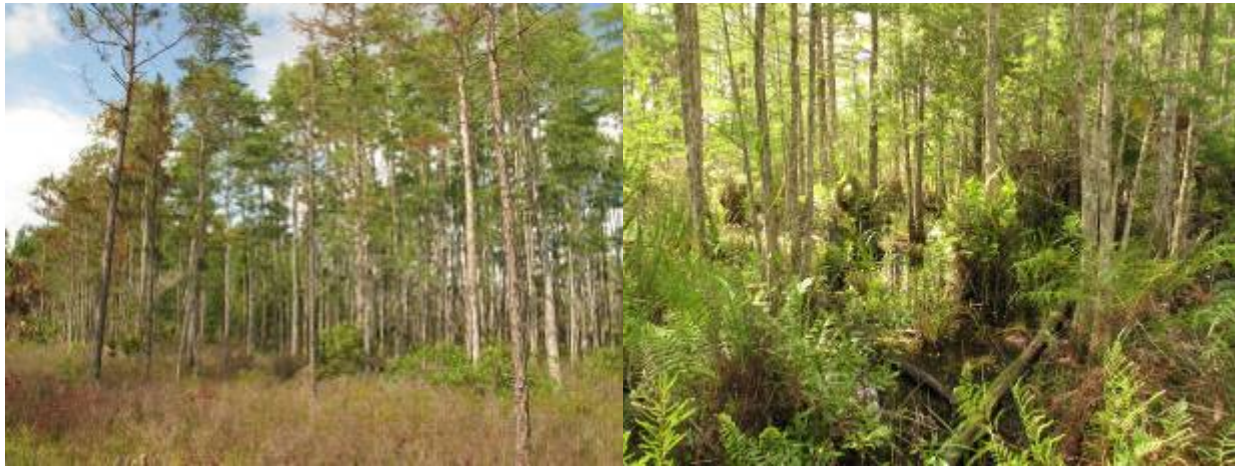
**Wetland ID: 09-04**

**Description:** This wetland is a 1.0 ha ephemeral forested swamp. Cypress trees dominate the canopy, and cover >75% of the wetland. The midstory is dominated by small cypress trees and wax myrtle, and covers 5-25% of the wetland. A great diversity of herbaceous vegetation grows throughout the wetland, and covers >75% of the basin. There is some evidence of cattle in the wetland, including trails and feces. The adjacent uplands are mesic flatwoods that are managed with prescribed fire and mechanical vegetation removal.

**Wetland Concerns:** Cattle

**Restoration Action Recommended:** The uplands in this MU are in good ecological condition, although we have observed some cattle-related effects in both wetlands and uplands in some areas. We recommend removing cattle from this unit to prevent destruction of the intact flatwoods community and the embedded wetlands.

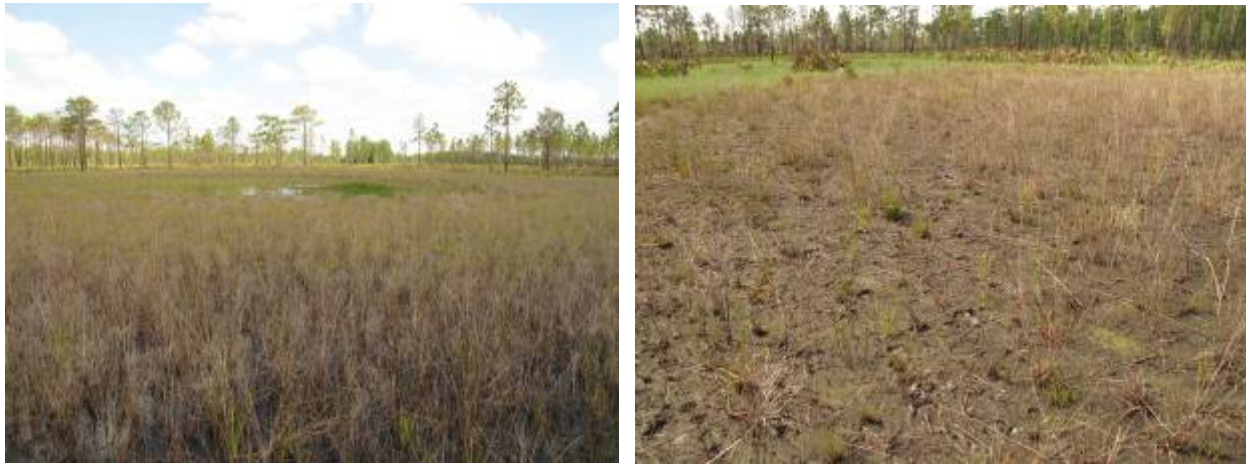
**Wetland ID: 09-05**

**Description:** This wetland is a 0.6 ha ephemeral marsh. There is no tree canopy or midstory cover. Maidencane grows in the wetland center and sedges/grasses and *Hypericum* grow around the outer edge. The herbaceous vegetation covers 50-75% of the basin. The vegetation was recently trampled by cattle and the wetland is heavily grazed. This wetland provides a good example of the negative effects of cattle in wetlands. The adjacent uplands are scrubby flatwoods that are managed with prescribed fire and mechanical vegetation removal.

**Wetland Concerns:** Cattle

**Restoration Action Recommended:** The uplands in this MU are in good ecological condition, although we have observed some cattle-related effects in both wetlands and uplands in some areas. We recommend removing cattle from this unit to prevent destruction of the intact flatwoods community and the embedded wetlands.

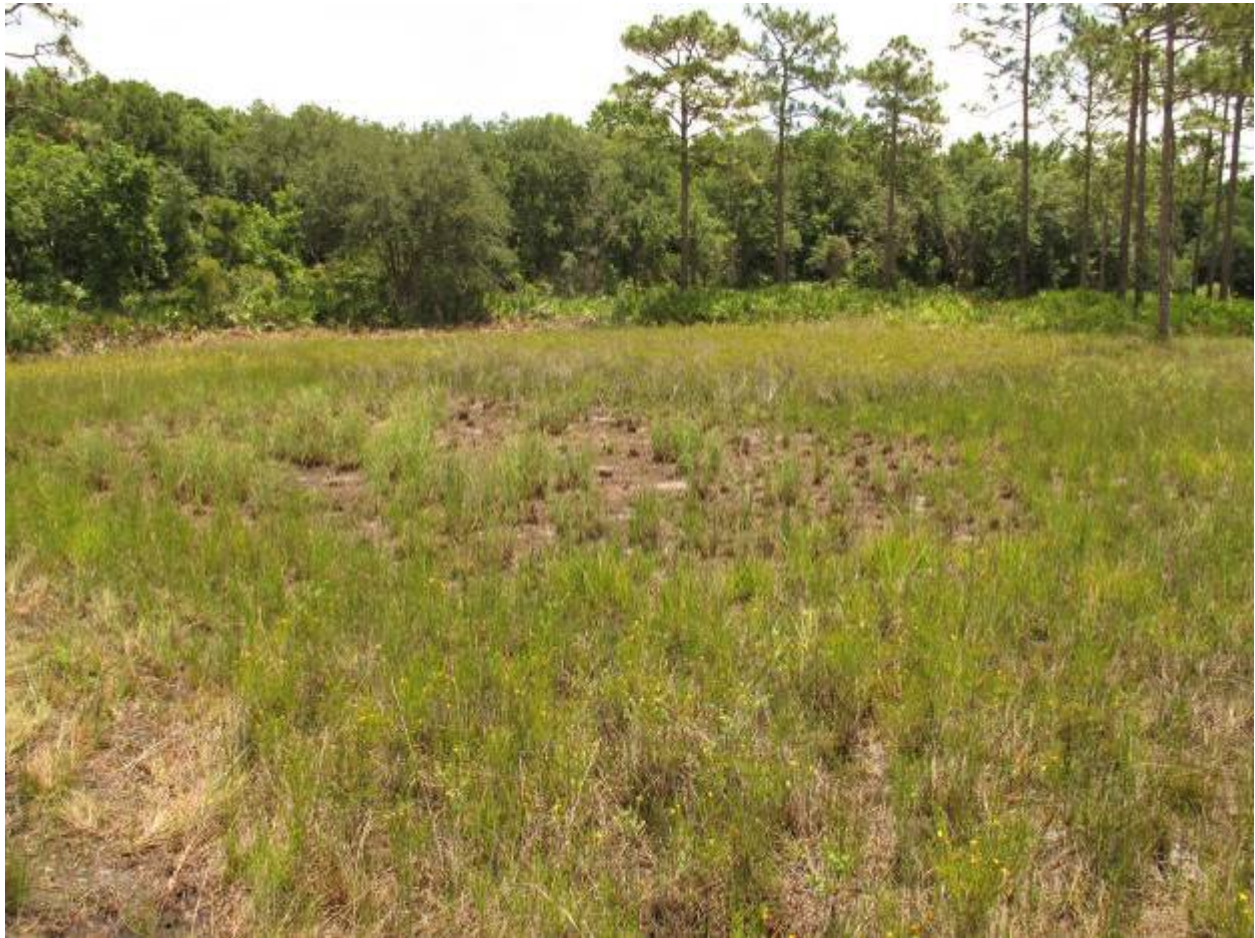
**Wetland ID: 10-01**

**Description:** This wetland is a 0.1 ha ephemeral marsh. There is no tree canopy or midstory cover. Sedges/grasses grow throughout the wetland, and cover >75% of the basin. There is evidence of cattle in the wetland, including tracks and feces. An auto track bisects the western edge of the wetland. The adjacent uplands are mesic flatwoods that are managed with prescribed fire.

**Wetland Concerns:** Cattle, Vehicular damage

**Restoration Action Recommended:** The uplands in this MU are in good ecological condition, although we have observed some cattle-related effects in both wetlands and uplands in some areas. We recommend removing cattle from this unit to prevent destruction of the intact flatwoods community and the embedded wetlands. If the auto track is necessary, reroute it away from the wetland.

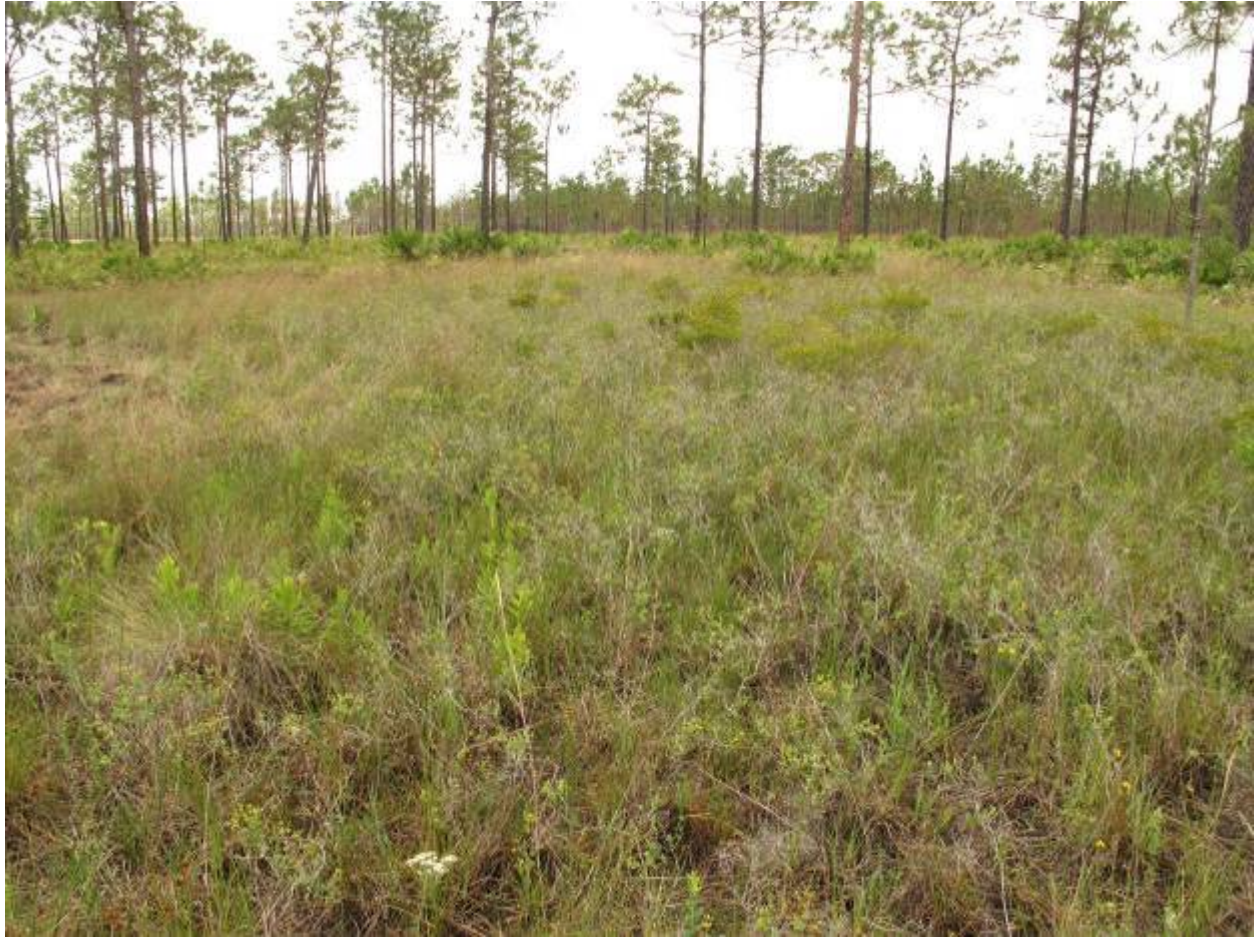
**Wetland ID: 10-02**

**Description:** This wetland is a 0.1 ha ephemeral marsh. There is no tree canopy or midstory cover. Sedges/grasses and *Hypericum* grow throughout the wetland, and cover >75% of the basin. There is evidence of cattle in the wetland, including feces. The adjacent uplands are mesic flatwoods that are managed with prescribed fire.

**Wetland Concerns:** Cattle

**Restoration Action Recommended:** The uplands in this MU are in good ecological condition, although we have observed some cattle-related effects in both wetlands and uplands in some areas. We recommend removing cattle from this unit to prevent destruction of the intact flatwoods community and the embedded wetlands.

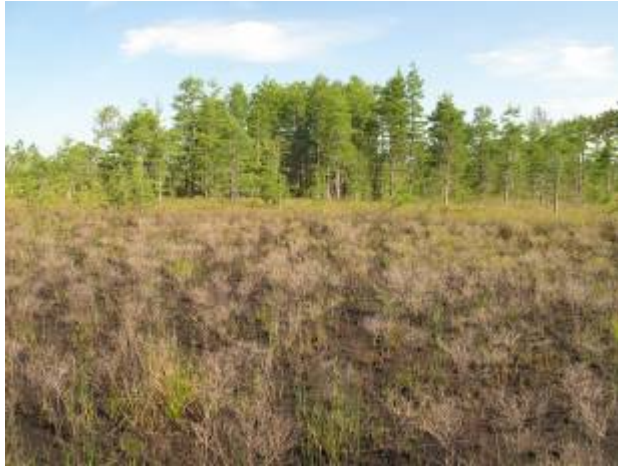
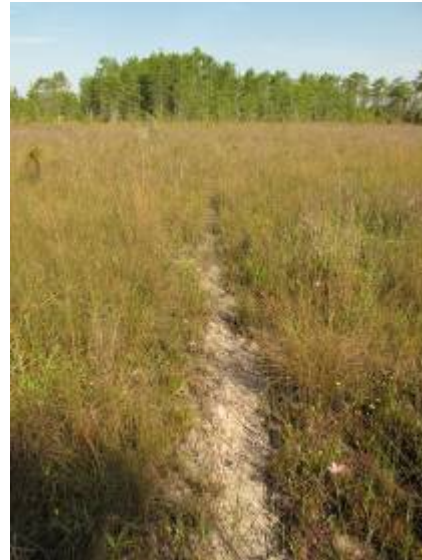
**Wetland ID: 10-03**

**Description:** This wetland is a 0.8 ha ephemeral marsh. A cypress dome is forming in the center of the wetland. The tree canopy covers 5-25% of the basin. There is no midstory cover. *Hypericum* is abundant within the wetland. Maidencane grows beneath the cypress and sedges/grasses grow in the marsh area outside the cypress dome. The herbaceous vegetation covers 50-75% of the basin. Recent drying in the wetland has exposed bare soil; grasses are re-sprouting. A cattle trail/shallow ditch flows southeast from the wetland and connects this wetland with 10-02 during times of high water. It is unclear whether the ditch feature started as a cattle trail or was human-constructed. Regardless of its origin, the feature is now acting as a ditch that drains the wetland during times of high water. The adjacent uplands are mesic flatwoods that are managed with prescribed fire and mechanical vegetation removal.

**Wetland Concerns:** Cattle, Ditching

**Restoration Action Recommended:** Fill the ditch to break connectivity with the wetland. Alternatively, the ditch could be plugged and vegetation allowed to regenerate. The uplands in this MU are in good ecological condition, although we have observed some cattle-related effects in both wetlands and uplands in some areas. We recommend removing cattle from this unit to prevent destruction of the intact flatwoods community and the embedded wetlands.

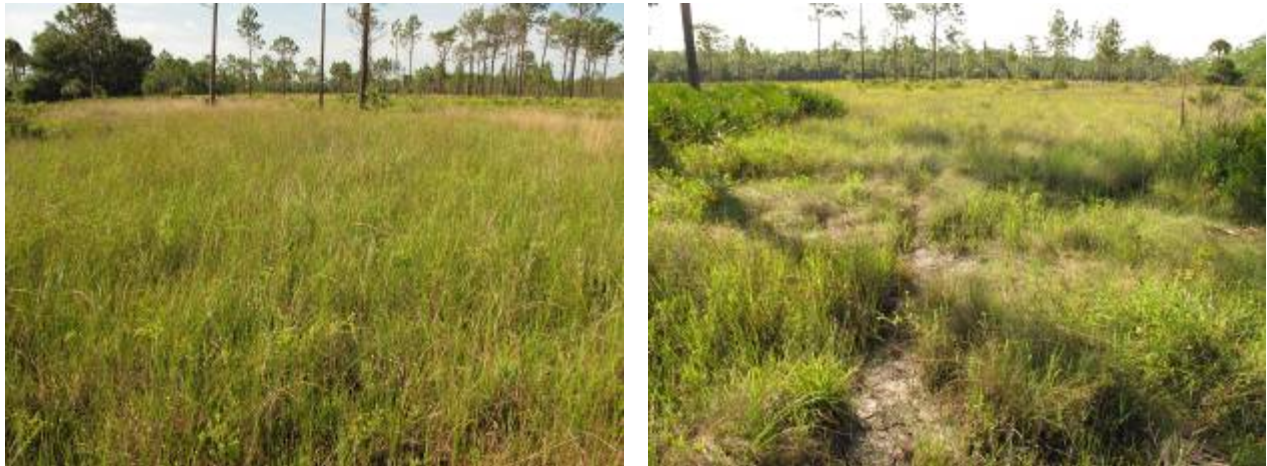
**Wetland ID: 10-04**

**Description:** This wetland is a 0.2 ha ephemeral marsh. There is no tree canopy or midstory cover. Sedges/grasses grow throughout the wetland, and cover >75% of the basin. There is evidence of cattle in the wetland, including feces. A cattle trail/ditch (see 10-03 description) enters this wetland from the northwest side, connecting the wetland with 10-03. The adjacent uplands are mesic flatwoods that are managed with prescribed fire.

**Wetland Concerns:** Cattle, Ditching

**Restoration Action Recommended:** Fill the ditch to break connectivity with the wetland. Alternatively, the ditch could be plugged and vegetation allowed to regenerate. The uplands in this MU are in good ecological condition, although we have observed some cattle-related effects in both wetlands and uplands in some areas. We recommend removing cattle from this unit to prevent destruction of the intact flatwoods community and the embedded wetlands.

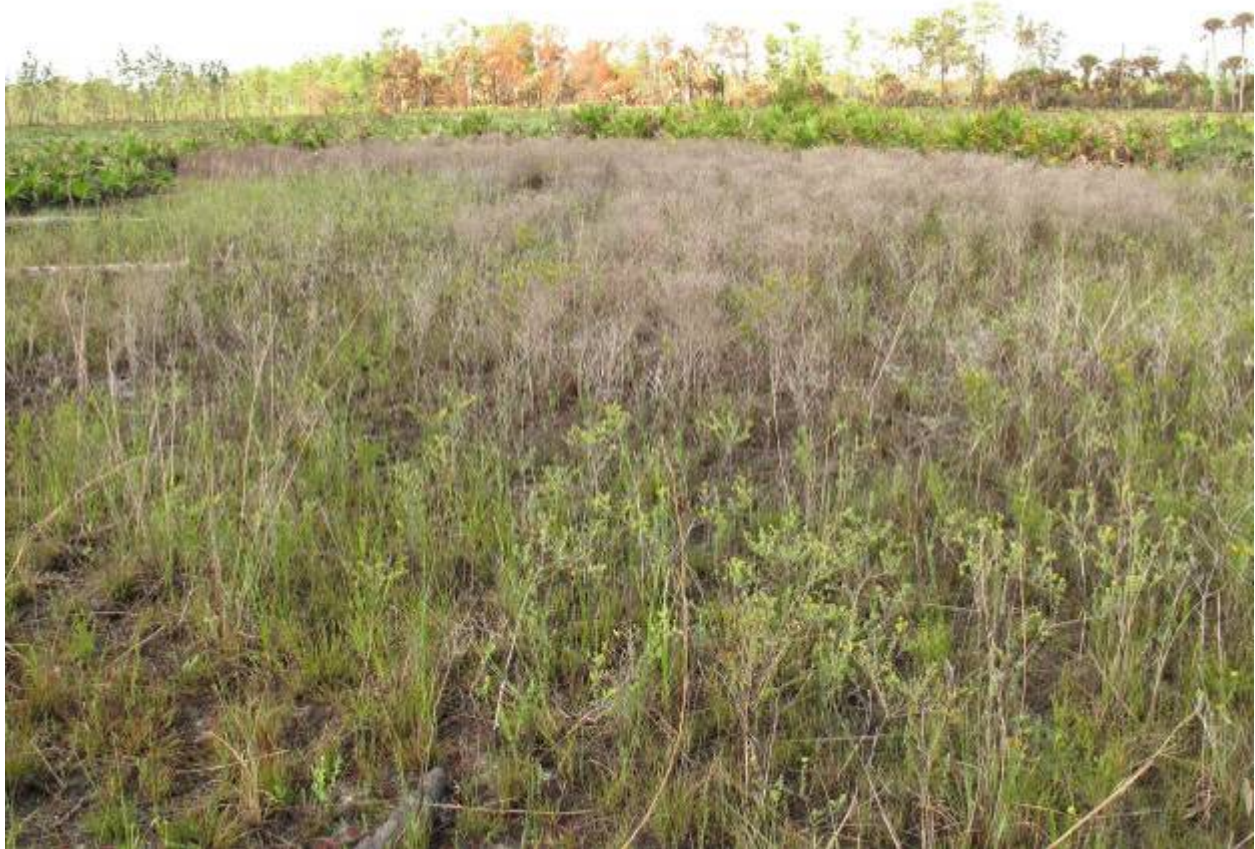
**Wetland ID: 10-05**

**Description:** This wetland is a <0.1 ha ephemeral marsh. There is no tree canopy or midstory cover. Sedges/grasses grow throughout the wetland, and cover >75% of the basin. We observed no evidence of cattle in the wetland, although cattle are allowed in this MU. The adjacent uplands are mesic flatwoods that are managed with prescribed fire.

**Wetland Concerns:** None

**Restoration Action Recommended:** The uplands in this MU are in good ecological condition, although we have observed some cattle-related effects in both wetlands and uplands in some areas. We recommend removing cattle from this unit to prevent destruction of the intact flatwoods community and the embedded wetlands.

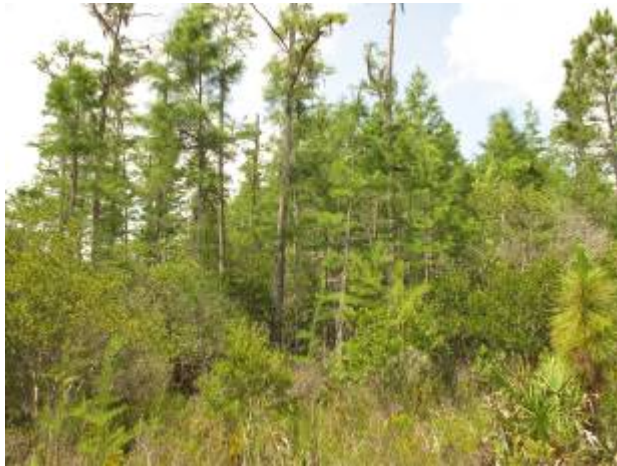
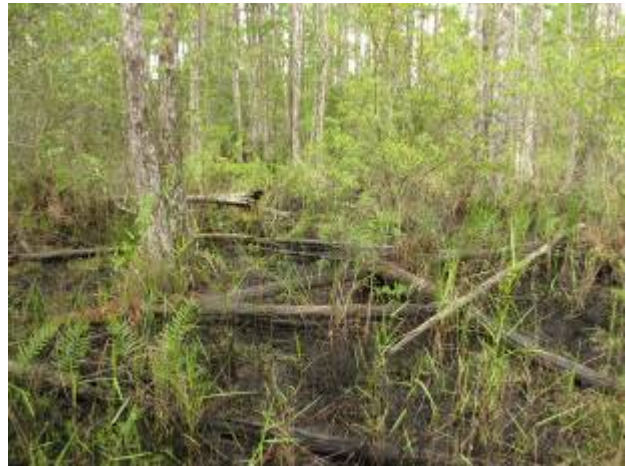
**Wetland ID: 11-01**

**Description:** This wetland is a 0.6 ha ephemeral forested swamp. Cypress trees dominate the canopy, and cover >75% of the wetland. The midstory is dominated by wax myrtle, and covers 50-75% of the wetland. The outer half of the wetland is brushy, the interior is more open. Maidencane and fern grow in the wetland center and sedges/grasses grow around the other edges of the wetland. The herbaceous vegetation covers >75% of the basin. We observed no evidence of cattle in the wetland, although cattle are allowed in this MU. The adjacent uplands are mesic flatwoods that are managed with prescribed fire.

**Wetland Concerns:** None

**Restoration Action Recommended:** The uplands in this MU are in good ecological condition, although we have observed some cattle-related effects in both wetlands and uplands in some areas. We recommend removing cattle from this unit to prevent destruction of the intact flatwoods community and the embedded wetlands.

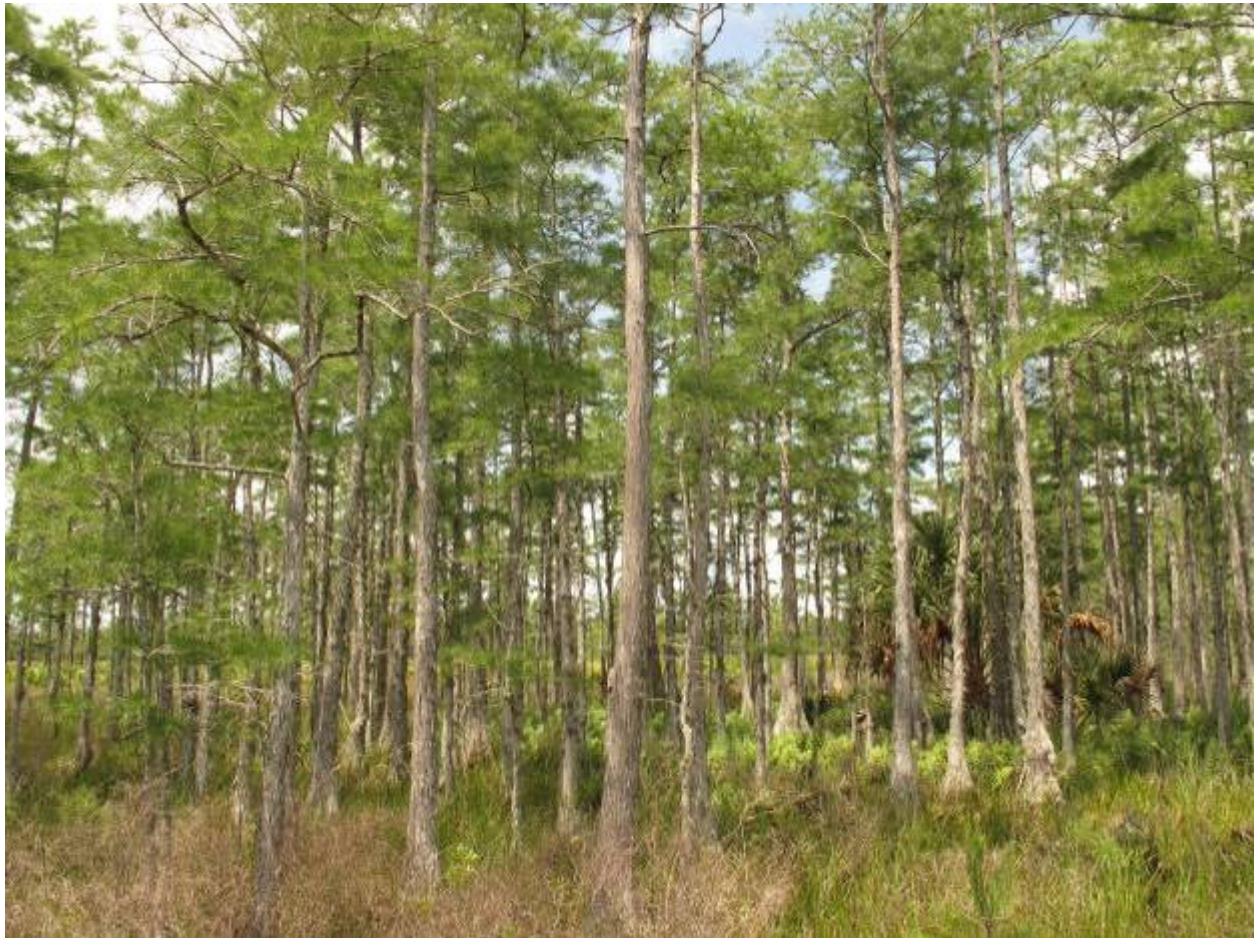
**Wetland ID: 11-02**

**Description:** This wetland is a 0.6 ha ephemeral forested swamp. Cypress trees dominate the canopy, and cover >75% of the wetland. There is no midstory cover. Fern and sedges/grasses grow throughout the wetland, and cover >75% of the basin. This wetland appears to burn frequently. We observed no evidence of cattle in the wetland, although cattle are allowed in this MU. The adjacent uplands are mesic flatwoods that are managed with prescribed fire.

**Wetland Concerns:** None

**Restoration Action Recommended:** The uplands in this MU are in good ecological condition, although we have observed some cattle-related effects in both wetlands and uplands in some areas. We recommend removing cattle from this unit to prevent destruction of the intact flatwoods community and the embedded wetlands.

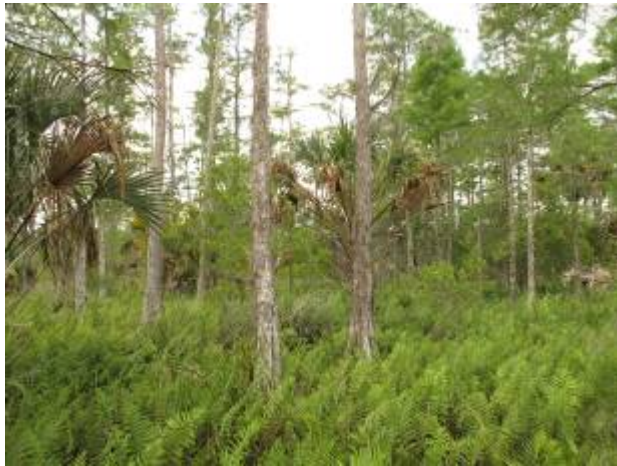
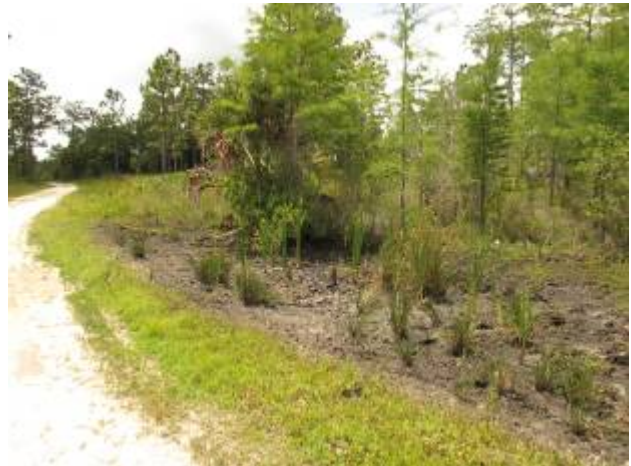
**Wetland ID: 11-03**

**Description:** This wetland is a 0.2 ha ephemeral forested swamp. This wetland is likely a marsh succeeding to a cypress dome. Cypress trees dominate the canopy, and cover 50-75% of the wetland. The midstory is dominated by wax myrtle, and covers 5-25% of the wetland. Fern and sedges/grasses grow throughout the wetland, and cover >75% of the basin. There is evidence of cattle in the wetland, including a muddy area with heavy trampling and feces. A MU boundary/road was routed through the north side of the wetland. The adjacent uplands are mesic flatwoods that are managed with prescribed fire.

**Wetland Concerns:** Cattle, Road

**Restoration Action Recommended:** Re-route the MU boundary/road northward around the wetland. The uplands in this management unit are in good ecological condition. The uplands in this MU are in good ecological condition, although we have observed some cattle-related effects in both wetlands and uplands in some areas. We recommend removing cattle from this unit to prevent destruction of the intact flatwoods community and the embedded wetlands.

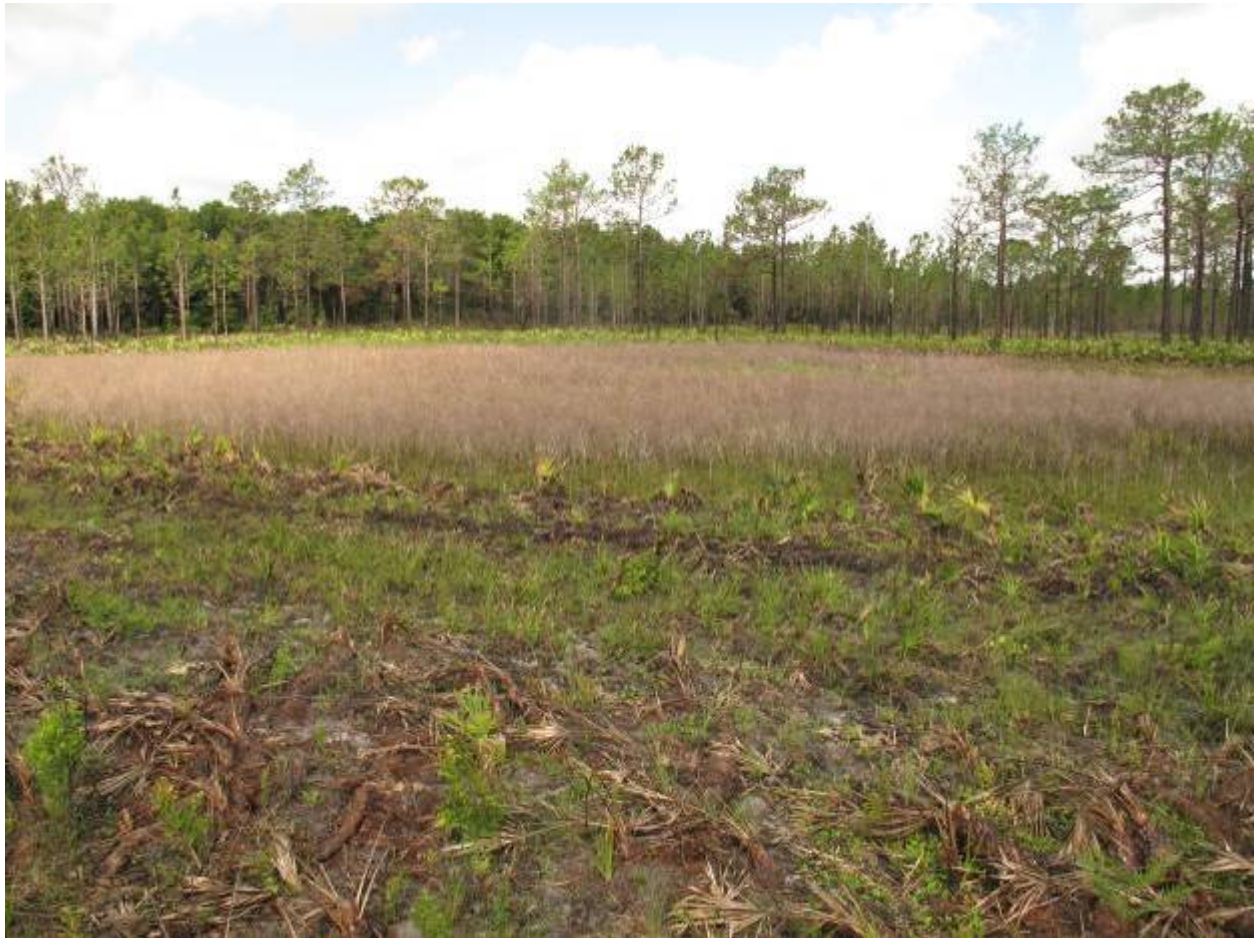
**Wetland ID: 12-01**

**Description:** This wetland is a 0.3 ha ephemeral marsh. There is no tree canopy or midstory cover. *Hypericum* was abundant but was recently killed by inundation and fire. Maidencane grows in the wetland center and sedges/grasses grow throughout the wetland. The herbaceous vegetation covers >75% of the basin. A recent fire burned through half of the wetland. There is evidence of cattle in the wetland. The adjacent uplands are scrubby flatwoods that are managed with prescribed fire.

**Wetland Concerns:** Cattle

**Restoration Action Recommended:** The uplands in this MU are in good ecological condition, although we have observed some cattle-related effects in both wetlands and uplands in some areas. We recommend removing cattle from this unit to prevent destruction of the intact flatwoods community and the embedded wetlands.

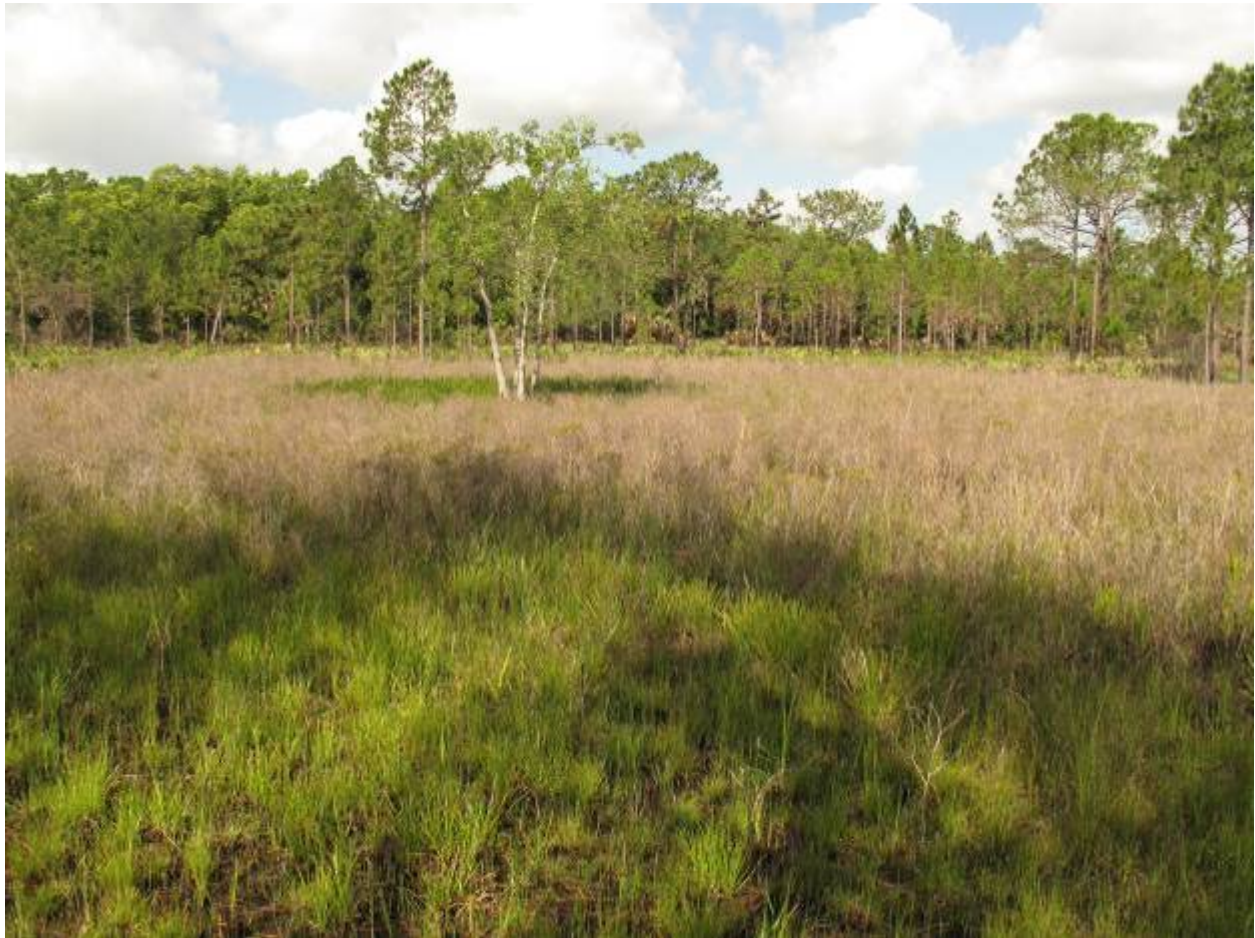
**Wetland ID: 12-02**

**Description:** This wetland is a 0.3 ha ephemeral marsh. There is no tree canopy or midstory cover. Pickerelweed grows in the wetland center and sedges/grasses grow throughout the wetland. The herbaceous vegetation covers >75% of the basin. A recent fire burned into the wetland edges. There is evidence of cattle in the wetland, including tracks and feces. The adjacent uplands are scrubby flatwoods that are managed with prescribed fire.

**Wetland Concerns:** Cattle

**Restoration Action Recommended:** The uplands in this MU are in good ecological condition, although we have observed some cattle-related effects in both wetlands and uplands in some areas. We recommend removing cattle from this unit to prevent destruction of the intact flatwoods community and the embedded wetlands.

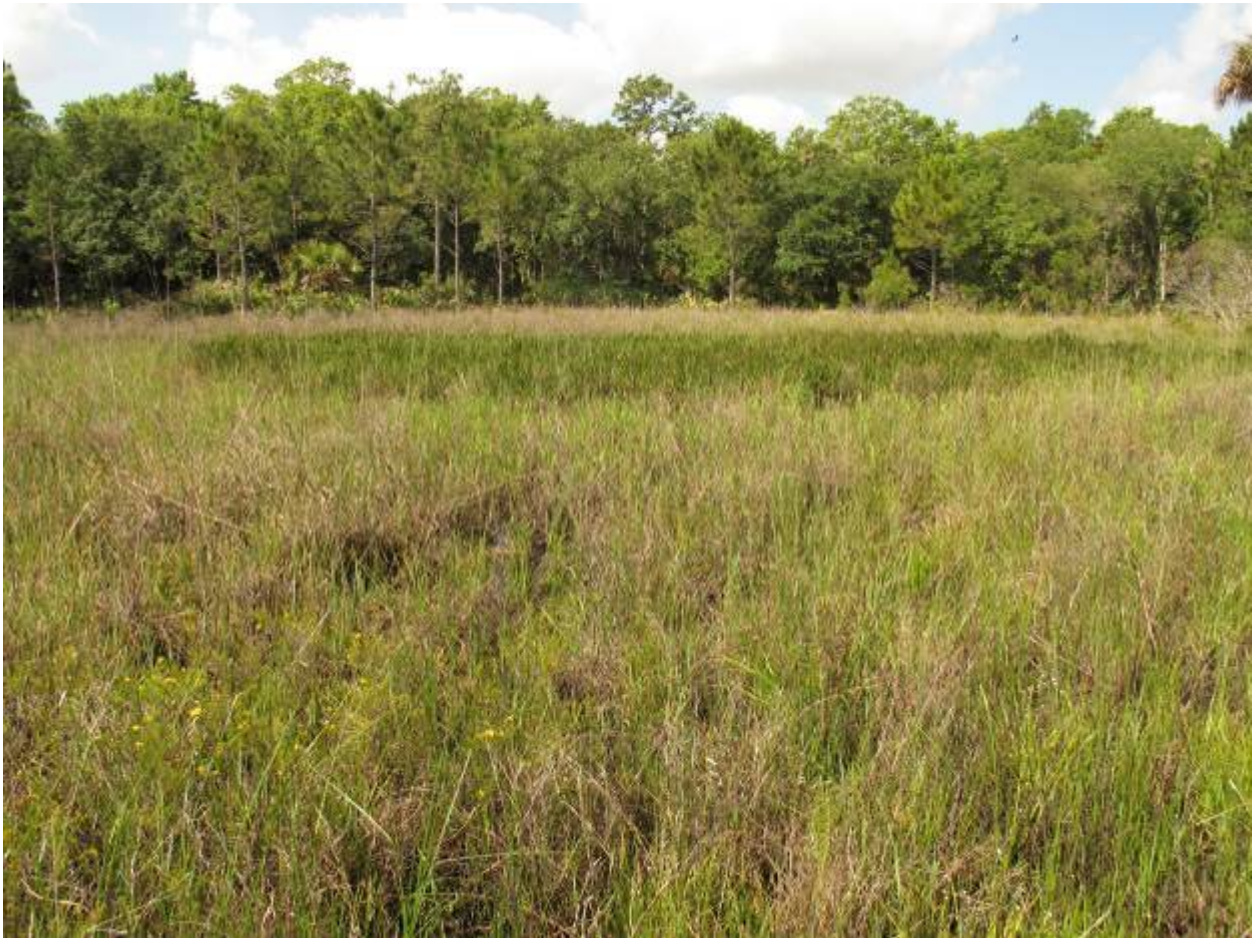
**Wetland ID: 12-03**

**Description:** This wetland is a 0.2 ha ephemeral marsh. There is no tree canopy or midstory cover. Pickerelweed grows in the wetland center, maidencane grows throughout, and sedges/grasses grow in a ring around the wetland. The herbaceous vegetation covers >75% of the basin. There is evidence of cattle in the wetland. The adjacent uplands are scrubby flatwoods that are managed with prescribed fire.

**Wetland Concerns:** Cattle

**Restoration Action Recommended:** The uplands in this MU are in good ecological condition, although we have observed some cattle-related effects in both wetlands and uplands in some areas. We recommend removing cattle from this unit to prevent destruction of the intact flatwoods community and the embedded wetlands.

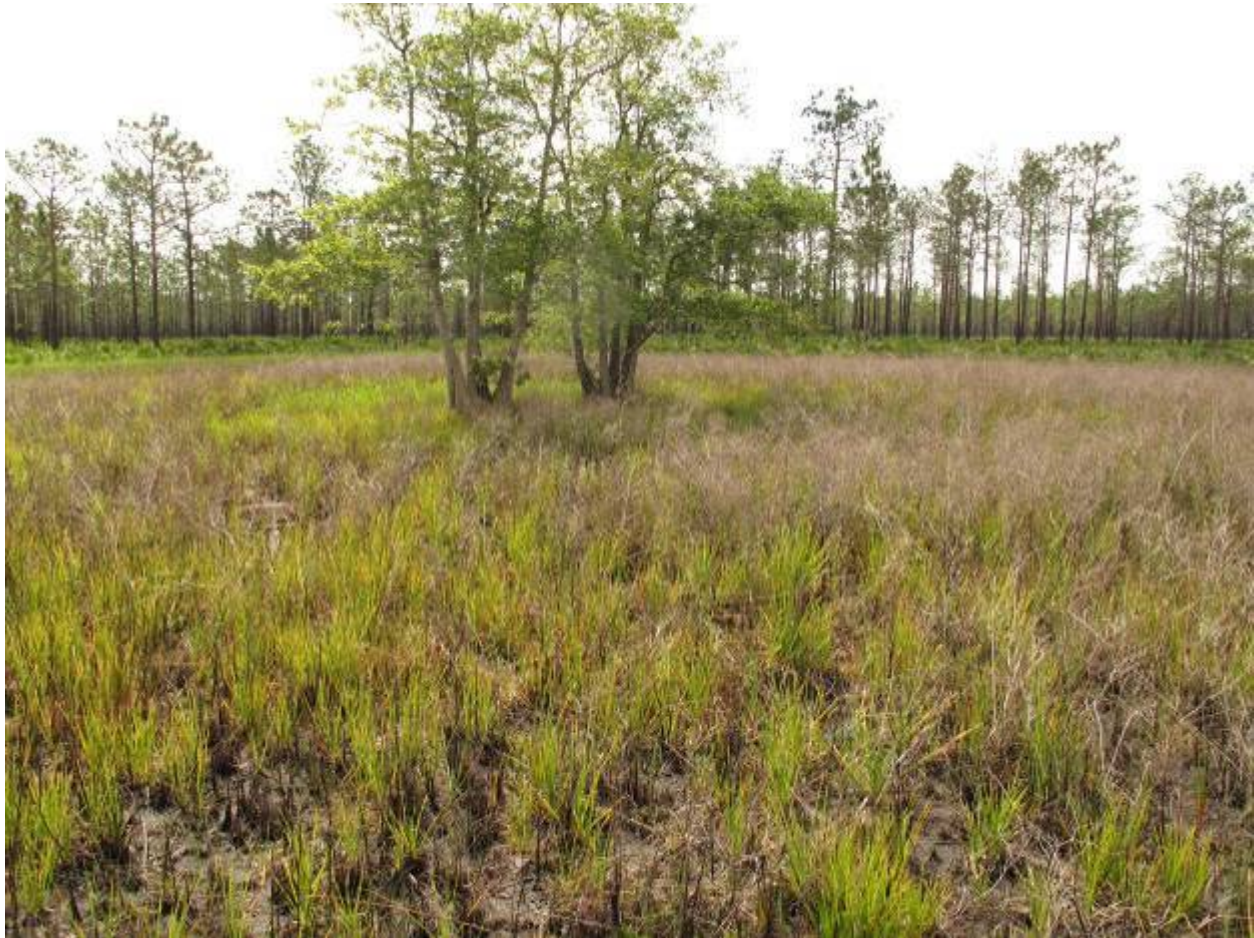
**Wetland ID: 12-04**

**Description:** This wetland is a 0.3 ha ephemeral marsh. A small patch of gum trees grow in the wetland center but cover <5% of the basin. There is no midstory cover. Sedges/grasses grow throughout the wetland, and cover >75% of the basin. A recent fire burned through the wetland basin. There are a few cattle tracks in the wetland but no trails have formed. Feral hog damage is minor. The adjacent uplands are scrubby flatwoods that are managed with prescribed fire.

**Wetland Concerns:** Feral hog damage, Cattle

**Restoration Action Recommended:** The uplands in this MU are in good ecological condition, although we have observed some cattle-related effects in both wetlands and uplands in some areas. We recommend removing cattle from this unit to prevent destruction of the intact flatwoods community and the embedded wetlands.

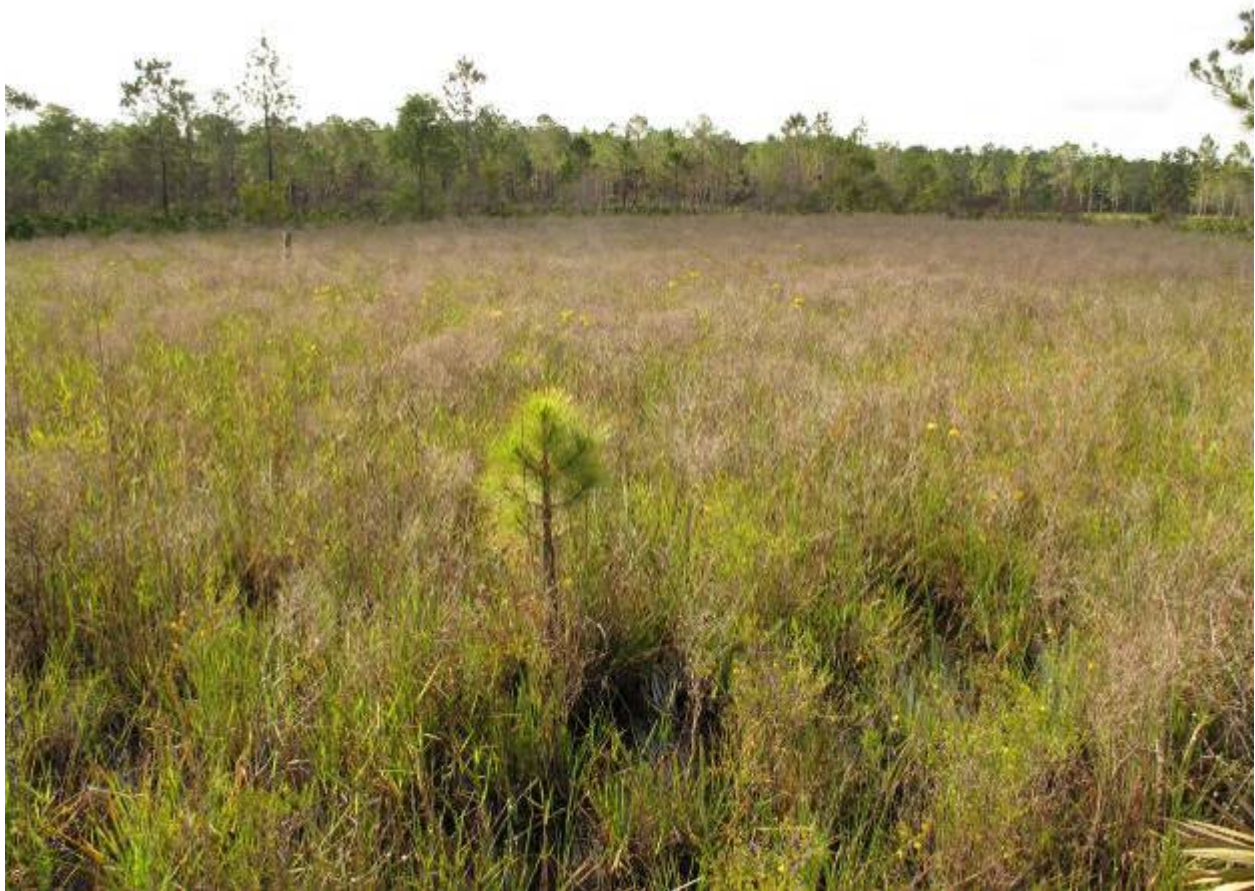
**Wetland ID: 13-01**

**Description:** This wetland is a 0.3 ha ephemeral marsh. There is no tree canopy or midstory cover. *Hypericum* is common within the wetland. Maidencane and sedges/grasses grow throughout the wetland, and cover >75% of the basin. Feral hog damage is minor. The adjacent uplands are mesic flatwoods that are managed with prescribed fire and mechanical vegetation removal.

**Wetland Concerns:** Feral hog damage

**Restoration Action Recommended:** The uplands in this MU are in good ecological condition, although we have observed some cattle-related effects in both wetlands and uplands in some areas. We recommend removing cattle from this unit to prevent destruction of the intact flatwoods community and the embedded wetlands.
