# **Inventory, Assessment, and Restoration Potential of Ephemeral Wetlands on FFWCC Wildlife Management Areas**

## **Triple N Ranch WMA Final Report**

Submitted by: Rebecca P.M. Means<sup>1</sup>, Ryan C. Means<sup>1</sup>, Steven A. Johnson<sup>2</sup>

15 May 2010 – 15 August 2010

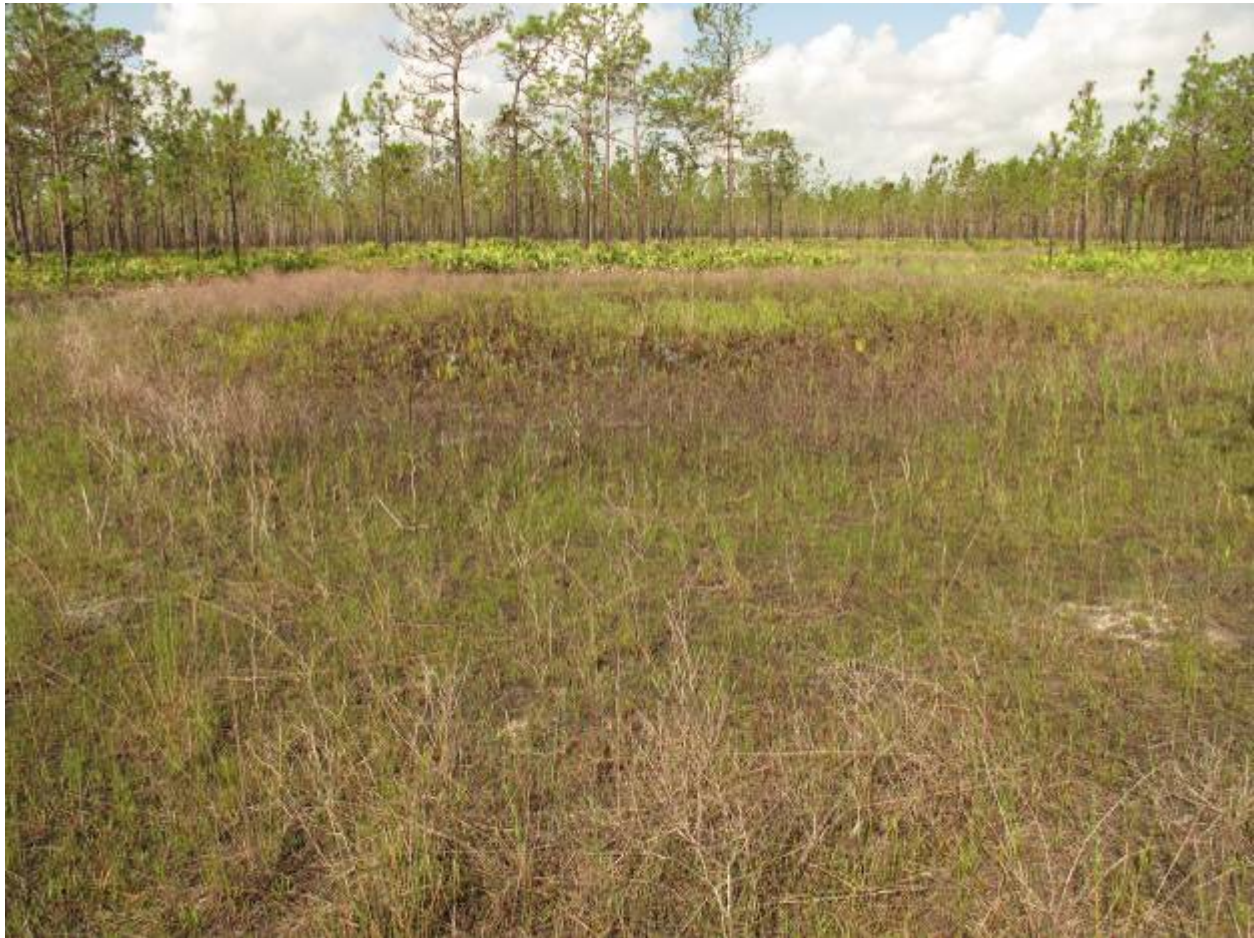
**Wetland ID: 13-02**

**Description:** This wetland is a 0.1 ha ephemeral marsh. There is no tree canopy or midstory cover. Sedges/grasses grow throughout the wetland, and cover 50-75% of the basin. A recent fire burned through the wetland basin. Cattle have formed a trail along the edge of the wetland. This wetland may connect with 13-03 to the west during times of high water. The adjacent uplands are a mix of mesic and scrubby flatwoods that are managed with prescribed fire and mechanical vegetation removal.

**Wetland Concerns:** Cattle

**Restoration Action Recommended:** The uplands in this MU are in good ecological condition, although we have observed some cattle-related effects in both wetlands and uplands in some areas. We recommend removing cattle from this unit to prevent destruction of the intact flatwoods community and the embedded wetlands.

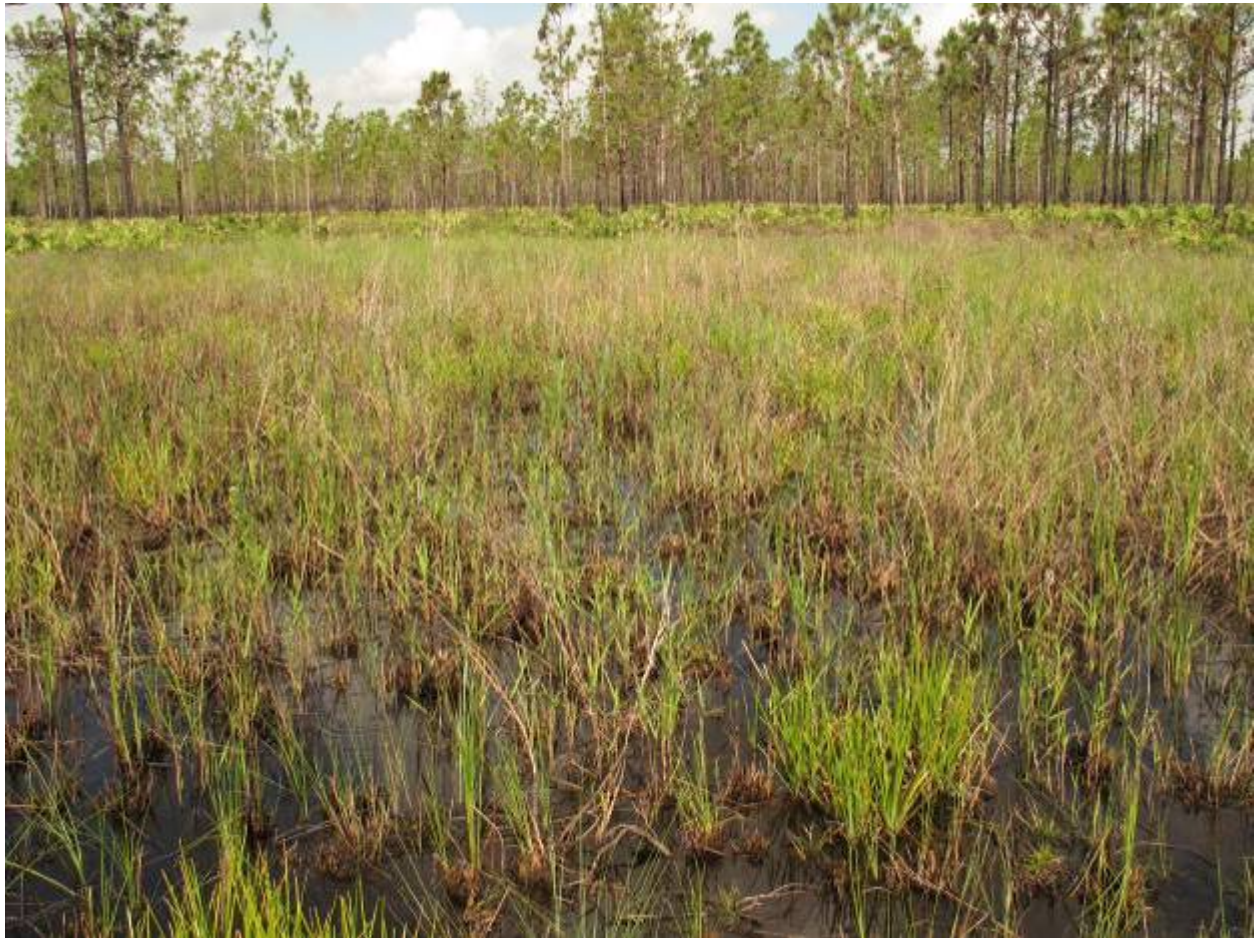
**Wetland ID: 13-03**

**Description:** This wetland is a 0.1 ha ephemeral marsh. There is no tree canopy or midstory cover. Sedges/grasses grow throughout the wetland, and cover >75% of the basin. A recent fire burned through the wetland basin. Cattle have formed a trail along the edge of the wetland. This wetland may connect with 13-02 to the east during times of high water. The adjacent uplands are a mix of mesic and scrubby flatwoods that are managed with prescribed fire and mechanical vegetation removal.

**Wetland Concerns:** Cattle

**Restoration Action Recommended:** The uplands in this MU are in good ecological condition, although we have observed some cattle-related effects in both wetlands and uplands in some areas. We recommend removing cattle from this unit to prevent destruction of the intact flatwoods community and the embedded wetlands.

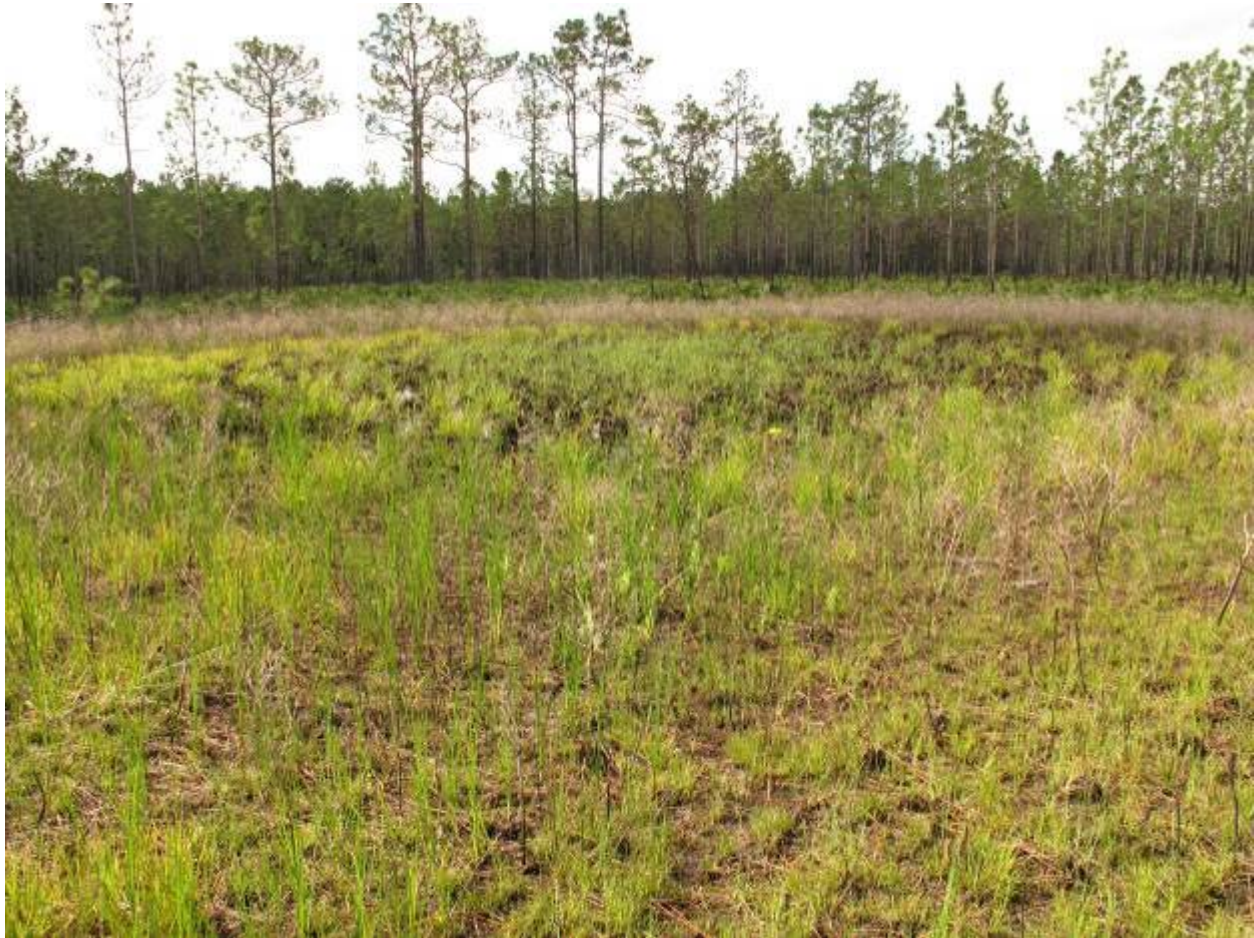
**Wetland ID: 13-04**

**Description:** This wetland is a 0.1 ha ephemeral marsh. There is no tree canopy or midstory cover. Sedges/grasses grow throughout the wetland, and cover 50-75% of the basin. A recent fire burned completely through the wetland basin. Cattle have formed a trail along the edge of the wetland. The adjacent uplands are scrubby flatwoods that are managed with prescribed fire and mechanical vegetation removal.

**Wetland Concerns:** Cattle

**Restoration Action Recommended:** The uplands in this MU are in good ecological condition, although we have observed some cattle-related effects in both wetlands and uplands in some areas. We recommend removing cattle from this unit to prevent destruction of the intact flatwoods community and the embedded wetlands.

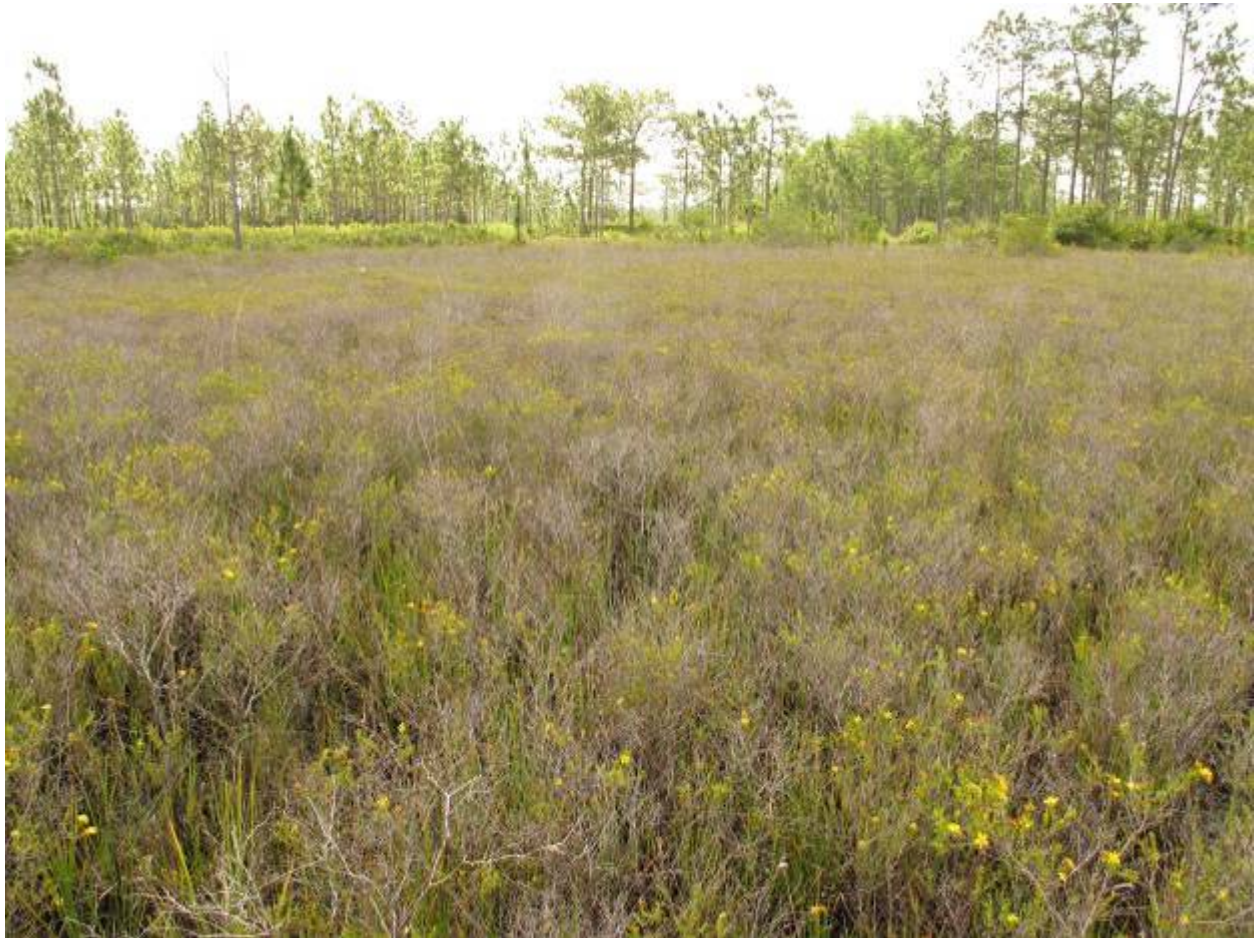
**Wetland ID: 14-01**

**Description:** This wetland is a 0.5 ha ephemeral marsh. There is no tree canopy or midstory cover. Sedges/grasses grow throughout the wetland, and cover >75% of the basin. We observed no evidence of cattle in the wetland, although cattle are allowed in this MU. The adjacent uplands are scrubby flatwoods that are managed with prescribed fire.

**Wetland Concerns:** None

**Restoration Action Recommended:** The uplands in this MU are in good ecological condition, although we have observed some cattle-related effects in both wetlands and uplands in some areas. We recommend removing cattle from this unit to prevent destruction of the intact flatwoods community and the embedded wetlands.

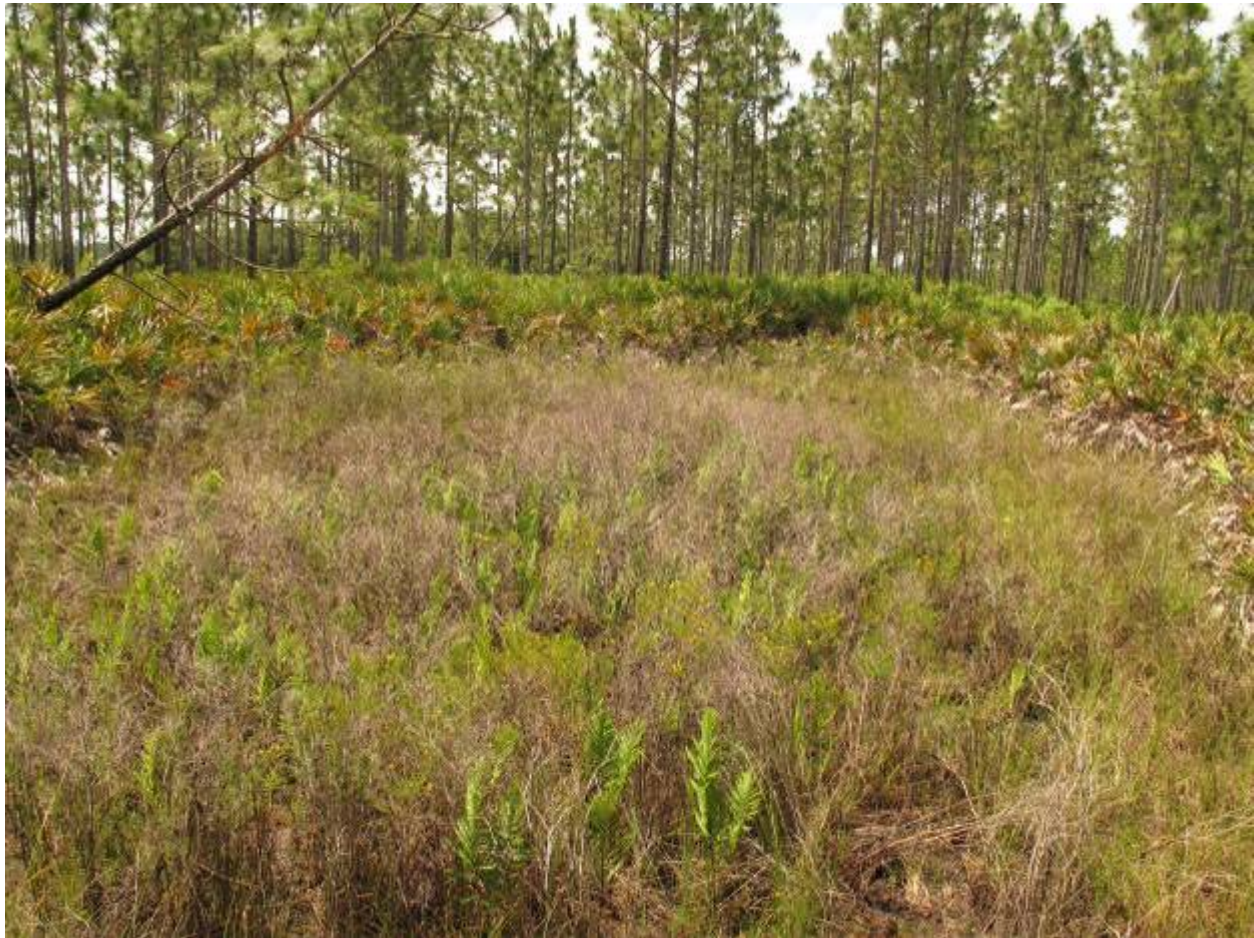
**Wetland ID: 14-02**

**Description:** This wetland is a <0.1 ha ephemeral marsh. There is no tree canopy or midstory cover. Sedges/grasses and fern grow throughout the wetland, and cover >75% of the basin. Feral hog damage is minor. We observed no evidence of cattle in the wetland, although cattle are allowed in this MU. The adjacent uplands are mesic flatwoods that are managed with prescribed fire.

**Wetland Concerns:** Feral hog damage

**Restoration Action Recommended:** The uplands in this MU are in good ecological condition, although we have observed some cattle-related effects in both wetlands and uplands in some areas. We recommend removing cattle from this unit to prevent destruction of the intact flatwoods community and the embedded wetlands.

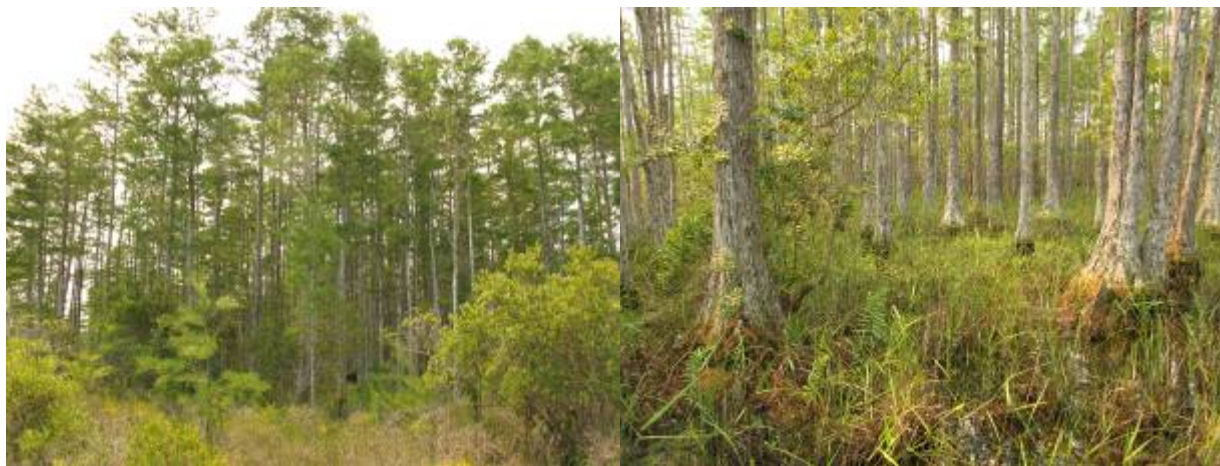
**Wetland ID: 14-03**

**Description:** This wetland is a 0.7 ha ephemeral forested swamp. Cypress trees dominate the canopy, and cover >75% of the basin. The midstory is dominated by wax myrtle, and covers 5-25% of the wetland. Sedges/grasses grow in a ring around the cypress dome and maidencane grows throughout the wetland. The herbaceous vegetation covers >75% of the basin. We observed no evidence of cattle in the wetland, although cattle are allowed in this MU. The adjacent uplands are a mix of mesic and scrubby flatwoods that are managed with prescribed fire.

**Wetland Concerns:** None

**Restoration Action Recommended:** The uplands in this MU are in good ecological condition, although we have observed some cattle-related effects in both wetlands and uplands in some areas. We recommend removing cattle from this unit to prevent destruction of the intact flatwoods community and the embedded wetlands.

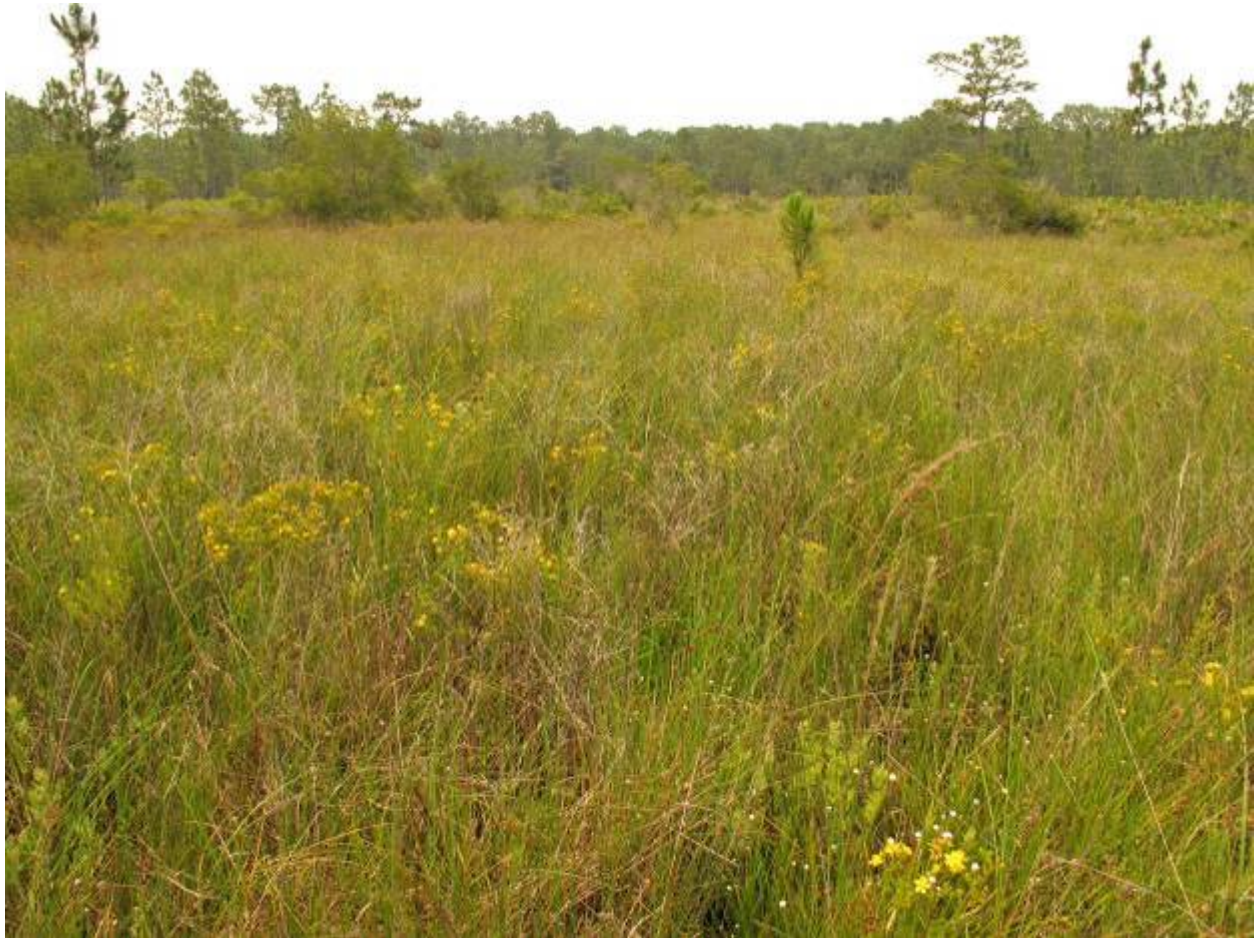
**Wetland ID: 14-04**

**Description:** This wetland is a 0.3 ha ephemeral marsh. There is no tree canopy or midstory cover. Sedges/grasses grow throughout this healthy marsh, and cover >75% of the basin. We observed no evidence of cattle in the wetland, although cattle are allowed in this MU. The adjacent uplands are mesic flatwoods that are managed with prescribed fire.

**Wetland Concerns:** None

**Restoration Action Recommended** The uplands in this MU are in good ecological condition, although we have observed some cattle-related effects in both wetlands and uplands in some areas. We recommend removing cattle from this unit to prevent destruction of the intact flatwoods community and the embedded wetlands.

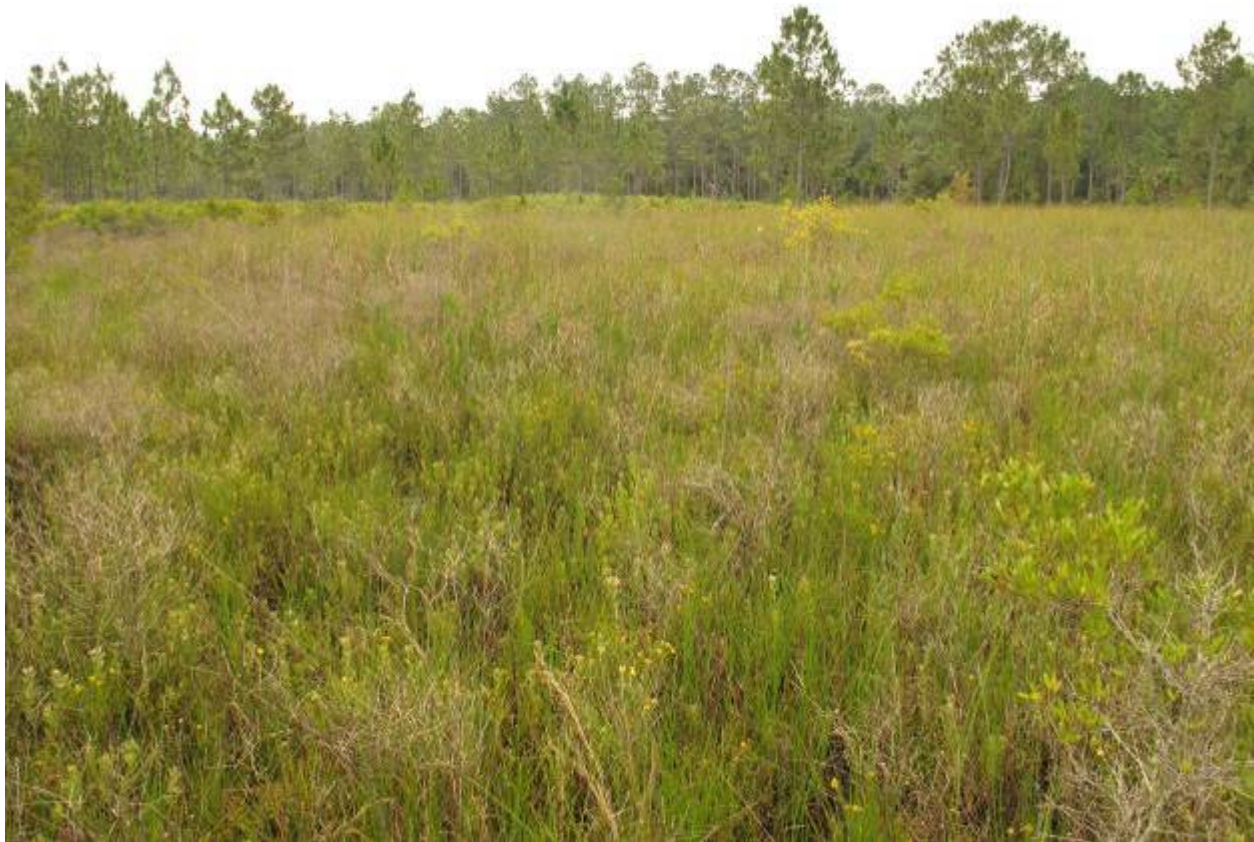
**Wetland ID: 14-05**

**Description:** This wetland is a 0.3 ha ephemeral marsh. There is no tree canopy or midstory cover. A high diversity of sedges/grasses and sawgrass grow throughout the wetland, and cover >75% of the basin. A game trail runs along the edge of the wetland but there is no evidence of cattle tracks. The adjacent uplands are a mix of scrubby and mesic flatwoods that are managed with prescribed fire.

**Wetland Concerns:** None

**Restoration Action Recommended:** The uplands in this MU are in good ecological condition, although we have observed some cattle-related effects in both wetlands and uplands in some areas. We recommend removing cattle from this unit to prevent destruction of the intact flatwoods community and the embedded wetlands.

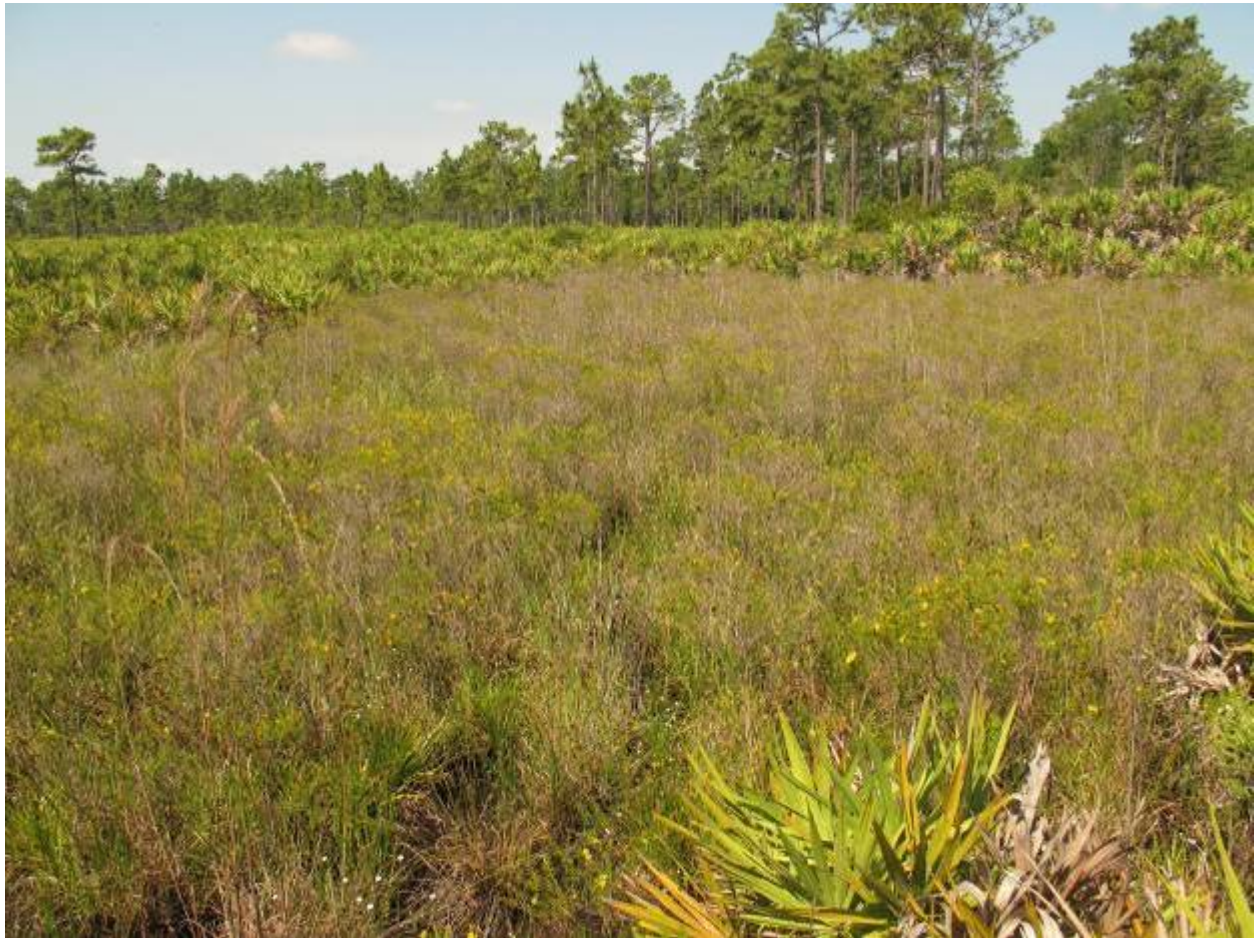
**Wetland ID: 15-01**

**Description:** This wetland is a 0.1 ha ephemeral marsh. There is no tree canopy or midstory cover. *Hypericum* is abundant within the wetland. Sedges/grasses grow throughout the wetland, and cover >75% of the basin. We observed no evidence of cattle in the wetland, although cattle are allowed in this MU. The adjacent uplands are mesic flatwoods that are managed with prescribed fire.

**Wetland Concerns:** None

**Restoration Action Recommended:** The uplands in this MU are in good ecological condition, although we have observed some cattle-related effects in both wetlands and uplands in some areas. We recommend removing cattle from this unit to prevent destruction of the intact flatwoods community and the embedded wetlands.

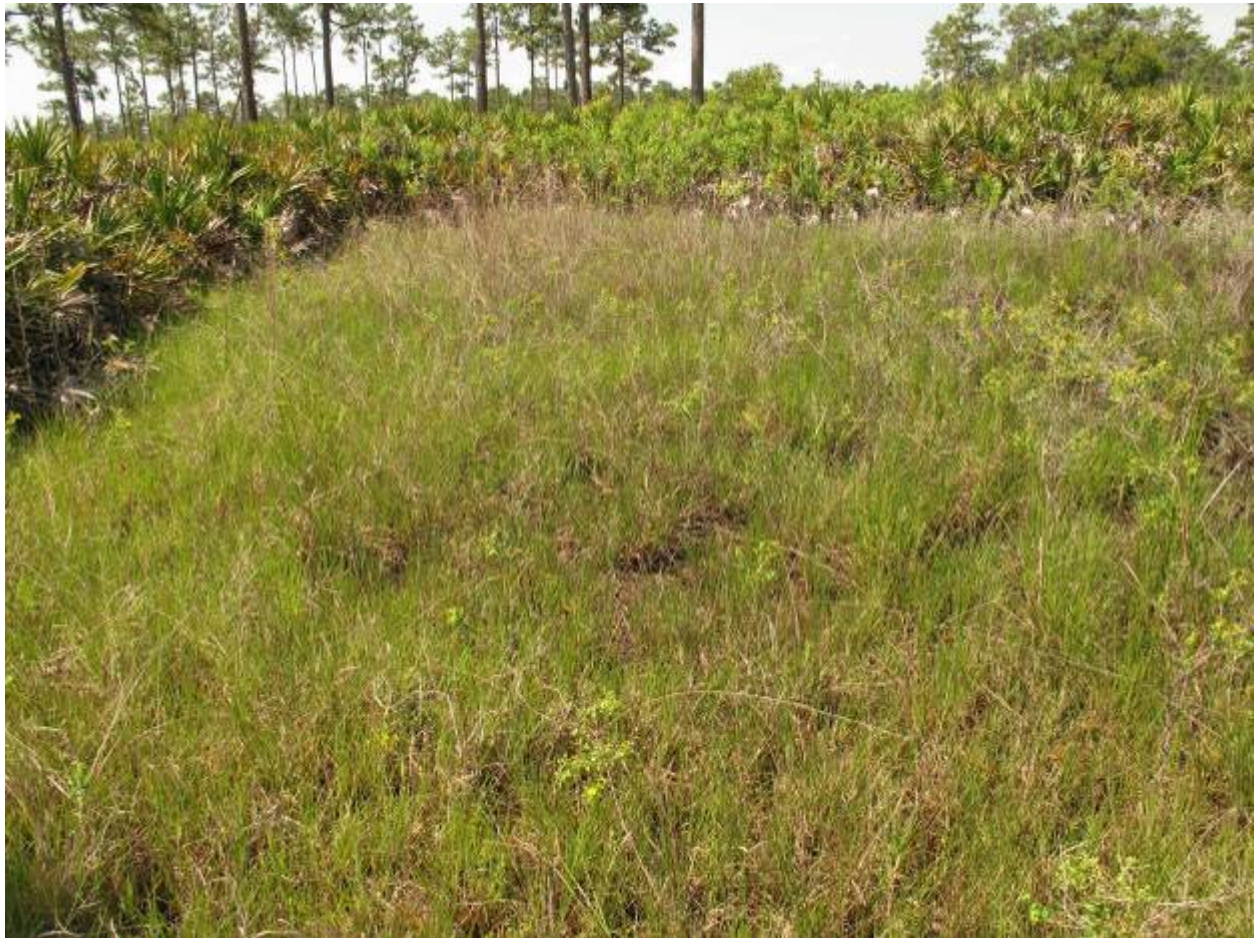
**Wetland ID: 15-02**

**Description:** This wetland is a <0.1 ha ephemeral marsh. There is no tree canopy or midstory cover. Sedges/grasses grow throughout the wetland, and cover >75% of the basin. We observed no evidence of cattle in the wetland, although cattle are allowed in this MU. The adjacent uplands are mesic flatwoods that are managed with prescribed fire.

**Wetland Concerns:** None

**Restoration Action Recommended:** The uplands in this MU are in good ecological condition, although we have observed some cattle-related effects in both wetlands and uplands in some areas. We recommend removing cattle from this unit to prevent destruction of the intact flatwoods community and the embedded wetlands.

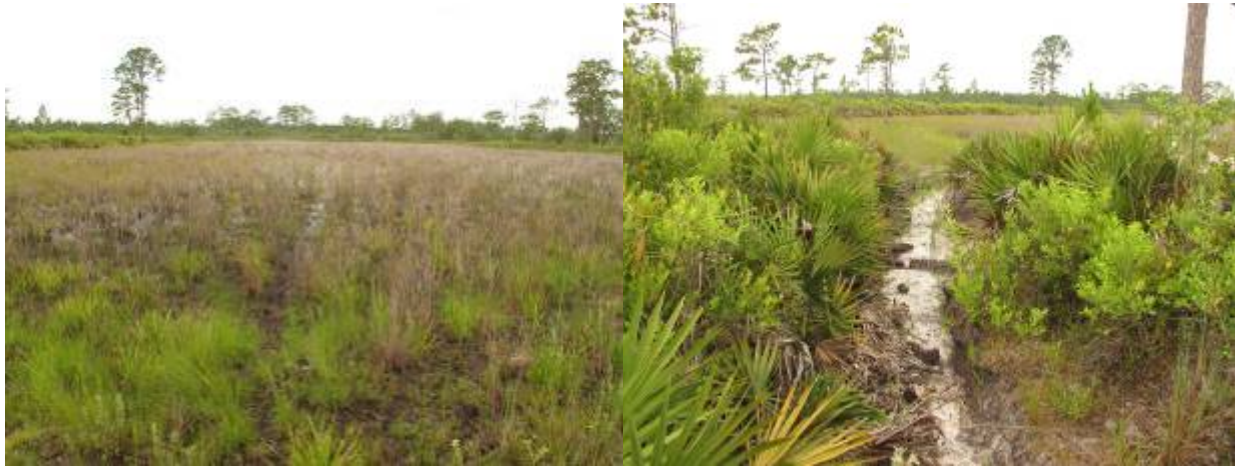
**Wetland ID: 16-01**

**Description:** This wetland is a 1.3 ha ephemeral marsh. There is no tree canopy or midstory cover. *Hypericum* is abundant and sedges/grasses grow throughout the wetland. The herbaceous vegetation covers >75% of the basin. A very shallow ditch on the south end connects the wetland to shallow roadside ditches. We observed no evidence of cattle in the wetland, although cattle are allowed in this MU. The adjacent uplands are scrubby flatwoods that are managed with prescribed fire.

**Wetland Concerns:** Ditching

**Restoration Action Recommended:** We recommend plugging the ditch to restore the wetland's isolation. However, the ditch is shallow so connection with the roadside ditches is likely infrequent. The uplands in this MU are in good ecological condition, although we have observed some cattle-related effects in both wetlands and uplands in some areas. We recommend removing cattle from this unit to prevent destruction of the intact flatwoods community and the embedded wetlands.

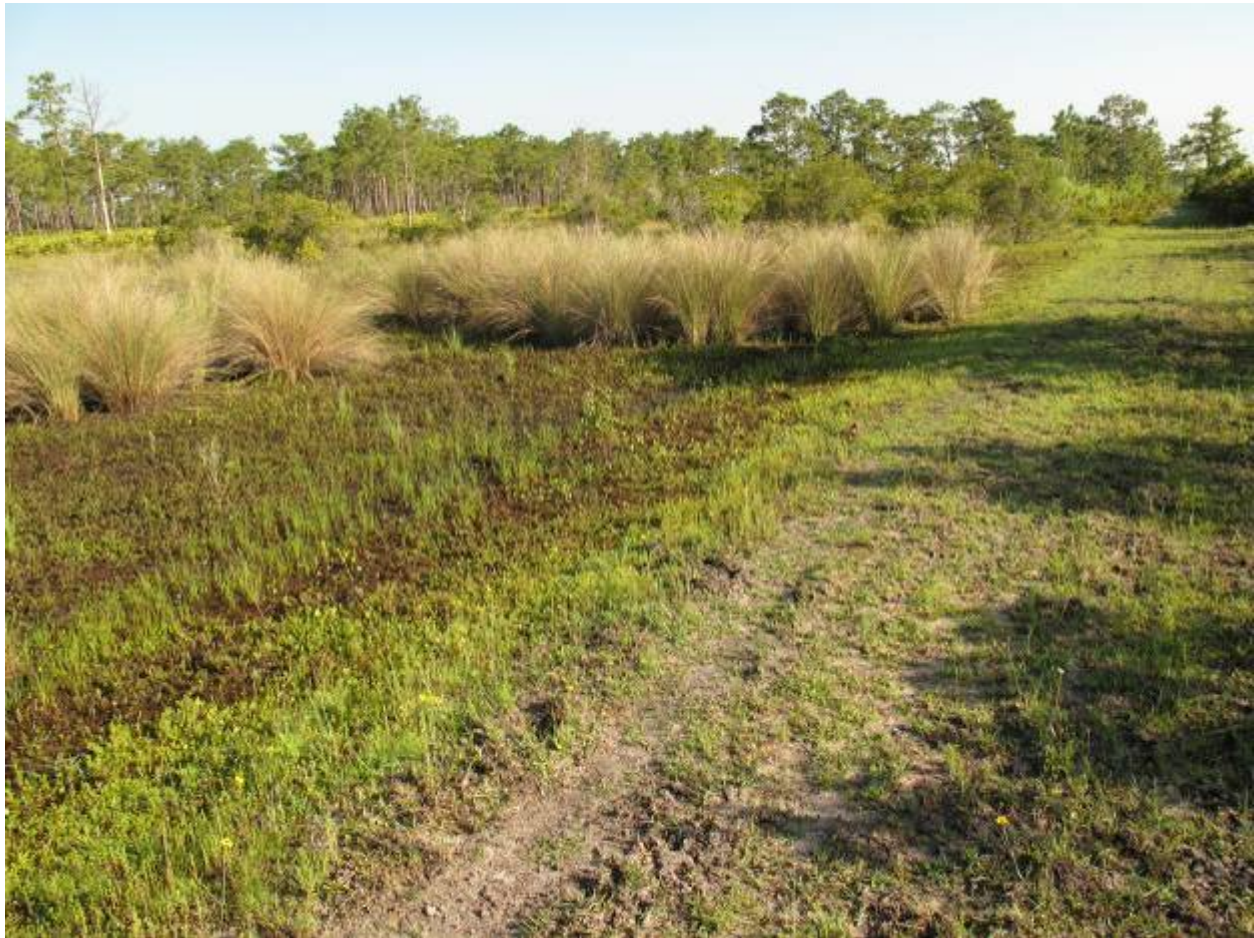
**Wetland ID: 17-01**

**Description:** This wetland is a 0.1 ha ephemeral marsh. There is no tree canopy cover. Wax myrtle grows around the wetland edge, and covers 5-25% of the wetland. Large sedge clumps grow in the wetland interior; other herbaceous vegetation is low-lying and appears to have been grazed. The herbaceous vegetation covers >75% of the basin. There is a fireline/MU boundary along the eastern edge of the wetland. The adjacent uplands are mesic flatwoods that are managed with prescribed fire. Cattle are allowed in this MU and animal trails are abundant in the uplands.

**Wetland Concerns:** Cattle, fireline/MU boundary

**Restoration Action Recommended:** The uplands in this MU are in good ecological condition, although we have observed some cattle-related effects in both wetlands and uplands in some areas. We recommend removing cattle from this unit to prevent destruction of the intact flatwoods community and the embedded wetlands. If possible re-route MU boundary/fireline further to the east.

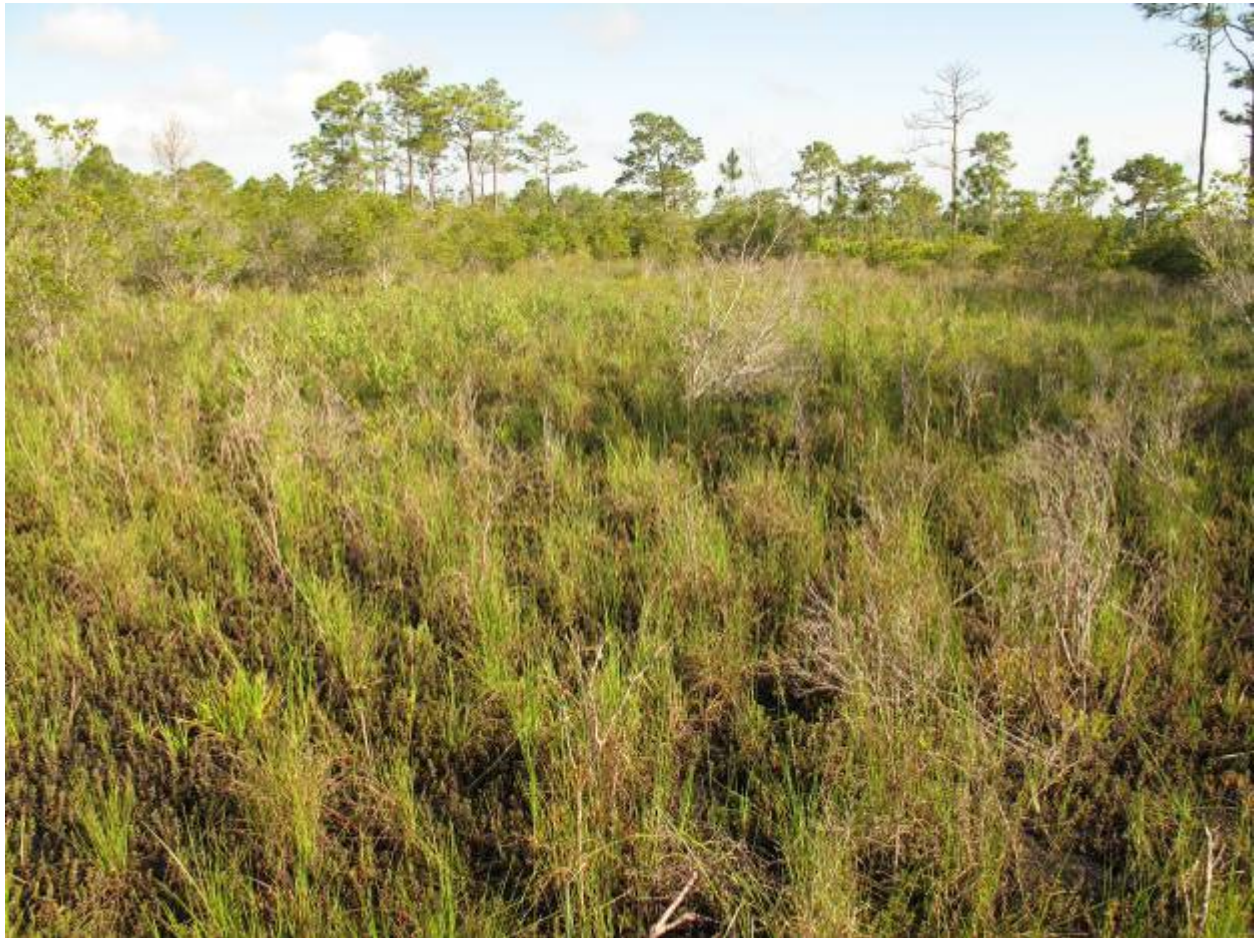
**Wetland ID: 17-02**

**Description:** This wetland is a 0.2 ha ephemeral marsh. There is no tree canopy cover. A ring of wax myrtle is forming around the wetland, and covers 5-25% of the wetland. Sedges/grasses and emergent vegetation grow throughout the wetland, and cover >75% of the basin. There are cattle tracks in the wetland. The adjacent uplands are mesic flatwoods that are managed with prescribed fire. Cattle are allowed in this MU and animal trails are abundant in the uplands.

**Wetland Concerns:** Cattle

**Restoration Action Recommended:** Continue periodic fire in the wetland to prevent the encroachment of wax myrtle. The uplands in this MU are in good ecological condition, although we have observed some cattle-related effects in both wetlands and uplands in some areas. We recommend removing cattle from this unit to prevent destruction of the intact flatwoods community and the embedded wetlands.

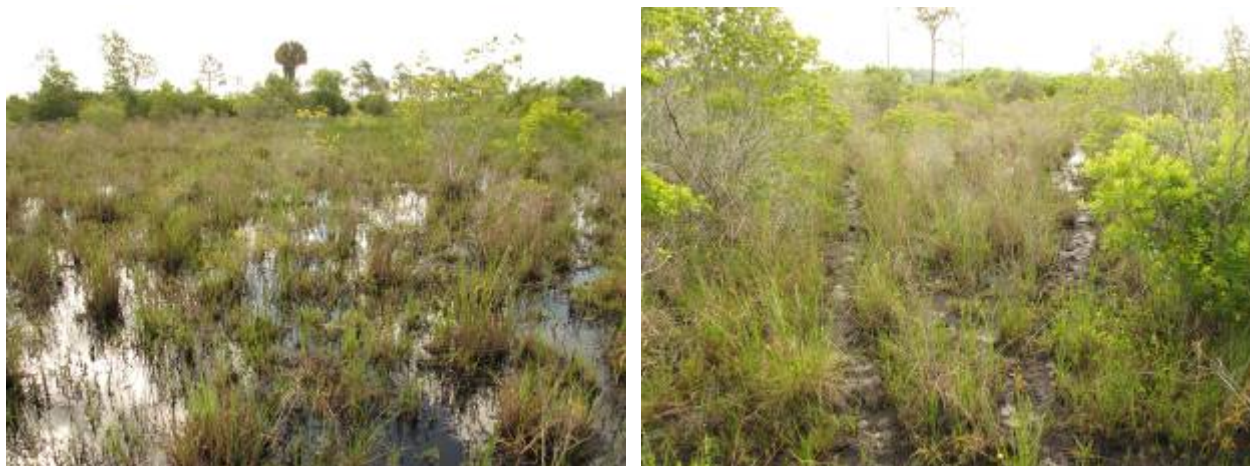
**Wetland ID: 17-03**

**Description:** This wetland is a 0.2 ha ephemeral marsh. There is no tree canopy cover. Wax myrtle is beginning to encroach from the wetland edge, and covers 5-25% of the wetland. Maidencane and emergent vegetation grow in the wetland center and sedges/grasses grow around the wetland edge. The herbaceous vegetation covers >75% of the basin. Cattle tracks and trails are plentiful. The wetland is surrounded by a dense palmetto ring and mesic flatwoods. Cattle are allowed in this MU and animal trails are abundant in the uplands.

**Wetland Concerns:** Cattle, Woody encroachment

**Restoration Action Recommended:** Encourage fire to burn in the wetland basin to reduce the encroaching woody vegetation. The uplands in this MU are in good ecological condition, although we have observed some cattle-related effects in both wetlands and uplands in some areas. We recommend removing cattle from this unit to prevent destruction of the intact flatwoods community and the embedded wetlands.

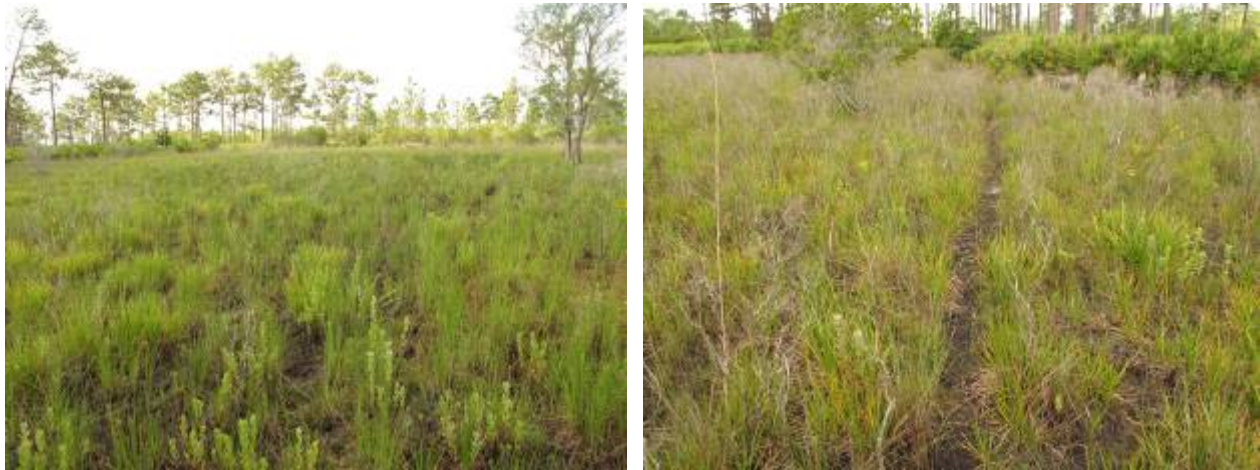
**Wetland ID: 17-04**

**Description:** This wetland is a 0.7 ha ephemeral marsh. There is no tree canopy cover. Wax myrtle is forming a ring around the north side of the wetland, and covers 5-25% of the wetland. Sedges/grasses and short, emergent vegetation grow throughout the wetland, and cover >75% of the basin. The native vegetation is intact but beginning to show impacts from grazing. Evidence of cattle grazing, tracks, and feces is abundant. The adjacent uplands are mesic flatwoods that are managed with prescribed fire.

**Wetland Concerns:** Cattle

**Restoration Action Recommended:** The uplands in this MU are in good ecological condition, although we have observed some cattle-related effects in both wetlands and uplands in some areas. We recommend removing cattle from this unit to prevent destruction of the intact flatwoods community and the embedded wetlands.

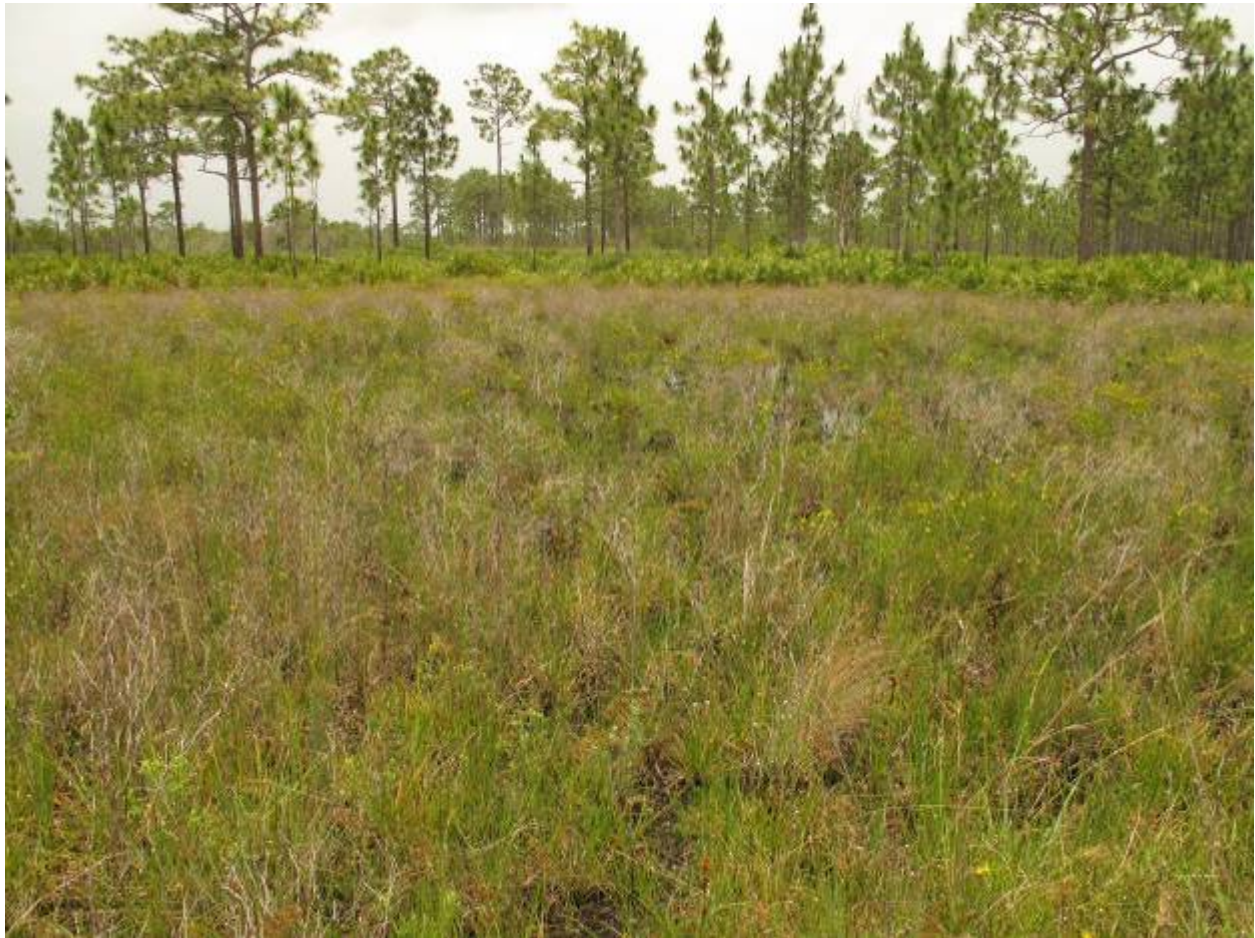
**Wetland ID: 18-01**

**Description:** This wetland is a 0.3 ha ephemeral marsh. There is no tree canopy or midstory cover. Sedges/grasses grow throughout the wetland, and cover >75% of the basin. There is feral hog damage in the wetland center and evidence of cattle grazing on the southern end of the wetland near the road. The adjacent uplands are mesic flatwoods that are managed with prescribed fire.

**Wetland Concerns:** Feral hog damage, Cattle

**Restoration Action Recommended:** The uplands in this MU are in good ecological condition, although we have observed some cattle-related effects in both wetlands and uplands in some areas. We recommend removing cattle from this unit to prevent destruction of the intact flatwoods community and the embedded wetlands.

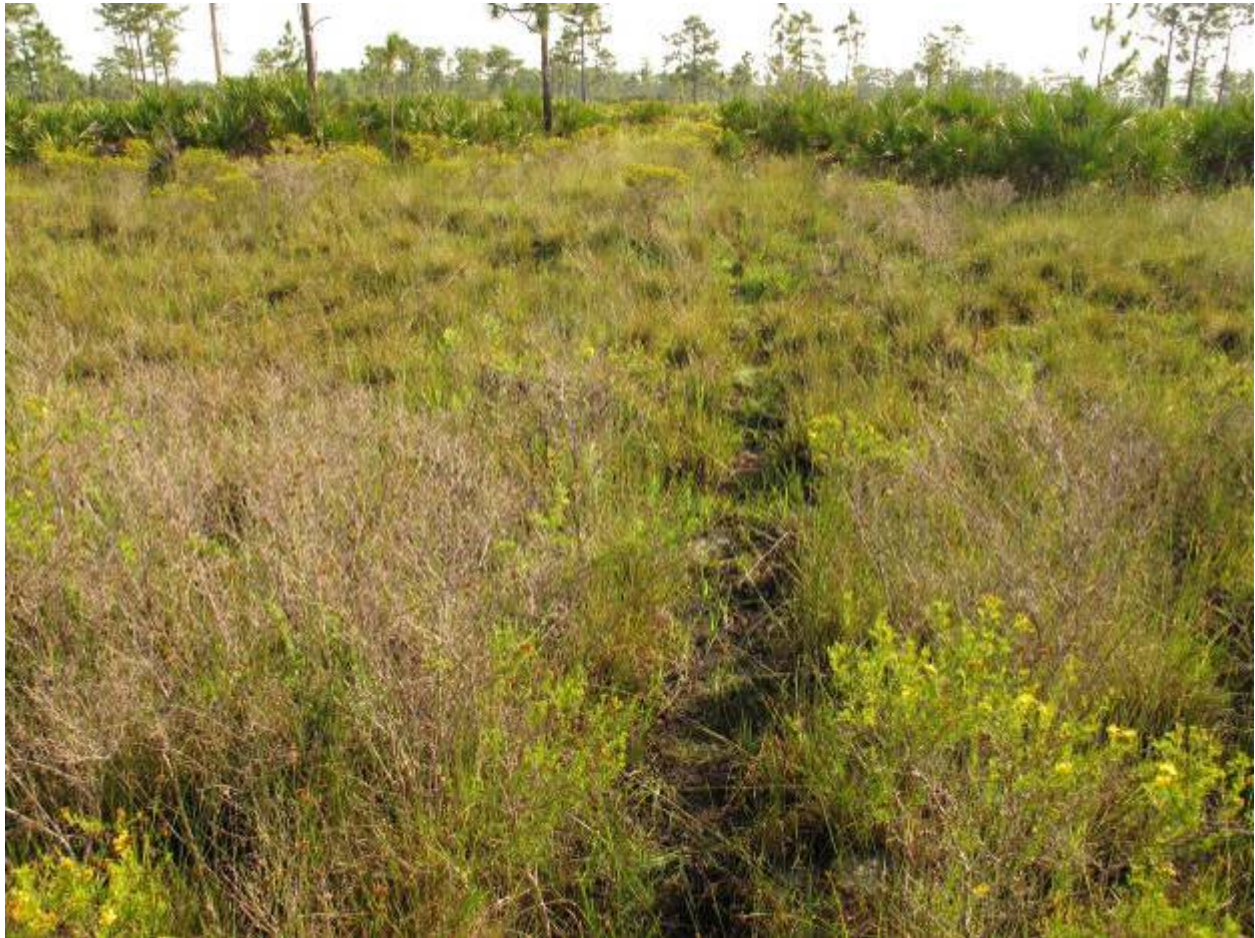
**Wetland ID: 18-02**

**Description:** This wetland is a <0.1 ha ephemeral marsh. There is no tree canopy or midstory cover. A diverse array of sedges/grasses grow throughout the wetland, and cover >75% of the basin. Cattle have worn a trail through the middle of the wetland. The adjacent uplands are scrubby flatwoods that are managed with prescribed fire.

**Wetland Concerns:** Cattle

**Restoration Action Recommended:** The uplands in this MU are in good ecological condition, although we have observed some cattle-related effects in both wetlands and uplands in some areas. We recommend removing cattle from this unit to prevent destruction of the intact flatwoods community and the embedded wetlands.

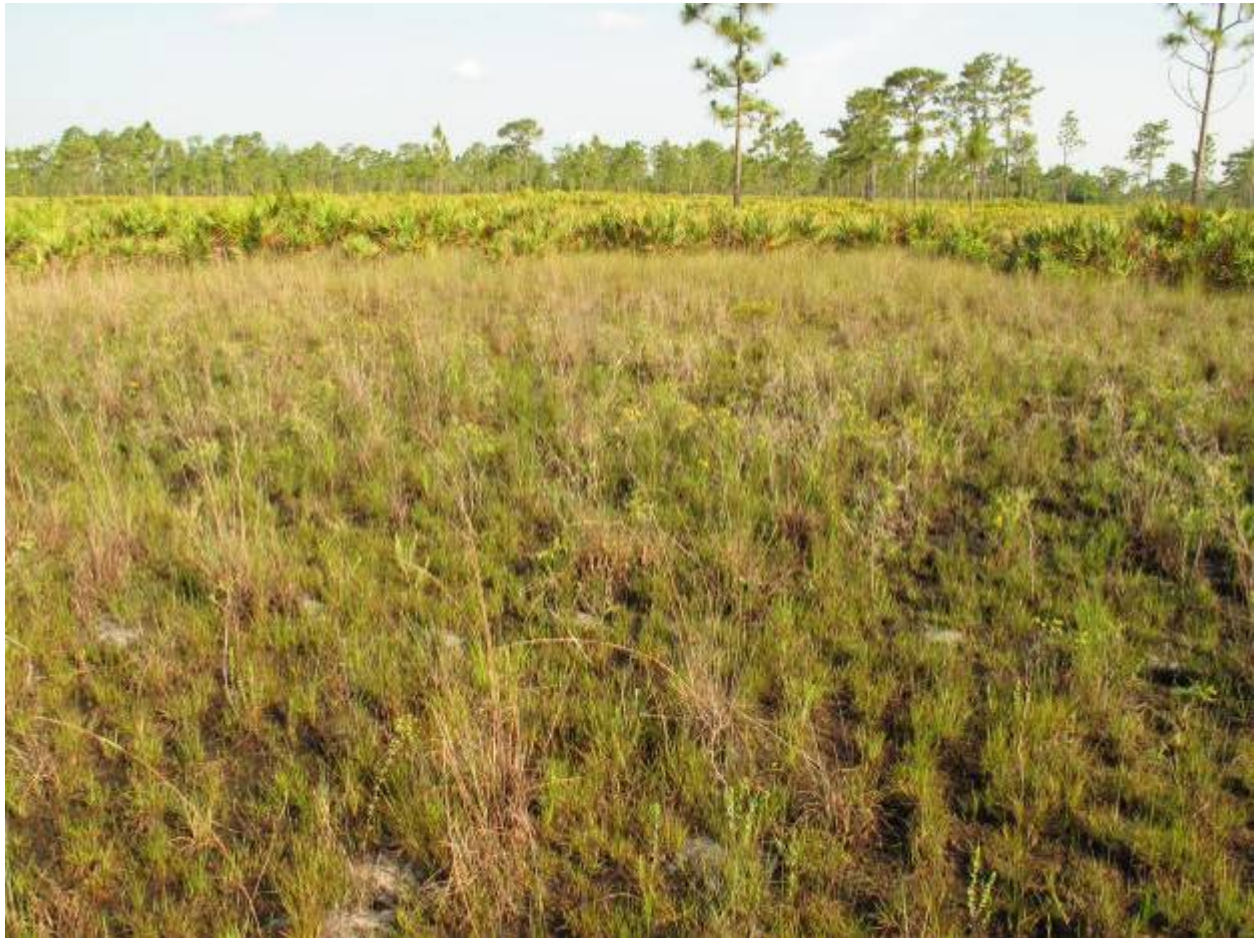
**Wetland ID: 18-03**

**Description:** This wetland is a <0.1 ha ephemeral marsh. There is no tree canopy or midstory cover. A diverse array of sedges/grasses grow throughout the wetland, and cover >75% of the basin. There is some evidence of cattle in the wetland. A recent fire burned through the wetland basin. The adjacent uplands are scrubby flatwoods that are managed with prescribed fire.

**Wetland Concerns:** Cattle

**Restoration Action Recommended:** The uplands in this MU are in good ecological condition, although we have observed some cattle-related effects in both wetlands and uplands in some areas. We recommend removing cattle from this unit to prevent destruction of the intact flatwoods community and the embedded wetlands.
