# **Inventory, Assessment, and Restoration Potential of Ephemeral Wetlands on FFWCC Wildlife Management Areas**

## **Triple N Ranch WMA Final Report**

Submitted by: Rebecca P.M. Means<sup>1</sup>, Ryan C. Means<sup>1</sup>, Steven A. Johnson<sup>2</sup>

15 May 2010 – 15 August 2010

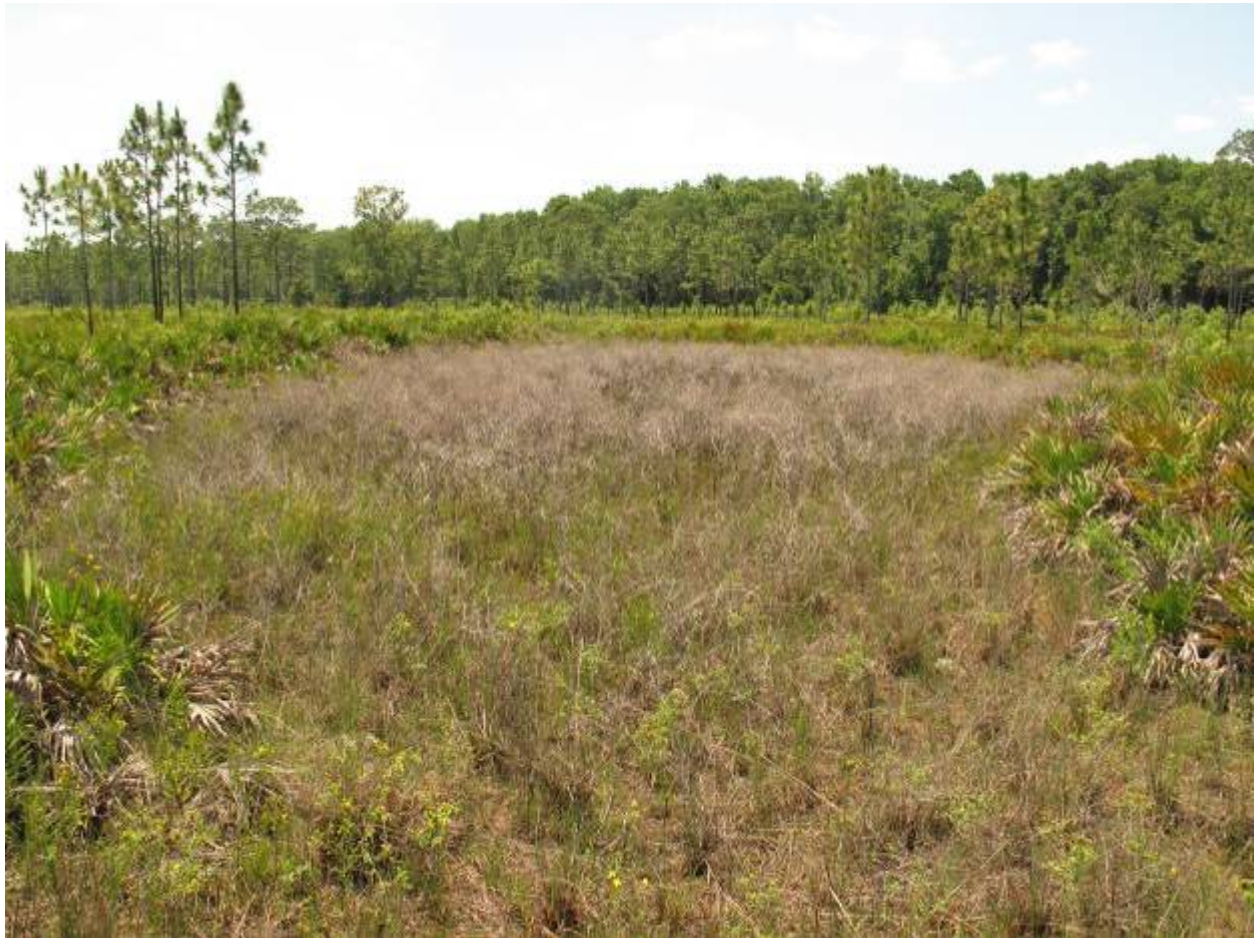
**Wetland ID: 19-01**

**Description:** This wetland is a <0.1 ha ephemeral marsh. There is no tree canopy or midstory cover. Recent inundation killed once abundant *Hypericum*. Sedges/grasses grow throughout the wetland, and cover >75% of the basin. The herbaceous vegetation has been grazed and there are cattle tracks and feces within the wetland. The adjacent uplands are scrubby flatwoods that are managed with prescribed fire.

**Wetland Concerns:** Cattle

**Restoration Action Recommended** The uplands in this MU are in good ecological condition, although we have observed some cattle-related effects in both wetlands and uplands in some areas. We recommend removing cattle from this unit to prevent destruction of the intact flatwoods community and the embedded wetlands.

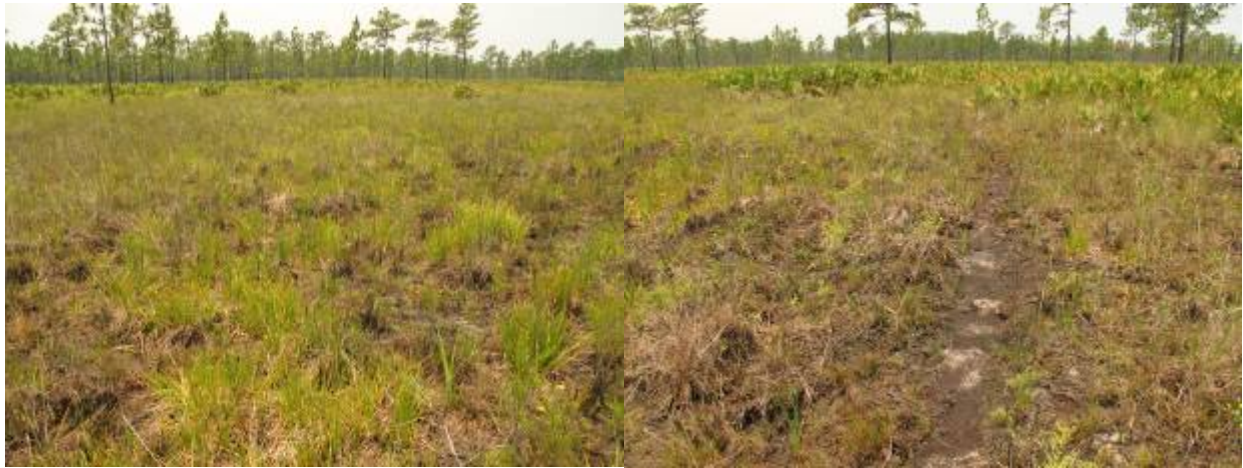
**Wetland ID: 20-01**

**Description:** This wetland is a 0.1 ha ephemeral marsh. There is no tree canopy or midstory cover. Sedges/grasses grow throughout the wetland, and cover >75% of the basin. The wetland has been impacted by cattle. There are multiple cattle trails in the wetland, denuded areas from grazing, and feces throughout. The adjacent uplands are scrubby flatwoods that are managed with prescribed fire.

**Wetland Concerns:** Cattle

**Restoration Action Recommended:** The uplands in this MU are in good ecological condition, although we have observed some cattle-related effects in both wetlands and uplands in some areas. We recommend removing cattle from this unit to prevent destruction of the intact flatwoods community and the embedded wetlands.

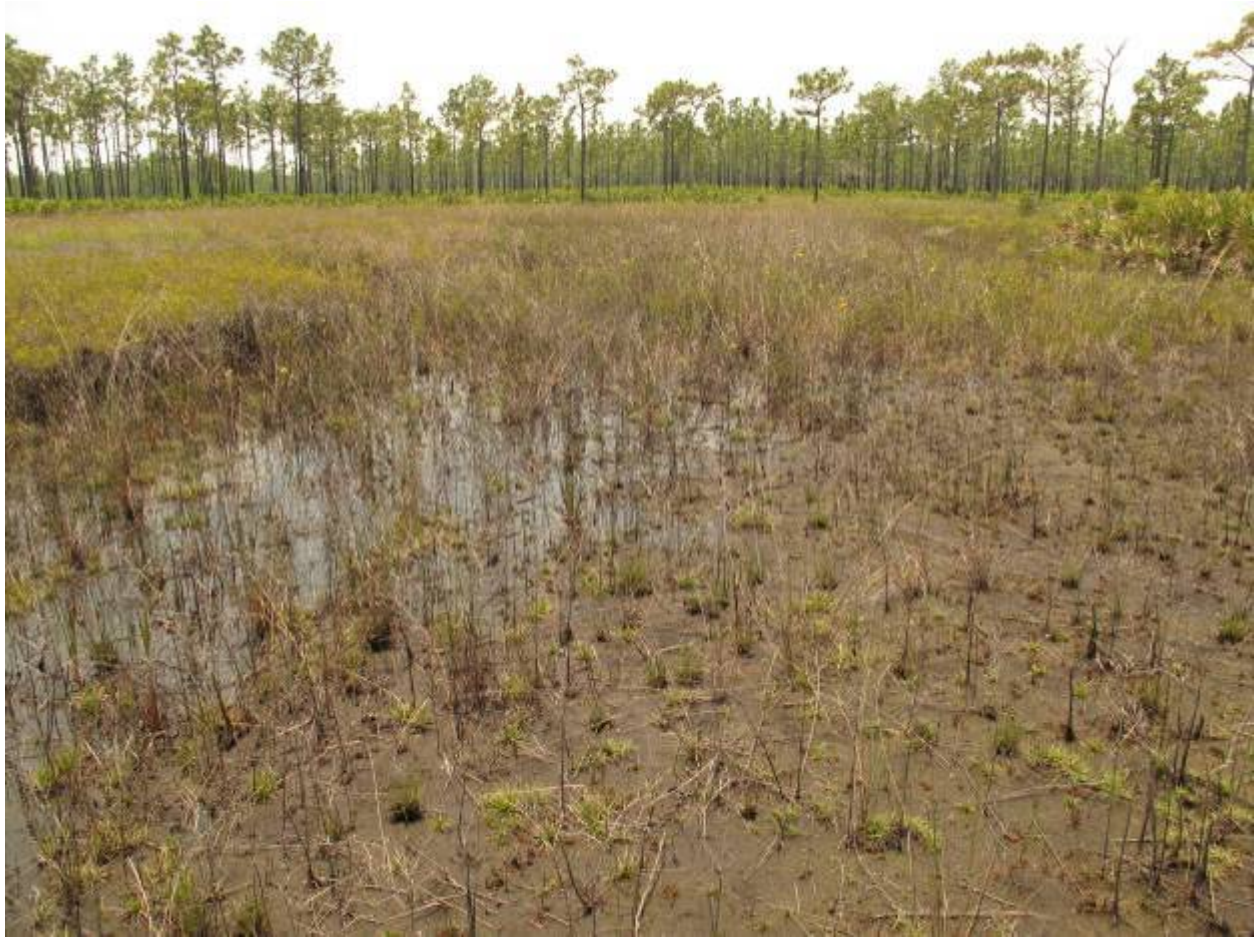
**Wetland ID: 20-02**

**Description:** This wetland is a 0.5 ha ephemeral marsh. There is no tree canopy or midstory cover. *Hypericum* is dense in the wetland interior. Sedges/grasses grow throughout the wetland, and cover >75% of the basin. There are areas of bare soil due to recent drying and cattle grazing. Cattle trails and feces are present along the wetland edge. The adjacent uplands are scrubby flatwoods that are managed with prescribed fire.

**Wetland Concerns:** Cattle

**Restoration Action Recommended:** The uplands in this MU are in good ecological condition, although we have observed some cattle-related effects in both wetlands and uplands in some areas. We recommend removing cattle from this unit to prevent destruction of the intact flatwoods community and the embedded wetlands.

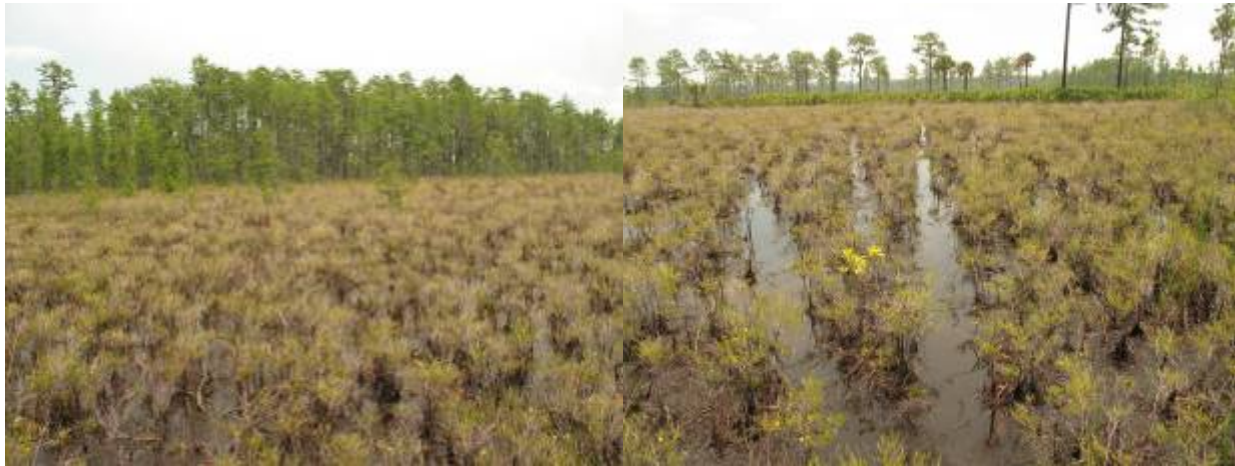
**Wetland ID: 20-03**

**Description:** This wetland is a 4.8 ha ephemeral forested swamp surrounded by marsh. This large, cross-shaped wetland has 3 areas of cypress dome connected by marsh. Cypress trees cover 50-75% of the basin. There is no midstory cover but *Hypericum* is abundant within the wetland. Sedges/grasses grow throughout the wetland, and cover 50-75% of the basin. Cattle trails are present throughout the wetland and there is evidence of grazing on the herbaceous vegetation. Cattle impacts are heavy around the wetland edge. Small fish were present in the wetland on the day of our visit. The adjacent uplands are scrubby flatwoods that are managed with prescribed fire.

**Wetland Concerns:** Cattle

**Restoration Action Recommended:** The uplands in this MU are in good ecological condition, although we have observed some cattle-related effects in both wetlands and uplands in some areas. We recommend removing cattle from this unit to prevent destruction of the intact flatwoods community and the embedded wetlands.

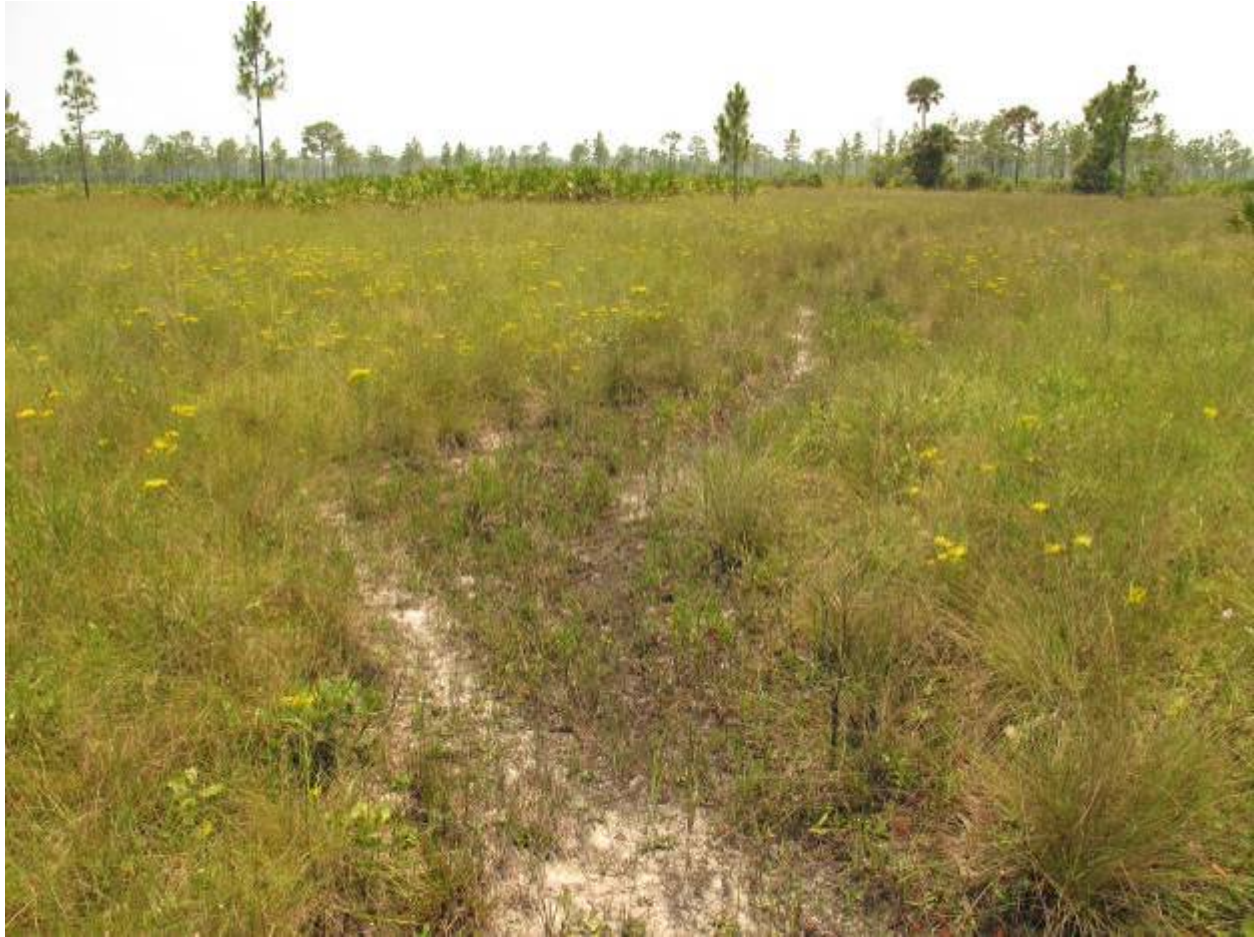
**Wetland ID: 20-04**

**Description:** This wetland is a 0.2 ha ephemeral marsh. There is no tree canopy or midstory cover. Sedges/grasses and other herbaceous vegetation grow throughout the wetland, and cover >75% of the basin. The wetland has been impacted by cattle. A shallow ditch/incised cattle trail leads from the north side of the wetland to a nearby road. The adjacent uplands are scrubby flatwoods that are managed with prescribed fire.

**Wetland Concerns:** Cattle, Ditching

**Restoration Action Recommended:** Fill the ditch/trail to restore the wetland's isolation. The uplands in this management unit are in good ecological condition. The uplands in this MU are in good ecological condition, although we have observed some cattle-related effects in both wetlands and uplands in some areas. We recommend removing cattle from this unit to prevent destruction of the intact flatwoods community and the embedded wetlands.

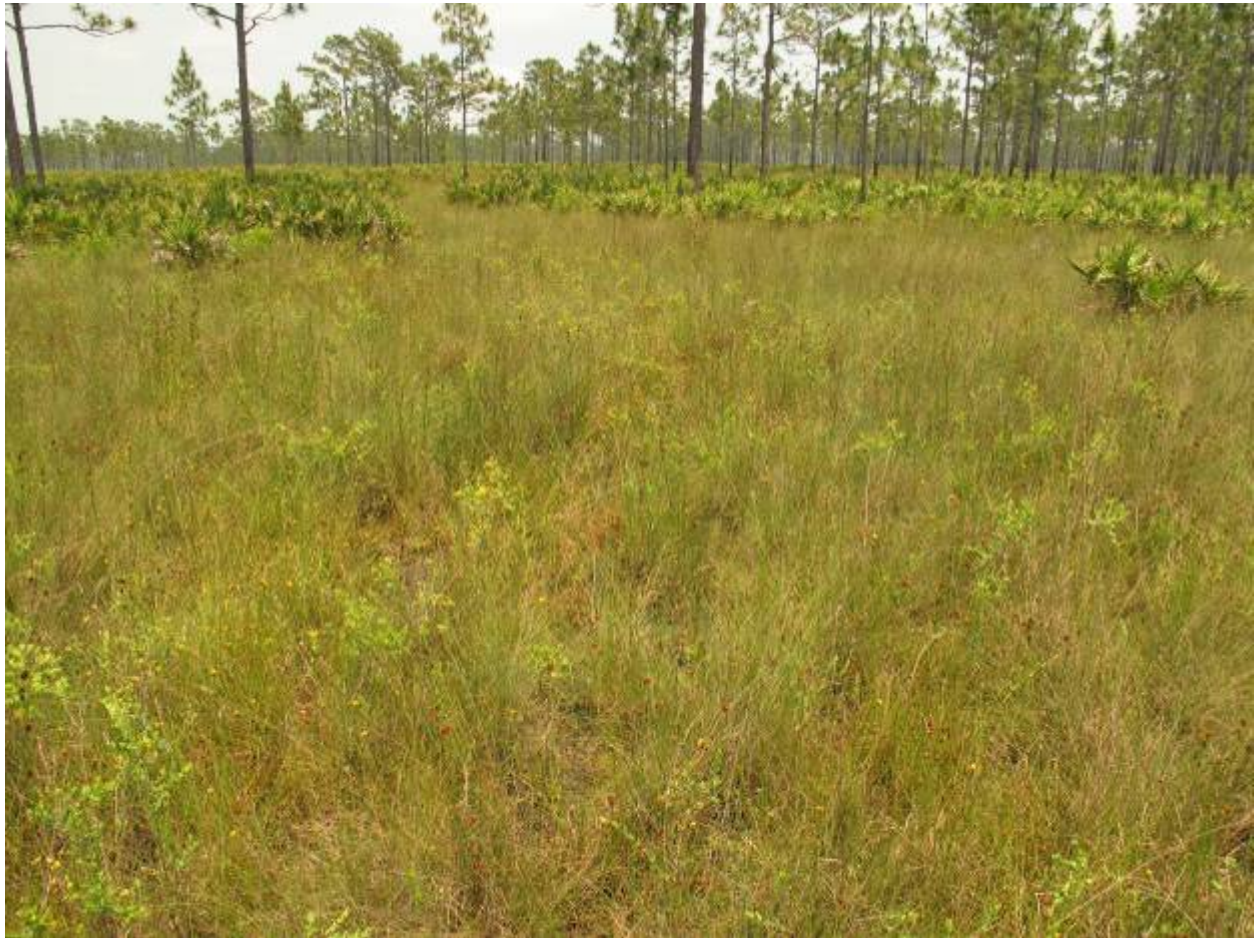
**Wetland ID: 20-05**

**Description:** This wetland is a <0.1 ha highly ephemeral marsh. There is no tree canopy or midstory cover. Sedges/grasses grow throughout the wetland, and cover >75% of the basin. There is evidence of cattle in and around the wetland but there is still a diversity of herbaceous vegetation. The adjacent uplands are scrubby flatwoods that are managed with prescribed fire.

**Wetland Concerns:** Cattle

**Restoration Action Recommended** The uplands in this MU are in good ecological condition, although we have observed some cattle-related effects in both wetlands and uplands in some areas. We recommend removing cattle from this unit to prevent destruction of the intact flatwoods community and the embedded wetlands.

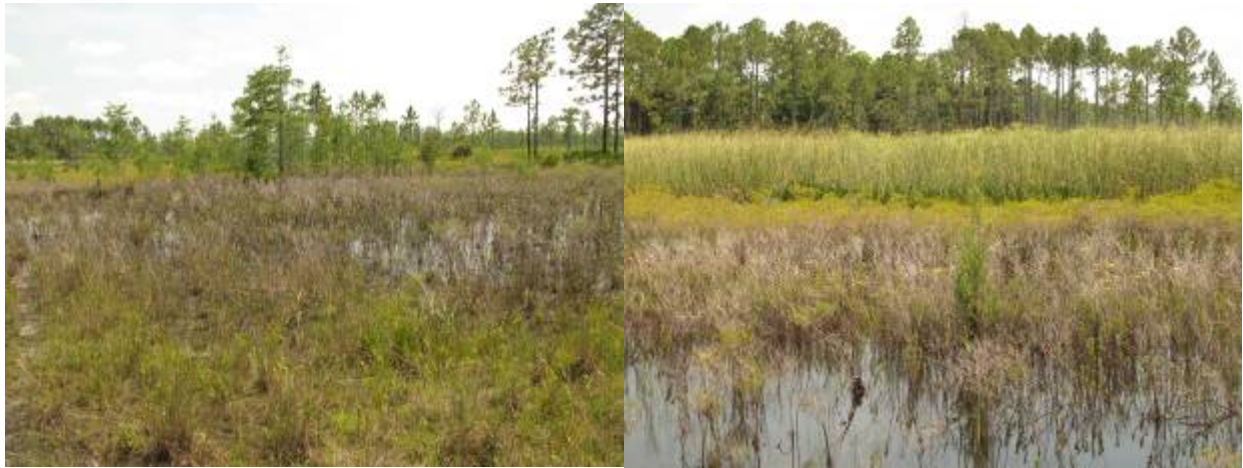
**Wetland ID: 21-01**

**Description:** This wetland is a 1.1 ha ephemeral marsh. This elongate marsh is varied in its vegetative structure. The northern third of the wetland is a small cypress stand. Sawgrass grows densely in the southern two-thirds of the wetland, and sedges/grasses grow around the wetland edge. *Hypericum* is common within the wetland. The tree canopy covers <5% of the basin and the herbaceous vegetation covers >75% of the wetland. There is evidence of cattle in the wetland, including tracks and feces. The adjacent uplands are scrubby flatwoods that are managed with prescribed fire.

**Wetland Concerns:** Cattle

**Restoration Action Recommended:** The uplands in this MU are in good ecological condition, although we have observed some cattle-related effects in both wetlands and uplands in some areas. We recommend removing cattle from this unit to prevent destruction of the intact flatwoods community and the embedded wetlands.

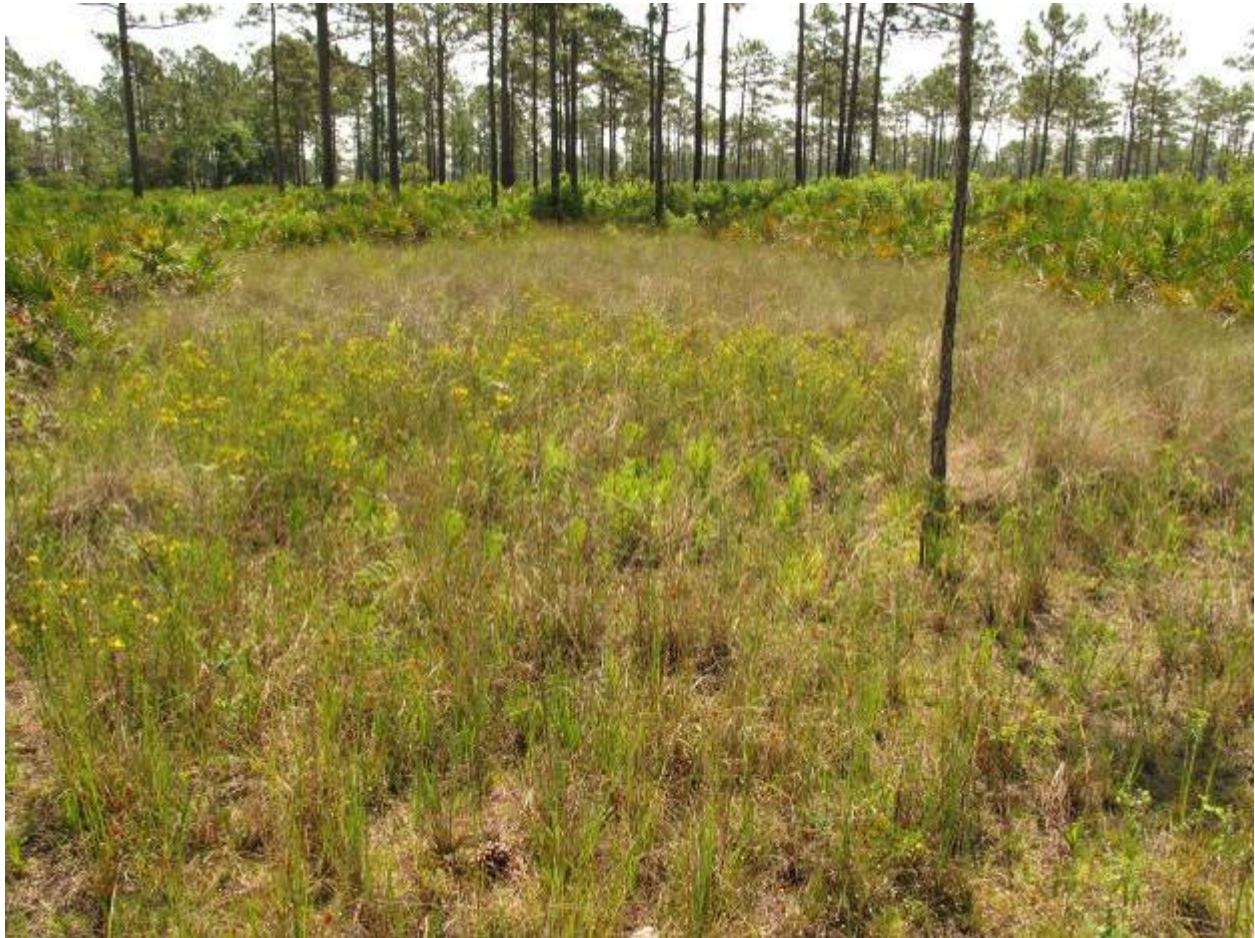
**Wetland ID: 24-01**

**Description:** This wetland is a <0.1 ha highly ephemeral marsh. There is no tree canopy or midstory cover. Sedges/grasses grow throughout the wetland, and cover >75% of the basin. We observed no evidence of cattle in the wetland, although cattle are allowed in this MU. The adjacent uplands are mesic flatwoods that are managed with prescribed fire.

**Wetland Concerns:** None

**Restoration Action Recommended:** The uplands in this MU are in good ecological condition, although we have observed some cattle-related effects in both wetlands and uplands in some areas. We recommend removing cattle from this unit to prevent destruction of the intact flatwoods community and the embedded wetlands.

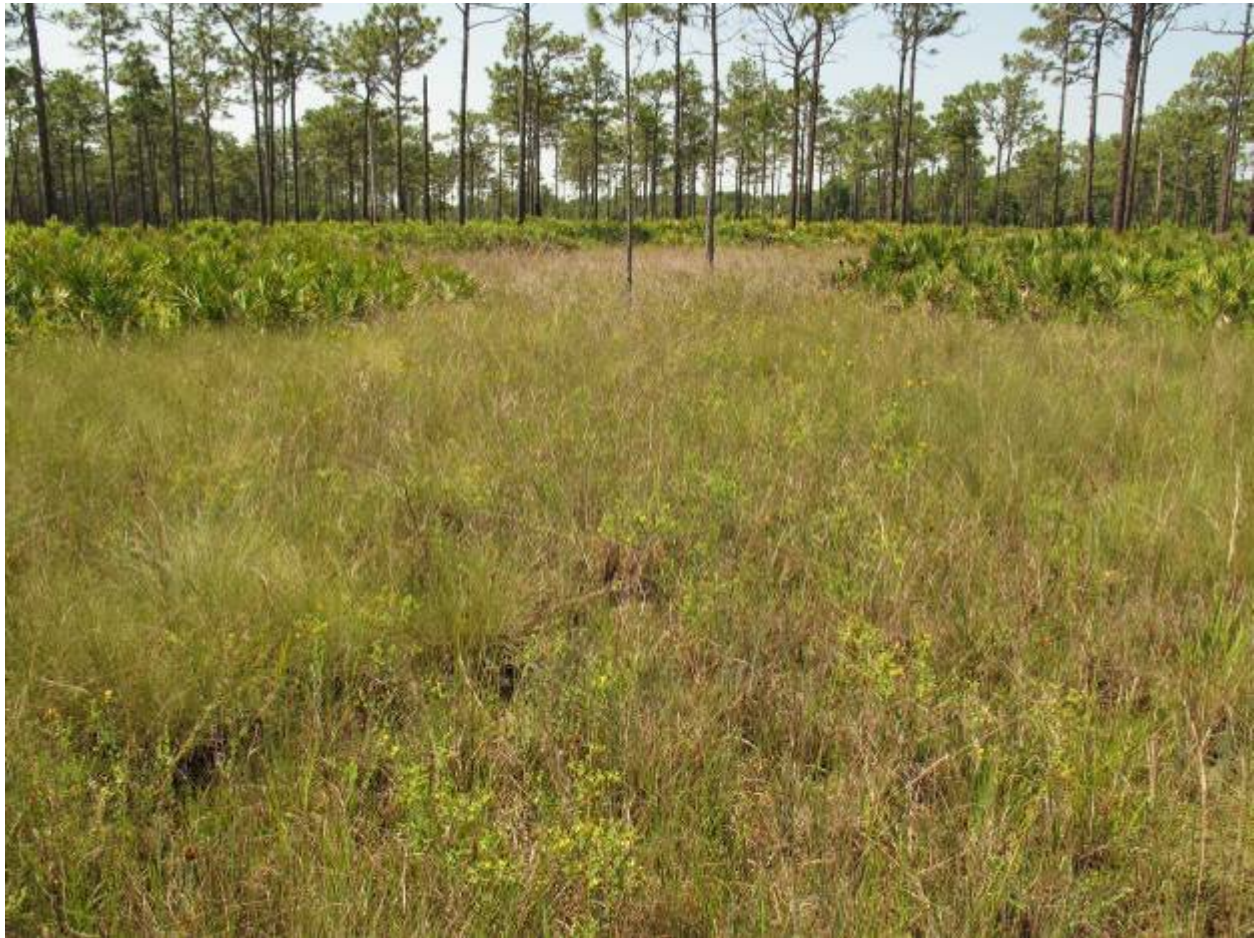
**Wetland ID: 24-02**

**Description:** This wetland is a 0.1 ha ephemeral marsh. There is no tree canopy or midstory cover. *Sphagnum* grows in scattered patches and sedges/grasses grow throughout the wetland. The herbaceous vegetation covers >75% of the basin. We observed no evidence of cattle in the wetland, although cattle are allowed in this MU. The adjacent uplands are mesic flatwoods that are managed with prescribed fire.

**Wetland Concerns:** None

**Restoration Action Recommended:** The uplands in this MU are in good ecological condition, although we have observed some cattle-related effects in both wetlands and uplands in some areas. We recommend removing cattle from this unit to prevent destruction of the intact flatwoods community and the embedded wetlands.

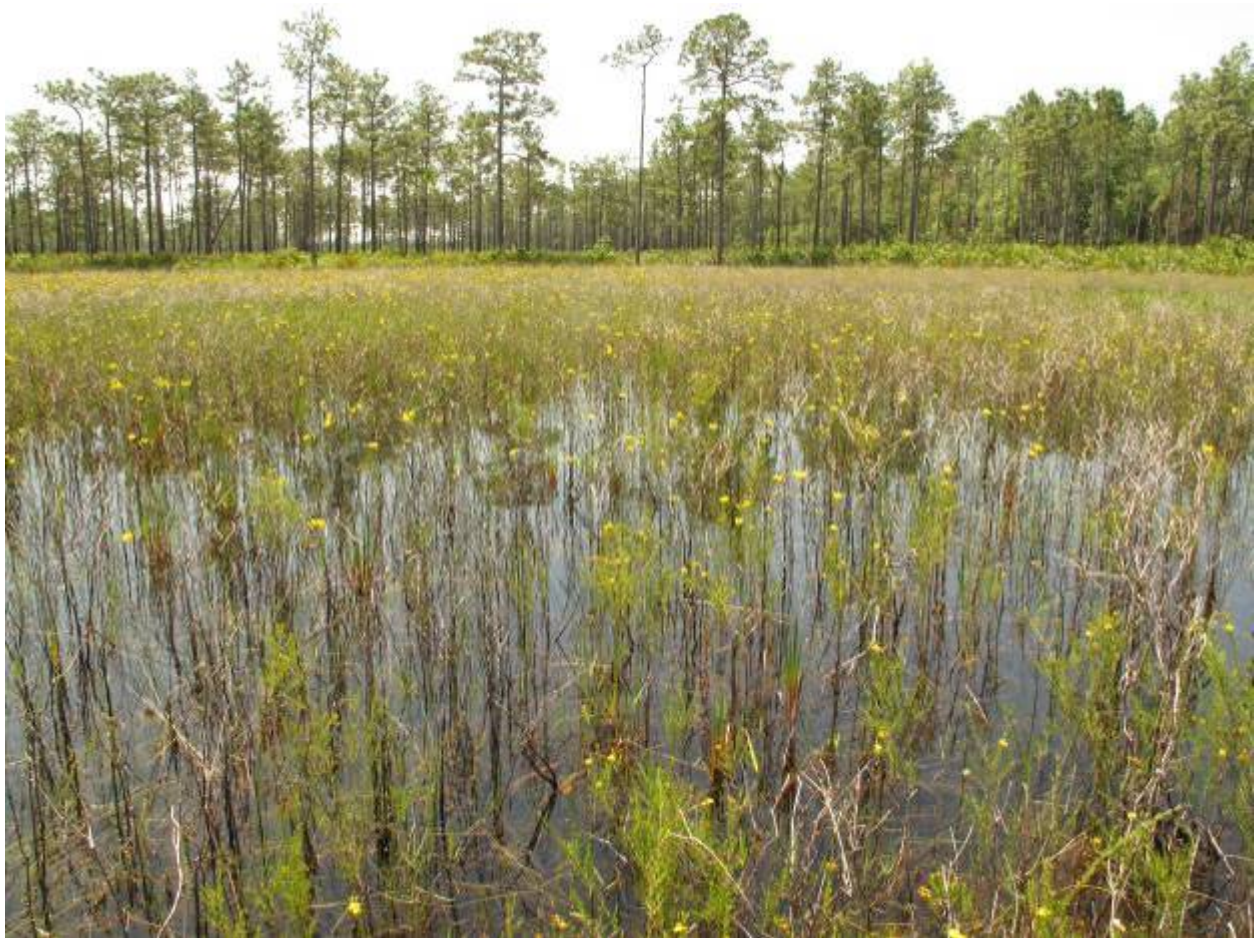
**Wetland ID: 24-03**

**Description:** This wetland is a 0.7 ha ephemeral marsh. There is no tree canopy or midstory cover. A diverse array of herbaceous vegetation grows throughout the wetland, and covers >75% of the basin. We observed no evidence of cattle in the wetland, although cattle are allowed in this MU. The adjacent uplands are a mix of scrubby and mesic flatwoods that are managed with prescribed fire.

**Wetland Concerns:** None

**Restoration Action Recommended:** The uplands in this MU are in good ecological condition, although we have observed some cattle-related effects in both wetlands and uplands in some areas. We recommend removing cattle from this unit to prevent destruction of the intact flatwoods community and the embedded wetlands.

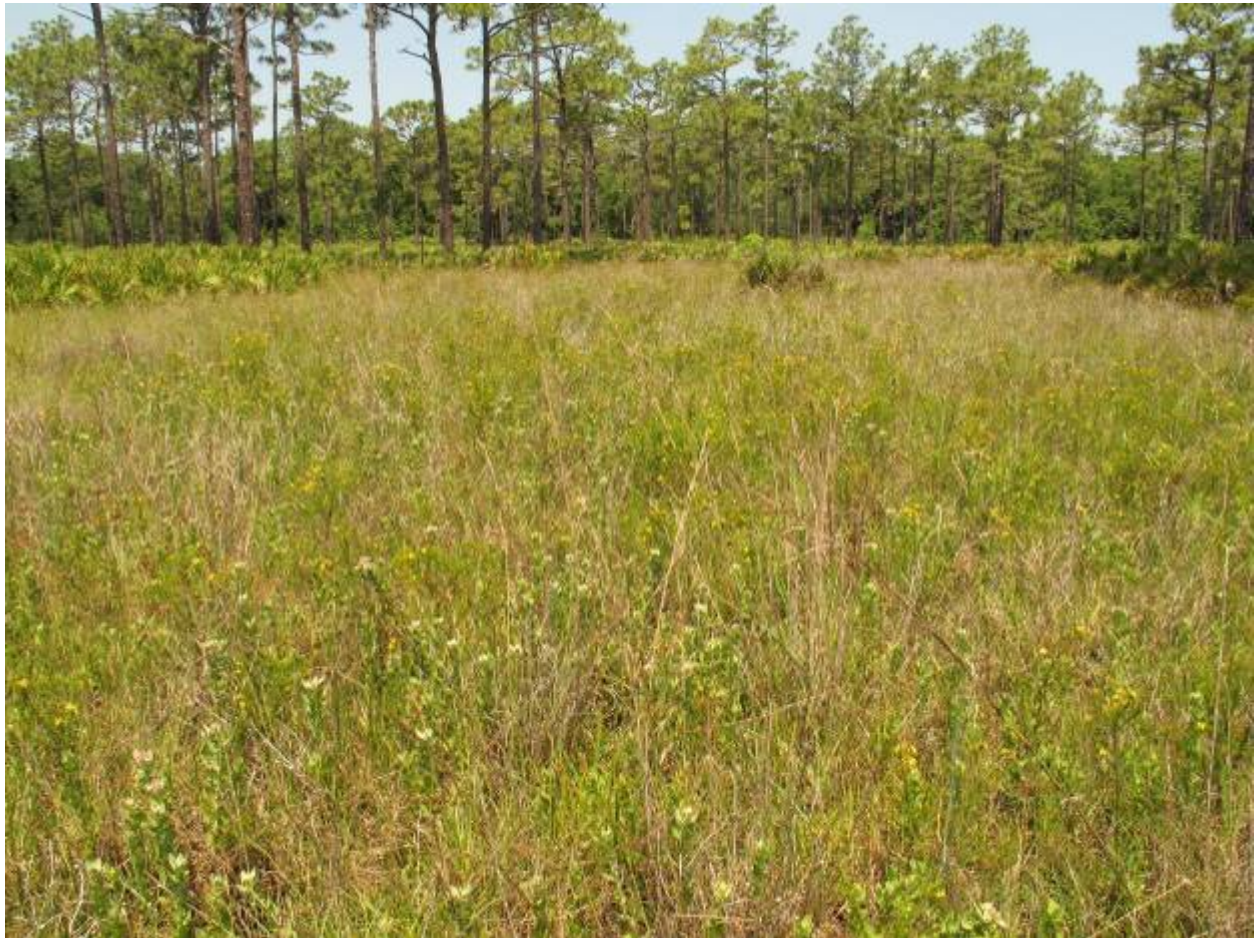
**Wetland ID: 24-04**

**Description:** This wetland is a 0.1 ha ephemeral marsh. There is no tree canopy or midstory cover. A diverse array of herbaceous vegetation grows throughout the wetland, and covers >75% of the basin. *Hypericum* also is common. There is evidence of cattle in the wetland (feces) although the wetland still appears to be healthy. The adjacent uplands are a mix of scrubby and mesic flatwoods that are managed with prescribed fire.

**Wetland Concerns:** Cattle

**Restoration Action Recommended:** The uplands in this MU are in good ecological condition, although we have observed some cattle-related effects in both wetlands and uplands in some areas. We recommend removing cattle from this unit to prevent destruction of the intact flatwoods community and the embedded wetlands.

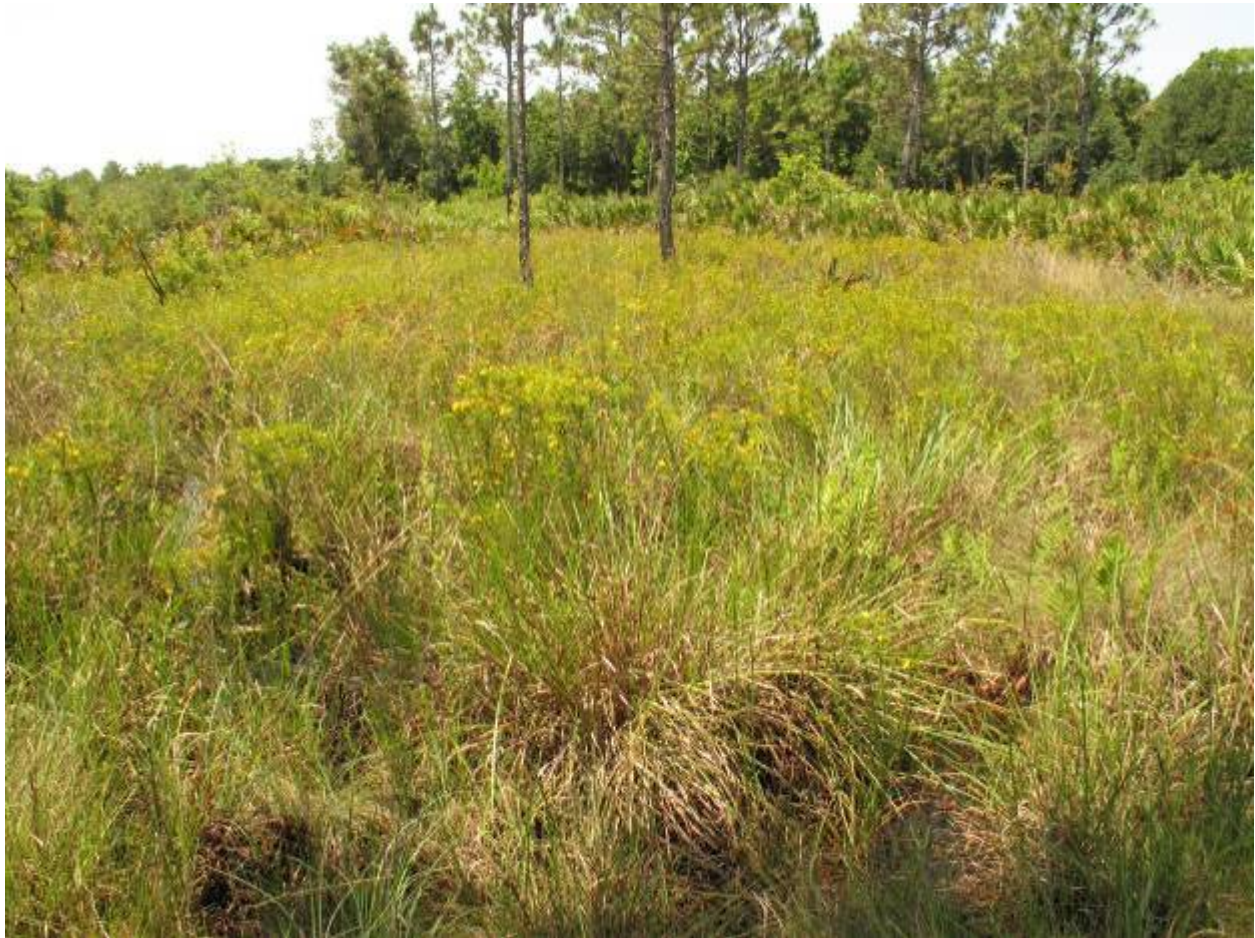
**Wetland ID: 24-05**

**Description:** This wetland is a <0.1 ha ephemeral marsh. There is no tree canopy or midstory cover. *Hypericum* is common within the wetland. Sedges/grasses grow throughout the wetland, and cover >75% of the basin. Feral hog damage is patchy and minor. We observed no evidence of cattle in the wetland, although cattle are allowed in this MU. The adjacent uplands are a mix of scrubby and mesic flatwoods that are managed with prescribed fire.

**Wetland Concerns:** Feral hog damage

**Restoration Action Recommended:** The uplands in this MU are in good ecological condition, although we have observed some cattle-related effects in both wetlands and uplands in some areas. We recommend removing cattle from this unit to prevent destruction of the intact flatwoods community and the embedded wetlands.

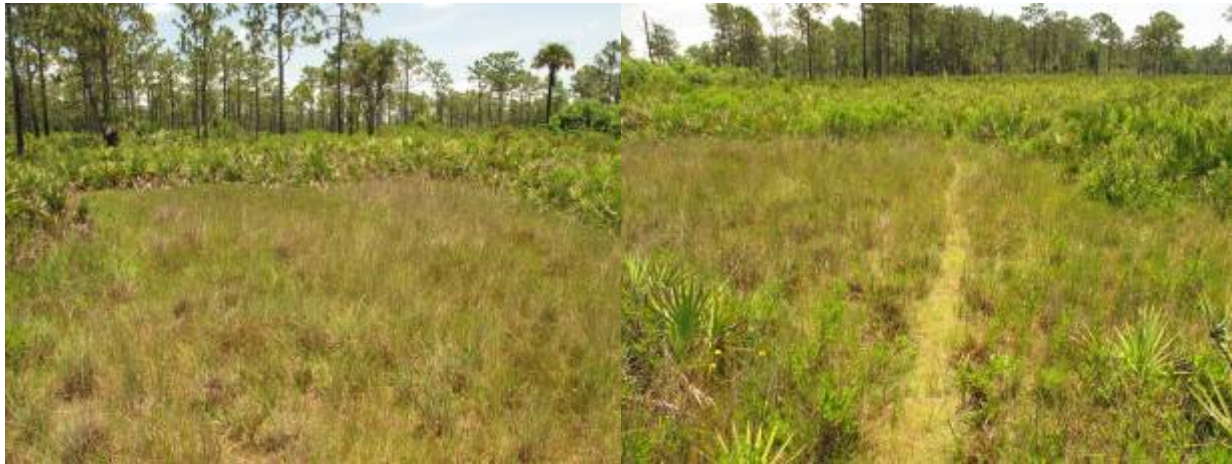
**Wetland ID: 24-06**

**Description:** This wetland is a <0.1 ha highly ephemeral marsh. There is no tree canopy or midstory cover. Sedges/grasses grow throughout the wetland, and cover >75% of the basin. The herbaceous vegetation has been grazed and is not very diverse. A cattle trail is prominent through the wetland center. The adjacent uplands are a mix of scrubby and mesic flatwoods that are managed with prescribed fire.

**Wetland Concerns:** Cattle

**Restoration Action Recommended:** The uplands in this MU are in good ecological condition, although we have observed some cattle-related effects in both wetlands and uplands in some areas. We recommend removing cattle from this unit to prevent destruction of the intact flatwoods community and the embedded wetlands.

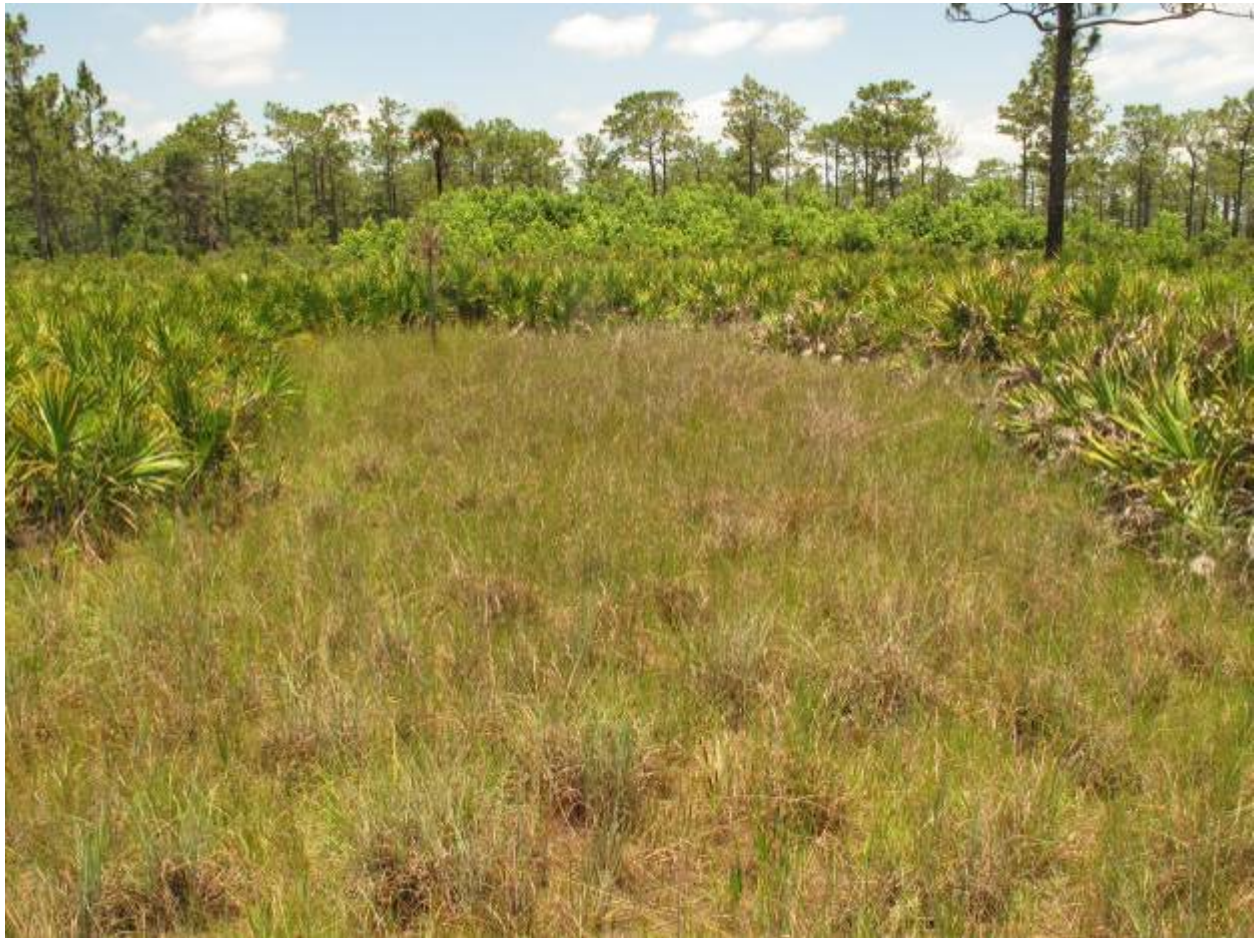
**Wetland ID: 24-07**

**Description:** This wetland is a <0.1 ha ephemeral marsh. There is no tree canopy or midstory cover. Sedges/grasses grow throughout the wetland, and cover >75% of the basin. We observed no evidence of cattle in the wetland, although a nearby wetland (24-06) has been impacted. The adjacent uplands are scrubby flatwoods that are managed with prescribed fire.

**Wetland Concerns:** None

**Restoration Action Recommended:** The uplands in this MU are in good ecological condition, although we have observed some cattle-related effects in both wetlands and uplands in some areas. We recommend removing cattle from this unit to prevent destruction of the intact flatwoods community and the embedded wetlands.

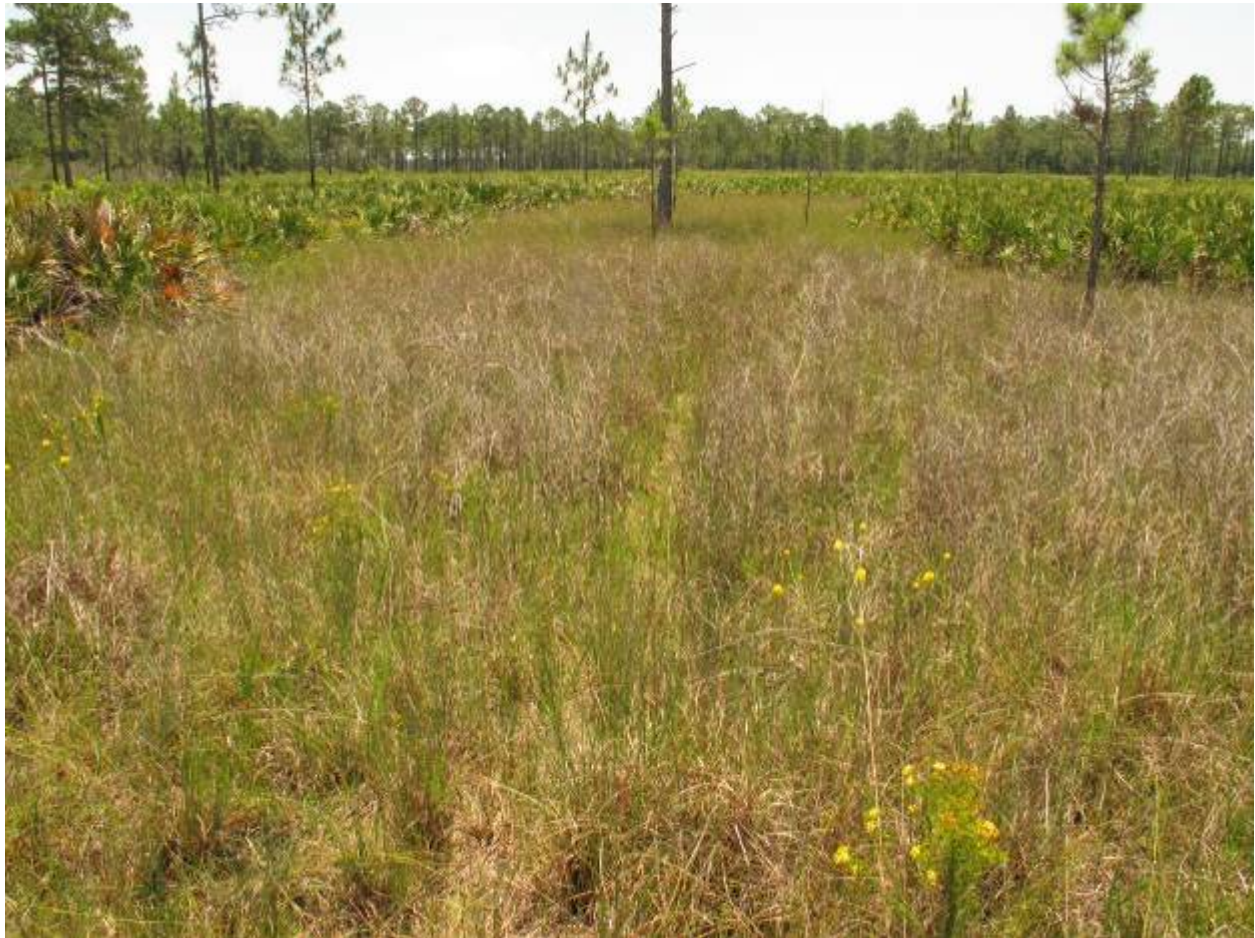
**Wetland ID: 24-08**

**Description:** This wetland is a <0.1 ha highly ephemeral marsh. There is no tree canopy or midstory cover. Sedges/grasses grow throughout the wetland, and cover >75% of the basin. A cattle trail runs through the wetland basin. The adjacent uplands are scrubby flatwoods that are managed with prescribed fire.

**Wetland Concerns:** Cattle

**Restoration Action Recommended:** The uplands in this MU are in good ecological condition, although we have observed some cattle-related effects in both wetlands and uplands in some areas. We recommend removing cattle from this unit to prevent destruction of the intact flatwoods community and the embedded wetlands.

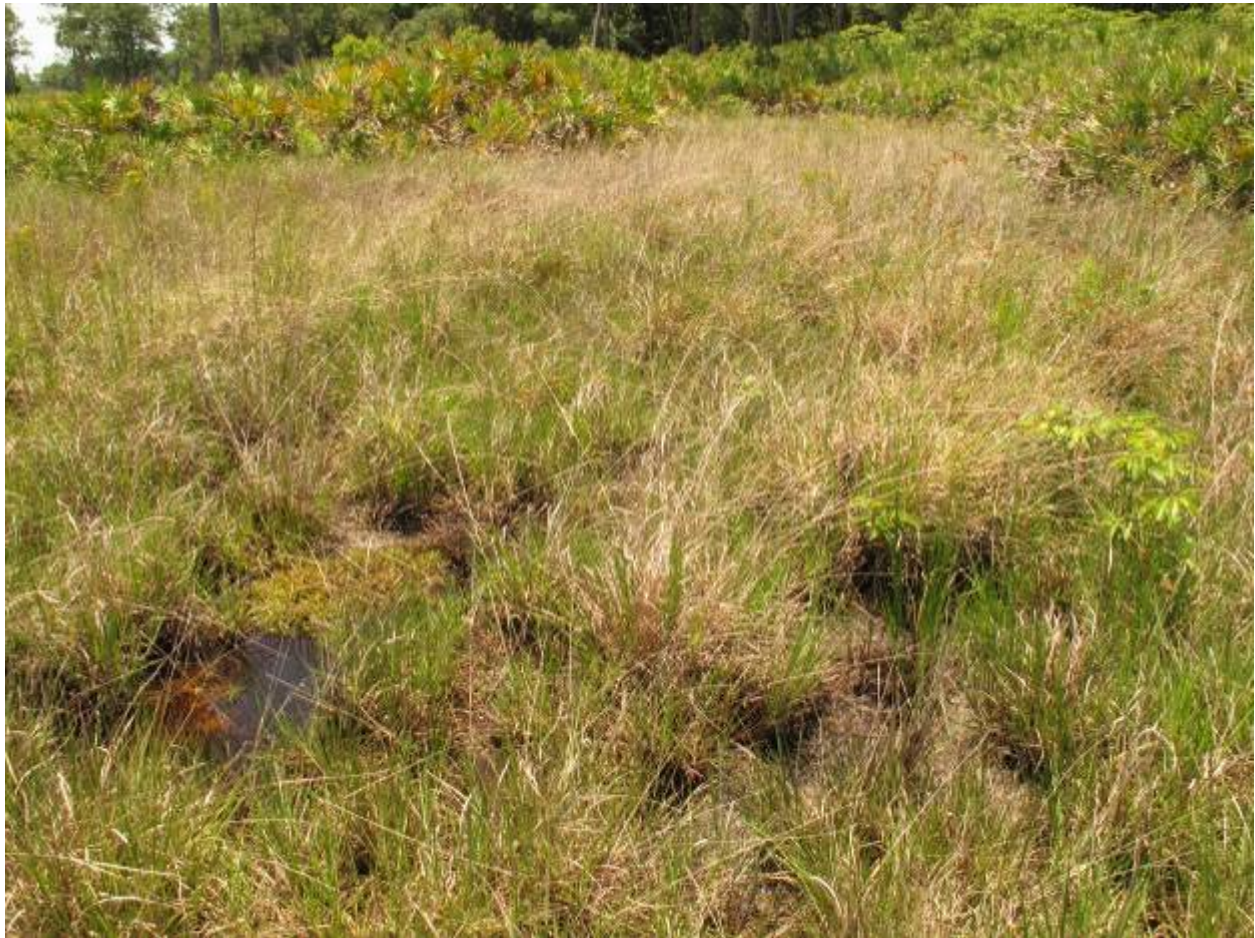
**Wetland ID: 24-09**

**Description:** This wetland is a 0.1 ha ephemeral marsh. There is no tree canopy or midstory cover. Sedges/grasses grow throughout the wetland, and cover >75% of the basin. There is evidence of cattle in the wetland, including trails and feces. The adjacent uplands are mesic flatwoods to the east and a creek with hardwood swamp to the west.

**Wetland Concerns:** Cattle

**Restoration Action Recommended:** The uplands in this MU are in good ecological condition, although we have observed some cattle-related effects in both wetlands and uplands in some areas. We recommend removing cattle from this unit to prevent destruction of the intact flatwoods community and the embedded wetlands.

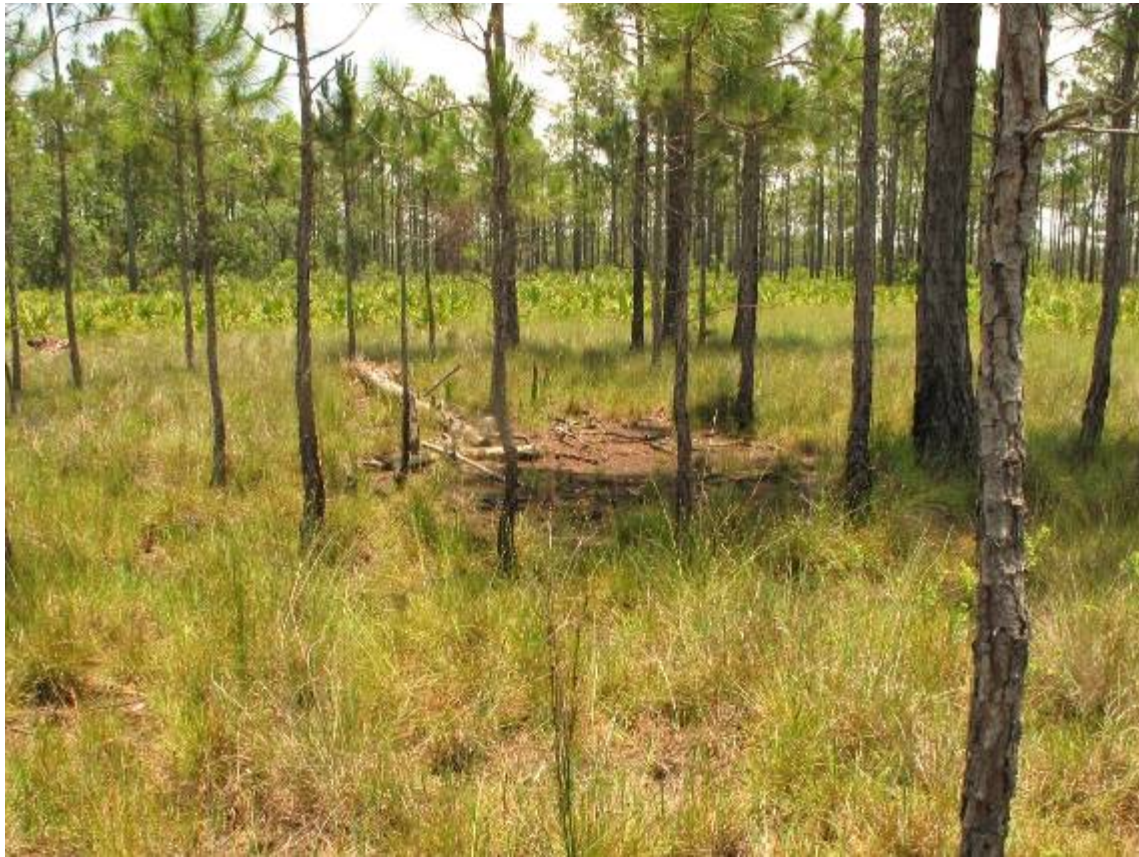
**Wetland ID: 24-10**

**Description:** This wetland is a 0.1 ha highly ephemeral marsh. Pine trees have encroached into the wetland and cover 25-50% of the basin. There is no midstory cover. Sedges/grasses grow throughout the wetland, and cover >75% of the basin. Cattle trails lead into the wetland. The adjacent uplands are scrubby flatwoods that are managed with prescribed fire.

**Wetland Concerns:** Cattle, Woody encroachment

**Restoration Action Recommended:** Remove pine trees from wetland interior. The uplands in this MU are in good ecological condition, although we have observed some cattle-related effects in both wetlands and uplands in some areas. We recommend removing cattle from this unit to prevent destruction of the intact flatwoods community and the embedded wetlands.

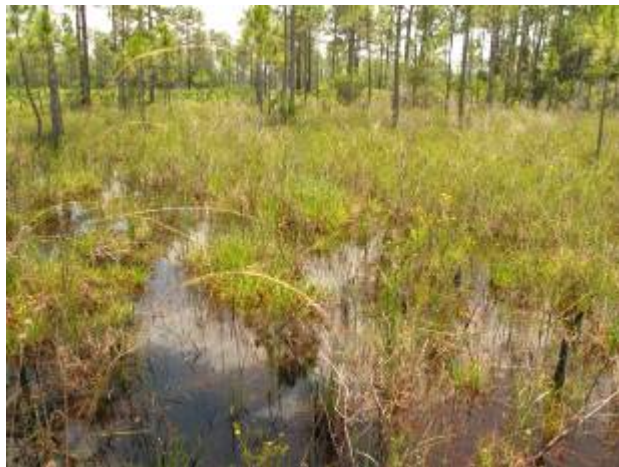
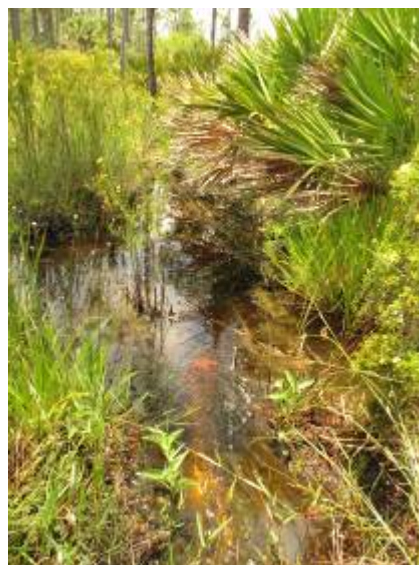
**Wetland ID: 24-11**

**Description:** This wetland is a 0.3 ha ephemeral marsh. Pine trees have encroached into the wetland and cover 5-25% of the basin. There is no midstory cover. Sedges/grasses grow throughout the wetland, and cover >75% of the basin. Cattle trails lead into the wetland. A small, flowing creek drains the south side of the wetland. We were unable to tell if this feature is natural or is an old, shallow ditch. The adjacent uplands are a mix of mesic and scrubby flatwoods that are managed with prescribed fire.

**Wetland Concerns:** Cattle, Woody encroachment

**Restoration Action Recommended:** If the creek was formed by human activity, we recommend plugging the ditch to eliminate connectivity. Remove pines from wetland interior. The uplands in this MU are in good ecological condition, although we have observed some cattle-related effects in both wetlands and uplands in some areas. We recommend removing cattle from this unit to prevent destruction of the intact flatwoods community and the embedded wetlands.
