# **Inventory, Assessment, and Restoration Potential of Ephemeral Wetlands on FFWCC Wildlife Management Areas**

## **Triple N Ranch WMA Final Report**

Submitted by: Rebecca P.M. Means<sup>1</sup>, Ryan C. Means<sup>1</sup>, Steven A. Johnson<sup>2</sup>

15 May 2010 – 15 August 2010

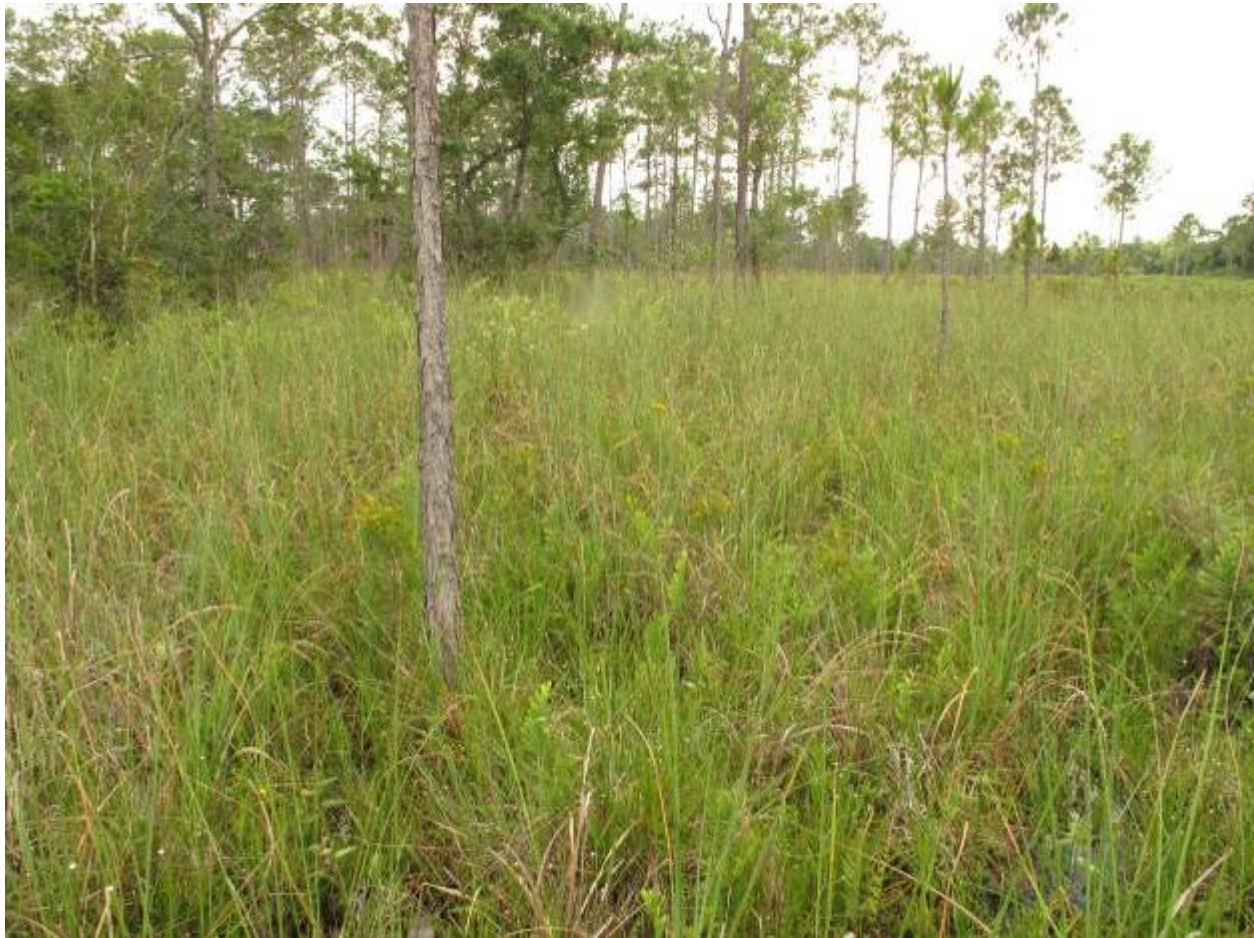
**Wetland ID: 24-12**

**Description:** This wetland is a 0.6 ha semi-permanent marsh. Pine and holly trees dominate the canopy, and cover 5-25% of the basin. The midstory is a mix of wax myrtle, buttonbush, and fetterbush, and covers 5-25% of the wetland. Sawgrass grows throughout the wetland, and covers >75% of the basin. This wetland may connect with a larger swamp to the east during times of high water. Pig frogs were calling on the day of our visit. The adjacent uplands are a mix of mesic and scrubby flatwoods that are managed with prescribed fire.

**Wetland Concerns:** None

**Restoration Action Recommended:** The uplands in this MU are in good ecological condition, although we have observed some cattle-related effects in both wetlands and uplands in some areas. We recommend removing cattle from this unit to prevent destruction of the intact flatwoods community and the embedded wetlands.

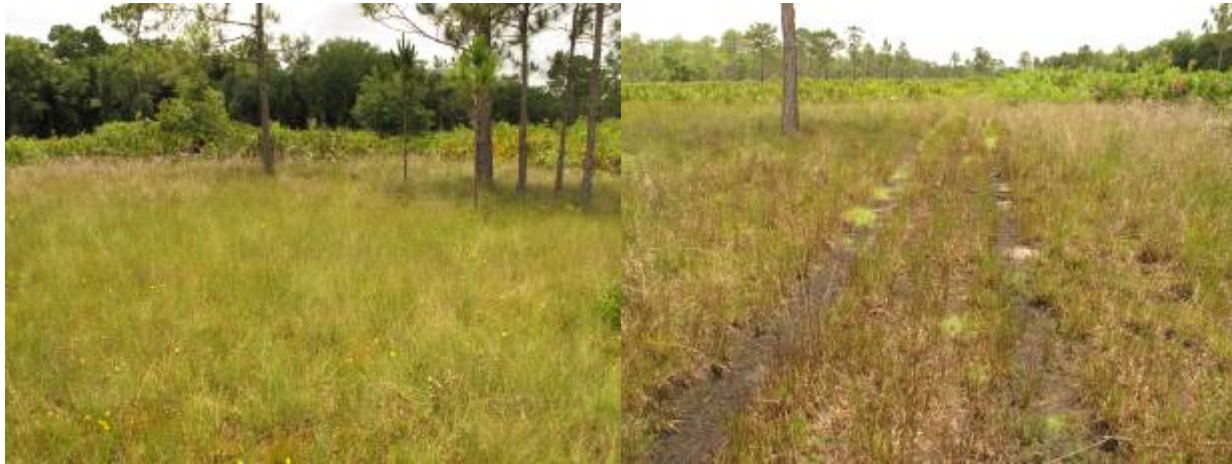
**Wetland ID: 24-13**

**Description:** This wetland is a <0.1 ha ephemeral marsh. Pine trees have encroached into the wetland and cover 5-25% of the basin. There is no midstory cover. Sedges/grasses grow throughout the wetland, and cover >75% of the basin. Cattle trails lead into the wetland. An auto track was created through the west side of the wetland. The adjacent uplands are a mix of mesic and scrubby flatwoods that are managed with prescribed fire.

**Wetland Concerns:** Cattle, Woody encroachment (minor), Vehicular damage

**Restoration Action Recommended:** The woody encroachment is minor, the pine trees could be removed or the wetland could be managed with prescribed fire alone. Abandon the current track and re-route to the west of the wetland. The uplands in this MU are in good ecological condition, although we have observed some cattle-related effects in both wetlands and uplands in some areas. We recommend removing cattle from this unit to prevent destruction of the intact flatwoods community and the embedded wetlands.

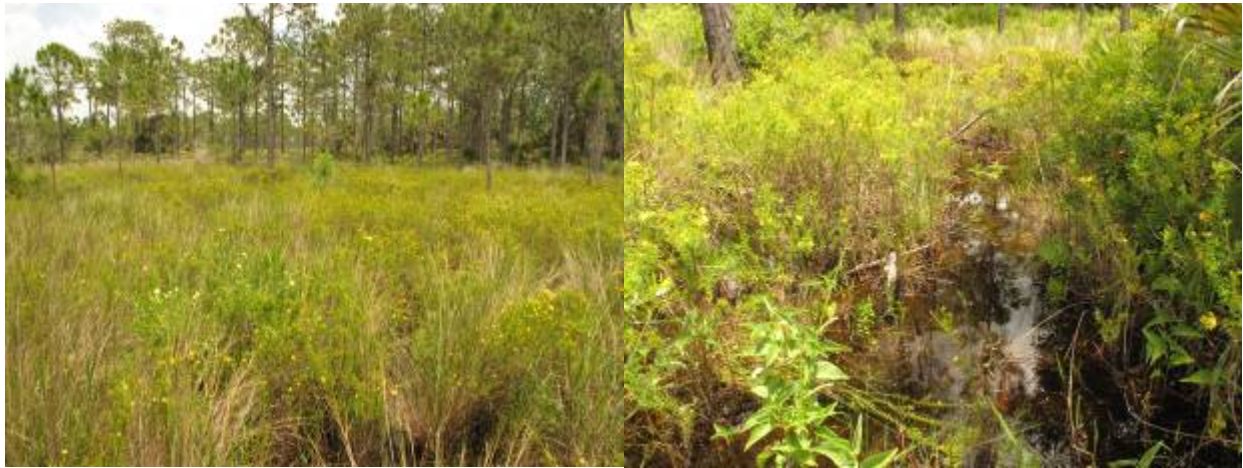
**Wetland ID: 24-14**

**Description:** This wetland is a 0.2 ha ephemeral marsh. Pine trees dominate the canopy, and cover 5-25% of the basin. There is no midstory cover. Sedges/grasses grow throughout the wetland, and cover >75% of the basin. The vegetation in this wetland is indicative of an ephemeral pond but a small, barely flowing stream connects this wetland to a swampy stream to the west. We were unable to discern if this stream is a human-constructed ditch or a natural feature. There is evidence of cattle in the wetland, including trails and feces. The adjacent uplands are a mix of mesic and scrubby flatwoods that are managed with prescribed fire.

**Wetland Concerns:** Cattle, Woody encroachment (minor), Ditching (possibly)

**Restoration Action Recommended:** The woody encroachment is minor, the pine trees could be removed or the wetland could be managed with prescribed fire alone. Fill in the ditch if it is human-constructed. The uplands in this MU are in good ecological condition, although we have observed some cattle-related effects in both wetlands and uplands in some areas. We recommend removing cattle from this unit to prevent destruction of the intact flatwoods community and the embedded wetlands.

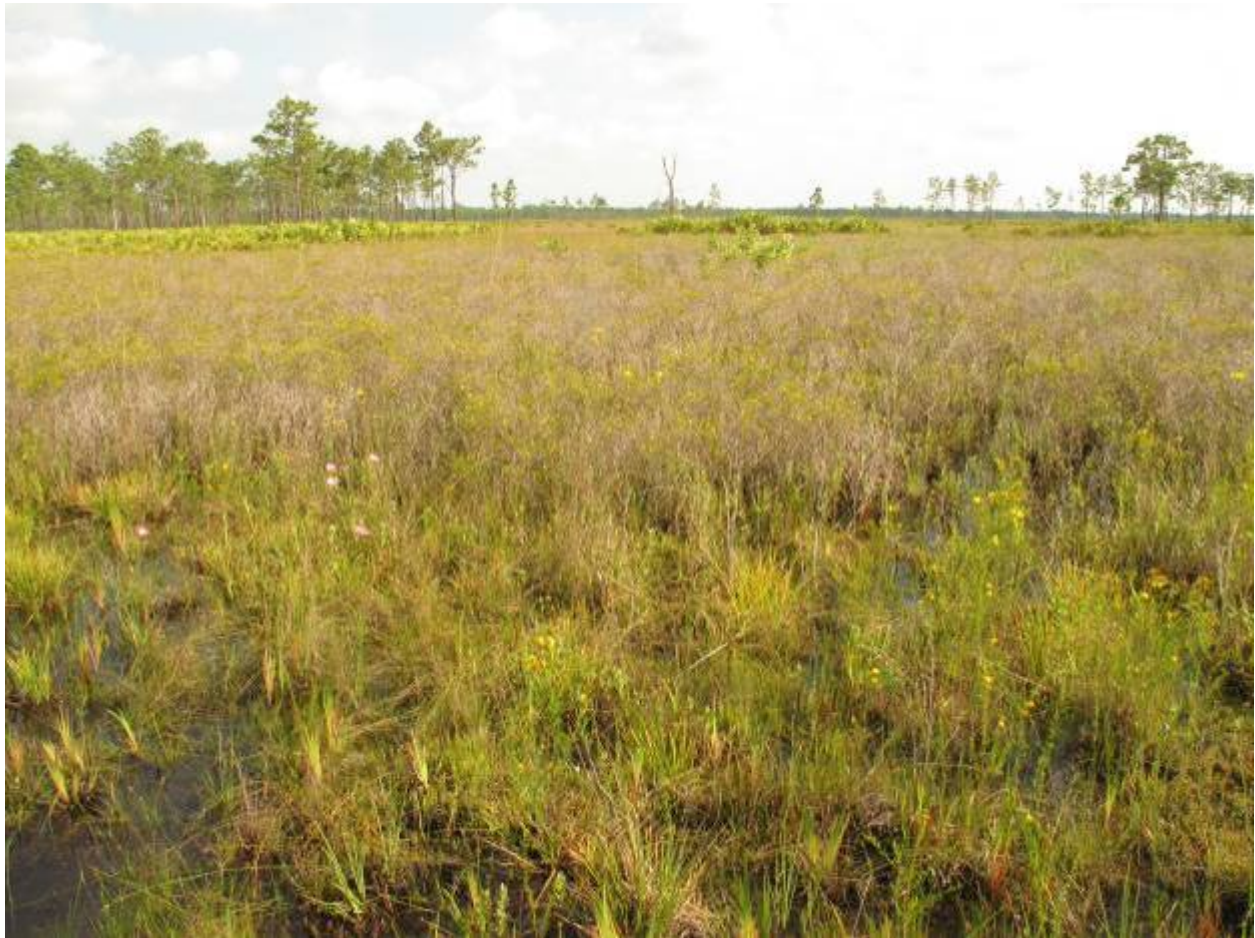
**Wetland ID: 25-01**

**Description:** This wetland is a 0.2 ha ephemeral marsh. There is no tree canopy or midstory cover. *Hypericum* is abundant in the wetland center and sedges/grasses grow throughout the wetland. The herbaceous vegetation covers >75% of the basin. Feral hog damage is minor and patchy. There is evidence of cattle in the wetland, including feces. This wetland may connect to a long strand of low, marshy, open flatwoods to the north during times of high water. The adjacent uplands are a mix of scrubby and mesic flatwoods that are managed with prescribed fire.

**Wetland Concerns:** Cattle, Feral hog damage

**Restoration Action Recommended:** The uplands in this MU are in good ecological condition, although we have observed some cattle-related effects in both wetlands and uplands in some areas. We recommend removing cattle from this unit to prevent destruction of the intact flatwoods community and the embedded wetlands.

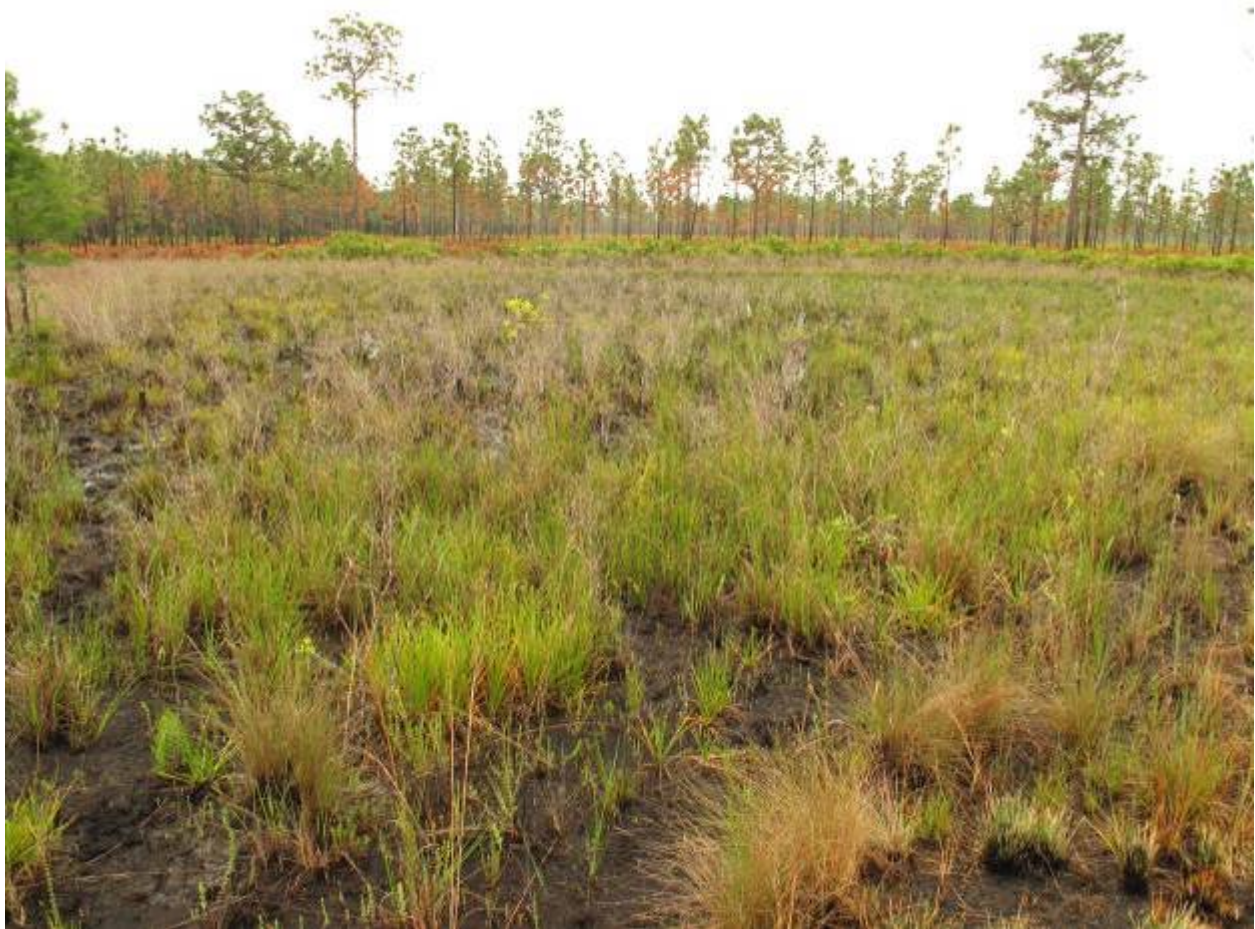
**Wetland ID: 28-01**

**Description:** This wetland is a 0.3 ha ephemeral marsh. There is no tree canopy or midstory cover. Sedges/grasses grow throughout the wetland, and cover >75% of the basin. A recent fire burned into the wetland edges. There is evidence of cattle in the wetland, though no negative impacts are evident. The adjacent uplands are mesic flatwoods to the east and a creek with hardwood swamp to the west.

**Wetland Concerns:** Cattle

**Restoration Action Recommended:** The uplands in this MU are in good ecological condition, although we have observed some cattle-related effects in both wetlands and uplands in some areas. We recommend removing cattle from this unit to prevent destruction of the intact flatwoods community and the embedded wetlands.

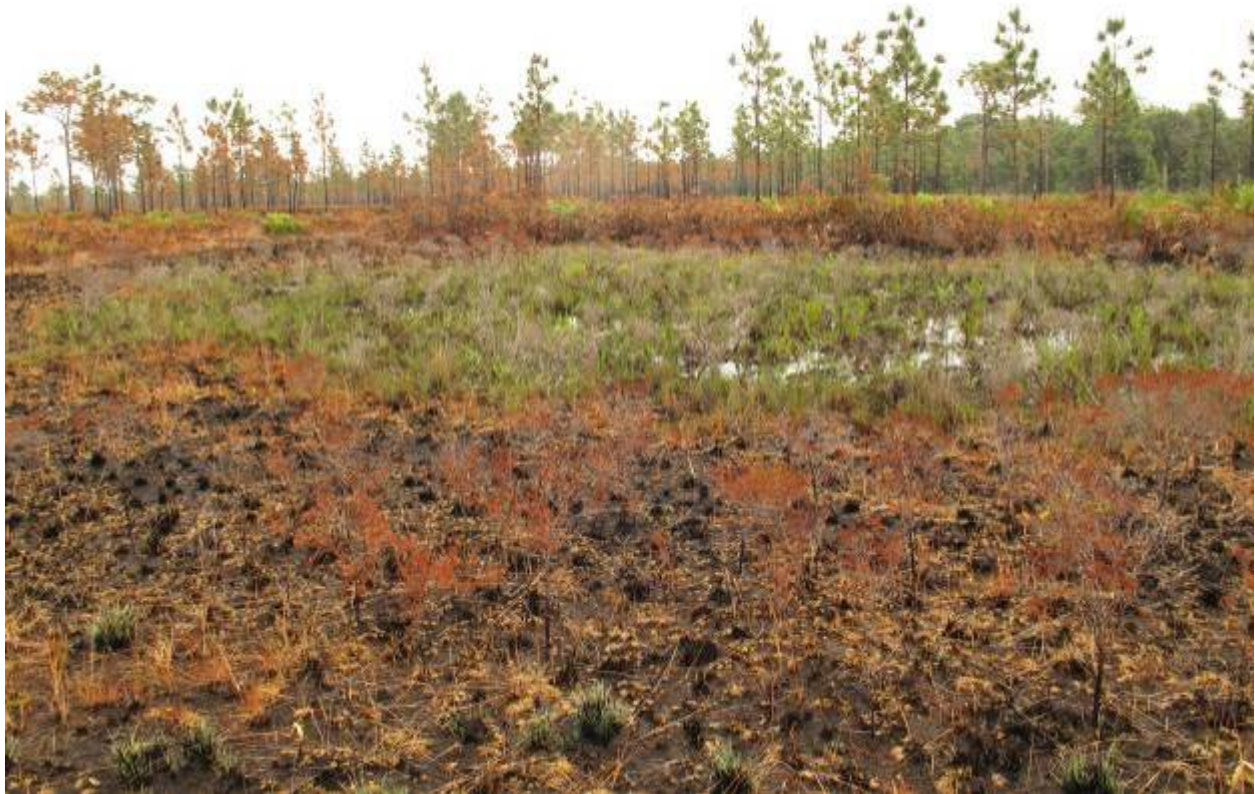
**Wetland ID: 28-02**

**Description:** This wetland is a 0.1 ha ephemeral marsh. There is no tree canopy or midstory cover. Sedges/grasses grow throughout the wetland, and cover >75% of the basin. Trails, likely from cattle, have formed around the wetland edge. Feral hog damage is old and has grown over with vegetation. A recent fire burned into the wetland basin. The adjacent uplands are mesic flatwoods that are managed with prescribed fire.

**Wetland Concerns:** Feral hog damage, Cattle

**Restoration Action Recommended:** The uplands in this MU are in good ecological condition, although we have observed some cattle-related effects in both wetlands and uplands in some areas. We recommend removing cattle from this unit to prevent destruction of the intact flatwoods community and the embedded wetlands.

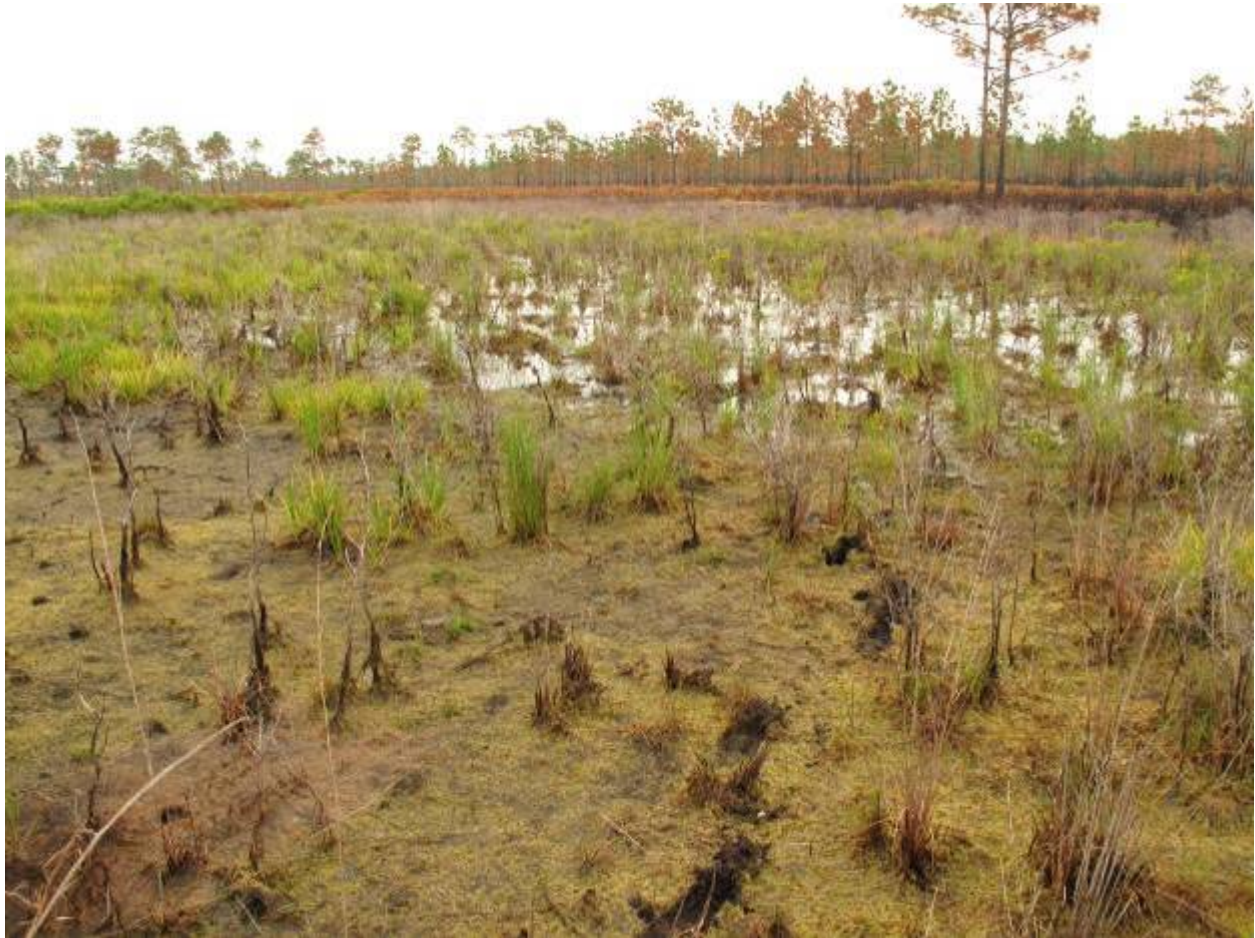
**Wetland ID: 28-03**

**Description:** This wetland is a 0.2 ha ephemeral marsh. There is no tree canopy or midstory cover. Sedges/grasses and *Sphagnum* grow throughout the wetland, and cover >75% of the basin. There are light cattle trails and grazing evident on the vegetation. The adjacent uplands are mesic flatwoods that are managed with prescribed fire.

**Wetland Concerns:** Cattle

**Restoration Action Recommended:** The uplands in this MU are in good ecological condition, although we have observed some cattle-related effects in both wetlands and uplands in some areas. We recommend removing cattle from this unit to prevent destruction of the intact flatwoods community and the embedded wetlands.

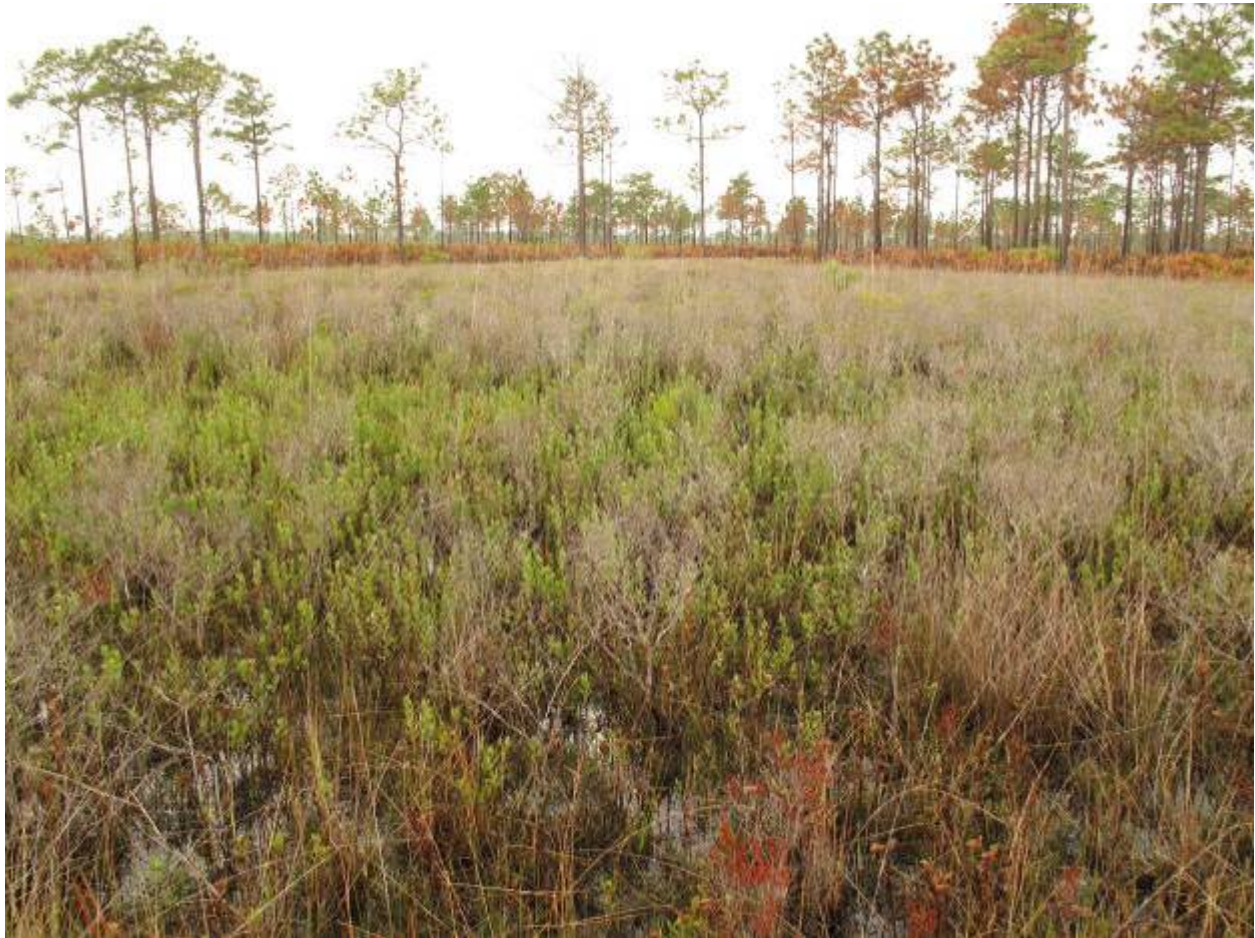
**Wetland ID: 28-04**

**Description:** This wetland is a 0.4 ha ephemeral marsh. There is no tree canopy or midstory cover. Sedges/grasses grow throughout the wetland, and cover >75% of the basin. This appears to be a very healthy marsh. A recent fire burned into the wetland edges. The adjacent uplands are mesic flatwoods that are managed with prescribed fire.

**Wetland Concerns:** None

**Restoration Action Recommended:** The uplands in this MU are in good ecological condition, although we have observed some cattle-related effects in both wetlands and uplands in some areas. We recommend removing cattle from this unit to prevent destruction of the intact flatwoods community and the embedded wetlands.

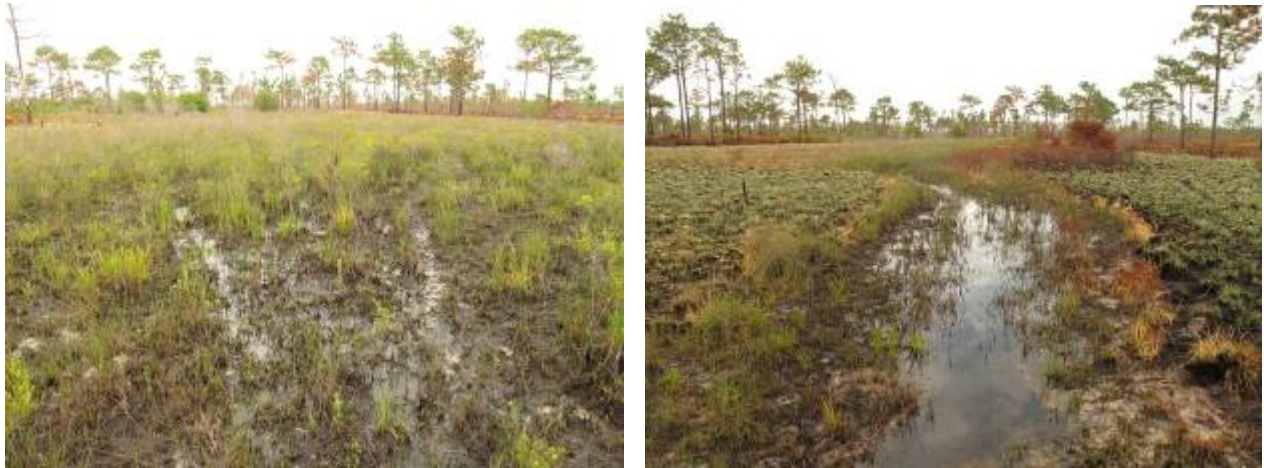
**Wetland ID: 28-05**

**Description:** This wetland is a 0.5 ha ephemeral marsh. There is no tree canopy or midstory cover. Sedges/grasses grow throughout the wetland, and cover >75% of the basin. There are cattle tracks and trails in the wetland, although the vegetation is still diverse and intact. A ditch enters the wetland on the north side and exits on the south end, draining the wetland to a creek and to 28-06. Fish were present in the ditch and the pond on the day of our visit. A recent fire burned to the wetland edge. The adjacent uplands are mesic flatwoods that are managed with prescribed fire.

**Wetland Concerns:** Cattle, Ditching

**Restoration Action Recommended:** Fill the ditches to restore the wetland's isolation. The uplands in this MU are in good ecological condition, although we have observed some cattle-related effects in both wetlands and uplands in some areas. We recommend removing cattle from this unit to prevent destruction of the intact flatwoods community and the embedded wetlands.

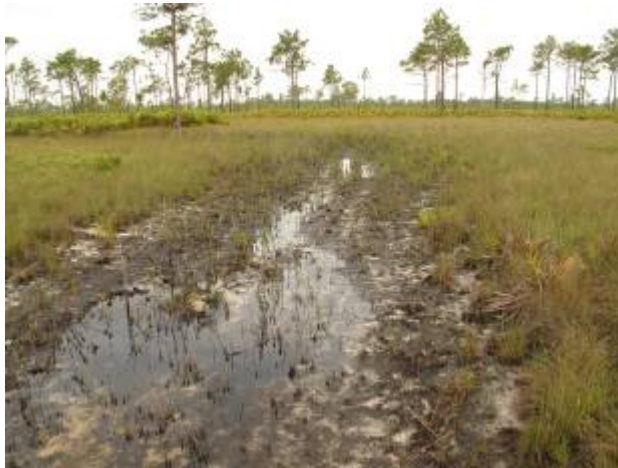
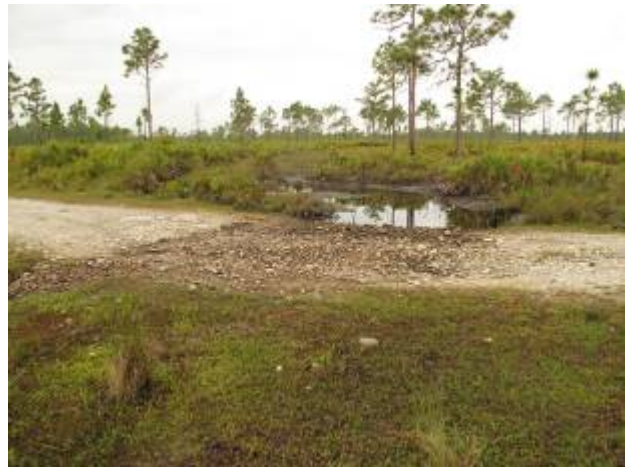
**Wetland ID: 28-06**

**Description:** This wetland is a 0.1 ha ephemeral marsh. There is no tree canopy or midstory cover. Sedges/grasses grow throughout the wetland, and cover >75% of the basin. A ditch enters the south end of the wetland and exits the east end, connecting this wetland with 28-05. Fish were present in the ditch's deeper holes on the day of our visit. The adjacent uplands are mesic flatwoods that are managed with prescribed fire.

**Wetland Concerns:** Ditching

**Restoration Action Recommended:** Fill the ditches to restore the wetland's isolation. The uplands in this MU are in good ecological condition, although we have observed some cattle-related effects in both wetlands and uplands in some areas. We recommend removing cattle from this unit to prevent destruction of the intact flatwoods community and the embedded wetlands.

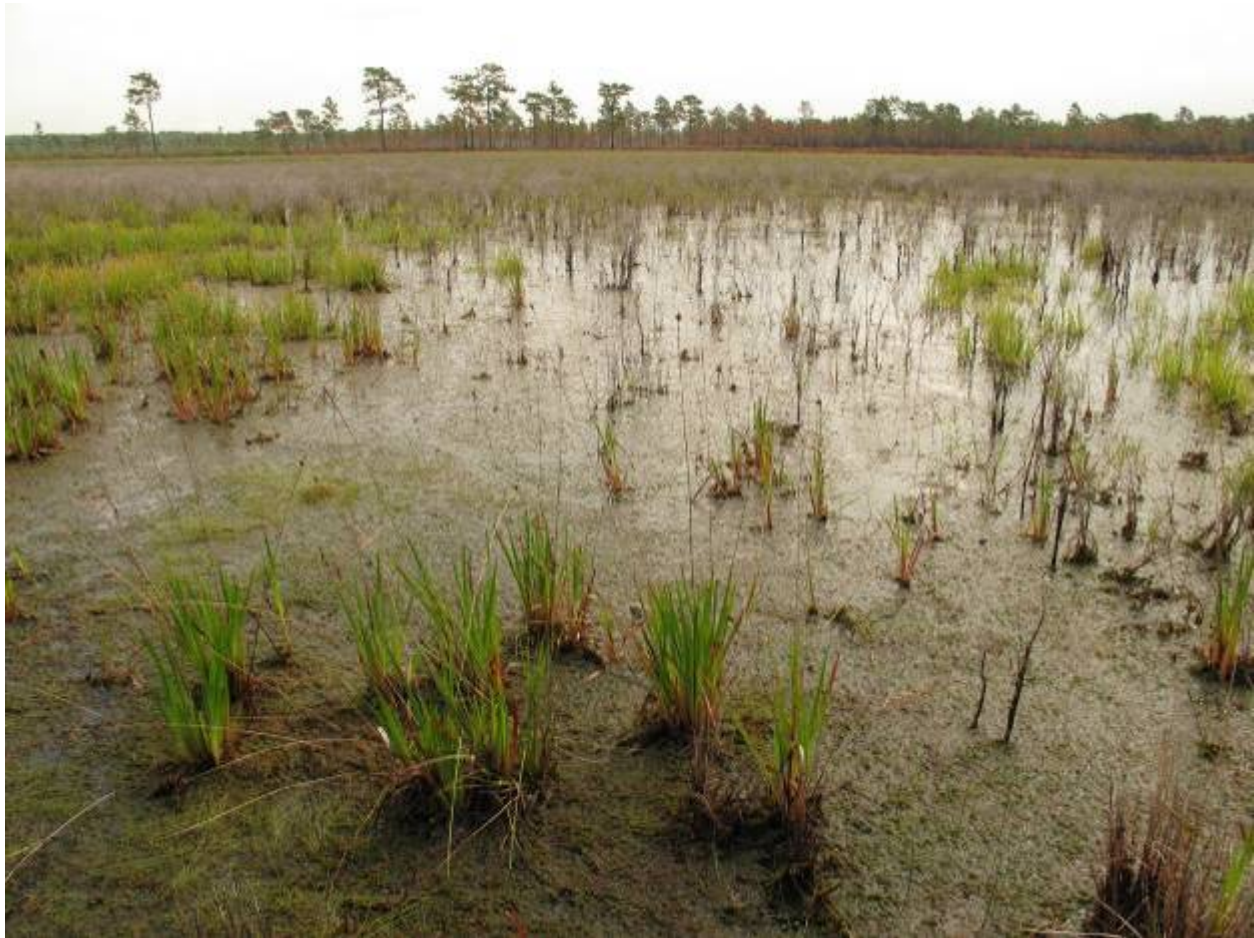
**Wetland ID: 28-07**

**Description:** This wetland is a 2.1 ha ephemeral marsh. There is no tree canopy or midstory cover. Sedges/grasses and *Sphagnum* grow throughout the wetland, and cover >75% of the basin. This appears to be a very healthy marsh with minimal cattle presence. A recent fire burned into the wetland edges. The adjacent uplands are mesic flatwoods that are managed with prescribed fire.

**Wetland Concerns:** None

**Restoration Action Recommended:** The uplands in this MU are in good ecological condition, although we have observed some cattle-related effects in both wetlands and uplands in some areas. We recommend removing cattle from this unit to prevent destruction of the intact flatwoods community and the embedded wetlands.

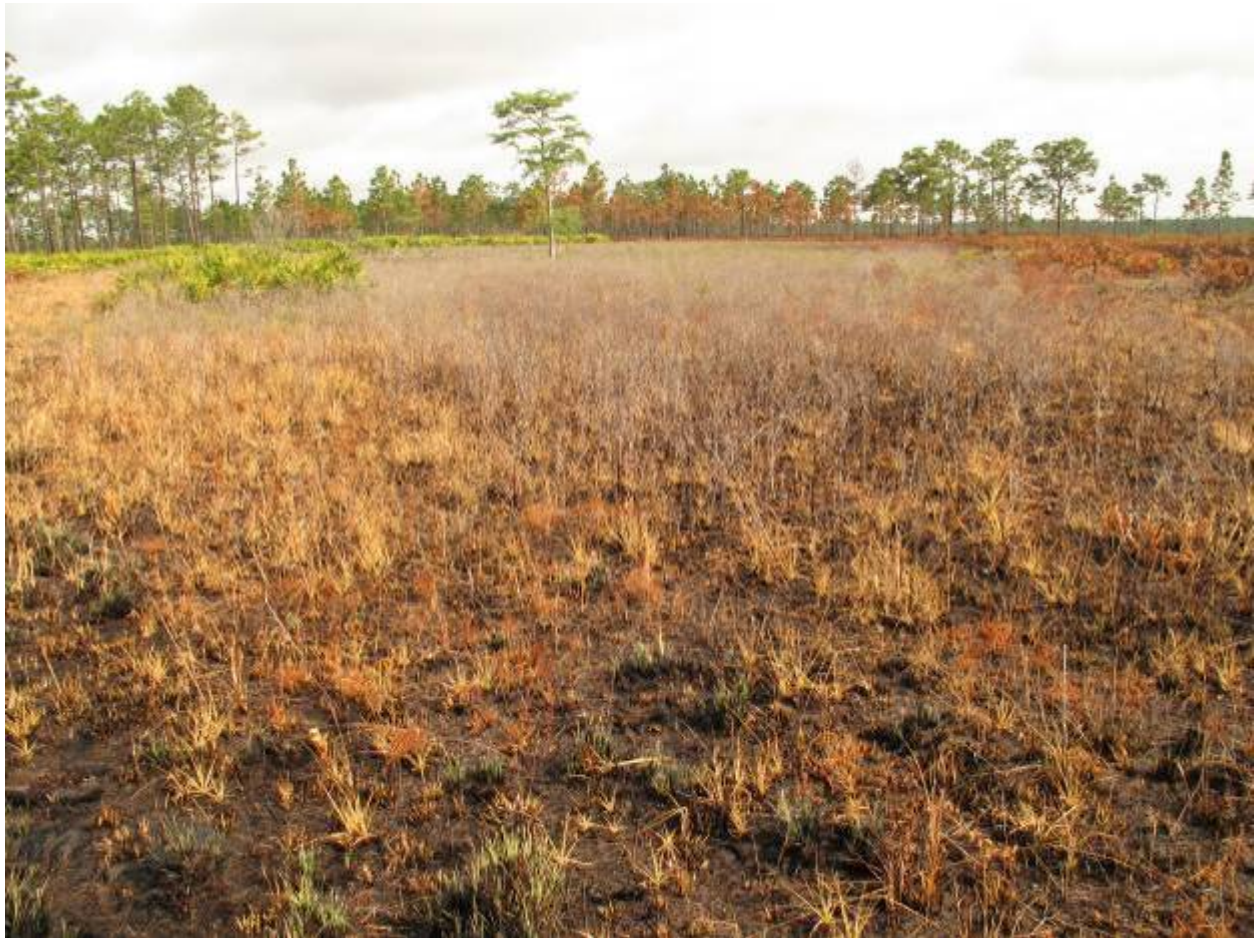
**Wetland ID: 28-08**

**Description:** This wetland is a 0.6 ha ephemeral marsh. There is no tree canopy or midstory cover. *Hypericum* is abundant within the wetland. Sedges/grasses grow throughout the wetland, and cover >75% of the basin. There is a system of cattle trails through the wetland. What appears to be a fenced-in, rectangular study plot is in the north end of the wetland. A recent fire burned through the wetland. The adjacent uplands are mesic flatwoods that are managed with prescribed fire.

**Wetland Concerns:** Cattle

**Restoration Action Recommended:** The uplands in this MU are in good ecological condition, although we have observed some cattle-related effects in both wetlands and uplands in some areas. We recommend removing cattle from this unit to prevent destruction of the intact flatwoods community and the embedded wetlands.

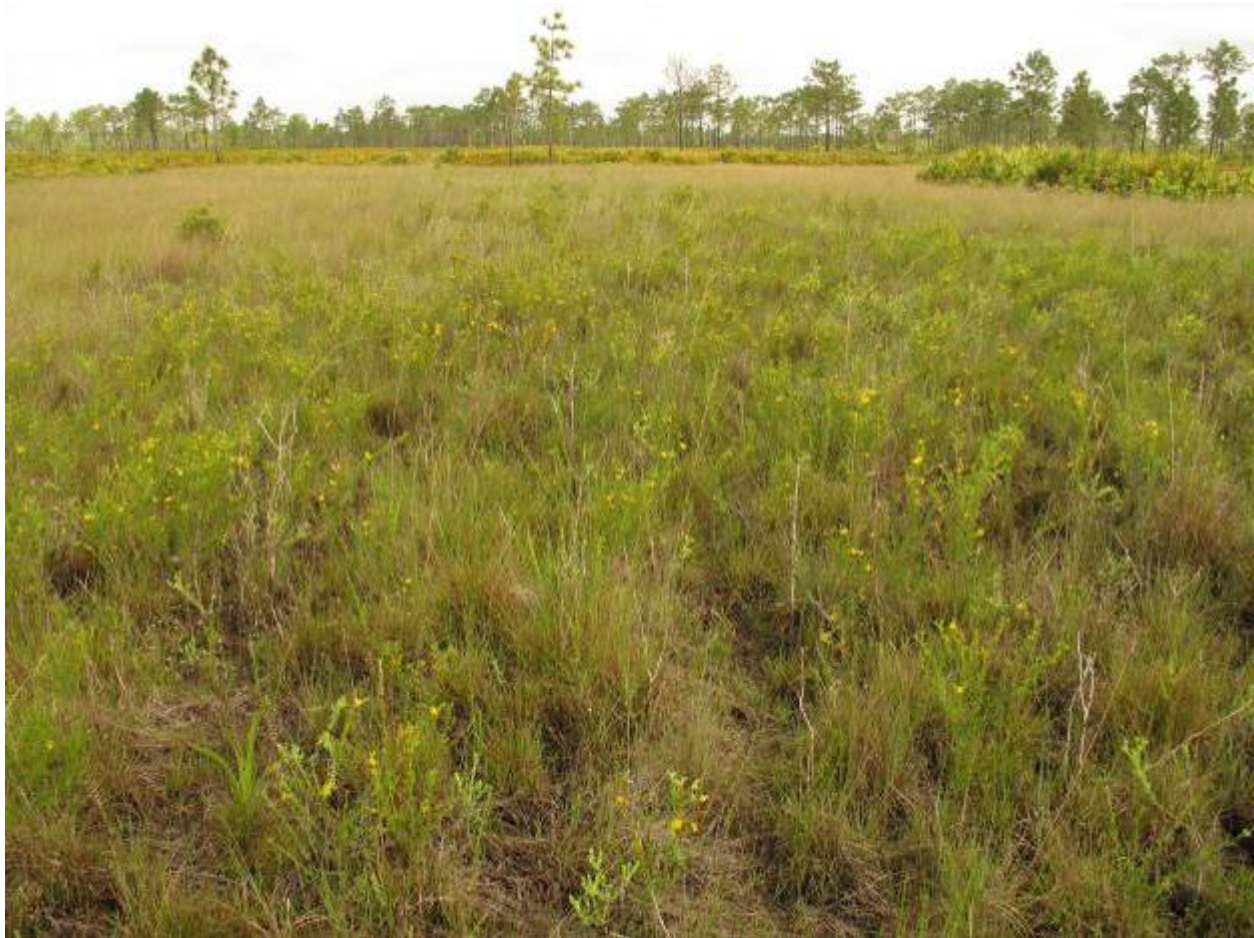
**Wetland ID: 28-09**

**Description:** This wetland is a 0.2 ha ephemeral marsh. There is no tree canopy or midstory cover. *Hypericum* is abundant within the wetland. Sedges/grasses grow throughout the wetland, and cover >75% of the basin. There is a cattle trail through the wetland, but the wetland appears to be very healthy. The adjacent uplands are mesic flatwoods that are managed with prescribed fire.

**Wetland Concerns:** Cattle

**Restoration Action Recommended:** The uplands in this MU are in good ecological condition, although we have observed some cattle-related effects in both wetlands and uplands in some areas. We recommend removing cattle from this unit to prevent destruction of the intact flatwoods community and the embedded wetlands.

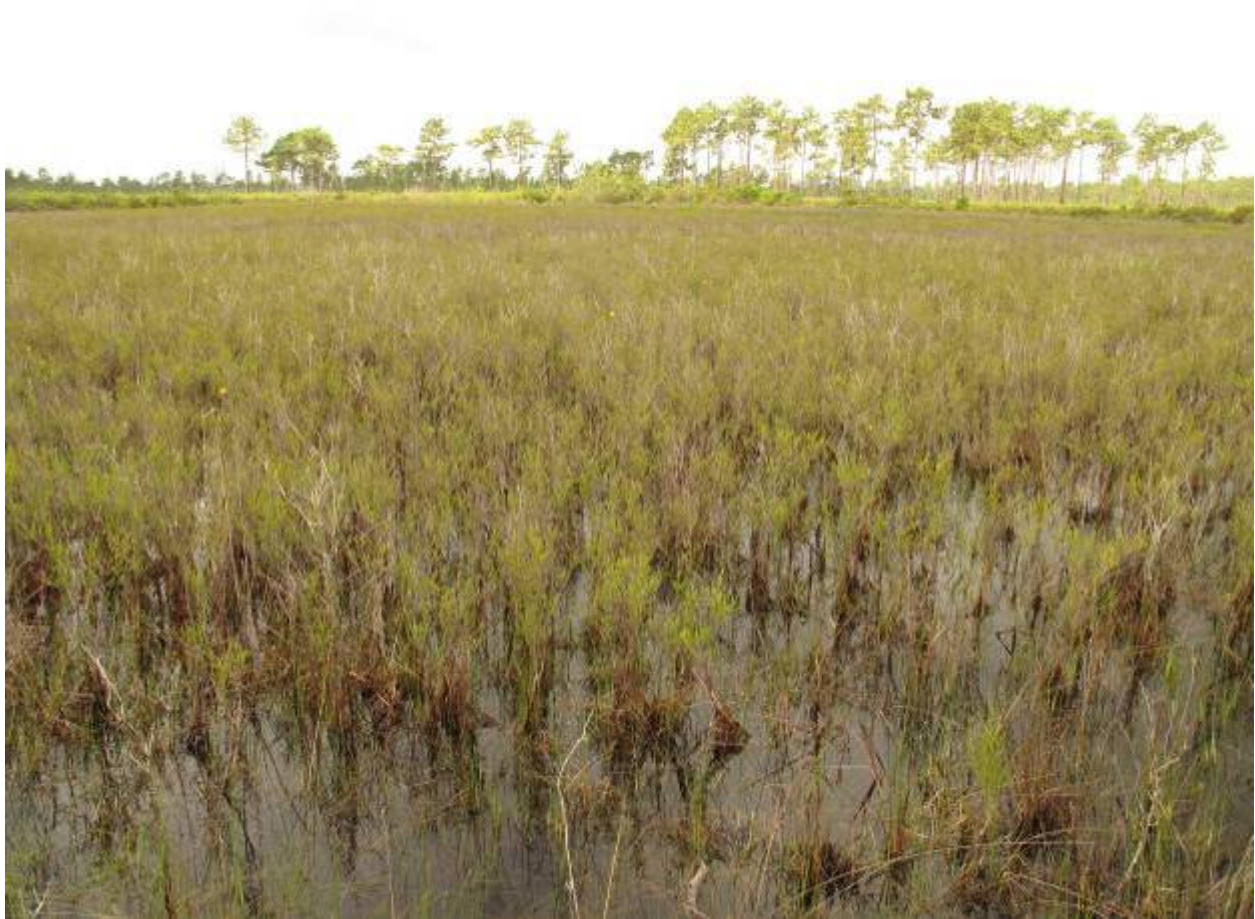
**Wetland ID: 28-10**

**Description:** This wetland is a 2.6 ha semi-permanent marsh. There is no tree canopy or midstory cover. *Hypericum* is common within the wetland. Emergent vegetation grows in a deeper hole in the south end of the wetland, sedges/grasses grow throughout the wetland. The herbaceous vegetation covers >75% of the basin. There are cattle trails around the wetland edge. Fish and pig frogs were present on the day of our visit, indicating longer hydroperiod. A shallow ditch leads out of the north end of the wetland and spills over a nearby access road. The adjacent uplands are mesic flatwoods that are managed with prescribed fire.

**Wetland Concerns:** Cattle, Ditching

**Restoration Action Recommended:** Fill the ditch to restore the wetland's isolation. The uplands in this MU are in good ecological condition, although we have observed some cattle-related effects in both wetlands and uplands in some areas. We recommend removing cattle from this unit to prevent destruction of the intact flatwoods community and the embedded wetlands.

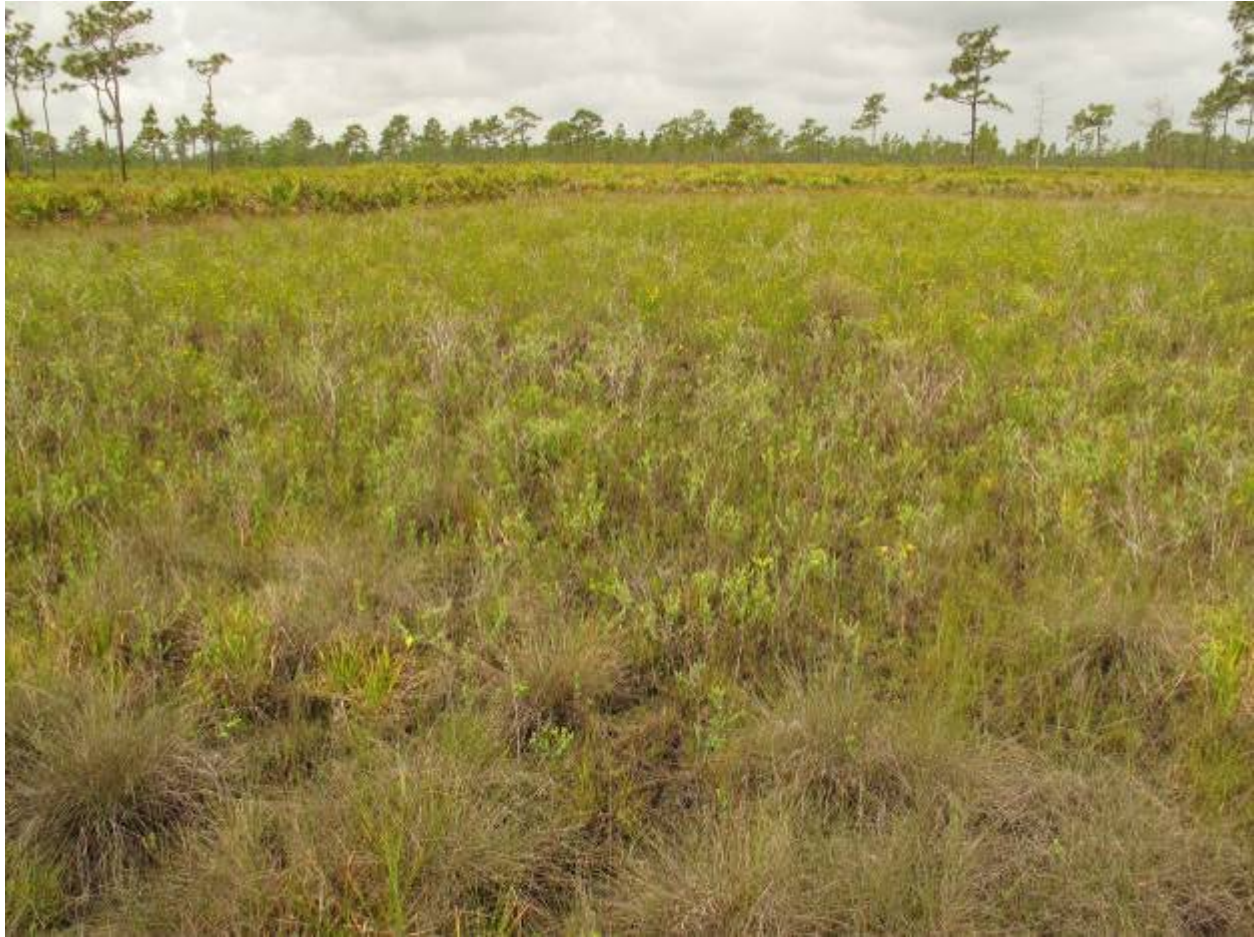
**Wetland ID: 28-11**

**Description:** This wetland is a 0.1 ha ephemeral marsh. There is no tree canopy or midstory cover. *Hypericum* is common within the wetland. Sedges/grasses grow throughout the wetland, and cover >75% of the basin. There are cattle trails and tracks around the wetland edge. The adjacent uplands are mesic flatwoods that are managed with prescribed fire.

**Wetland Concerns:** Cattle

**Restoration Action Recommended:** The uplands in this MU are in good ecological condition, although we have observed some cattle-related effects in both wetlands and uplands in some areas. We recommend removing cattle from this unit to prevent destruction of the intact flatwoods community and the embedded wetlands.

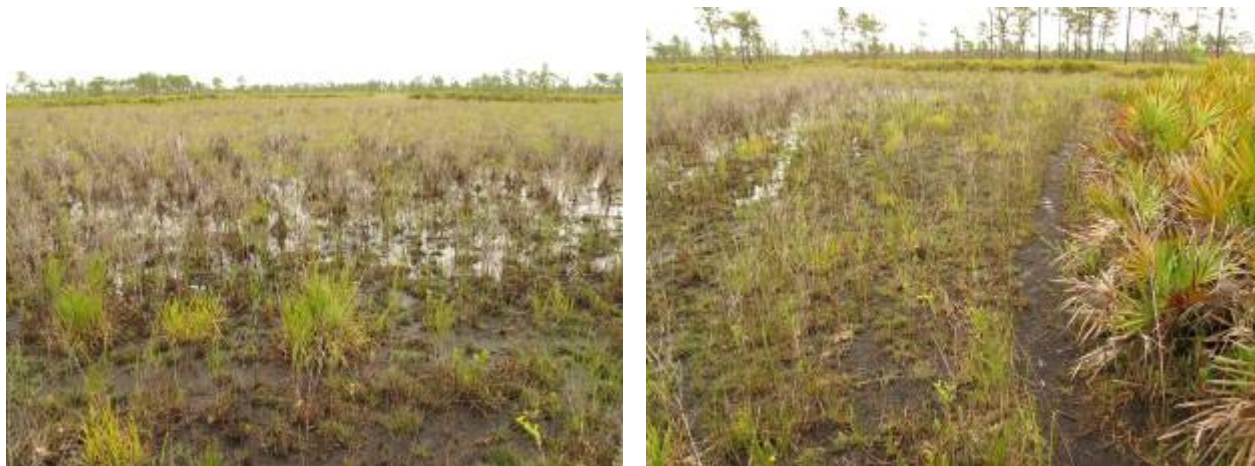
**Wetland ID: 28-12**

**Description:** This wetland is a 1.6 ha ephemeral marsh. There is no tree canopy or midstory cover. *Hypericum* is abundant within the wetland. Small, emergent vegetation is common in the wetland interior and sedges/grasses grow throughout the wetland. The herbaceous vegetation covers >75% of the basin. There are cattle trails into and around the edge of the wetland. The adjacent uplands are mesic flatwoods that are managed with prescribed fire.

**Wetland Concerns:** Cattle

**Restoration Action Recommended:** The uplands in this MU are in good ecological condition, although we have observed some cattle-related effects in both wetlands and uplands in some areas. We recommend removing cattle from this unit to prevent destruction of the intact flatwoods community and the embedded wetlands.

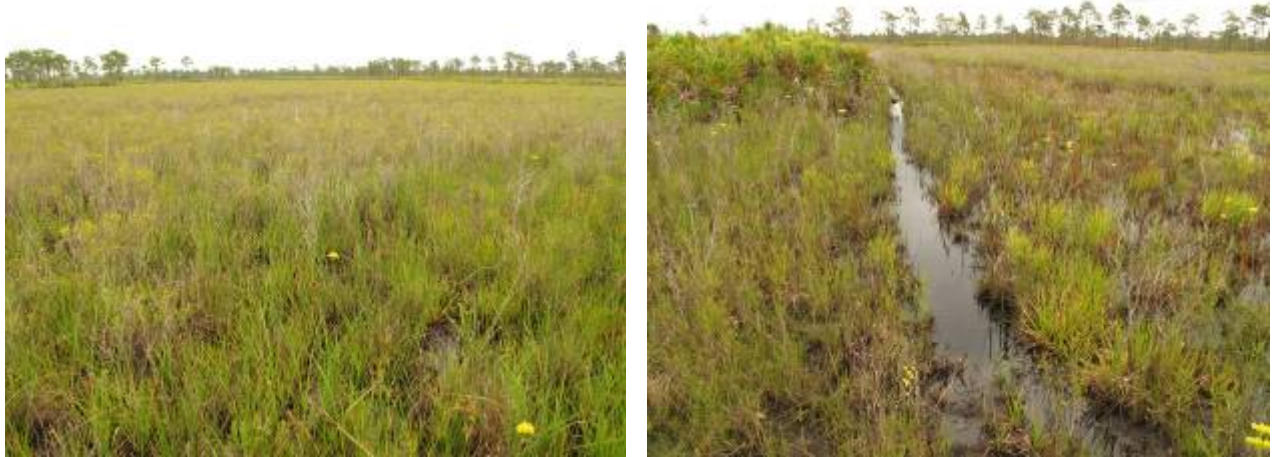
**Wetland ID: 28-13**

**Description:** This wetland is a 1.9 ha ephemeral marsh. There is no tree canopy or midstory cover. *Hypericum* is common within the wetland. A diverse array of herbaceous vegetation grows throughout the wetland, and covers >75% of the basin. Cattle trails are present, particularly around the wetland edge. The adjacent uplands are mesic flatwoods that are managed with prescribed fire.

**Wetland Concerns:** Cattle

**Restoration Action Recommended:** The uplands in this MU are in good ecological condition, although we have observed some cattle-related effects in both wetlands and uplands in some areas. We recommend removing cattle from this unit to prevent destruction of the intact flatwoods community and the embedded wetlands.

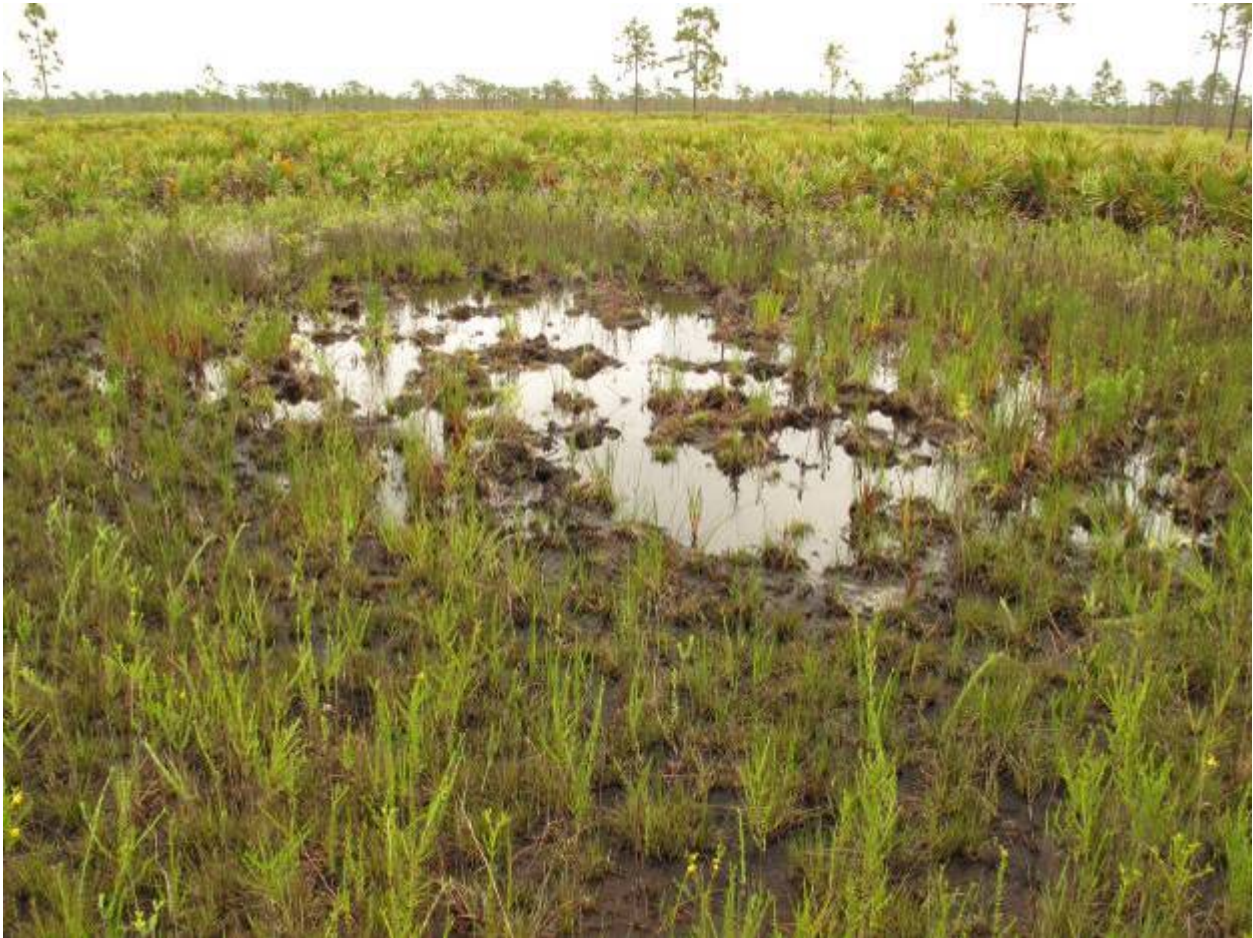
**Wetland ID: 28-14**

**Description:** This wetland is a <0.1 ha ephemeral marsh. There is no tree canopy or midstory cover. A diverse array of grasses and other herbaceous vegetation grows throughout, and covers >75% of the basin. There is a cattle trail around the wetland edge and severe feral hog damage in the wetland center. The adjacent uplands are mesic flatwoods that are managed with prescribed fire.

**Wetland Concerns:** Feral hog damage, Cattle

**Restoration Action Recommended:** The uplands in this MU are in good ecological condition, although we have observed some cattle-related effects in both wetlands and uplands in some areas. We recommend removing cattle from this unit to prevent destruction of the intact flatwoods community and the embedded wetlands.
