# **Inventory, Assessment, and Restoration Potential of Ephemeral Wetlands on FFWCC Wildlife Management Areas**

## **Triple N Ranch WMA Final Report**

Submitted by: Rebecca P.M. Means<sup>1</sup>, Ryan C. Means<sup>1</sup>, Steven A. Johnson<sup>2</sup>

15 May 2010 – 15 August 2010

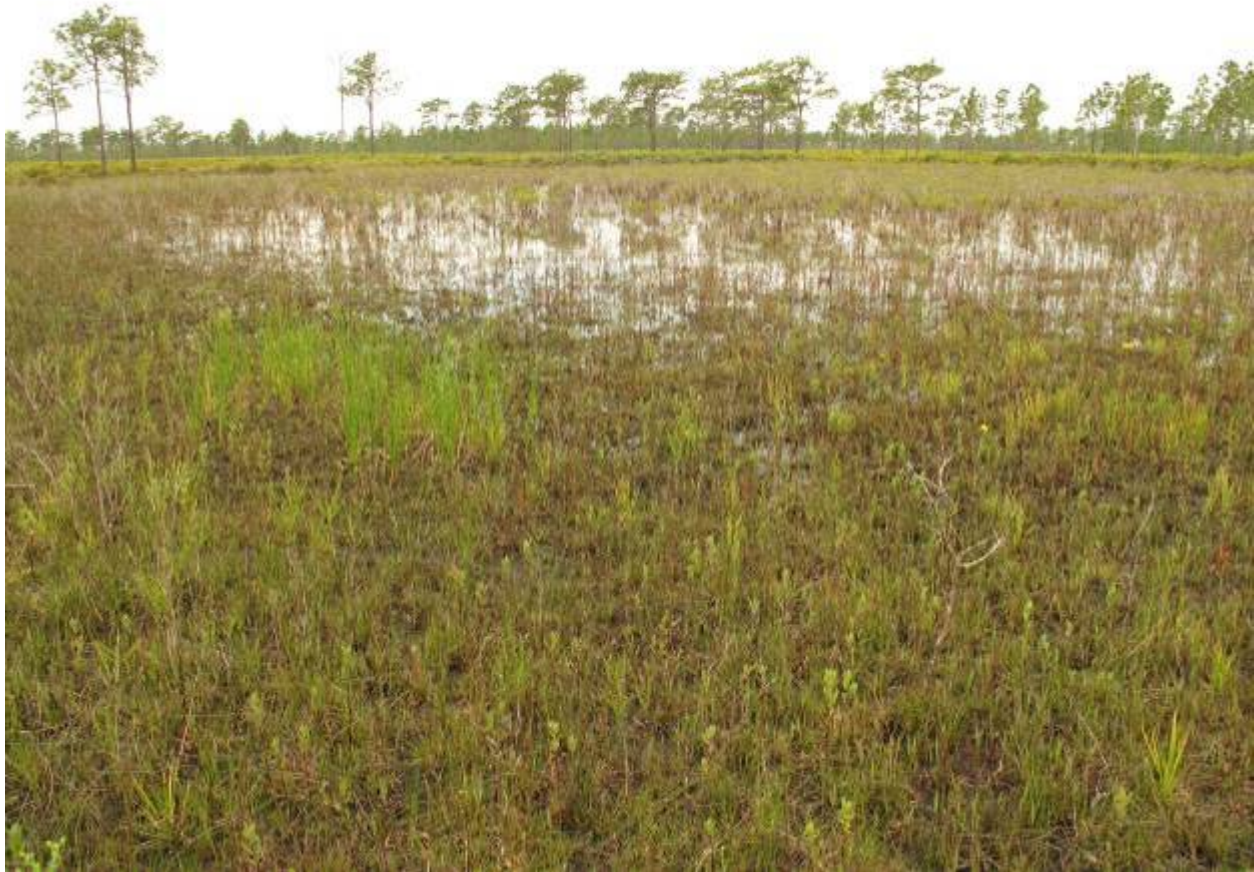
**Wetland ID: 28-15**

**Description:** This wetland is a 0.4 ha ephemeral marsh. There is no tree canopy or midstory cover. A diverse array of herbaceous vegetation grows throughout the wetland, and covers >75% of the basin. There is a cattle trail around the wetland edge. Fish were present on the day of our visit. The adjacent uplands are mesic flatwoods that are managed with prescribed fire.

**Wetland Concerns:** Cattle

**Restoration Action Recommended:** The uplands in this MU are in good ecological condition, although we have observed some cattle-related effects in both wetlands and uplands in some areas. We recommend removing cattle from this unit to prevent destruction of the intact flatwoods community and the embedded wetlands.

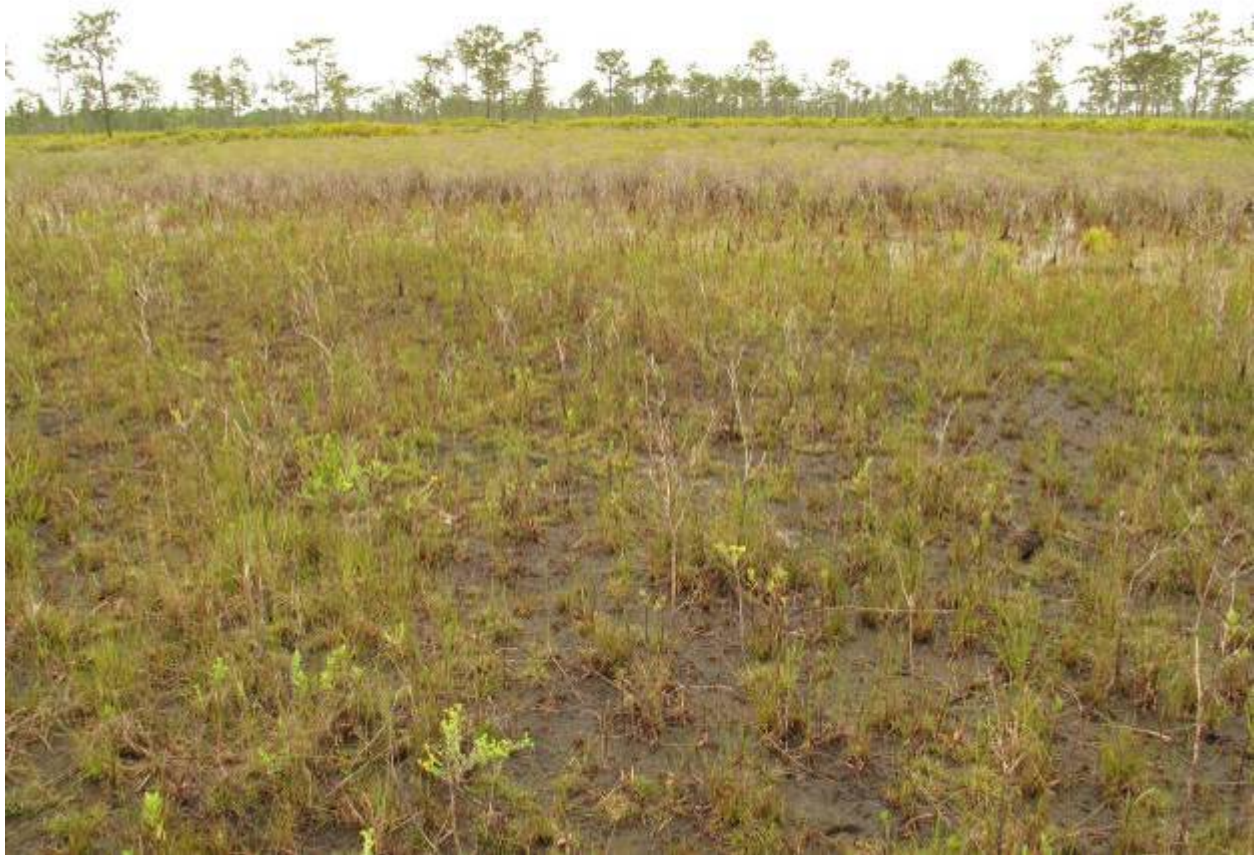
**Wetland ID: 28-16**

**Description:** This wetland is a 0.9 ha ephemeral marsh. This fairly large wetland has 2 lobes, with deeper areas in both the north and south ends. There is no tree canopy or midstory cover. *Hypericum* is common within the wetland. Sedges/grasses and emergent vegetation grow throughout the wetland, and cover >75% of the basin. Cattle trails and feces are present in the wetland. The adjacent uplands are mesic flatwoods that are managed with prescribed fire.

**Wetland Concerns:** Cattle

**Restoration Action Recommended:** The uplands in this MU are in good ecological condition, although we have observed some cattle-related effects in both wetlands and uplands in some areas. We recommend removing cattle from this unit to prevent destruction of the intact flatwoods community and the embedded wetlands.

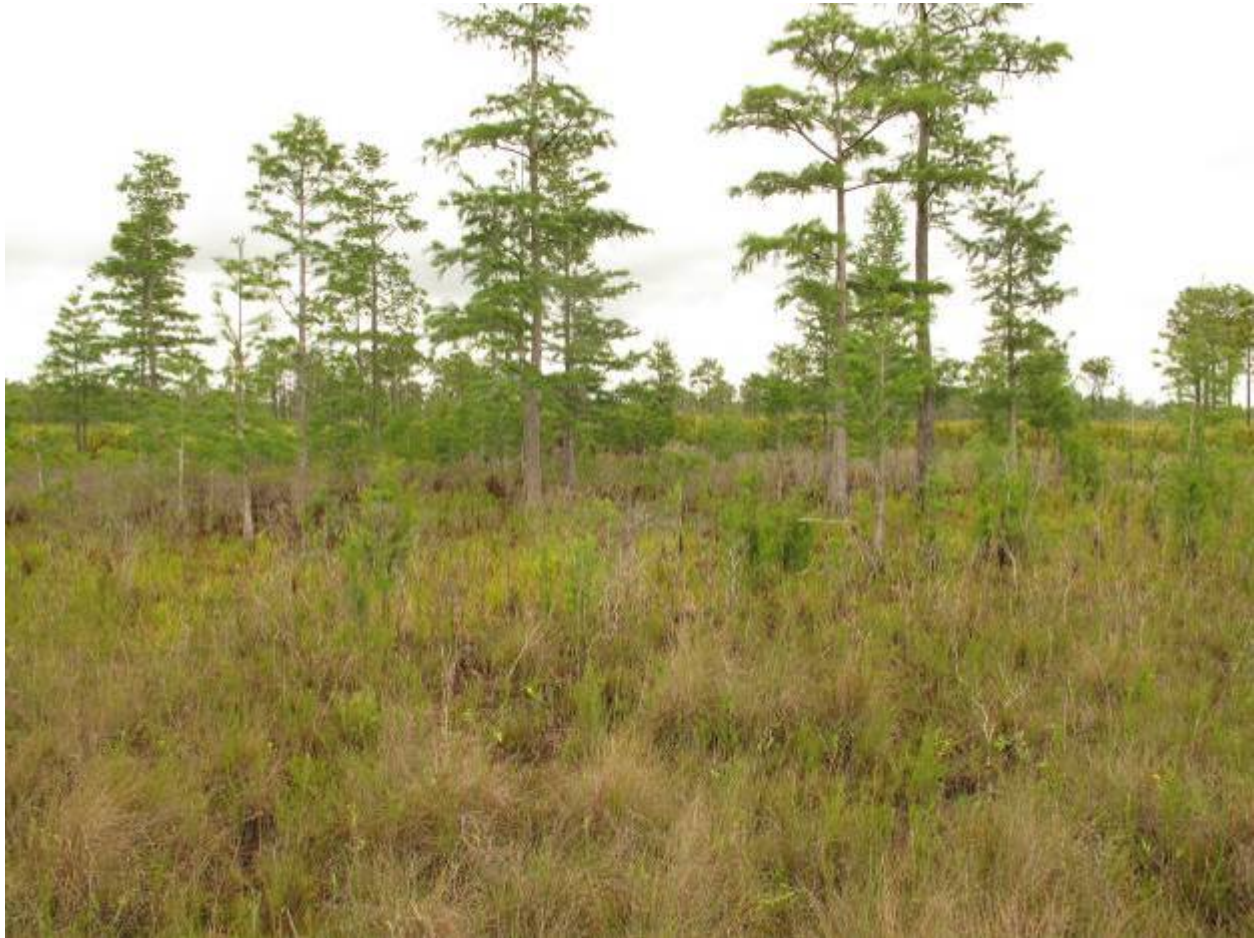
**Wetland ID: 28-17**

**Description:** This wetland is a 0.1 ha ephemeral marsh. It appears to be an herbaceous marsh succeeding to a cypress dome. Large cypress trees cover 25-50% of the basin and small cypress trees cover 5-25% of the basin. *Sphagnum* is widespread in the wetland center, and sedges/grasses and other herbaceous vegetation grow throughout the wetland. The herbaceous vegetation covers >75% of the basin. There is evidence of cattle in the wetland, including tracks and feces. The adjacent uplands are mesic flatwoods that are managed with prescribed fire.

**Wetland Concerns:** Cattle

**Restoration Action Recommended:** The uplands in this MU are in good ecological condition, although we have observed some cattle-related effects in both wetlands and uplands in some areas. We recommend removing cattle from this unit to prevent destruction of the intact flatwoods community and the embedded wetlands.

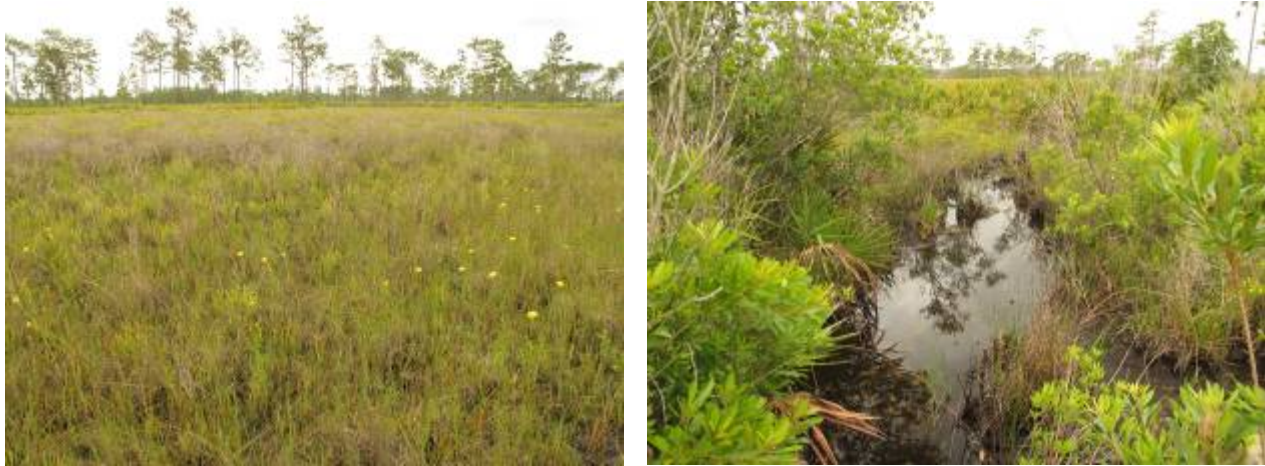
**Wetland ID: 28-18**

**Description:** This wetland is a 0.6 ha ephemeral marsh. There is no tree canopy or midstory cover. *Hypericum* is common within the wetland. A diverse array of herbaceous vegetation grows throughout the wetland, and covers >75% of the basin. Cattle trails are present in the wetland. A drainage ditch enters the southwest corner of the wetland and exits the southeast corner, flowing into a large swamp system. Wetland 28-06 also connects to this large swamp system. Silt and sand has accumulated where the ditch enters the wetland. Small fish were present in the wetland on the day of our visit. The adjacent uplands are mesic flatwoods that are managed with prescribed fire.

**Wetland Concerns:** Cattle, Ditching

**Restoration Action Recommended:** Filling both ditches should eliminated the runoff issue and restore the wetland's isolation. The uplands in this MU are in good ecological condition, although we have observed some cattle-related effects in both wetlands and uplands in some areas. We recommend removing cattle from this unit to prevent destruction of the intact flatwoods community and the embedded wetlands.

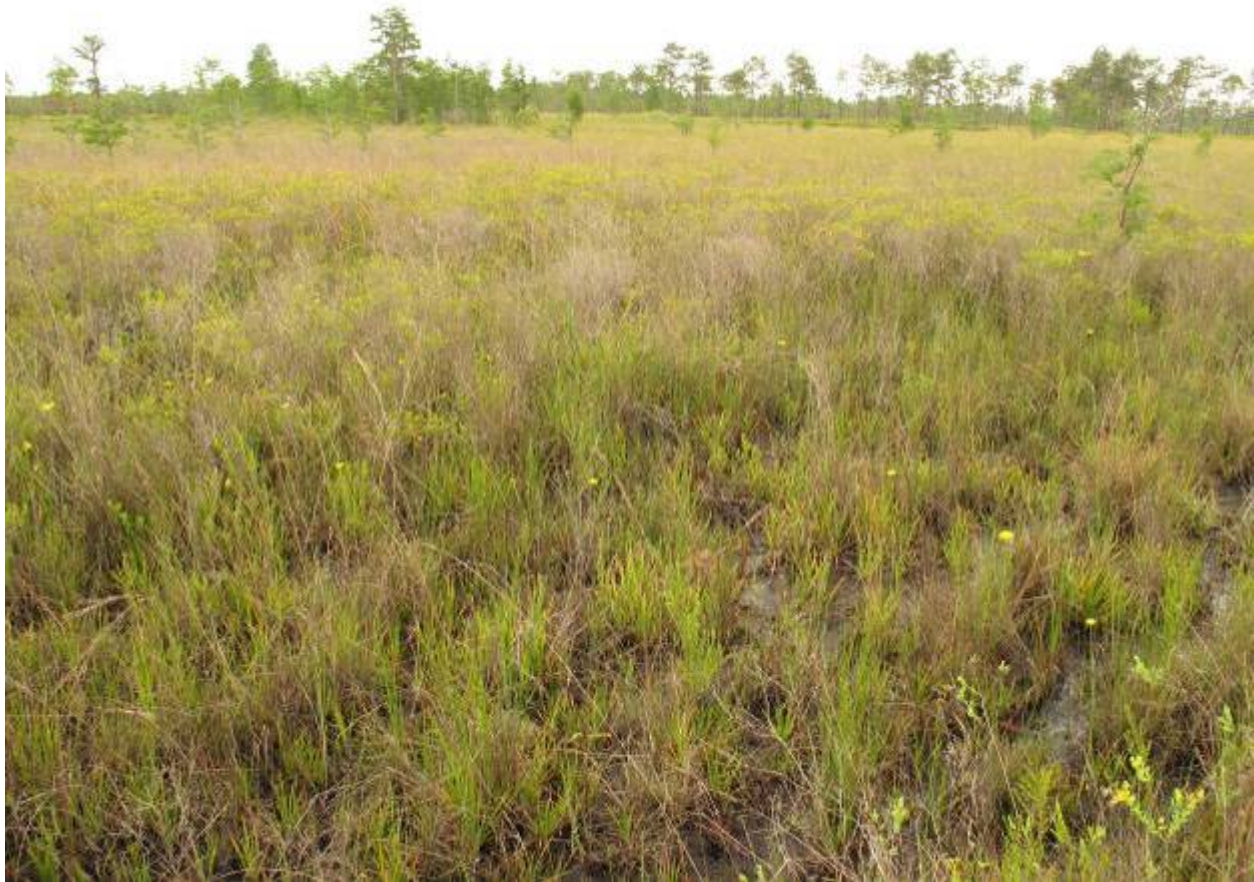
**Wetland ID: 28-19**

**Description:** This wetland is a 9.3 ha ephemeral mix of marsh and forested swamp. A cypress dome covers 25% of the basin. There is no midstory cover. A diverse array of herbaceous vegetation grows throughout the wetland, and covers >75% of the basin. Cattle trails and tracks are present in the wetland. A ditch on the west side connects this wetland with 28-18 and a ditch on the north side connects this wetland with 28-06. The adjacent uplands are mesic flatwoods that are managed with prescribed fire.

**Wetland Concerns:** Cattle, Ditching

**Restoration Action Recommended:** Fill both ditches to restore the wetland's isolation. The uplands in this MU are in good ecological condition, although we have observed some cattle-related effects in both wetlands and uplands in some areas. We recommend removing cattle from this unit to prevent destruction of the intact flatwoods community and the embedded wetlands.

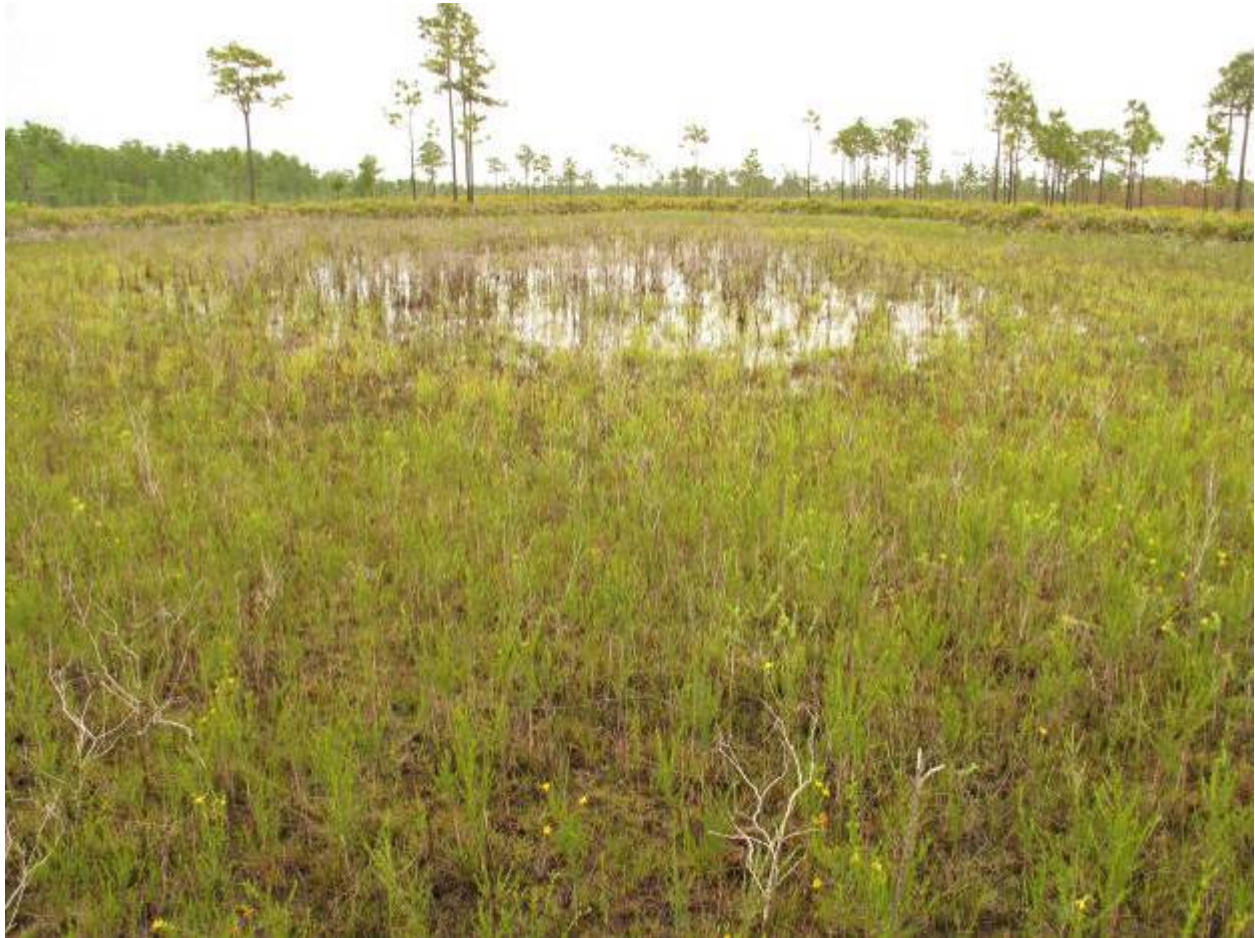
**Wetland ID: 28-20**

**Description:** This wetland is a 0.3 ha ephemeral marsh. There is no tree canopy or midstory cover. *Hypericum* is common within the wetland. A diverse array of herbaceous vegetation grows throughout the wetland, and covers >75% of the basin. There is evidence of cattle in the wetland, including tracks and feces. Small fish (may be *Gambusia*) were present on the day of our visit. The adjacent uplands are mesic flatwoods that are managed with prescribed fire.

**Wetland Concerns:** Cattle

**Restoration Action Recommended:** The uplands in this MU are in good ecological condition, although we have observed some cattle-related effects in both wetlands and uplands in some areas. We recommend removing cattle from this unit to prevent destruction of the intact flatwoods community and the embedded wetlands.

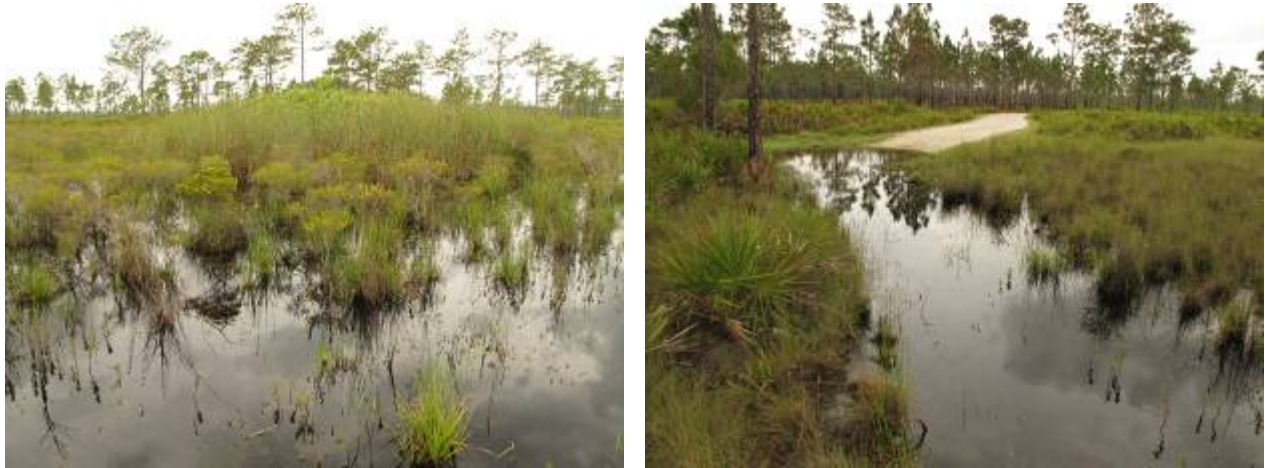
**Wetland ID: 28-21**

**Description:** This wetland is a 1.2 ha ephemeral marsh. It appears to be the north end of a long strand; the south end narrowly connects to the strand. There is no tree canopy or midstory cover. *Hypericum* is common in the wetland interior. Grasses/sedges grow throughout the wetland, and cover >75% of the basin. There is evidence of cattle in the wetland, including trails and feces. A ditch flows from the east side of the wetland basin. The adjacent uplands are mesic flatwoods that are managed with prescribed fire.

**Wetland Concerns:** Cattle, Ditching

**Restoration Action Recommended:** Fill the ditch on the east side of the wetland to restore the wetland's isolation. The uplands in this MU are in good ecological condition, although we have observed some cattle-related effects in both wetlands and uplands in some areas. We recommend removing cattle from this unit to prevent destruction of the intact flatwoods community and the embedded wetlands.

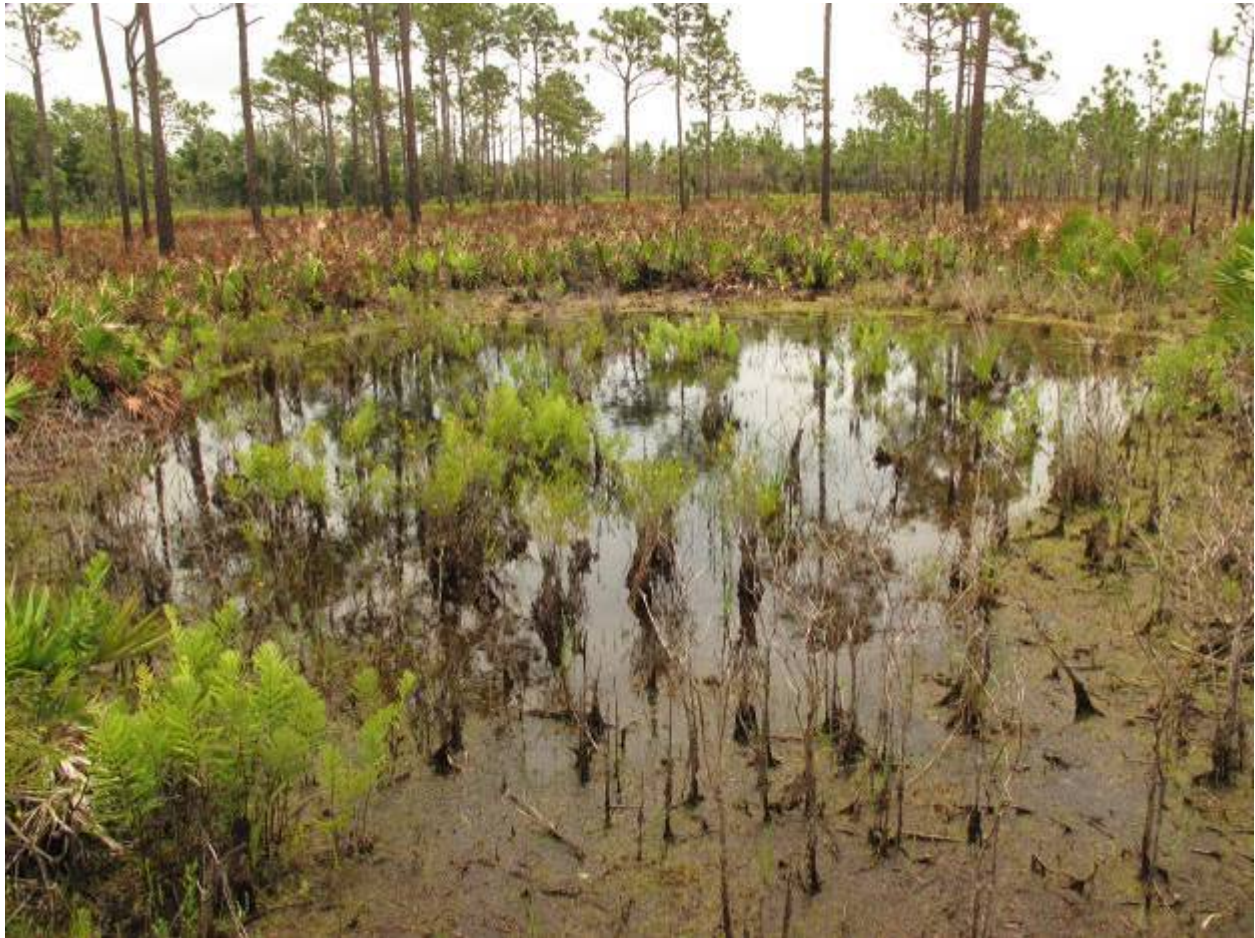
**Wetland ID: 28-22**

**Description:** This wetland is a <0.1 ha ephemeral marsh. There is no tree canopy or midstory cover. *Sphagnum* and sedges/grasses grow throughout the wetland, and cover >75% of the basin. There is evidence of cattle in the wetland, including tracks and feces. A recent fire burned to the wetland edges. The adjacent uplands are a mix of scrubby and mesic flatwoods that are managed with prescribed fire.

**Wetland Concerns:** Cattle

**Restoration Action Recommended:** The uplands in this MU are in good ecological condition, although we have observed some cattle-related effects in both wetlands and uplands in some areas. We recommend removing cattle from this unit to prevent destruction of the intact flatwoods community and the embedded wetlands.

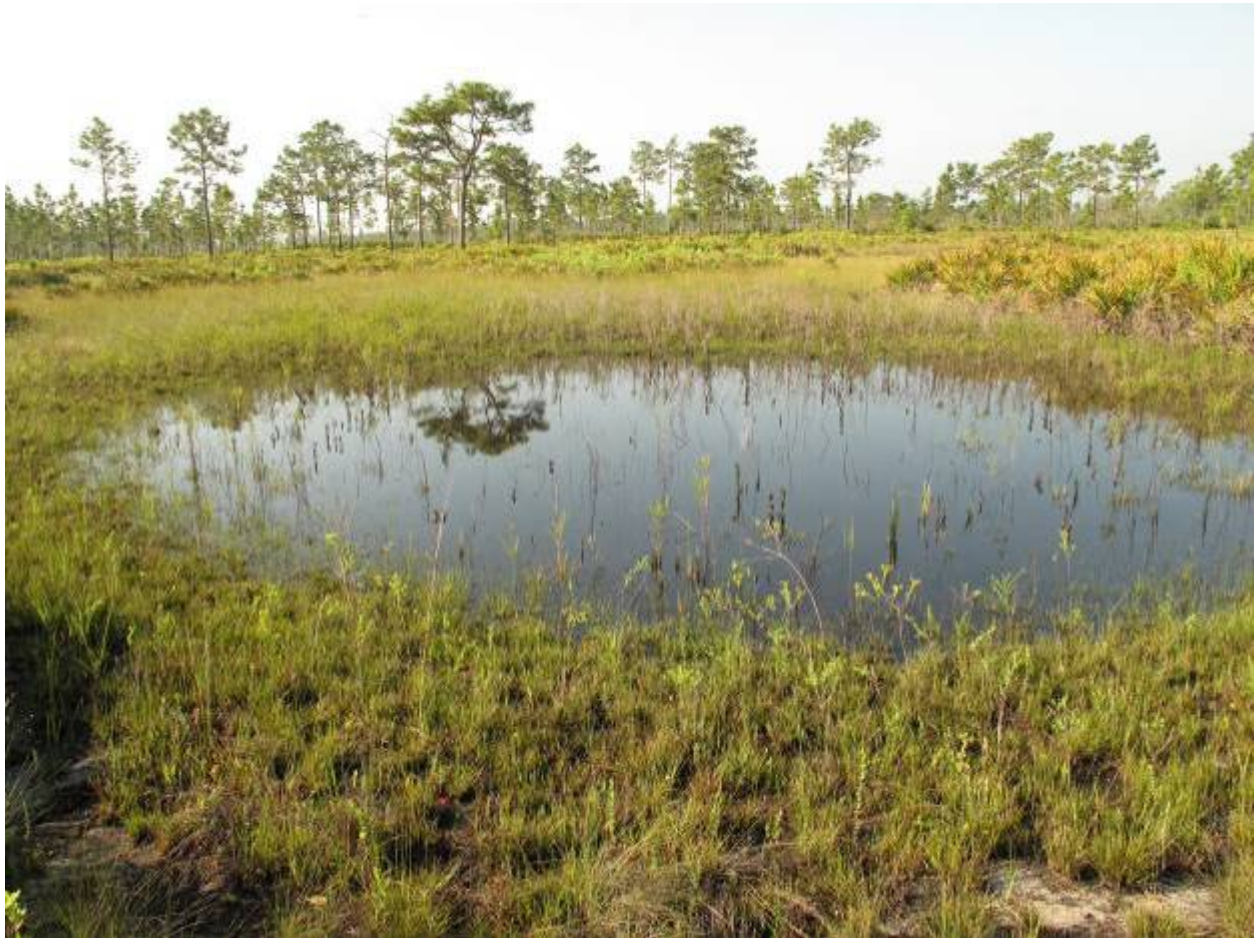
**Wetland ID: 29-01**

**Description:** This wetland is a <0.1 ha ephemeral marsh. There is no tree canopy or midstory cover. Sedges/grasses grow throughout the wetland, and cover >75% of the basin. The herbaceous vegetation is low-lying, possible from cattle grazing. There are cattle trails around the wetland edge. The adjacent uplands are mesic flatwoods that are managed with prescribed fire.

**Wetland Concerns:** Cattle

**Restoration Action Recommended:** The uplands in this MU are in good ecological condition, although we have observed some cattle-related effects in both wetlands and uplands in some areas. We recommend removing cattle from this unit to prevent destruction of the intact flatwoods community and the embedded wetlands.

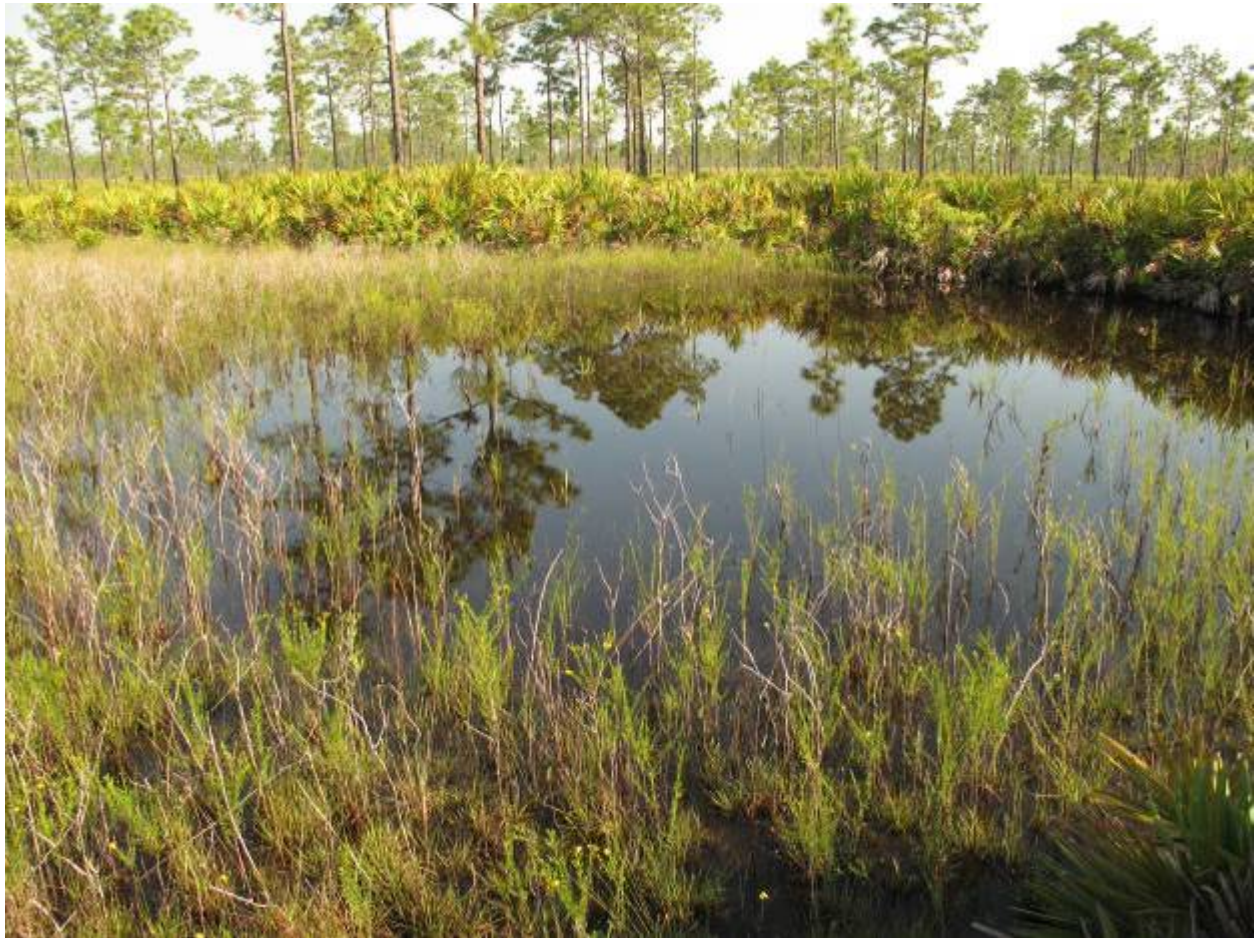
**Wetland ID: 29-02**

**Description:** This wetland is a <0.1 ha ephemeral marsh. There is no tree canopy or midstory cover. Sedges/grasses grow throughout the wetland, and cover >75% of the basin. There is a deeper hole in the northeast quadrant of the wetland. There is evidence of cattle around the wetland edge but the wetland appears to be very healthy. The adjacent uplands are mesic flatwoods that are managed with prescribed fire.

**Wetland Concerns:** Cattle

**Restoration Action Recommended:** The uplands in this MU are in good ecological condition, although we have observed some cattle-related effects in both wetlands and uplands in some areas. We recommend removing cattle from this unit to prevent destruction of the intact flatwoods community and the embedded wetlands.

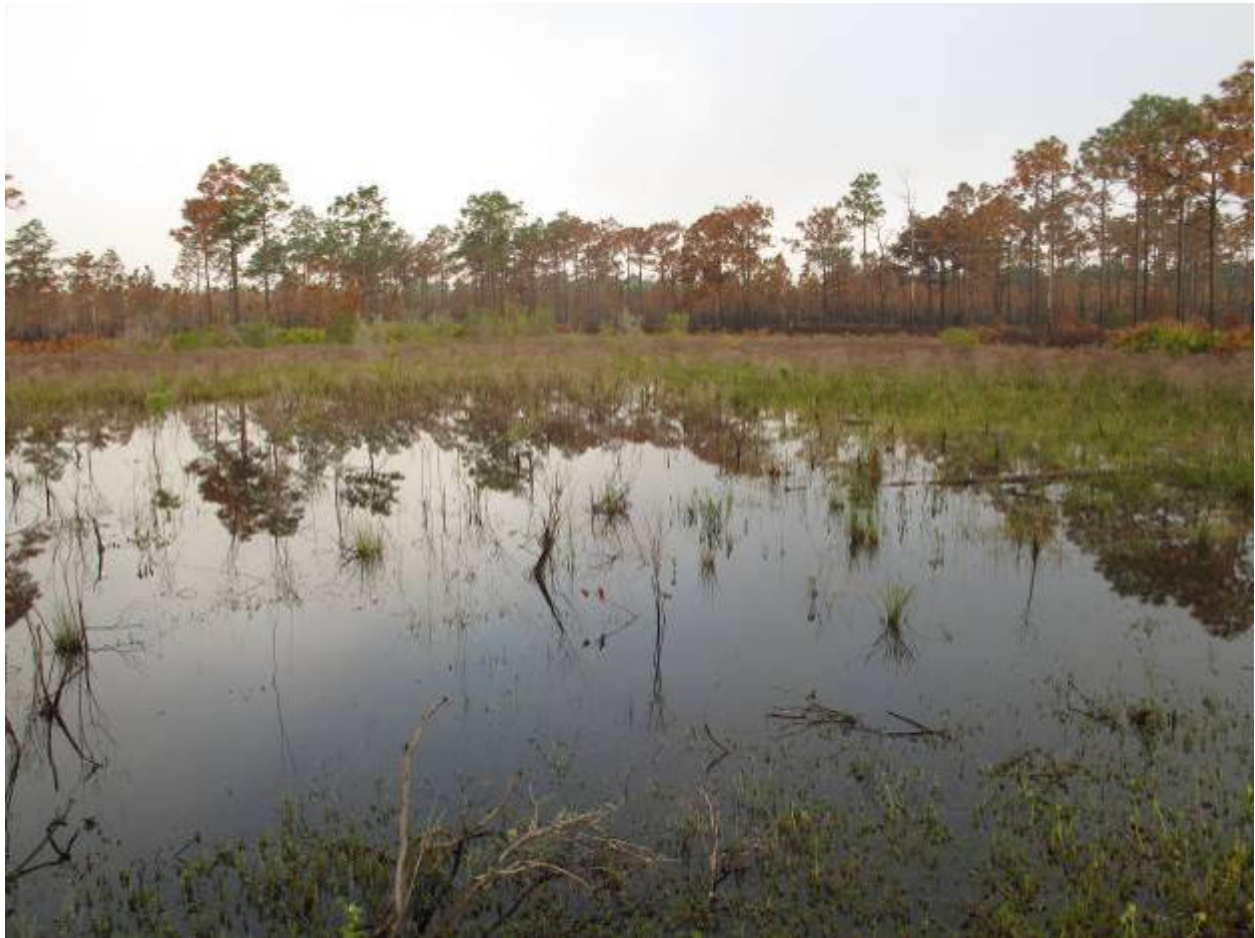
**Wetland ID: 30-01**

**Description:** This wetland is a 0.5 ha ephemeral marsh. There is no tree canopy or midstory cover. *Hypericum* is abundant within the wetland. A diverse array of herbaceous vegetation grows throughout the wetland, and covers >75% of the basin. A road/property boundary clips the east side of the wetland. A recent fire burned into the wetland edge. The adjacent uplands are mesic flatwoods that are managed with prescribed fire.

**Wetland Concerns:** Cattle, Road/Property boundary

**Restoration Action Recommended:** The uplands in this MU are in good ecological condition, although we have observed some cattle-related effects in both wetlands and uplands in some areas. We recommend removing cattle from this unit to prevent destruction of the intact flatwoods community and the embedded wetlands. The road does not appear to be negatively impacting the wetland and, given that it is a property boundary, we do not recommend any restoration action to address the road.

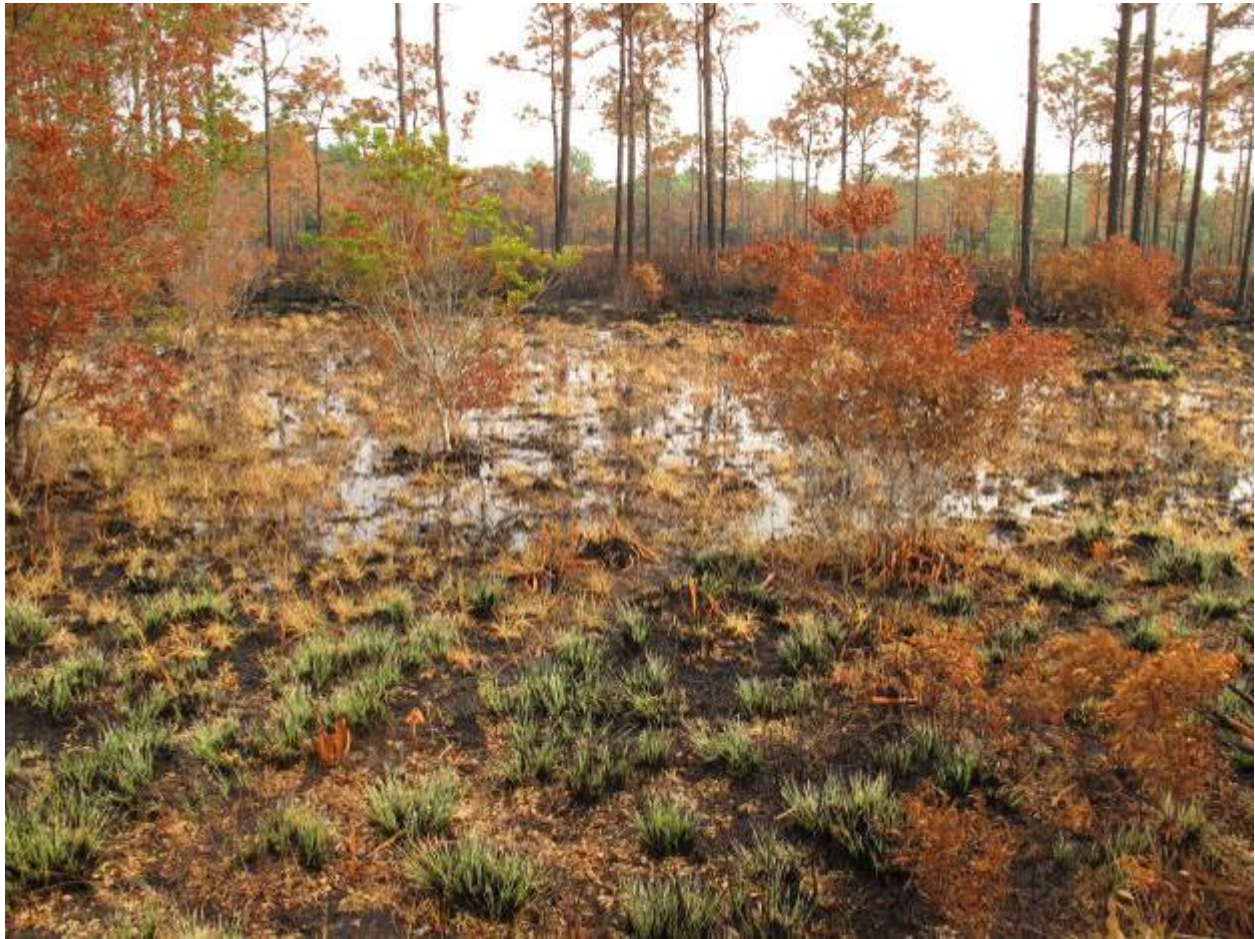
**Description:** This wetland is a 0.1 ha ephemeral marsh. A recent fire burned entirely through the wetland, and killed many encroaching wax myrtles. There is no tree canopy or midstory cover. Sedges/grasses grow throughout the wetland, and new post-fire growth is emerging. There is evidence of cattle in the wetland, including trails and feces. The adjacent uplands are mesic flatwoods that are managed with prescribed fire.

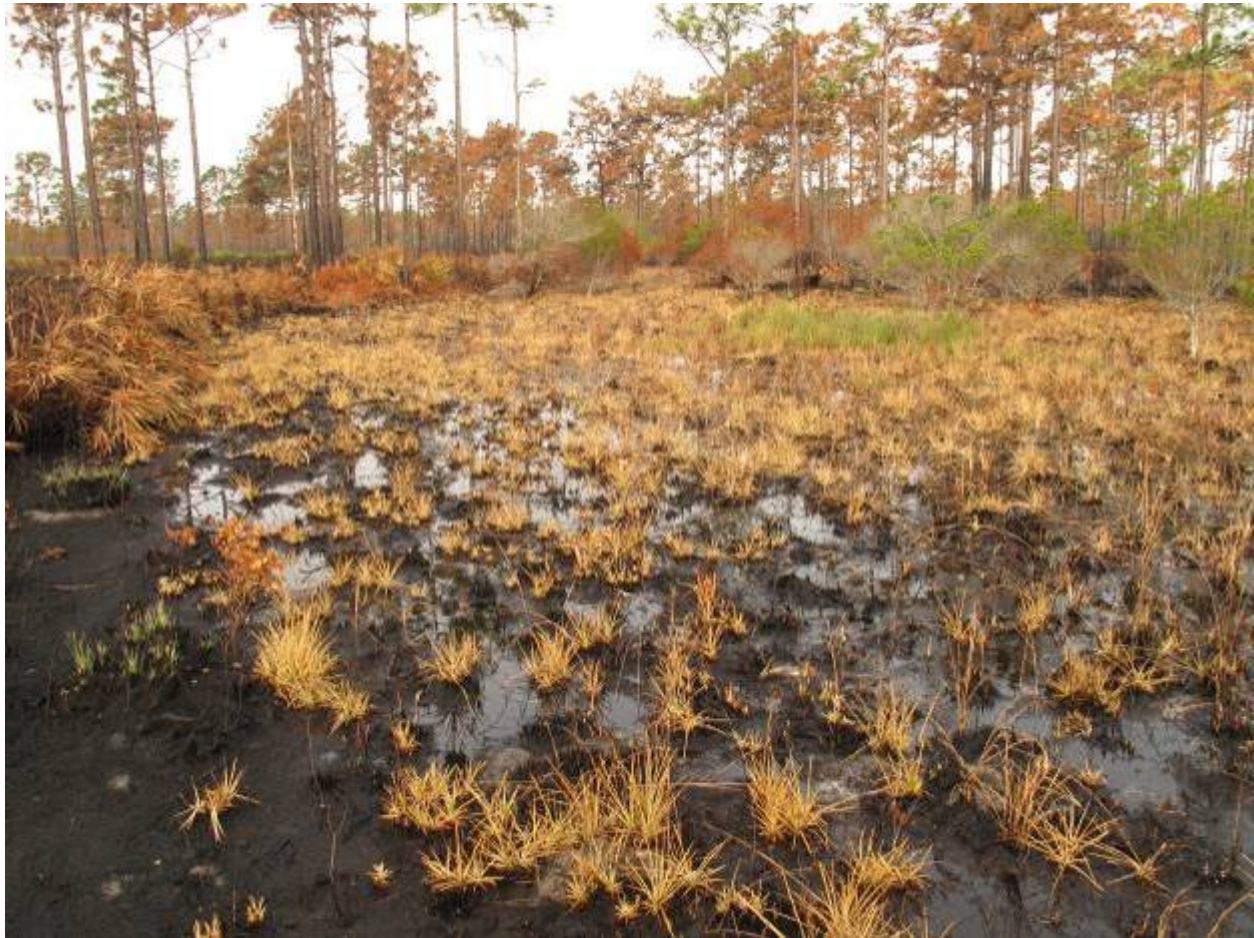
**Wetland ID: 30-03**

**Description:** This wetland is a 0.1 ha ephemeral marsh. A recent fire burned through the entire wetland basin. There is no tree canopy. Wax myrtle grow scattered throughout the wetland basin, the recent fire killed a few of the shrubs. Sedges/grasses grow throughout the wetland, and new post-fire growth is emerging.. There are cattle trails in the wetland. The adjacent uplands are mesic flatwoods that are managed with prescribed fire.

**Wetland Concerns:** Cattle

**Restoration Action Recommended:** The uplands in this MU are in good ecological condition, although we have observed some cattle-related effects in both wetlands and uplands in some areas. We recommend removing cattle from this unit to prevent destruction of the intact flatwoods community and the embedded wetlands.

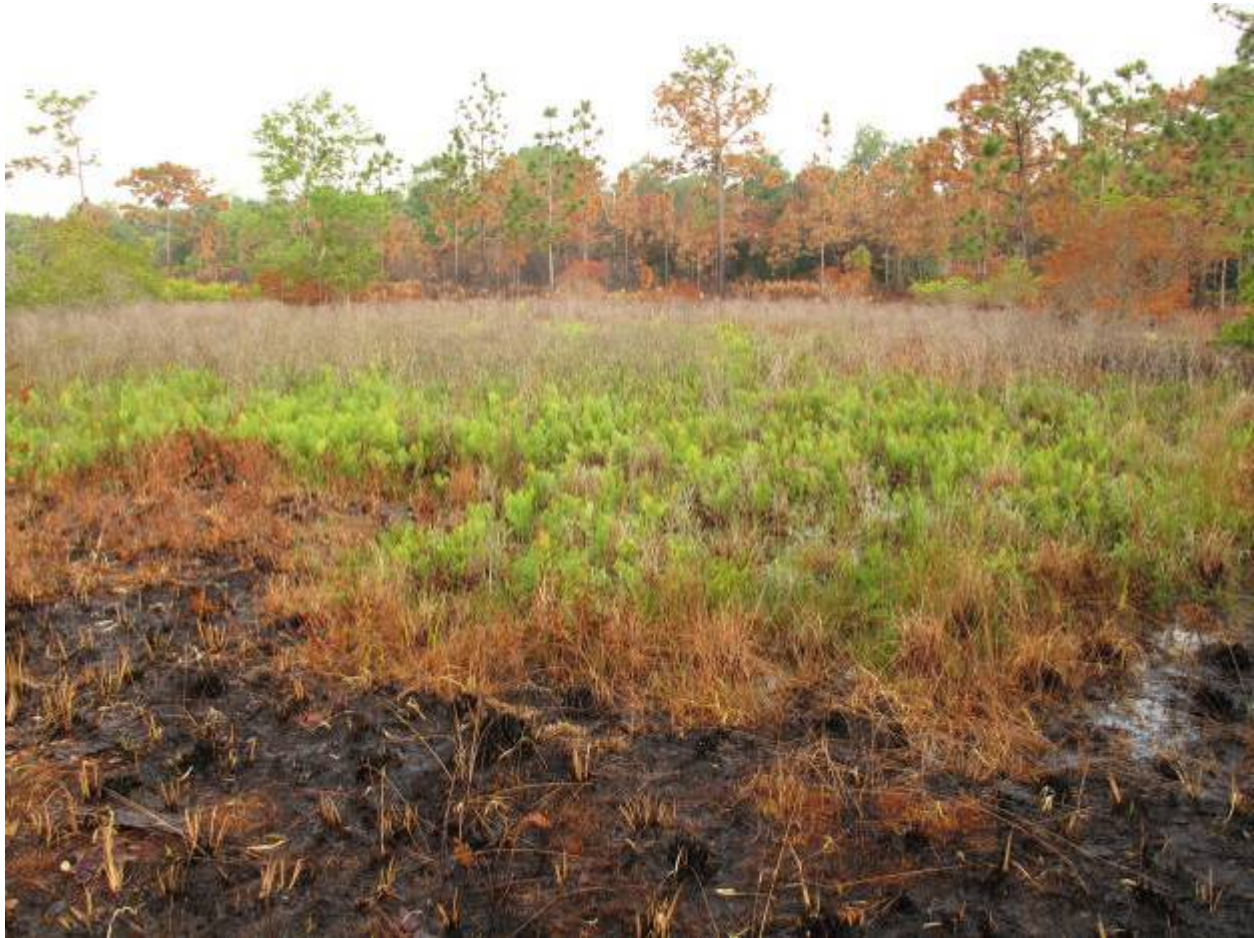
**Wetland ID: 30-04**

**Description:** This wetland is a 0.1 ha ephemeral marsh. There is no tree canopy or midstory cover. *Hypericum* and wax myrtle grow in a ring around the wetland edge. Sedges/grasses, fern, and *Sphagnum* grows throughout the wetland. The herbaceous vegetation covers >75% of the basin. A recent fire burned to the wetland edge. Old feral hog damage has eroded and now is covered with vegetation. Cattle trails and feces are present along the wetland edge. The adjacent uplands are mesic flatwoods that are managed with prescribed fire.

**Wetland Concerns:** Feral hog damage, Cattle

**Restoration Action Recommended:** The uplands in this MU are in good ecological condition, although we have observed some cattle-related effects in both wetlands and uplands in some areas. We recommend removing cattle from this unit to prevent destruction of the intact flatwoods community and the embedded wetlands.

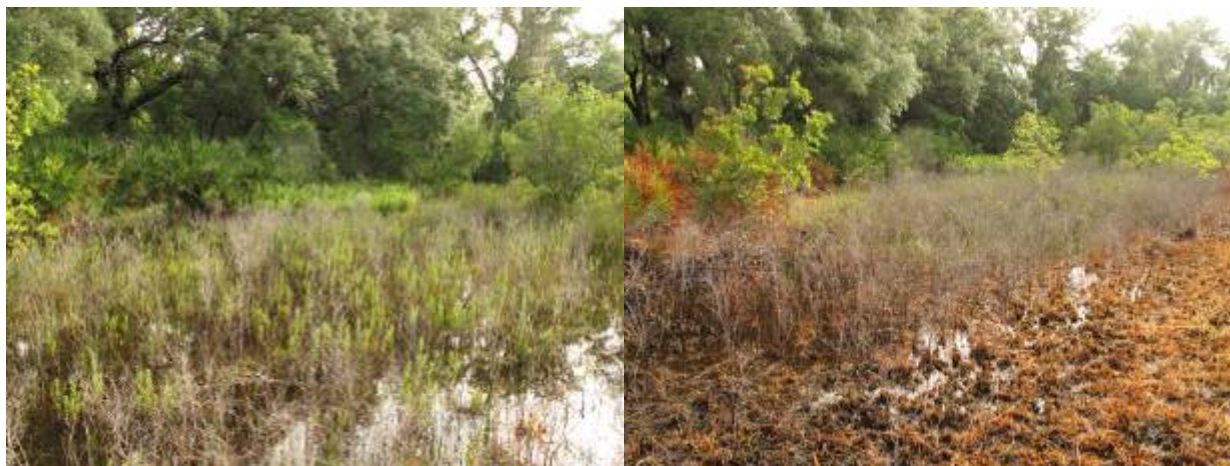
**Wetland ID: 30-05**

**Description:** This wetland is a <0.1 ha ephemeral marsh. There is no tree canopy. Wax myrtle are scattered throughout the wetland, and cover 5-25% of the basin. Sedges/grasses grow throughout the wetland, and cover >75% of the basin. A recent fire burned through the south and east side of the wetland. There are cattle feces and a cattle trail along the wetland edge. The wetland is situated adjacent to a hardwood hammock that is associated with a creek to the north. The adjacent uplands are mesic flatwoods that are managed with prescribed fire.

**Wetland Concerns:** Cattle

**Restoration Action Recommended:** Frequent fire will manage the wax myrtle that is beginning to encroach. The uplands in this MU are in good ecological condition, although we have observed some cattle-related effects in both wetlands and uplands in some areas. We recommend removing cattle from this unit to prevent destruction of the intact flatwoods community and the embedded wetlands.

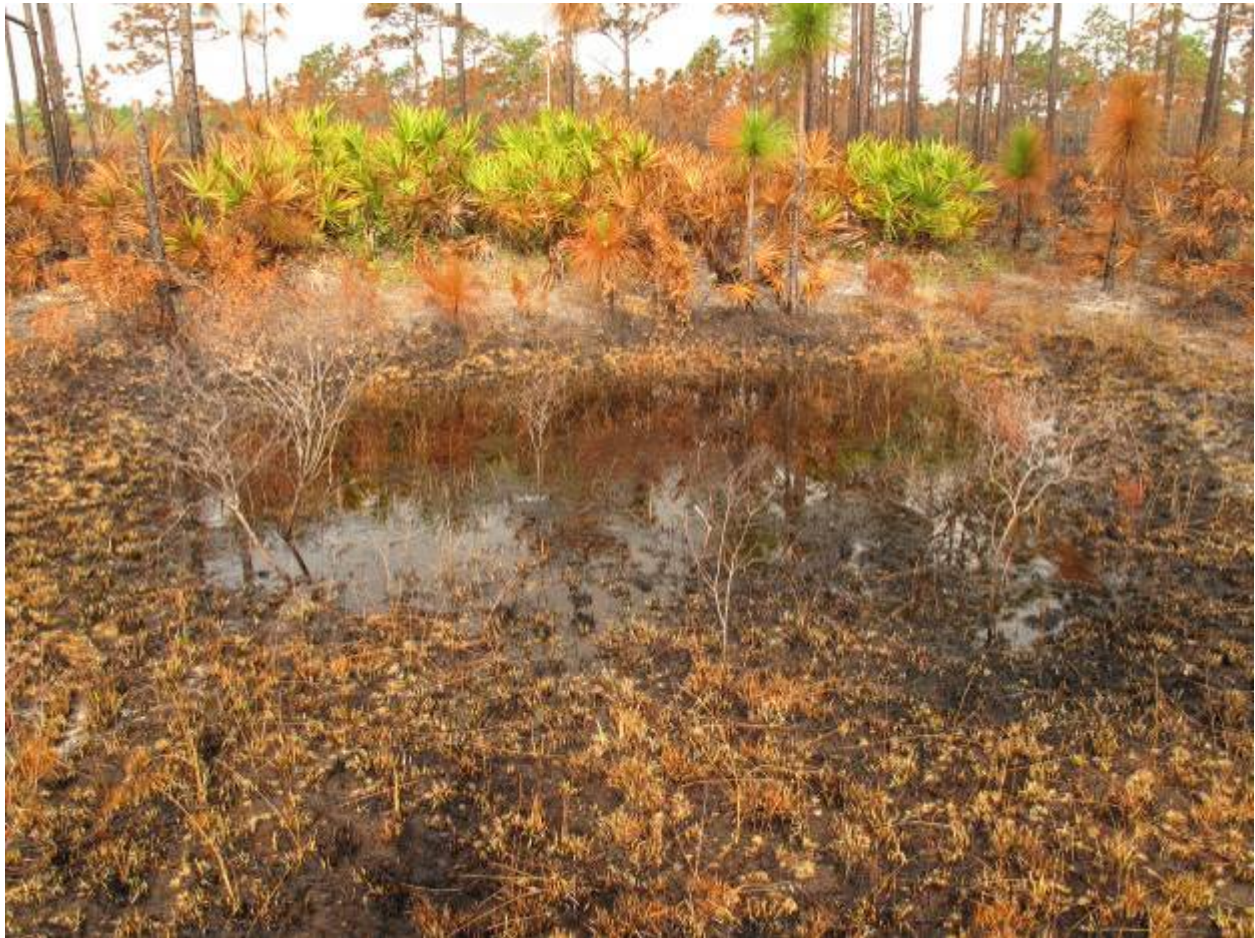
**Wetland ID: 30-06**

**Description:** This wetland is a 0.1 ha ephemeral marsh. This circular pond could be an old dug-out feature that is now functioning as an ephemeral wetland. A recent fire burned entirely through the wetland. There is no tree canopy or midstory cover. Sedges/grasses grow throughout the wetland, and new post-fire growth is emerging. The adjacent uplands are mesic flatwoods that are managed with prescribed fire.

**Wetland Concerns:** None

**Restoration Action Recommended:** The uplands in this MU are in good ecological condition, although we have observed some cattle-related effects in both wetlands and uplands in some areas. We recommend removing cattle from this unit to prevent destruction of the intact flatwoods community and the embedded wetlands.

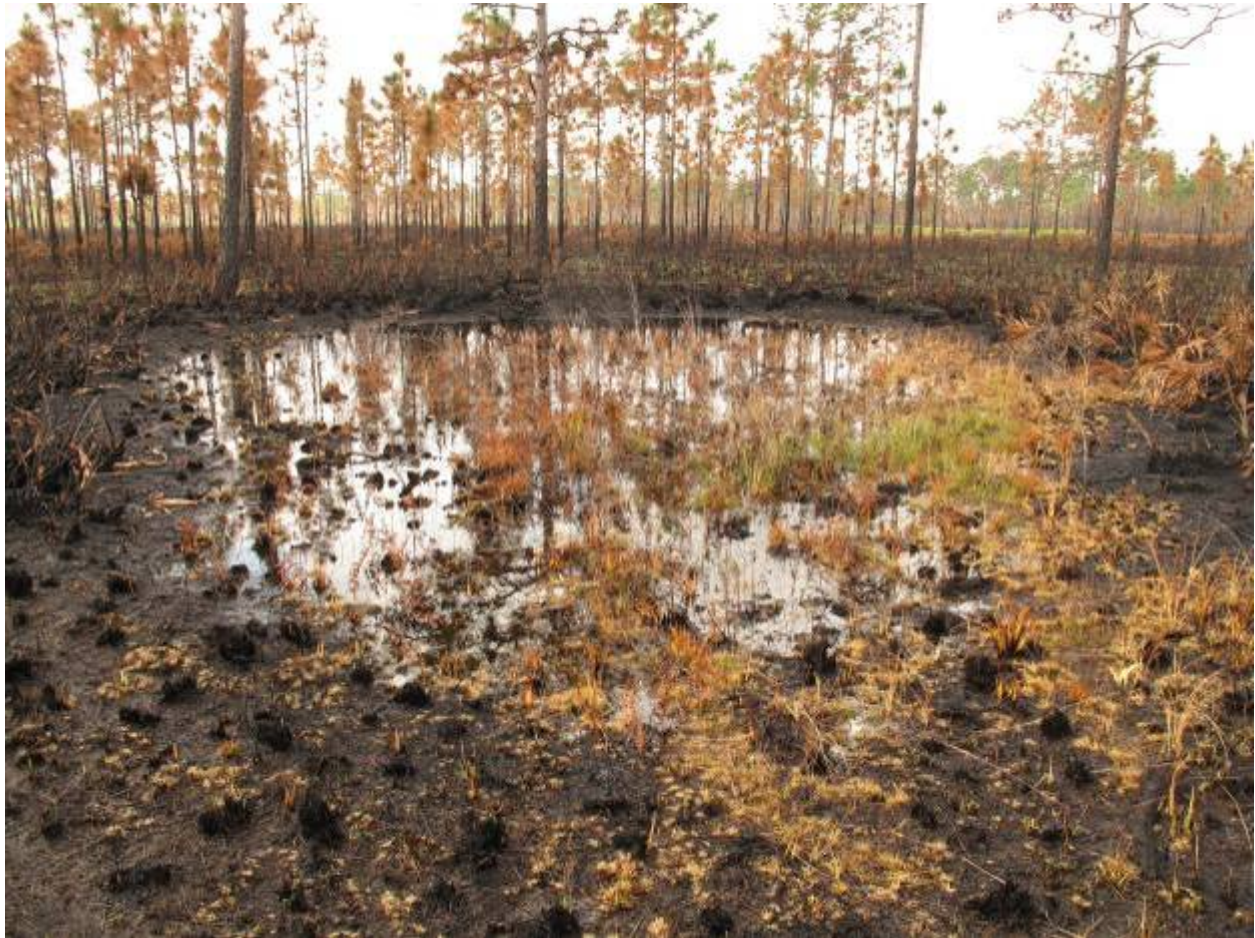
**Wetland ID: 30-07**

**Description:** This wetland is a <0.1 ha ephemeral marsh. A recent fire burned completely through the wetland basin. There is no tree canopy or midstory cover. A diverse array of herbaceous vegetation grows throughout, and new post-fire growth is emerging. A cattle trail leads into the wetland from the north side. The adjacent uplands are mesic flatwoods that are managed with prescribed fire.

**Wetland Concerns:** Cattle

**Restoration Action Recommended:** The uplands in this MU are in good ecological condition, although we have observed some cattle-related effects in both wetlands and uplands in some areas. We recommend removing cattle from this unit to prevent destruction of the intact flatwoods community and the embedded wetlands.
