# **Inventory, Assessment, and Restoration Potential of Ephemeral Wetlands on FFWCC Wildlife Management Areas**

## **Triple N Ranch WMA Final Report**

Submitted by: Rebecca P.M. Means<sup>1</sup>, Ryan C. Means<sup>1</sup>, Steven A. Johnson<sup>2</sup>

15 May 2010 – 15 August 2010

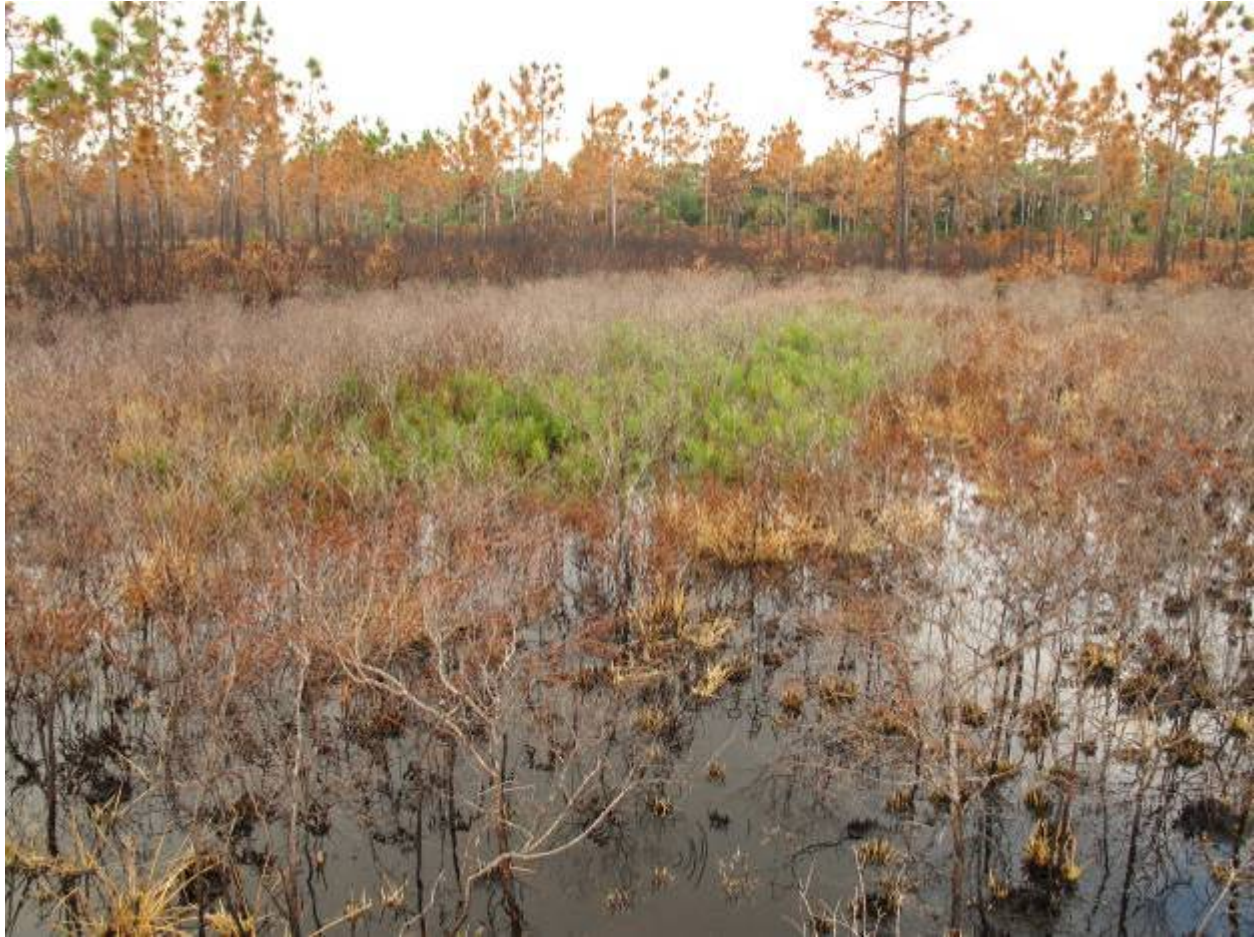
**Wetland ID: 30-08**

**Description:** This wetland is a 0.1 ha ephemeral marsh. A recent fire burned well into the wetland interior. There is no tree canopy or midstory cover. *Hypericum* is abundant within the wetland. A diverse array of herbaceous vegetation grows throughout and there is a patch of fern growing in the wetland center. New post-fire herbaceous growth is emerging. Cattle trails are present around the wetland edges. The adjacent uplands are mesic flatwoods that are managed with prescribed fire.

**Wetland Concerns:** Cattle

**Restoration Action Recommended:** The uplands in this MU are in good ecological condition, although we have observed some cattle-related effects in both wetlands and uplands in some areas. We recommend removing cattle from this unit to prevent destruction of the intact flatwoods community and the embedded wetlands.

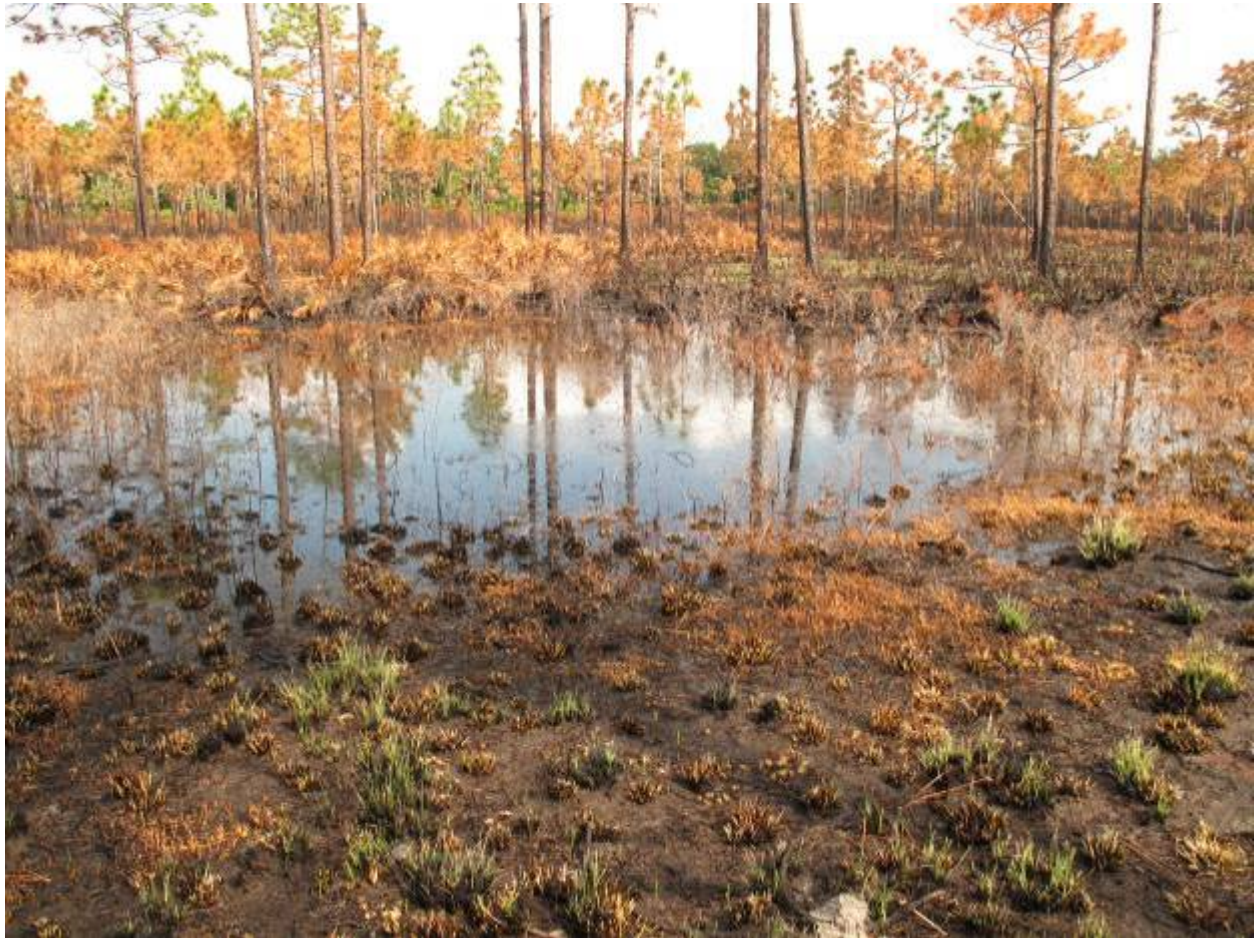
**Wetland ID: 30-09**

**Description:** This wetland is a <0.1 ha ephemeral marsh. A recent fire burned completely through the wetland basin. There is no tree canopy or midstory cover. Sedges/grasses and other herbaceous vegetation grows throughout the wetland, and new post-fire growth is emerging. A cattle trail is present along the eastern edge of the wetland. The adjacent uplands are mesic flatwoods that are managed with prescribed fire.

**Wetland Concerns:** Cattle

**Restoration Action Recommended:** The uplands in this MU are in good ecological condition, although we have observed some cattle-related effects in both wetlands and uplands in some areas. We recommend removing cattle from this unit to prevent destruction of the intact flatwoods community and the embedded wetlands.

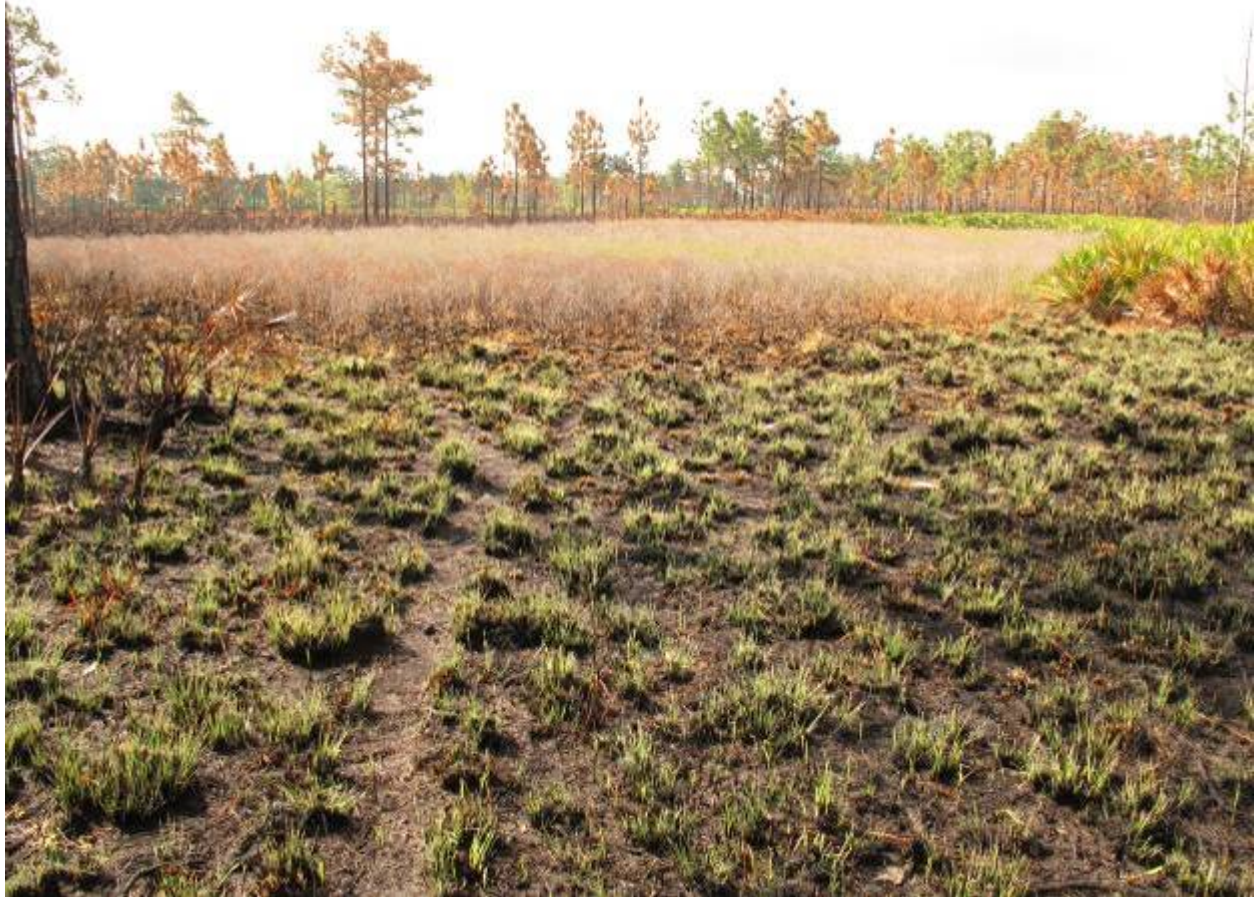
**Wetland ID: 30-10**

**Description:** This wetland is a 0.2 ha ephemeral marsh. A recent fire burned through about 40% of the basin, particularly on the north and east sides. There is no tree canopy or midstory cover. A diverse array of *Hypericum* and herbaceous vegetation grows throughout, and new post-fire growth is emerging. A cattle trail along the northern edge connects this wetland with 30-09. The adjacent uplands are mesic flatwoods that are managed with prescribed fire.

**Wetland Concerns:** Cattle

**Restoration Action Recommended:** The uplands in this MU are in good ecological condition, although we have observed some cattle-related effects in both wetlands and uplands in some areas. We recommend removing cattle from this unit to prevent destruction of the intact flatwoods community and the embedded wetlands.

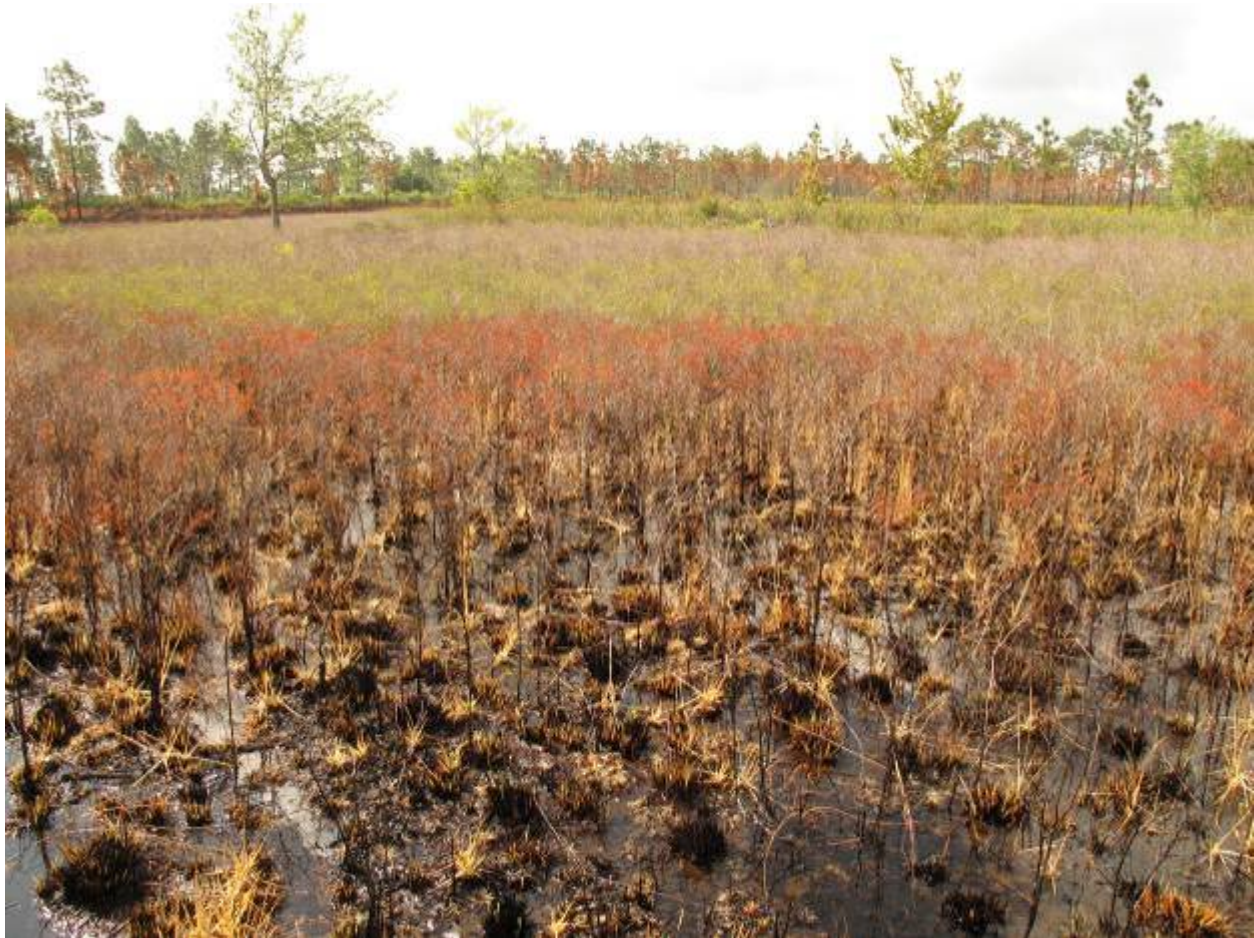
**Wetland ID: 30-11**

**Description:** This wetland is a 0.8 ha semi-permanent marsh. A recent fire burned through 30-40% of the basin. There is no tree canopy or midstory cover. *Hypericum* grows in a ring around the wetland center. Sawgrass grows in the wetland interior, and sedges/grasses grow around the wetland edge. The herbaceous vegetation covers >75% of the wetland. There is some evidence of cattle present in the wetland. The adjacent uplands are mesic flatwoods that are managed with prescribed fire.

**Wetland Concerns:** Cattle

**Restoration Action Recommended:** The uplands in this MU are in good ecological condition, although we have observed some cattle-related effects in both wetlands and uplands in some areas. We recommend removing cattle from this unit to prevent destruction of the intact flatwoods community and the embedded wetlands.

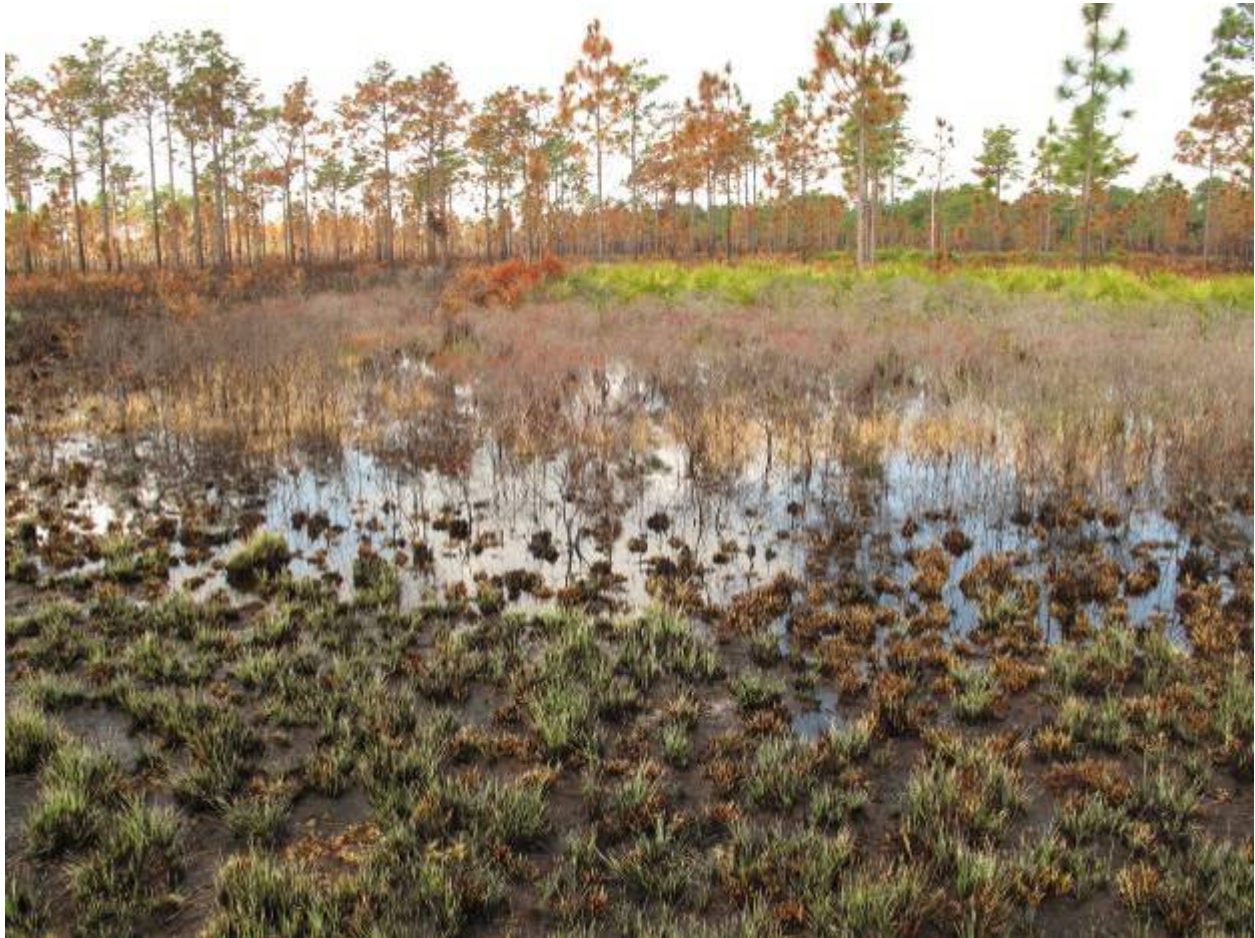
**Wetland ID: 30-12**

**Description:** This wetland is a <0.1 ha ephemeral marsh. A recent fire burned completely through the wetland basin. There is no tree canopy or midstory cover. A diverse array of herbaceous vegetation grows throughout, and new post-fire growth is emerging. A cattle trail is present around the eastern half of the wetland. The adjacent uplands are mesic flatwoods that are managed with prescribed fire.

**Wetland Concerns:** Cattle

**Restoration Action Recommended:** The uplands in this MU are in good ecological condition, although we have observed some cattle-related effects in both wetlands and uplands in some areas. We recommend removing cattle from this unit to prevent destruction of the intact flatwoods community and the embedded wetlands.

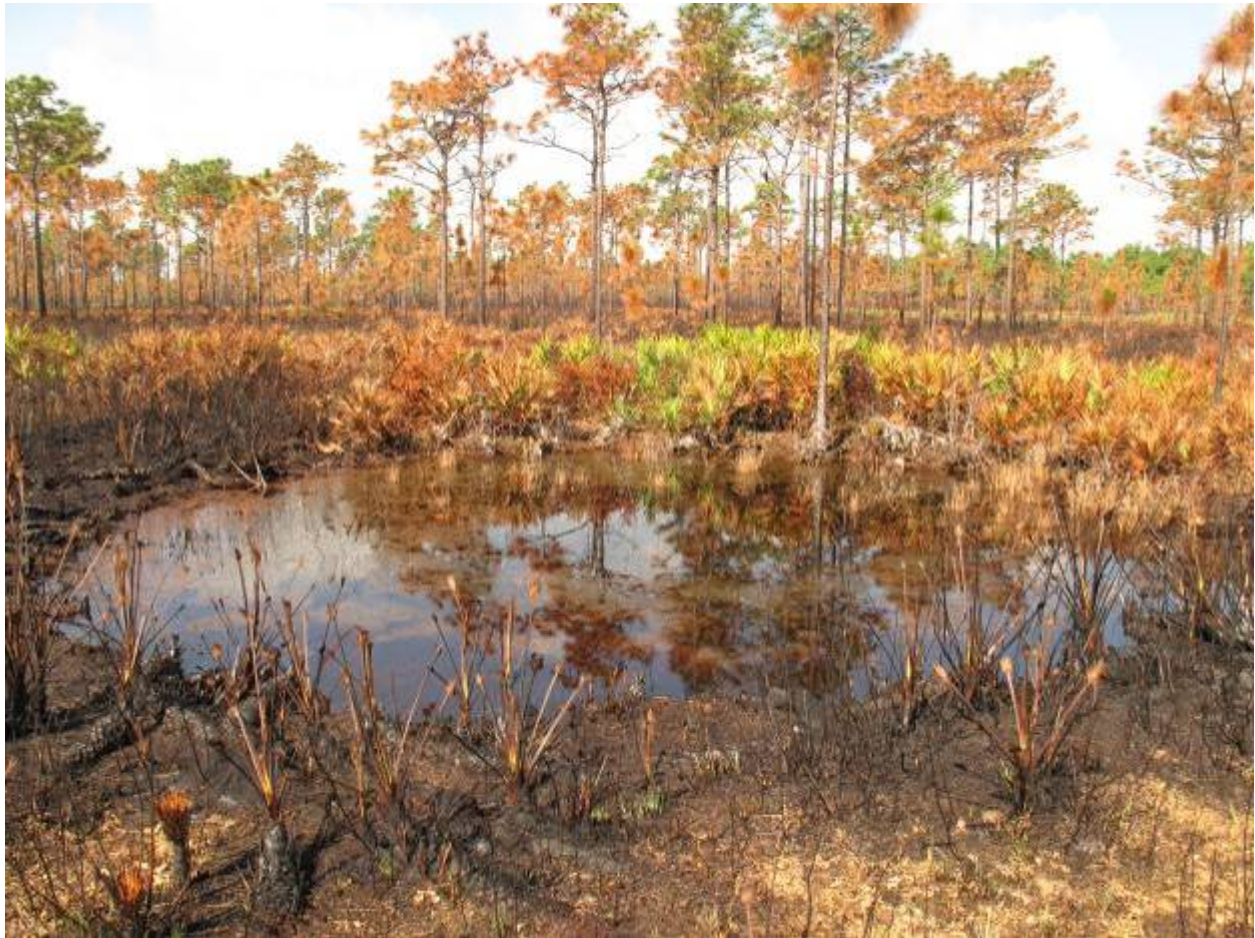
**Wetland ID: 30-13**

**Description:** This wetland is a <0.1 ha ephemeral marsh. A recent fire burned completely through the wetland basin. There is no tree canopy or midstory cover. Due to the recent fire, *Sphagnum* grows in scattered patches, and the herbaceous vegetation only covers 25-50% of the basin. No evidence of cattle was observed in the wetland, although cattle are allowed in this MU. The adjacent uplands are mesic flatwoods that are managed with prescribed fire.

**Wetland Concerns:** None

**Restoration Action Recommended:** The uplands in this MU are in good ecological condition, although we have observed some cattle-related effects in both wetlands and uplands in some areas. We recommend removing cattle from this unit to prevent destruction of the intact flatwoods community and the embedded wetlands.

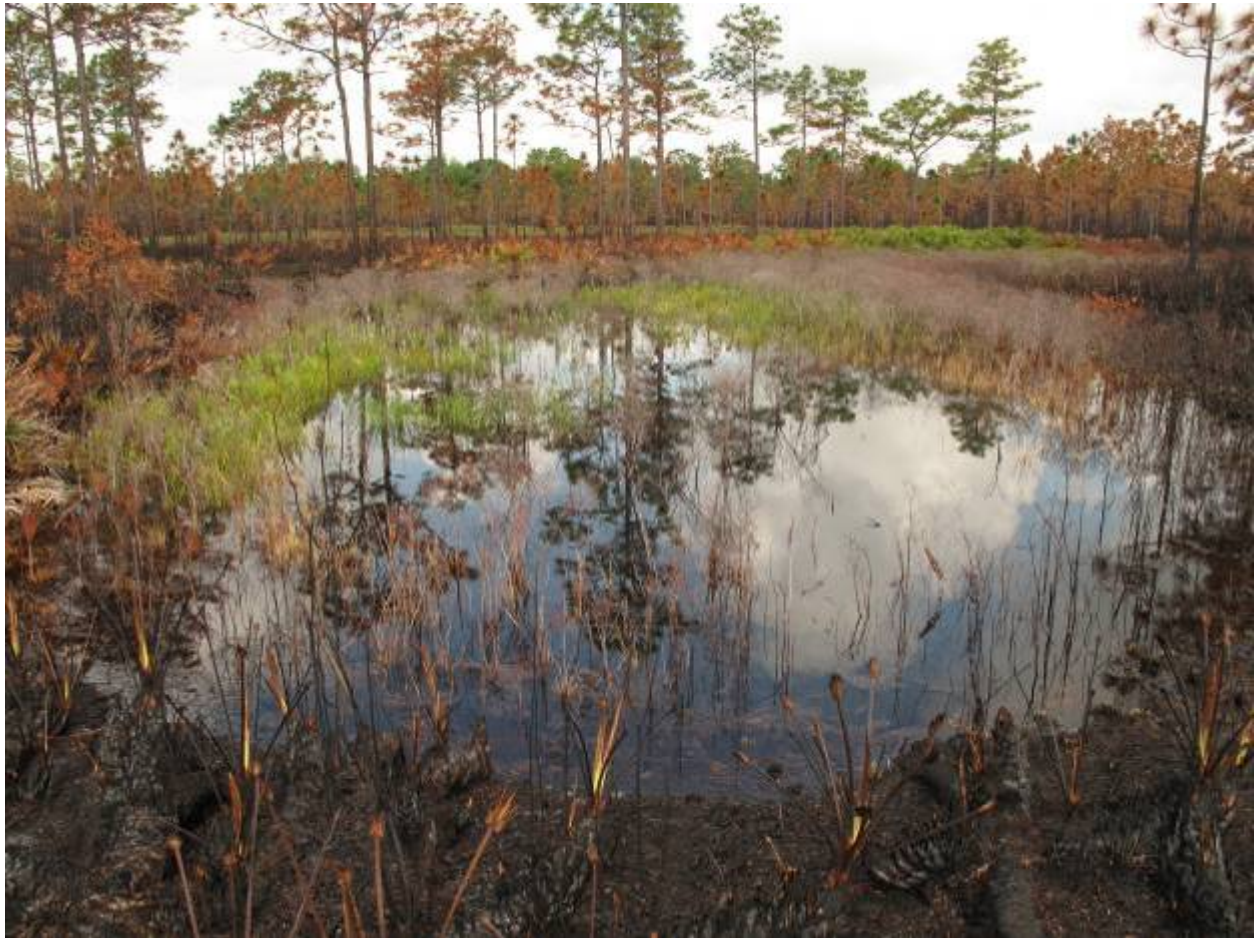
**Wetland ID: 30-14**

**Description:** This wetland is a 0.1 ha ephemeral marsh. A recent fire burned through 60% of the basin, on the north and east sides. There is no tree canopy or midstory cover. A diverse array of *Hypericum* and herbaceous vegetation grows throughout the wetland. This elongated marsh has deeper potholes in both ends. Small fish were present on the day of our visit. No evidence of cattle was observed in the wetland, although cattle are allowed in this MU. The adjacent uplands are mesic flatwoods that are managed with prescribed fire.

**Wetland Concerns:** None

**Restoration Action Recommended:** The uplands in this MU are in good ecological condition, although we have observed some cattle-related effects in both wetlands and uplands in some areas. We recommend removing cattle from this unit to prevent destruction of the intact flatwoods community and the embedded wetlands.

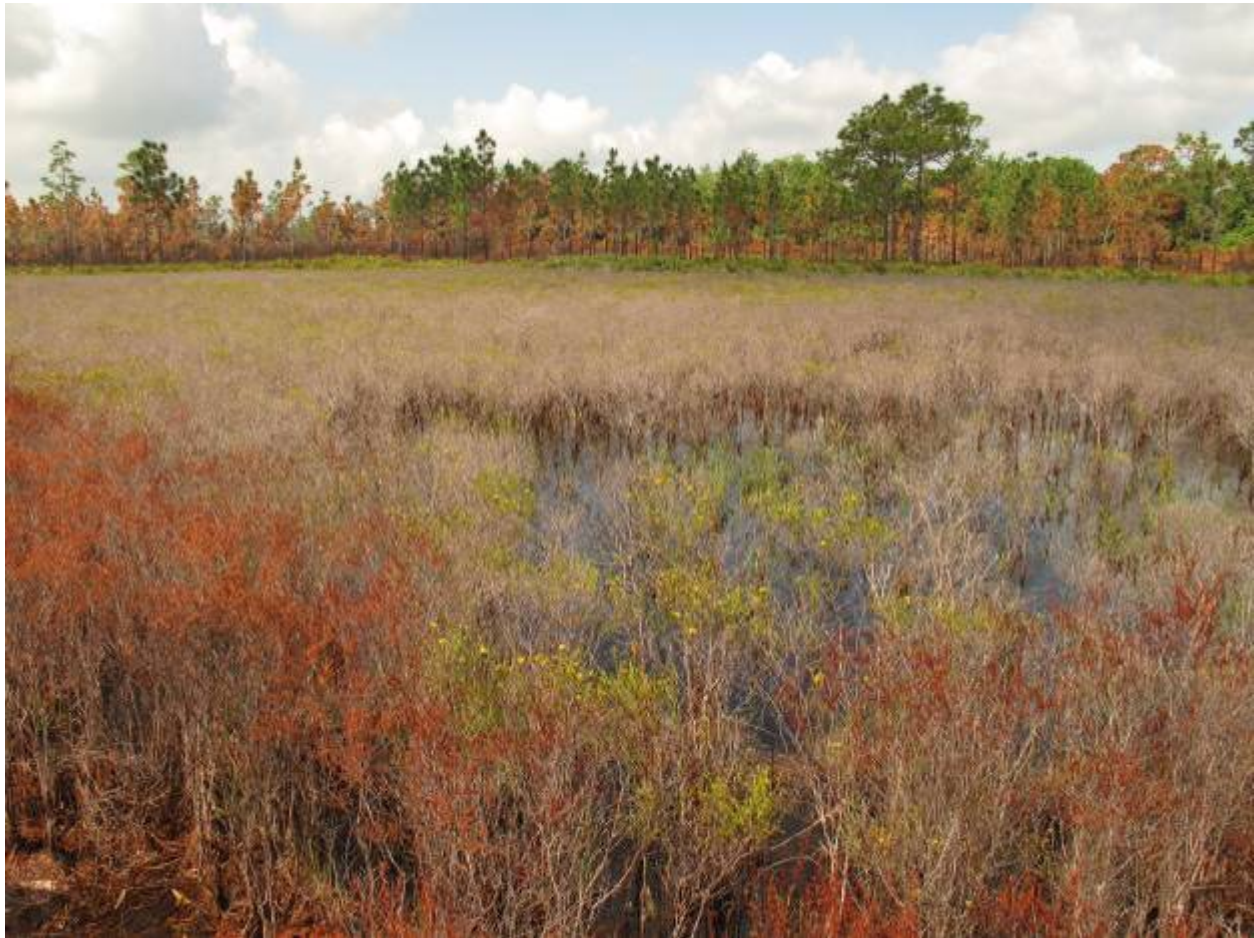
**Wetland ID: 30-15**

**Description:** This wetland is a 0.4 ha ephemeral marsh. There is no tree canopy or midstory cover. A recent fire burned through the wetland edges. *Hypericum* is common within the wetland. A diverse array of sedges/grasses and other herbaceous vegetation grows throughout the wetland, and covers >75% of the basin. Small fish, likely *Gambusia*, were present on the day of our visit. A small cattle trail runs along the eastern side of the wetland. The adjacent uplands are mesic flatwoods that are managed with prescribed fire.

**Wetland Concerns:** Cattle

**Restoration Action Recommended:** The uplands in this MU are in good ecological condition, although we have observed some cattle-related effects in both wetlands and uplands in some areas. We recommend removing cattle from this unit to prevent destruction of the intact flatwoods community and the embedded wetlands.

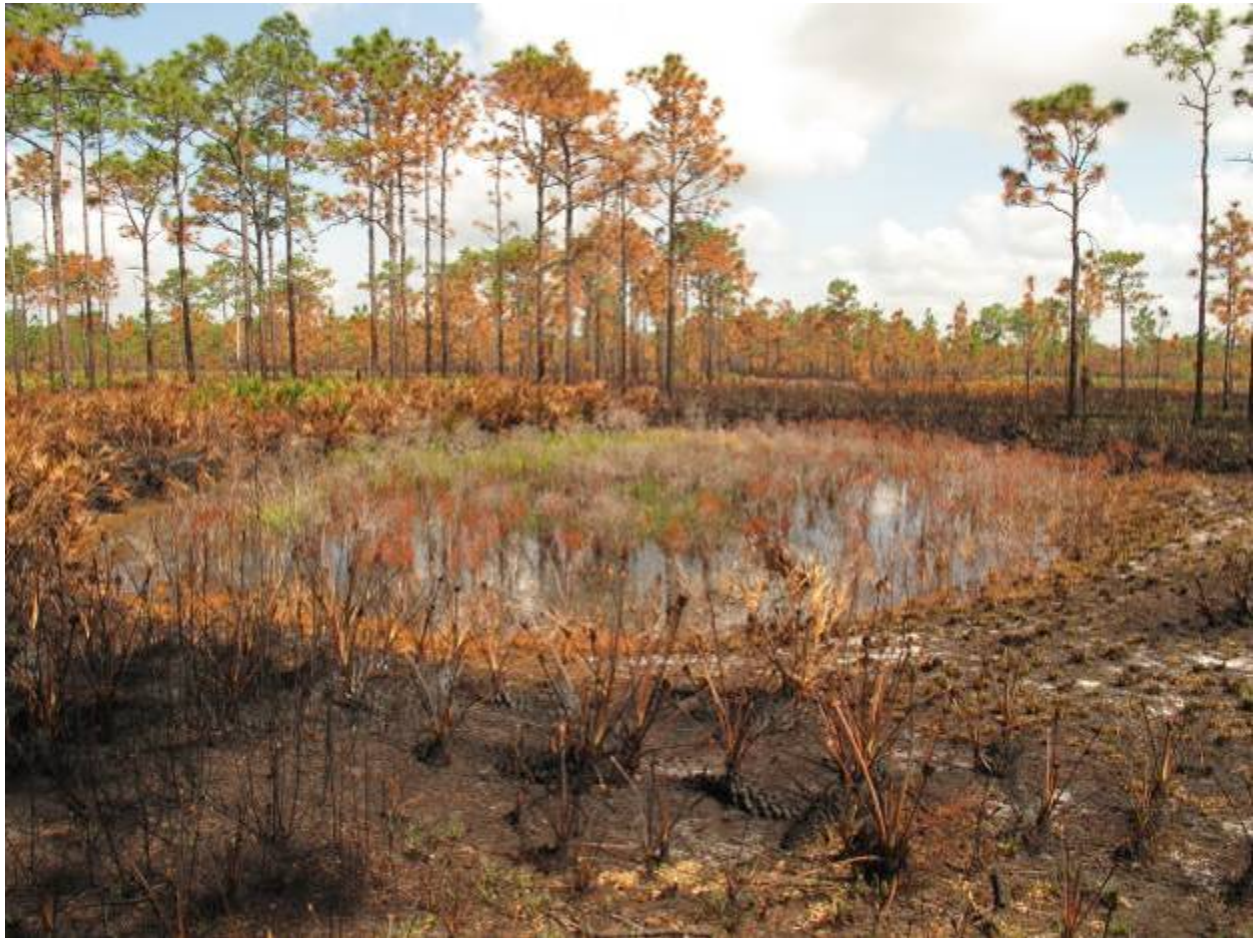
**Wetland ID: 30-16**

**Description:** This wetland is a <0.1 ha ephemeral marsh. A recent fire burned halfway through the wetland basin, but did not quite reach the wetland center. There is no tree canopy or midstory cover. *Hypericum* is common in the wetland. A diverse array of *Sphagnum*, sedges/grasses, and other herbaceous vegetation grows throughout the wetland, and covers >75% of the basin. Small fish, likely *Gambusia*, were present on the day of our visit. Cattle trails lead into the basin edge from multiple directions of the uplands. The adjacent uplands are mesic flatwoods that are managed with prescribed fire.

**Wetland Concerns:** Cattle

**Restoration Action Recommended:** The uplands in this MU are in good ecological condition, although we have observed some cattle-related effects in both wetlands and uplands in some areas. We recommend removing cattle from this unit to prevent destruction of the intact flatwoods community and the embedded wetlands.

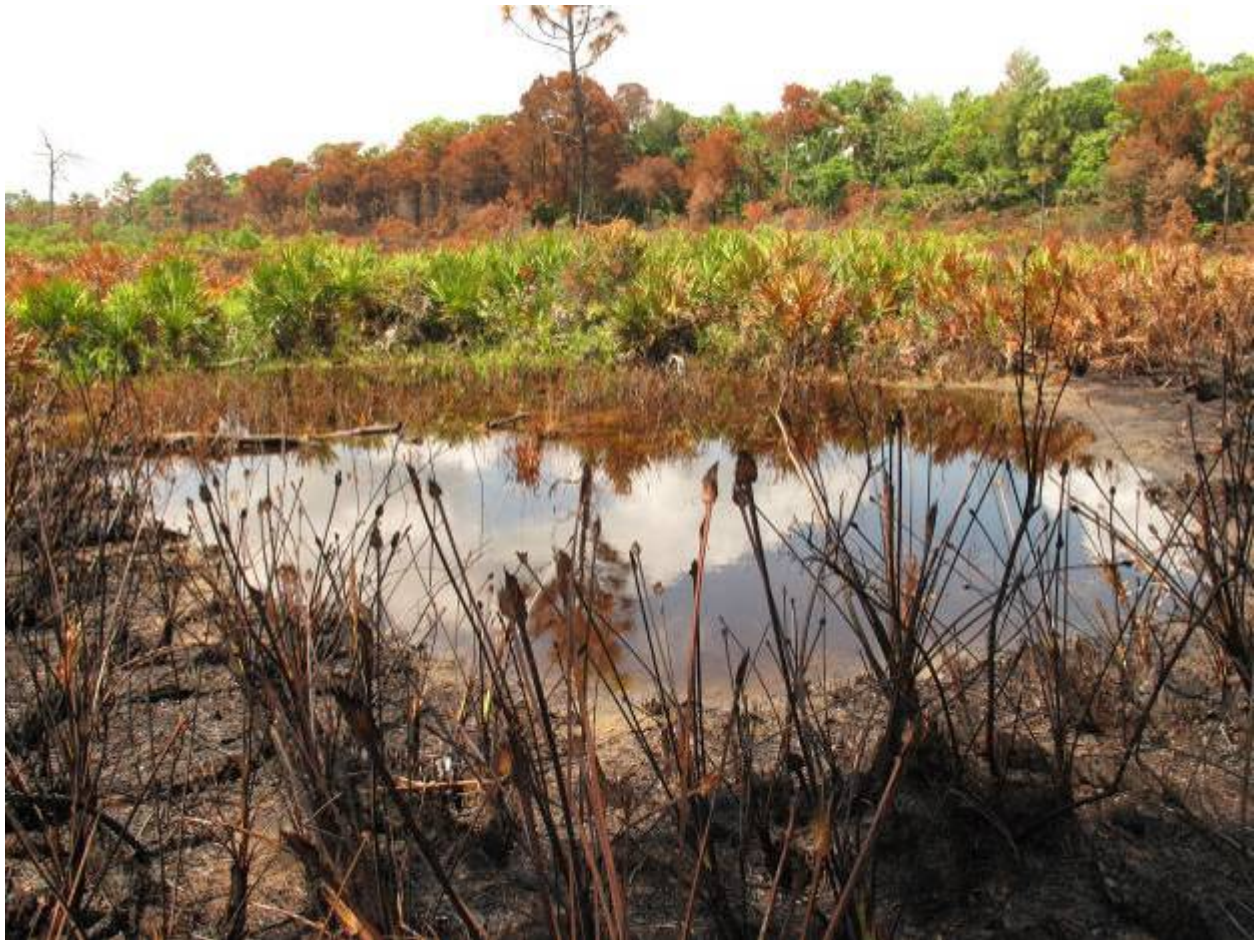
**Description:** This wetland is a <0.1 ha ephemeral marsh. There is no tree canopy or midstory cover. The herbaceous vegetation is dominated by *Sphagnum*, and covers >75% of the basin. A recent fire burned through the majority of the wetland basin. No evidence of cattle was observed in the wetland, although cattle are allowed in this MU. The wetland is surrounded by a dense palmetto ring, although 2/3 of the palmetto was burned in the recent fire. The adjacent uplands are mesic flatwoods that are managed with prescribed fire.

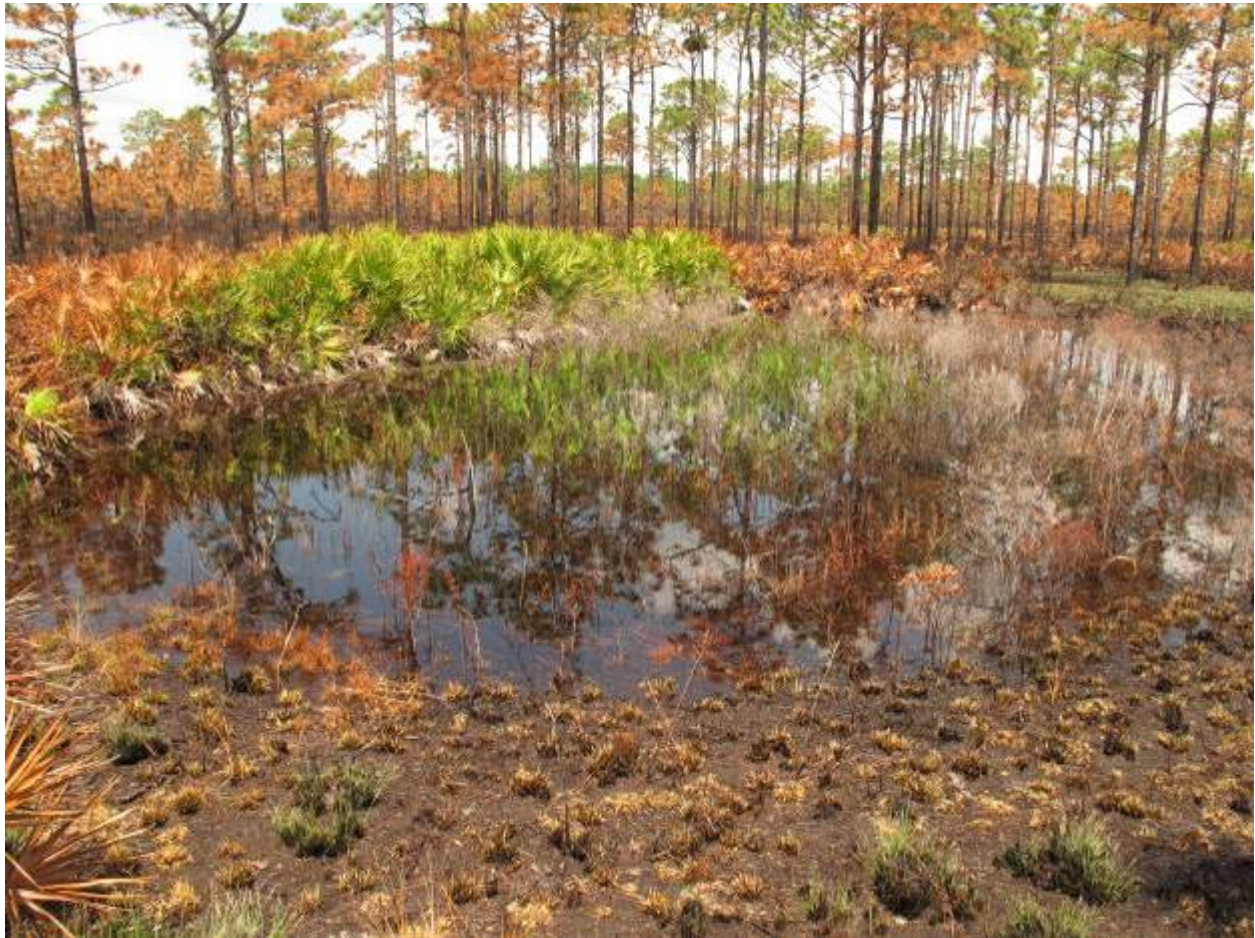
**Wetland ID: 30-18**

**Description:** This wetland is a <0.1 ha ephemeral marsh. There is no tree canopy or midstory cover. *Hypericum* is common within the wetland. Fern grow in the wetland center and sedges/grasses grow throughout the wetland. The herbaceous vegetation covers 50-75% of the basin. A recent fire burned through the majority of the wetland basin. A narrow land bridge separates this wetland from 30-19 to the east and there is a cattle trail along the land bridge. The adjacent uplands are mesic flatwoods that are managed with prescribed fire.

**Wetland Concerns:** Cattle

**Restoration Action Recommended:** The uplands in this MU are in good ecological condition, although we have observed some cattle-related effects in both wetlands and uplands in some areas. We recommend removing cattle from this unit to prevent destruction of the intact flatwoods community and the embedded wetlands.

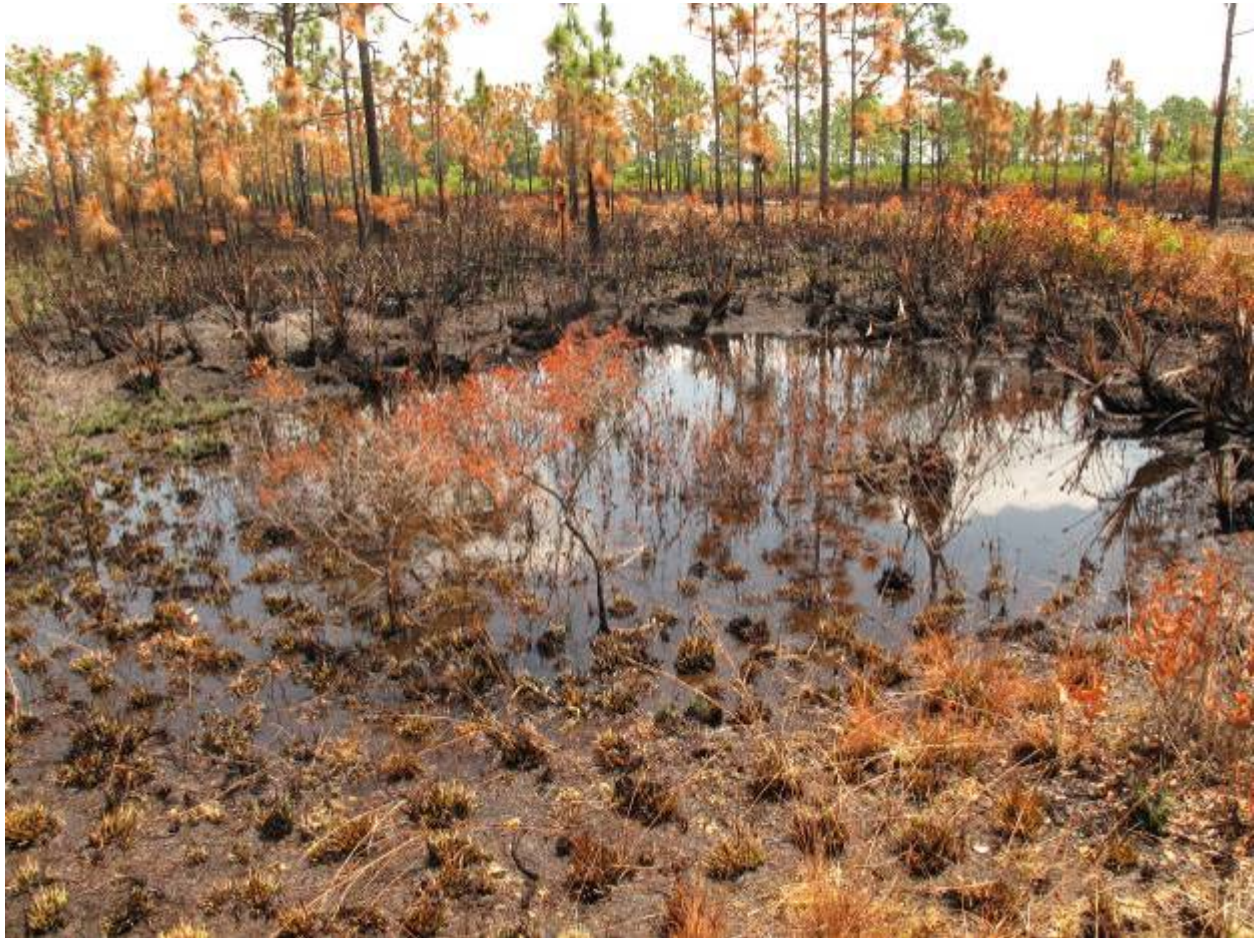
**Wetland ID: 30-19**

**Description:** This wetland is a <0.1 ha ephemeral marsh. A recent fire burned completely through the wetland basin. There is no tree canopy or midstory cover. A diverse array of herbaceous vegetation grows throughout the wetland, and new post-fire growth is emerging. A narrow land bridge separates this wetland from 30-18 to the west. There is evidence of cattle along the wetland edge, including feces. This pond is proximal to an access road with a shallow roadside ditch system. However, high ground separates the two so they will seldom connect. The adjacent uplands are mesic flatwoods that are managed with prescribed fire.

**Wetland Concerns:** Cattle

**Restoration Action Recommended:** The uplands in this MU are in good ecological condition, although we have observed some cattle-related effects in both wetlands and uplands in some areas. We recommend removing cattle from this unit to prevent destruction of the intact flatwoods community and the embedded wetlands.

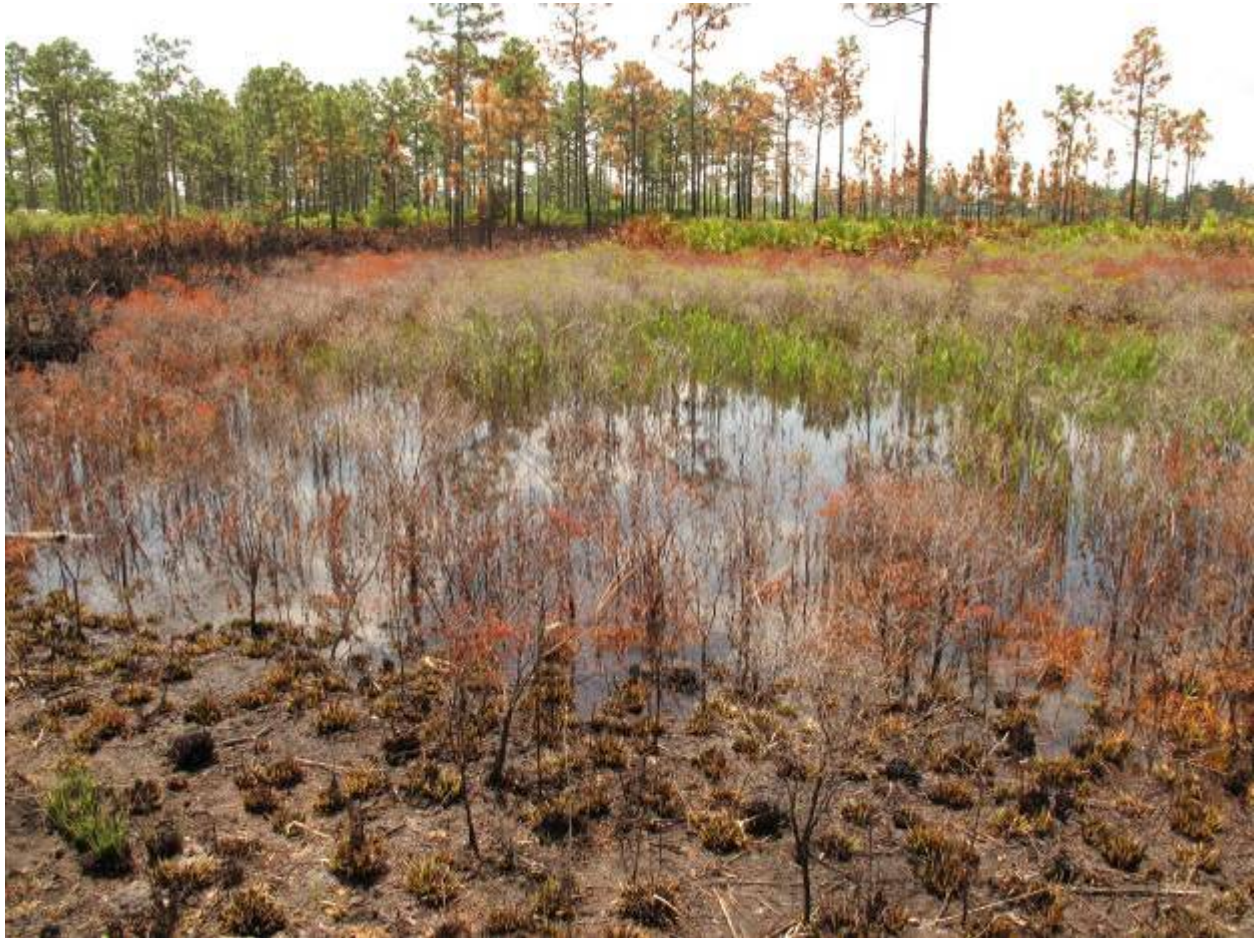
**Wetland ID: 30-20**

**Description:** This wetland is a 0.1 ha ephemeral marsh. *Hypericum* is common within the wetland. Fern grow in the wetland center and sedges/grasses grow throughout the wetland. The herbaceous vegetation covers >75% of the basin. There are 3 deeper holes within the wetland. A recent fire burned through half of the wetland basin. There is no tree canopy or midstory cover. No evidence of cattle was observed in the wetland, although cattle are allowed in this MU. The adjacent uplands are mesic flatwoods that are managed with prescribed fire.

**Wetland Concerns:** None

**Restoration Action Recommended:** The uplands in this MU are in good ecological condition, although we have observed some cattle-related effects in both wetlands and uplands in some areas. We recommend removing cattle from this unit to prevent destruction of the intact flatwoods community and the embedded wetlands.

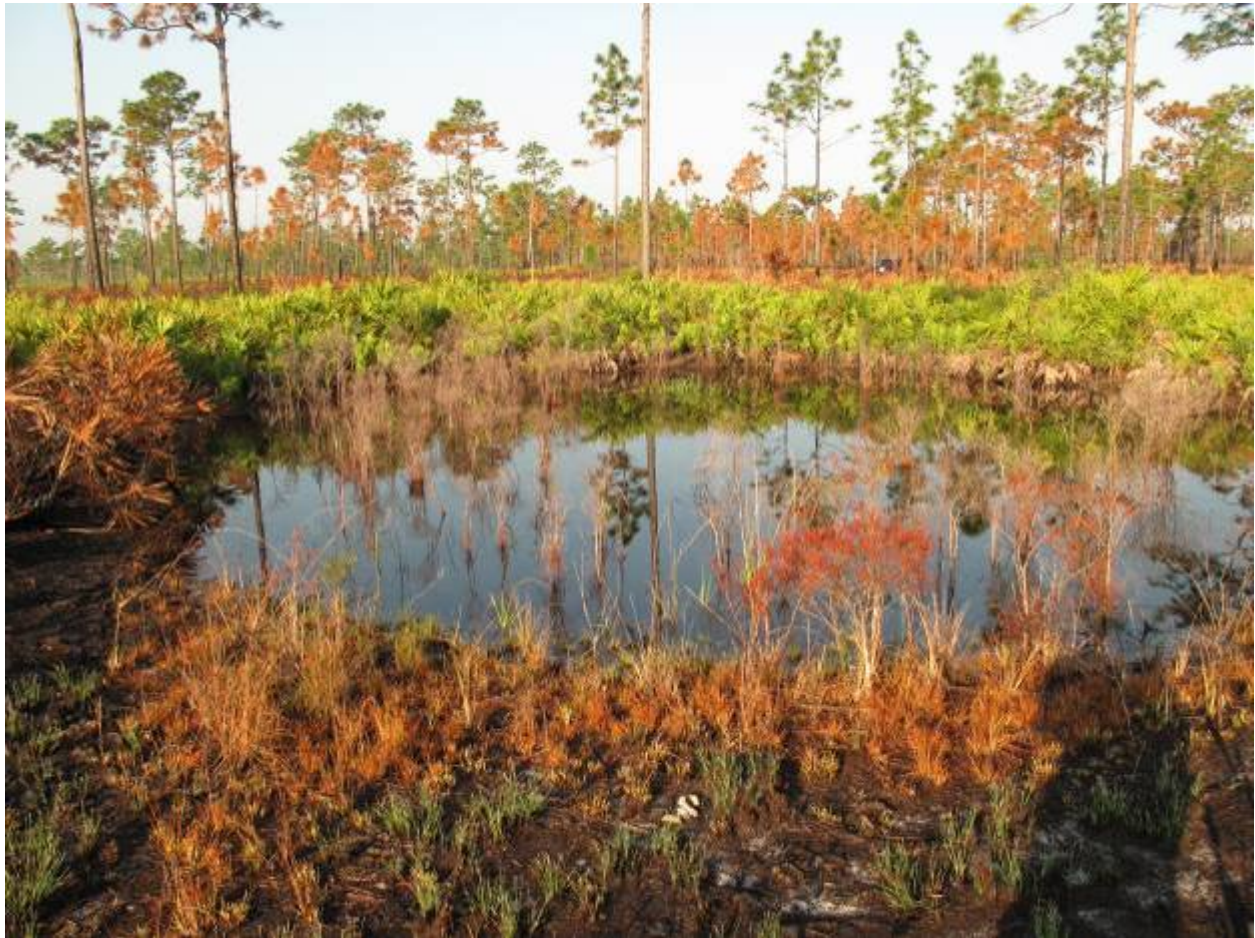
**Wetland ID: 30-21**

**Description:** This wetland is a <0.1 ha ephemeral marsh. There is no tree canopy or midstory cover. Sedges/grasses grow in a ring around the wetland edge, and cover 5-25% of the basin. A recent fire burned through the wetland basin. A small cattle trail leads into the wetland on the east side. Small fish were present on the day of our visit. The adjacent uplands are mesic flatwoods that are managed with prescribed fire.

**Wetland Concerns:** Cattle

**Restoration Action Recommended:** The uplands in this MU are in good ecological condition, although we have observed some cattle-related effects in both wetlands and uplands in some areas. We recommend removing cattle from this unit to prevent destruction of the intact flatwoods community and the embedded wetlands.

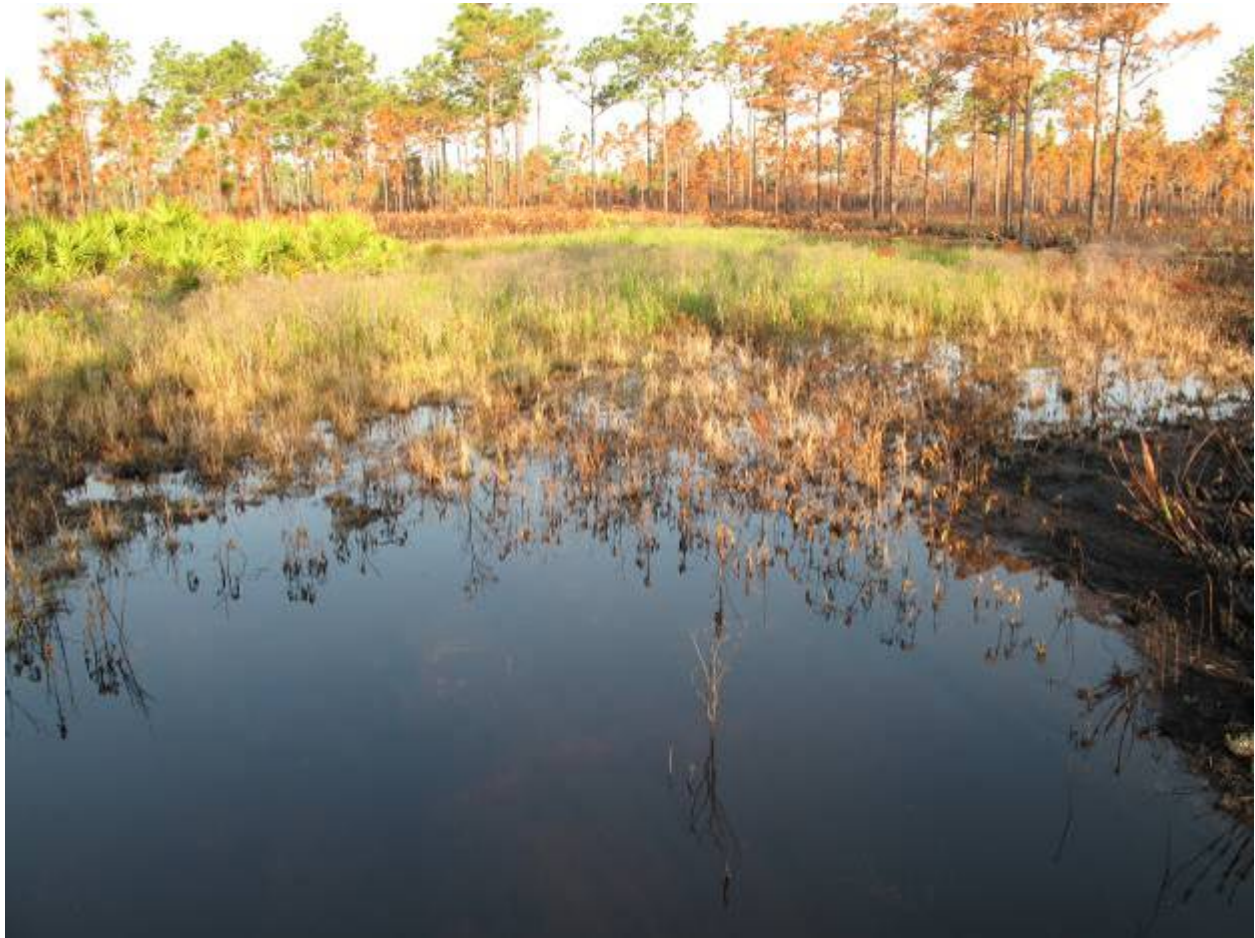
**Wetland ID: 30-22**

**Description:** This wetland is a 0.1 ha ephemeral marsh. There is no tree canopy or midstory cover. Sedges/grasses grow throughout the wetland, and cover >75% of the basin. A recent fire burned a quarter of the wetland, mostly on the east side. Old feral hog damage is patchy and has grown over with vegetation. A small cattle trail leads into the wetland on the north side. Small fish were present on the day of our visit. The adjacent uplands are mesic flatwoods that are managed with prescribed fire.

**Wetland Concerns:** Feral hog damage, Cattle

**Restoration Action Recommended:** The uplands in this MU are in good ecological condition, although we have observed some cattle-related effects in both wetlands and uplands in some areas. We recommend removing cattle from this unit to prevent destruction of the intact flatwoods community and the embedded wetlands.

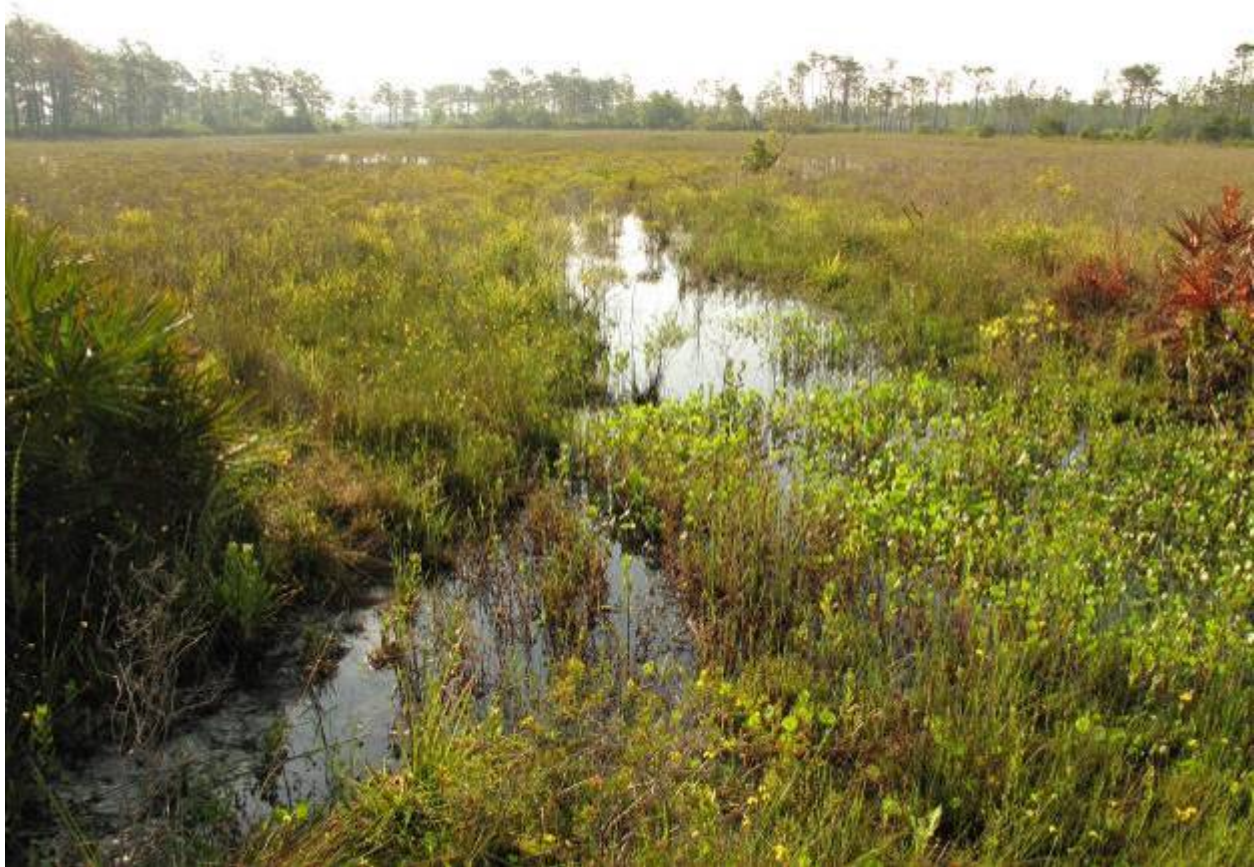
**Wetland ID: 30-23**

**Description:** This wetland is a 1.9 ha ephemeral marsh. There is no tree canopy or midstory cover. *Hypericum* is common around the outer half of the wetland. Maidencane grows in the wetland center and sedges/grasses grow throughout the wetland. The herbaceous vegetation covers >75% of the wetland. A ditch connects the wetland to a roadside ditch on the west side. There is a cattle trail on the north end. The eastern edge of the wetland is on private property and has a fenceline running through it and a private residence. Small fish were present on the day of our visit. The adjacent uplands are mesic flatwoods that are managed with prescribed fire.

**Wetland Concerns:** Cattle, Ditching

**Restoration Action Recommended:** Fill the ditch to restore the wetland's isolation. The uplands in this MU are in good ecological condition, although we have observed some cattle-related effects in both wetlands and uplands in some areas. We recommend removing cattle from this unit to prevent destruction of the intact flatwoods community and the embedded wetlands.
