# **Inventory, Assessment, and Restoration Potential of Ephemeral Wetlands on FFWCC Wildlife Management Areas**

## **Triple N Ranch WMA Final Report**

Submitted by: Rebecca P.M. Means<sup>1</sup>, Ryan C. Means<sup>1</sup>, Steven A. Johnson<sup>2</sup>

15 May 2010 – 15 August 2010

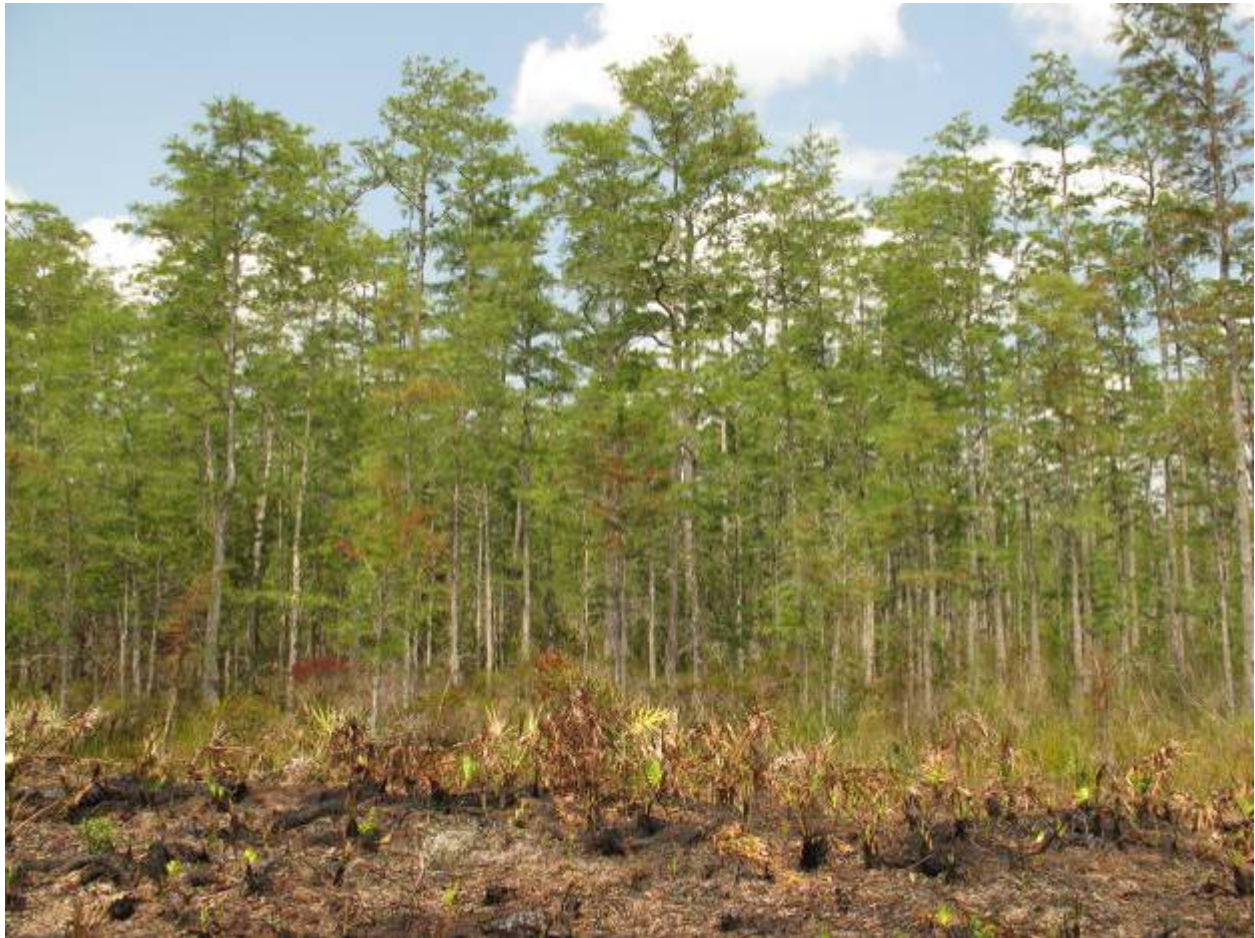
**Wetland ID: 32-01**

**Description:** This wetland is a 0.7 ha ephemeral forested swamp. Cypress trees dominate the canopy, and cover >75% of the basin. The midstory is dominated by wax myrtle and small cypress trees, and covers 5-25% of the basin. A diversity of sedges/grasses, maidencane, *Sphagnum*, and fern grow throughout the wetland, and cover >75% of the basin. A recent fire burned to the wetland edge. The adjacent uplands are scrubby flatwoods that are managed with prescribed fire.

**Wetland Concerns:** None

**Restoration Action Recommended:** The uplands in this MU are in good ecological condition, although we have observed some cattle-related effects in both wetlands and uplands in some areas. We recommend removing cattle from this unit to prevent destruction of the intact flatwoods community and the embedded wetlands.

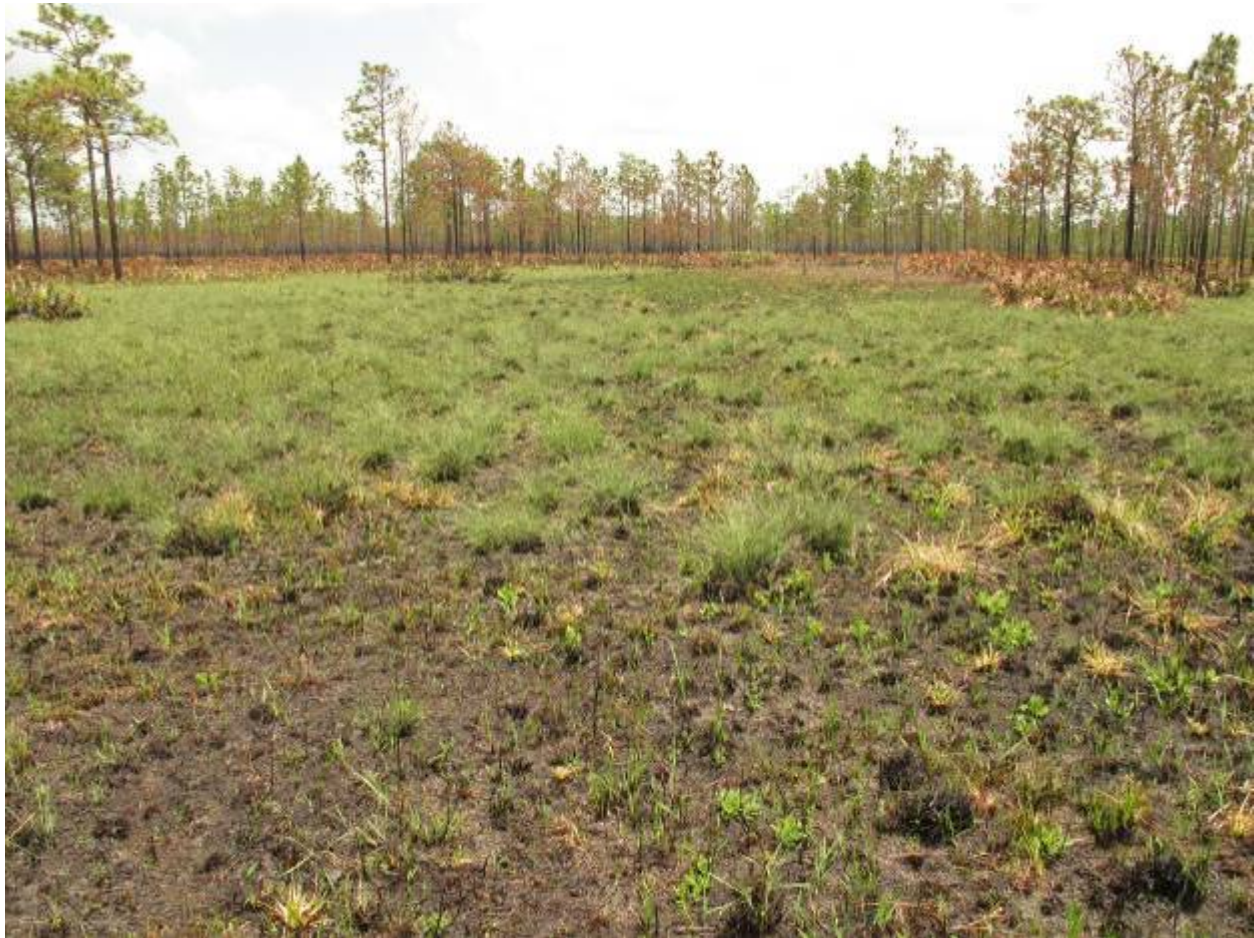
**Wetland ID: 32-02**

**Description:** This wetland is a 0.4 ha highly ephemeral wetland. There is no tree canopy or midstory cover. A recent fire burned through the wetland basin. Sedges/grasses grow throughout the wetland, and new post-fire growth is emerging. There is evidence of cattle in the wetland, including tracks and feces. The adjacent uplands are scrubby flatwoods that are managed with prescribed fire.

**Wetland Concerns:** Cattle

**Restoration Action Recommended:** The uplands in this MU are in good ecological condition, although we have observed some cattle-related effects in both wetlands and uplands in some areas. We recommend removing cattle from this unit to prevent destruction of the intact flatwoods community and the embedded wetlands.

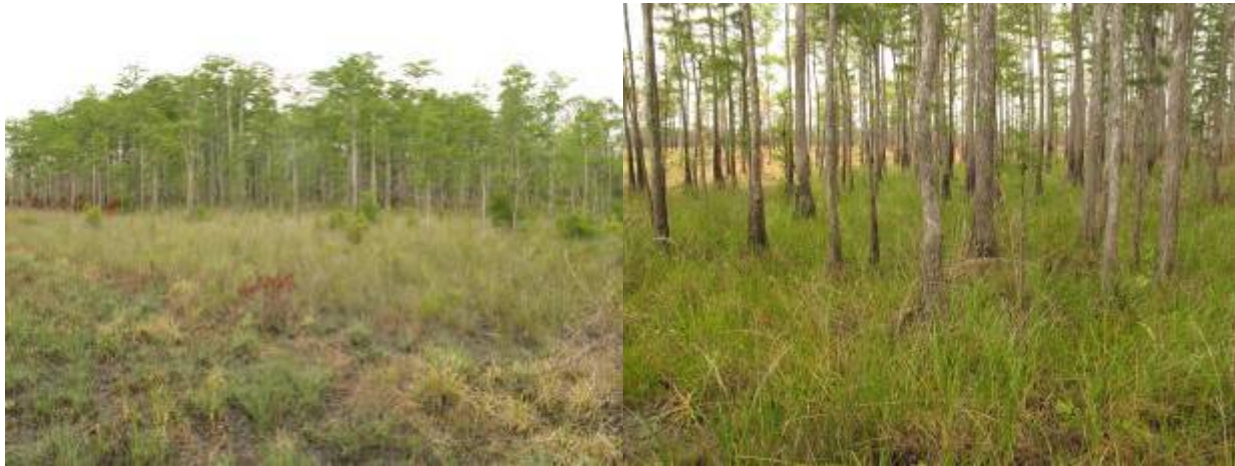
**Wetland ID: 32-03**

**Description:** This wetland is a 1.0 ha ephemeral forested swamp. It is a cypress dome is surrounded by an open marsh. Cypress trees dominate the canopy, and cover 50-75% of the basin. There is no midstory cover. Sedges/grasses grow throughout the wetland, and cover >75% of the basin. There is evidence of cattle in the wetland, including tracks, feces, and grazed vegetation. The adjacent uplands are scrubby flatwoods that are managed with prescribed fire.

**Wetland Concerns:** Cattle

**Restoration Action Recommended:** The uplands in this MU are in good ecological condition, although we have observed some cattle-related effects in both wetlands and uplands in some areas. We recommend removing cattle from this unit to prevent destruction of the intact flatwoods community and the embedded wetlands.

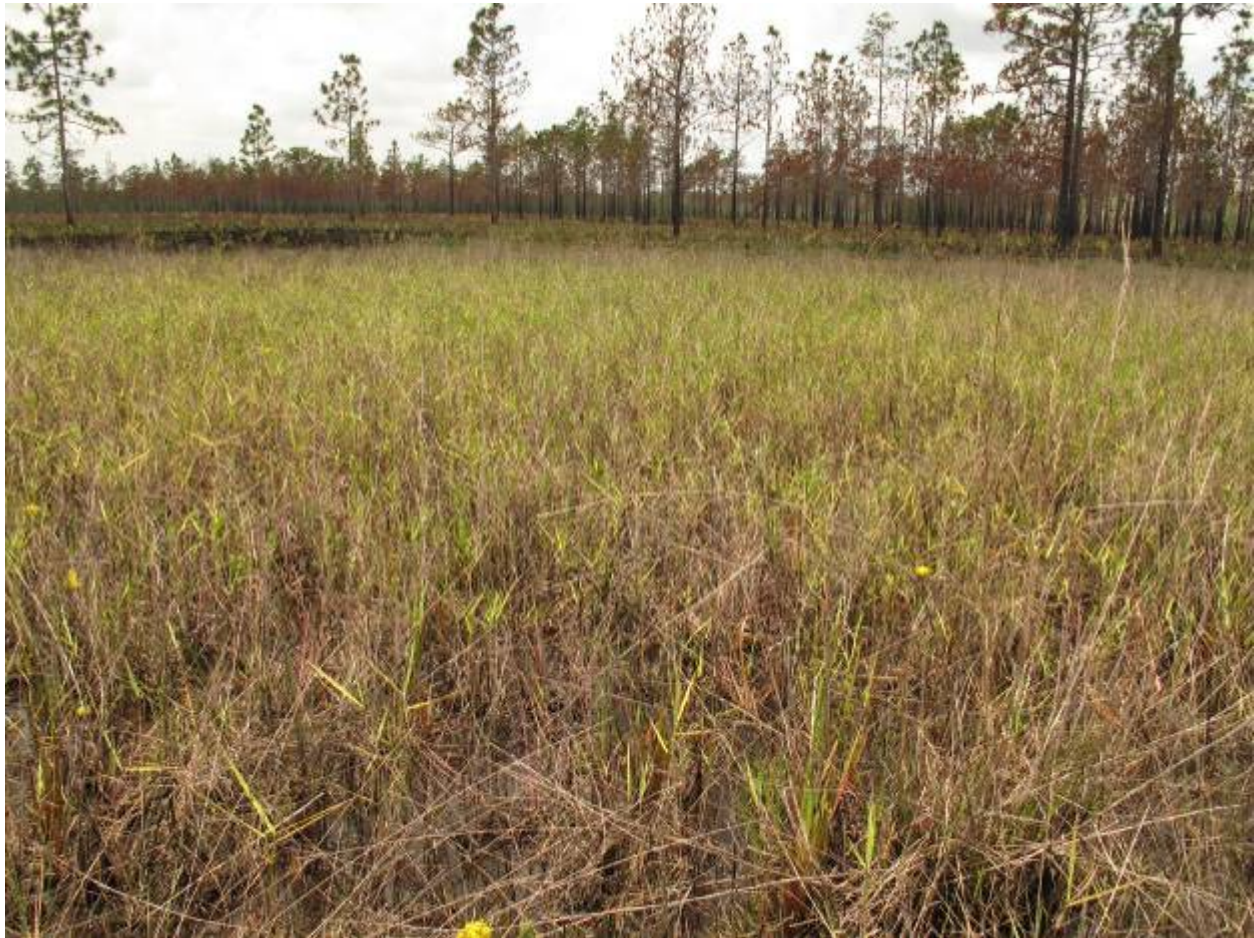
**Wetland ID: 32-04**

**Description:** This wetland is a 0.2 ha ephemeral wetland. There is no tree canopy or midstory cover. Maidencane grows in the wetland center and sedges/grasses grow around the outer ring of the wetland. The herbaceous vegetation covers >75% of the basin. There are cattle tracks in the wetland. The adjacent uplands are scrubby flatwoods that are managed with prescribed fire.

**Wetland Concerns:** Cattle

**Restoration Action Recommended:** The uplands in this MU are in good ecological condition, although we have observed some cattle-related effects in both wetlands and uplands in some areas. We recommend removing cattle from this unit to prevent destruction of the intact flatwoods community and the embedded wetlands.

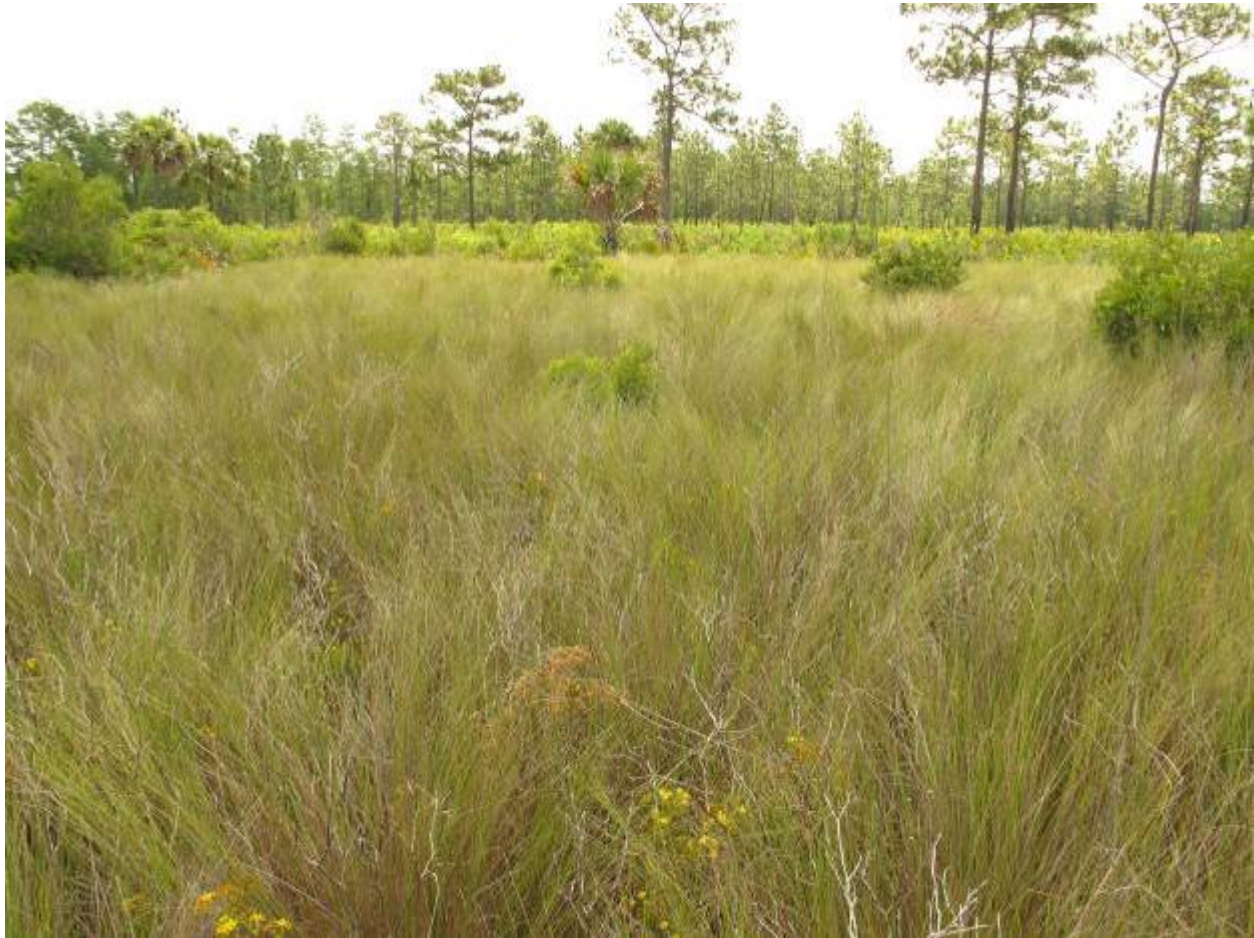
**Wetland ID: 33-01**

**Description:** This wetland is a 0.1 ha ephemeral wetland. There is no tree canopy or midstory cover. This wetland is dominated by cordgrass, with *Sphagnum* growing beneath. The herbaceous vegetation covers >75% of the basin. No evidence of cattle was observed in the wetland, although cattle are allowed in this MU. The adjacent uplands are a mix of mesic and scrubby flatwoods that are managed with prescribed fire.

**Wetland Concerns:** None

**Restoration Action Recommended:** The uplands in this MU are in good ecological condition, although we have observed some cattle-related effects in both wetlands and uplands in some areas. We recommend removing cattle from this unit to prevent destruction of the intact flatwoods community and the embedded wetlands.

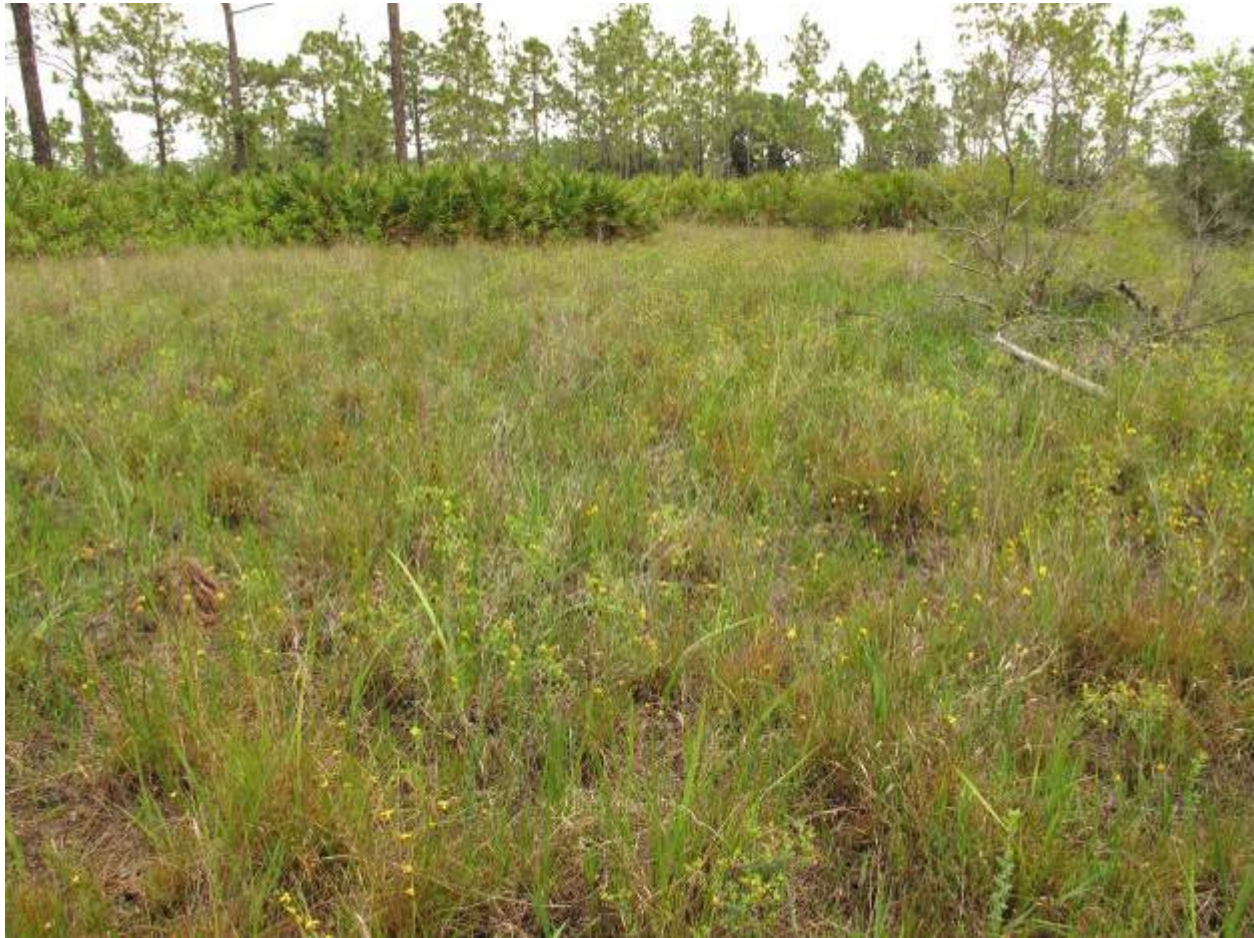
**Wetland ID: 33-02**

**Description:** This wetland is a 0.1 ha ephemeral wetland. There is no tree canopy or midstory cover. A diversity of sedges/grasses grow throughout the wetland, and cover >75% of the basin. This open marsh is scalloped with old feral hog damage. The damaged areas are now grown over with redroot. No evidence of cattle was observed in the wetland, although cattle are allowed in this MU. The adjacent uplands are scrubby flatwoods that are managed with prescribed fire.

**Wetland Concerns:** Feral hog damage

**Restoration Action Recommended:** The uplands in this MU are in good ecological condition, although we have observed some cattle-related effects in both wetlands and uplands in some areas. We recommend removing cattle from this unit to prevent destruction of the intact flatwoods community and the embedded wetlands.

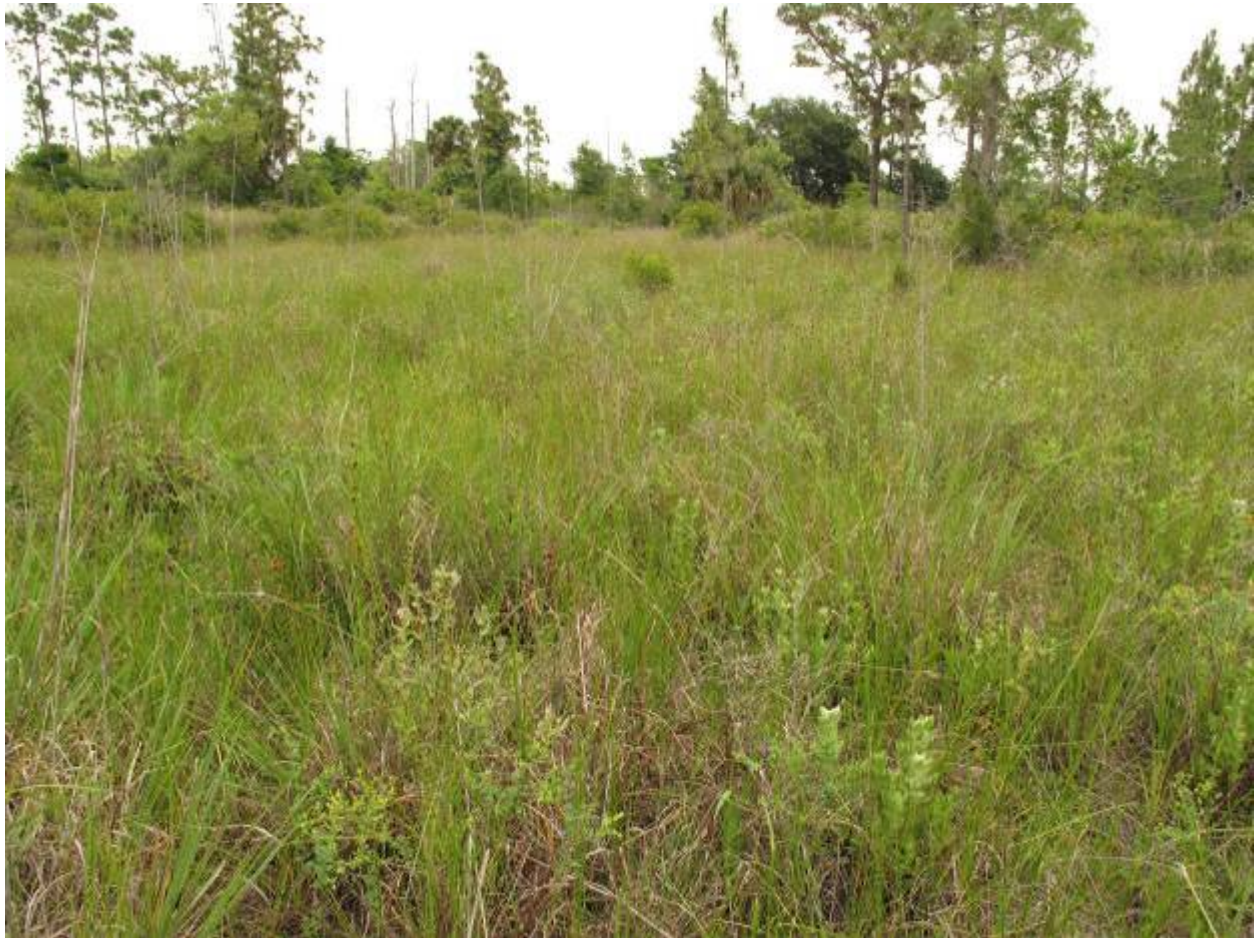
**Wetland ID: 33-03**

**Description:** This wetland is a 0.1 ha ephemeral wetland. There is no tree canopy cover. A few wax myrtles grow scattered throughout the wetland, and cover 5-25% of the basin. *Hypericum* is common in the wetland. Sedges/grasses grow throughout the wetland, and cover >75% of the basin. Old feces provide evidence of cattle utilizing the wetland. The adjacent uplands are scrubby flatwoods that are managed with prescribed fire.

**Wetland Concerns:** Cattle

**Restoration Action Recommended:** The uplands in this MU are in good ecological condition, although we have observed some cattle-related effects in both wetlands and uplands in some areas. We recommend removing cattle from this unit to prevent destruction of the intact flatwoods community and the embedded wetlands.

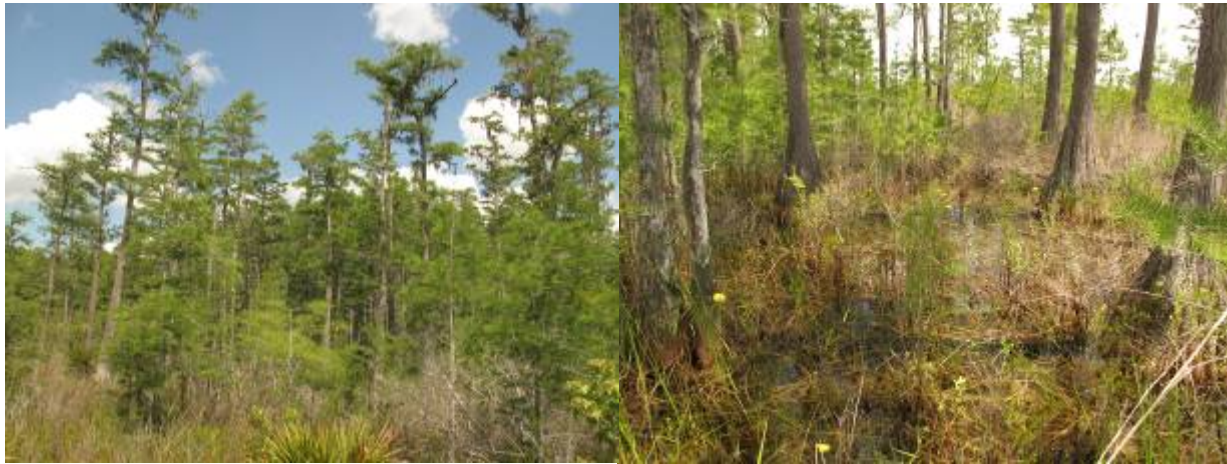
**Wetland ID: 35-01**

**Description:** This wetland is a 0.4 ha ephemeral forested wetland. Cypress and gum trees dominate the canopy, and cover 50-75% of the wetland. The midstory is dominated by small cypress trees, and cover 5-25% of the basin. Sedges/grasses and maidencane grow throughout the cypress dome, and cover >75% of the basin. There are cattle trails around the wetland edge. The adjacent uplands are scrubby flatwoods that are managed with prescribed fire.

**Wetland Concerns:** Cattle

**Restoration Action Recommended:** The uplands in this MU are in good ecological condition, although we have observed some cattle-related effects in both wetlands and uplands in some areas. We recommend removing cattle from this unit to prevent destruction of the intact flatwoods community and the embedded wetlands.

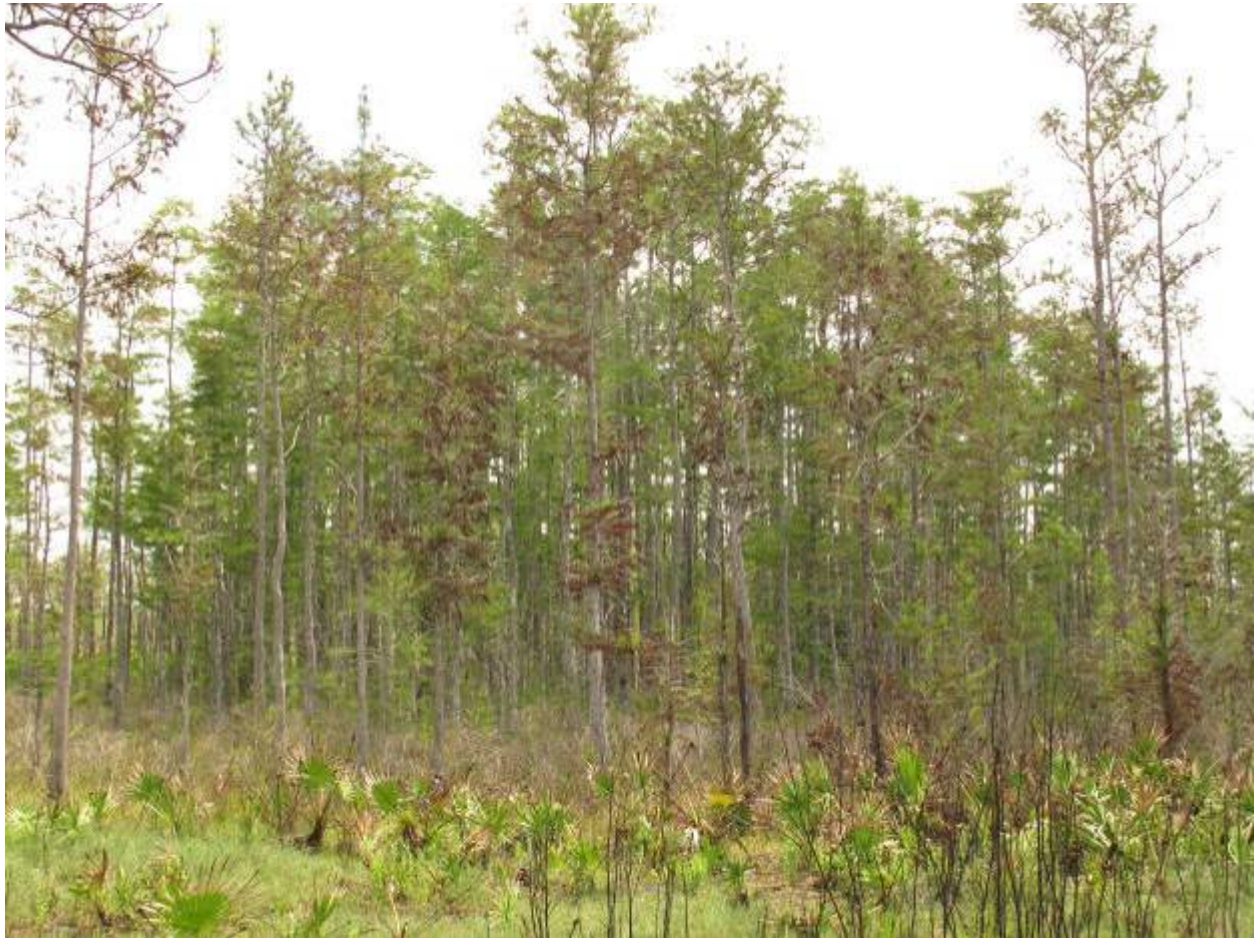
**Wetland ID: 35-02**

**Description:** This wetland is a 0.4 ha ephemeral forested swamp. Cypress trees dominate the canopy, and cover >75% of the wetland. There is no midstory cover. A diversity of herbaceous vegetation grows throughout the cypress dome, and covers >75% of the basin. No evidence of cattle was observed in the wetland, although cattle are allowed in this MU. The adjacent uplands are scrubby flatwoods that are managed with prescribed fire.

**Wetland Concerns:** None

**Restoration Action Recommended:** The uplands in this MU are in good ecological condition, although we have observed some cattle-related effects in both wetlands and uplands in some areas. We recommend removing cattle from this unit to prevent destruction of the intact flatwoods community and the embedded wetlands.

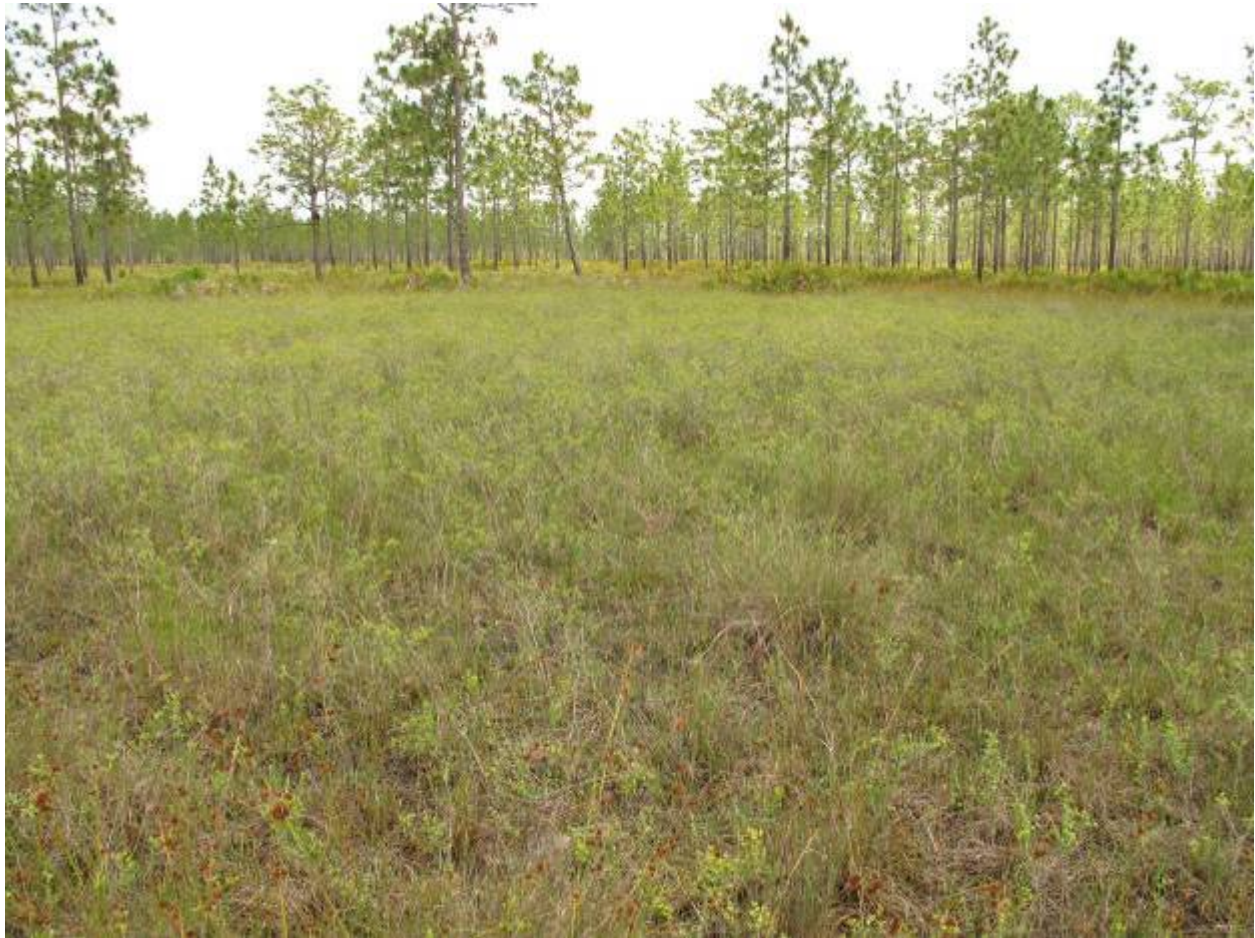
**Wetland ID: 36-01**

**Description:** This wetland is a 0.2 ha ephemeral marsh. There is no tree canopy or midstory cover. *Hypericum* is abundant throughout the wetland. Sedges/grasses grow throughout the wetland, and cover >75% of the basin. The herbaceous vegetation appears diverse and healthy despite the cattle tracks and grazing evident in the wetland. The adjacent uplands are scrubby flatwoods that are managed with prescribed fire.

**Wetland Concerns:** Cattle

**Restoration Action Recommended:** The uplands in this MU are in good ecological condition, although we have observed some cattle-related effects in both wetlands and uplands in some areas. We recommend removing cattle from this unit to prevent destruction of the intact flatwoods community and the embedded wetlands.

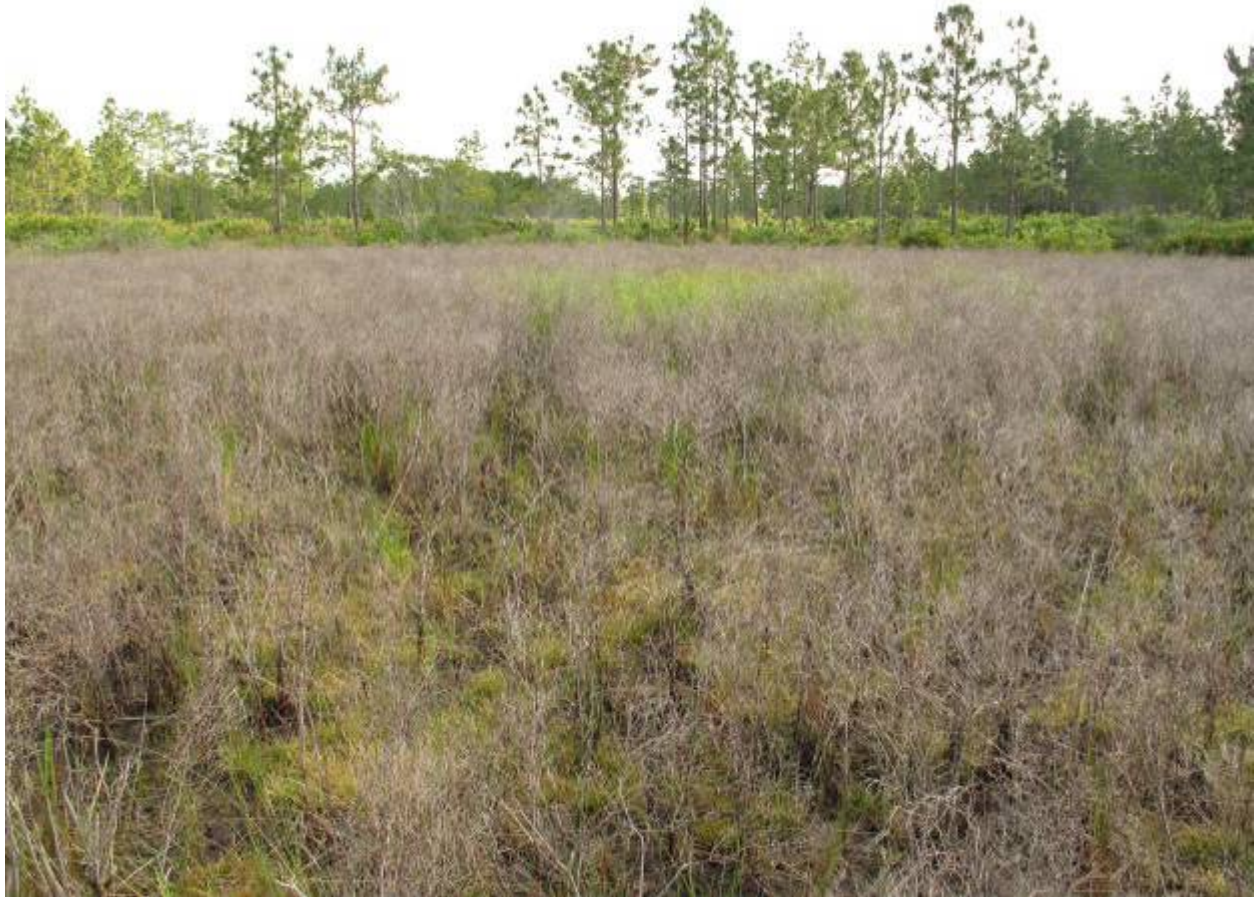
**Wetland ID: 37-01**

**Description:** This wetland is a 0.4 ha ephemeral marsh. There is no tree canopy or midstory cover. *Hypericum* was abundant throughout the wetland before most were killed by inundation. Sedges/grasses grow throughout the wetland, and cover >75% of the basin. This wetland has been impacted by cattle. There were obvious signs of grazing, a pervasive urine smell, and cattle feces throughout the wetland. A shallow ditch on the east side of the wetland connects to a nearby canal. The adjacent uplands are scrubby flatwoods that are managed with prescribed fire.

**Wetland Concerns:** Cattle, Ditch

**Restoration Action Recommended:** Fill the ditch to restore the wetland's isolation. The uplands in this MU are in good ecological condition, although we have observed some cattle-related effects in both wetlands and uplands in some areas. We recommend removing cattle from this unit to prevent destruction of the intact flatwoods community and the embedded wetlands.

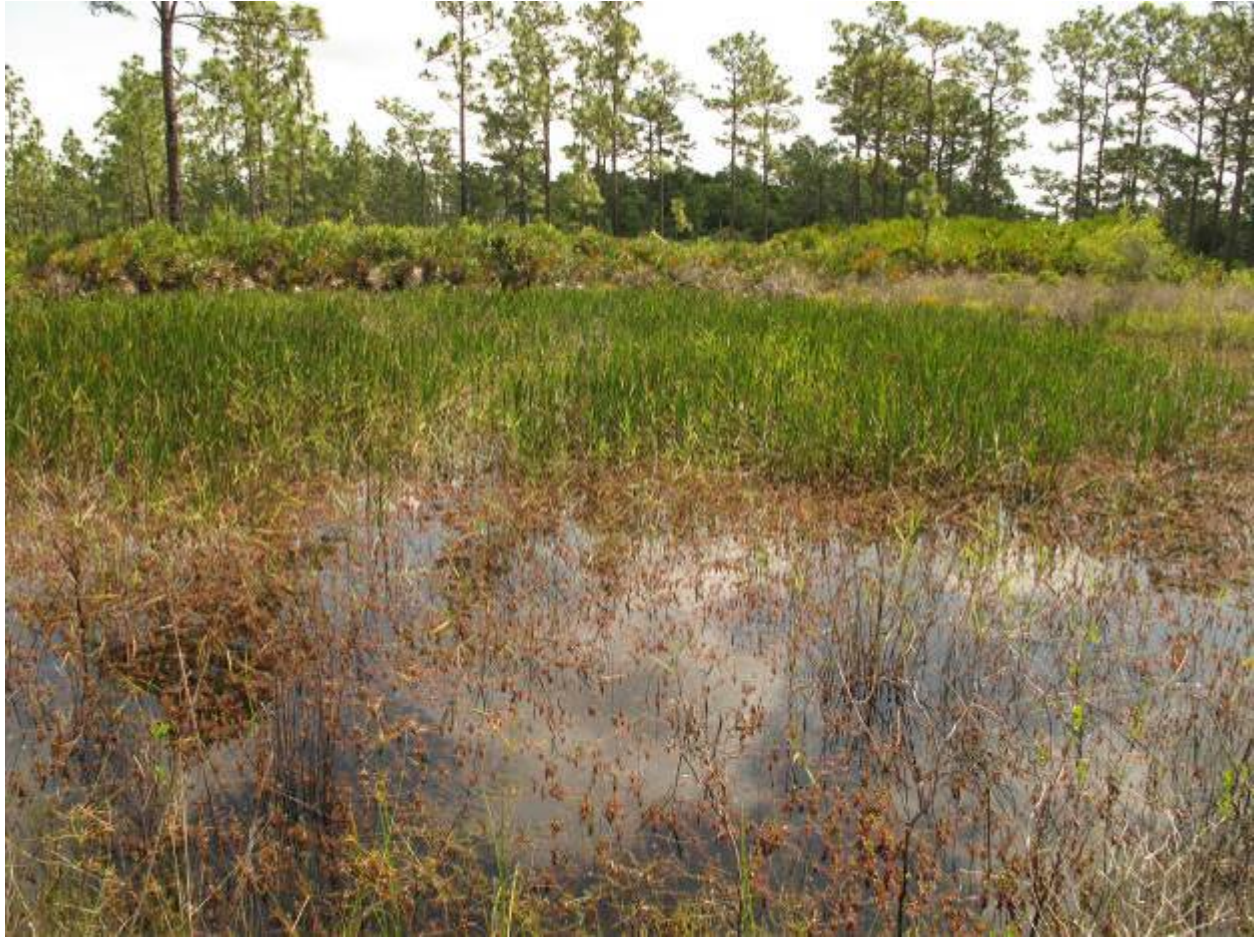
**Wetland ID: 37-02**

**Description:** This wetland is a 0.1 ha semi-permanent marsh. There is no tree canopy or midstory cover. Sedges/grasses and emergent vegetation grow throughout the wetland, and cover >75% of the basin. The adjacent uplands are scrubby flatwoods that are managed with prescribed fire.

**Wetland Concerns:** None

**Restoration Action Recommended:** The uplands in this MU are in good ecological condition, although we have observed some cattle-related effects in both wetlands and uplands in some areas. We recommend removing cattle from this unit to prevent destruction of the intact flatwoods community and the embedded wetlands.

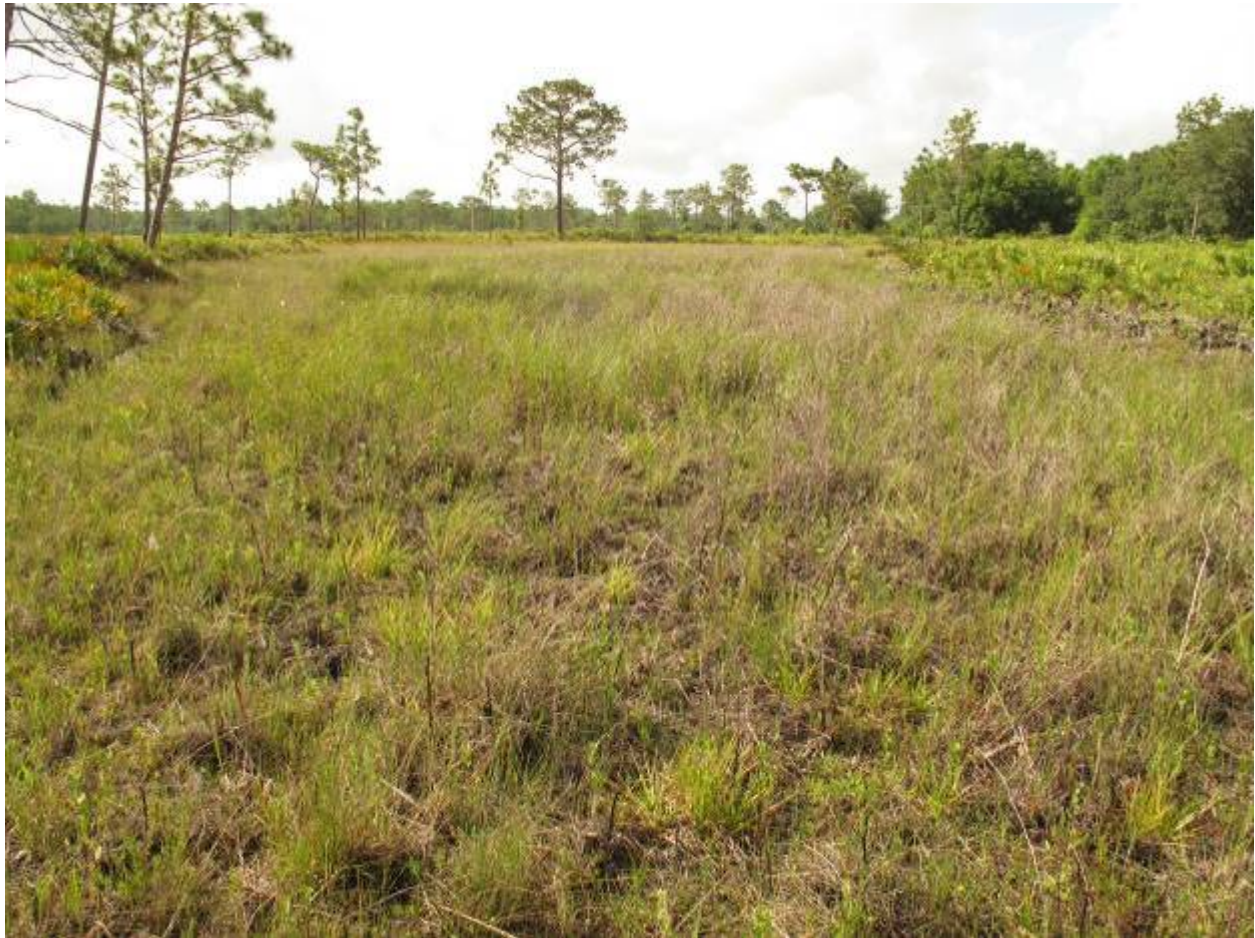
**Wetland ID: 38-01**

**Description:** This wetland is a 0.2 ha ephemeral marsh. There is no tree canopy or midstory cover. Sedges/grasses grow throughout the wetland, and cover >75% of the basin. This wetland has been impacted by cattle. There were obvious signs of grazing, tracks, and cattle feces throughout the wetland. The adjacent uplands are scrubby flatwoods that are managed with prescribed fire.

**Wetland Concerns:** Cattle

**Restoration Action Recommended:** The uplands in this MU are in good ecological condition, although we have observed some cattle-related effects in both wetlands and uplands in some areas. We recommend removing cattle from this unit to prevent destruction of the intact flatwoods community and the embedded wetlands.

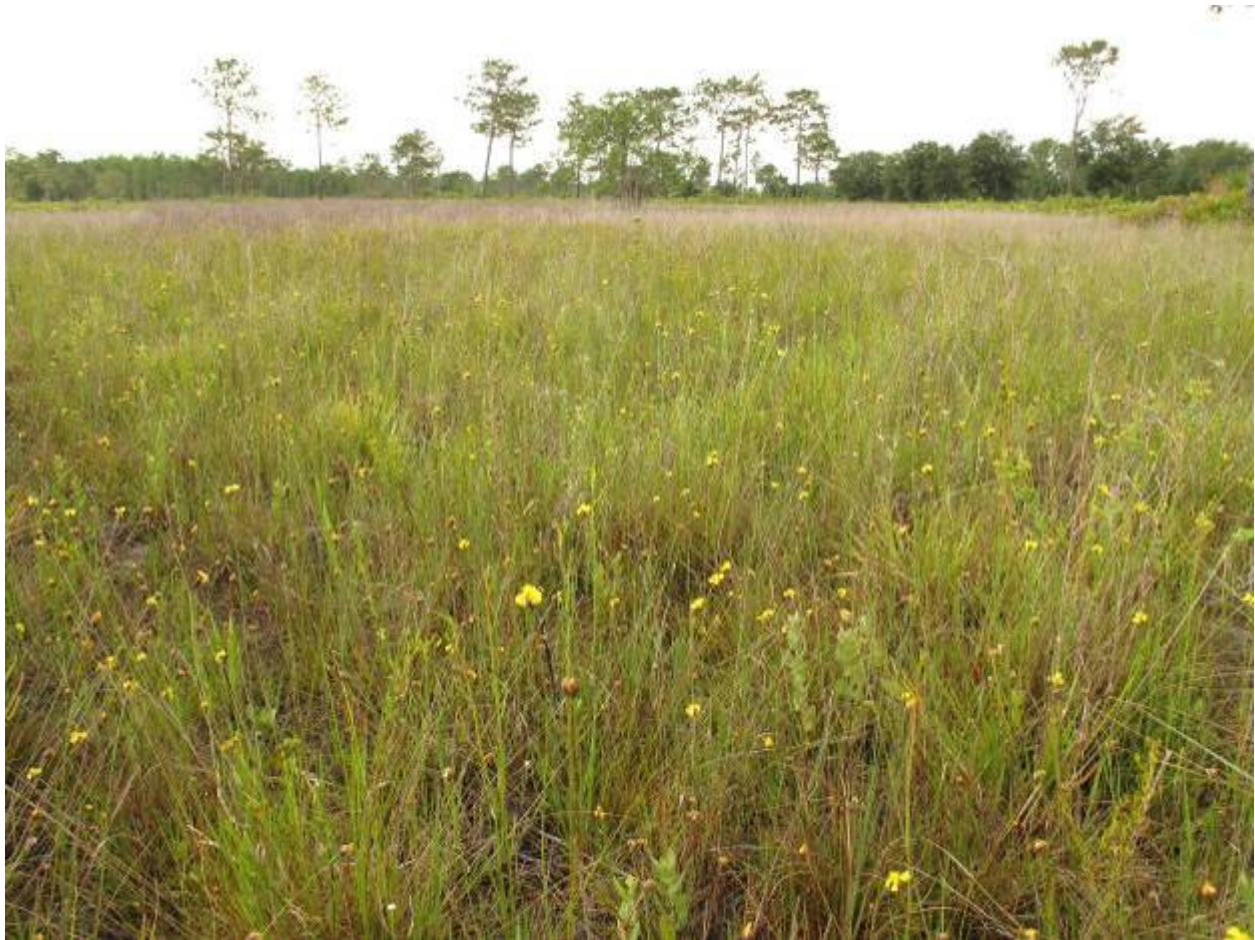
**Description:** This wetland is a 0.4 ha ephemeral marsh. There is no tree canopy or midstory cover. *Hypericum* was abundant throughout the wetland before most were killed by inundation. Pickerelweed and other emergent vegetation grow in the deeper wetland center and sedges/grasses grow in a ring around the wetland edge. The herbaceous vegetation covers >75% of the basin. Cattle trails are abundant around the wetland edge. The adjacent uplands are scrubby flatwoods that are managed with prescribed fire.

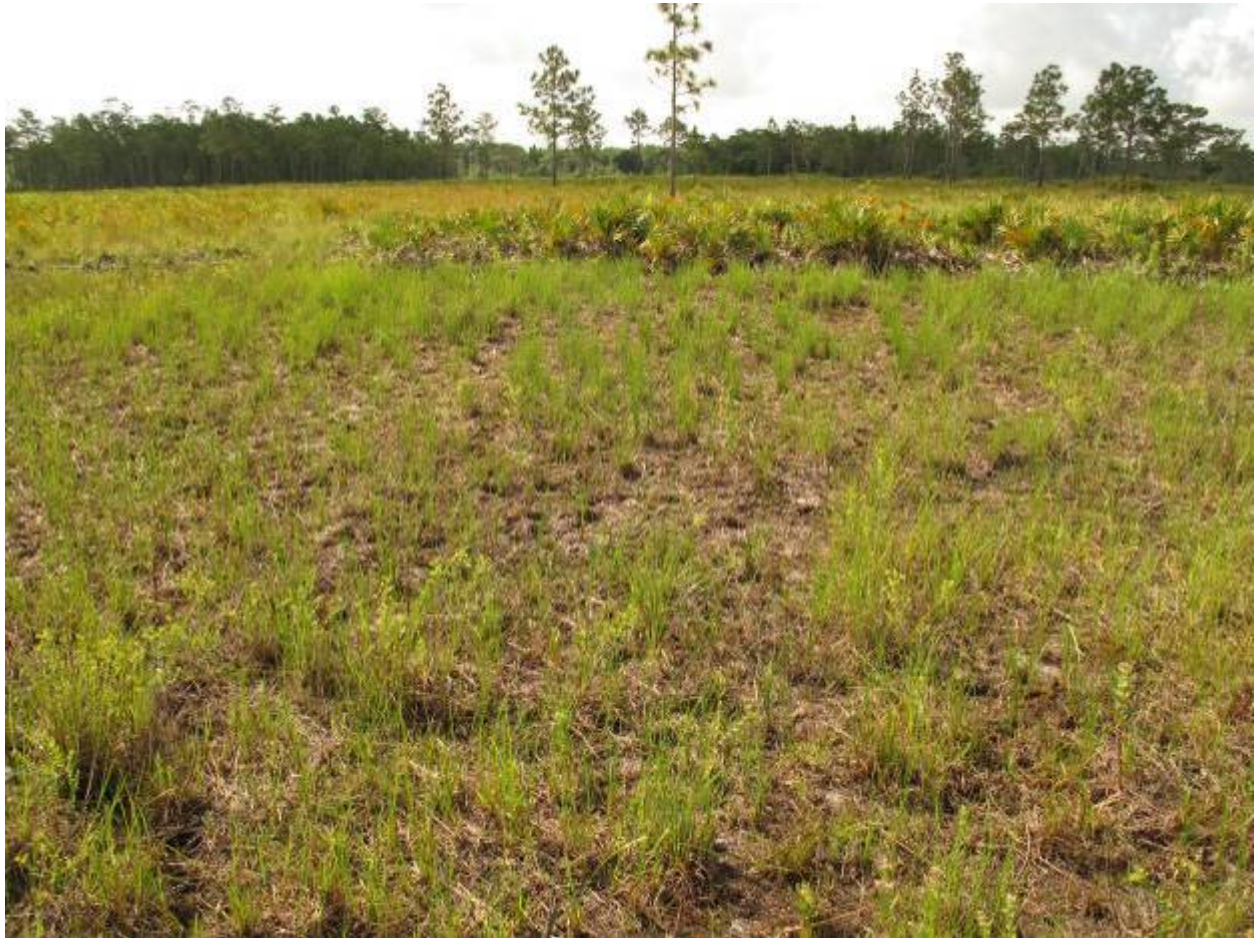
**Wetland ID: 38-03**

**Description:** This wetland is a <0.1 ha ephemeral marsh. There is no tree canopy or midstory cover. Sedges/grasses grow throughout the wetland, and cover 50-75% of the basin. This wetland has been impacted by cattle. There were obvious signs of grazing, many deep tracks, and cattle feces throughout the wetland. The adjacent uplands are scrubby flatwoods that are managed with prescribed fire.

**Wetland Concerns:** Cattle

**Restoration Action Recommended:** The uplands in this MU are in good ecological condition, although we have observed some cattle-related effects in both wetlands and uplands in some areas. We recommend removing cattle from this unit to prevent destruction of the intact flatwoods community and the embedded wetlands.

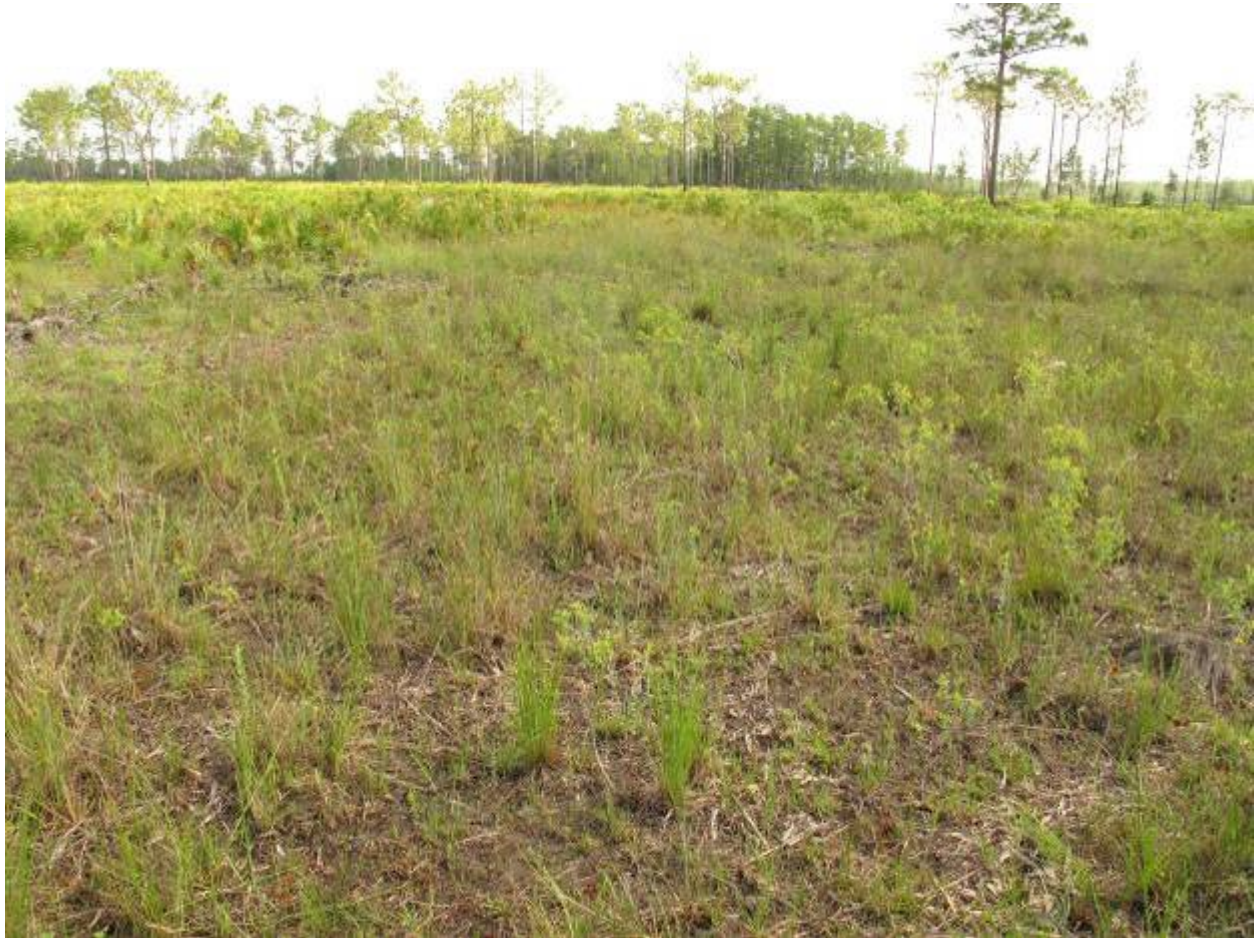
**Wetland ID: 38-04**

**Description:** This wetland is a <0.1 ha highly ephemeral marsh. There is no tree canopy or midstory cover. Sedges/grasses grow throughout the wetland, and cover >75% of the basin. Cattle are heavily grazing the wetland vegetation and plant diversity is low. The adjacent uplands are scrubby flatwoods that are managed with prescribed fire.

**Wetland Concerns:** Cattle

**Restoration Action Recommended:** The uplands in this MU are in good ecological condition, although we have observed some cattle-related effects in both wetlands and uplands in some areas. We recommend removing cattle from this unit to prevent destruction of the intact flatwoods community and the embedded wetlands.

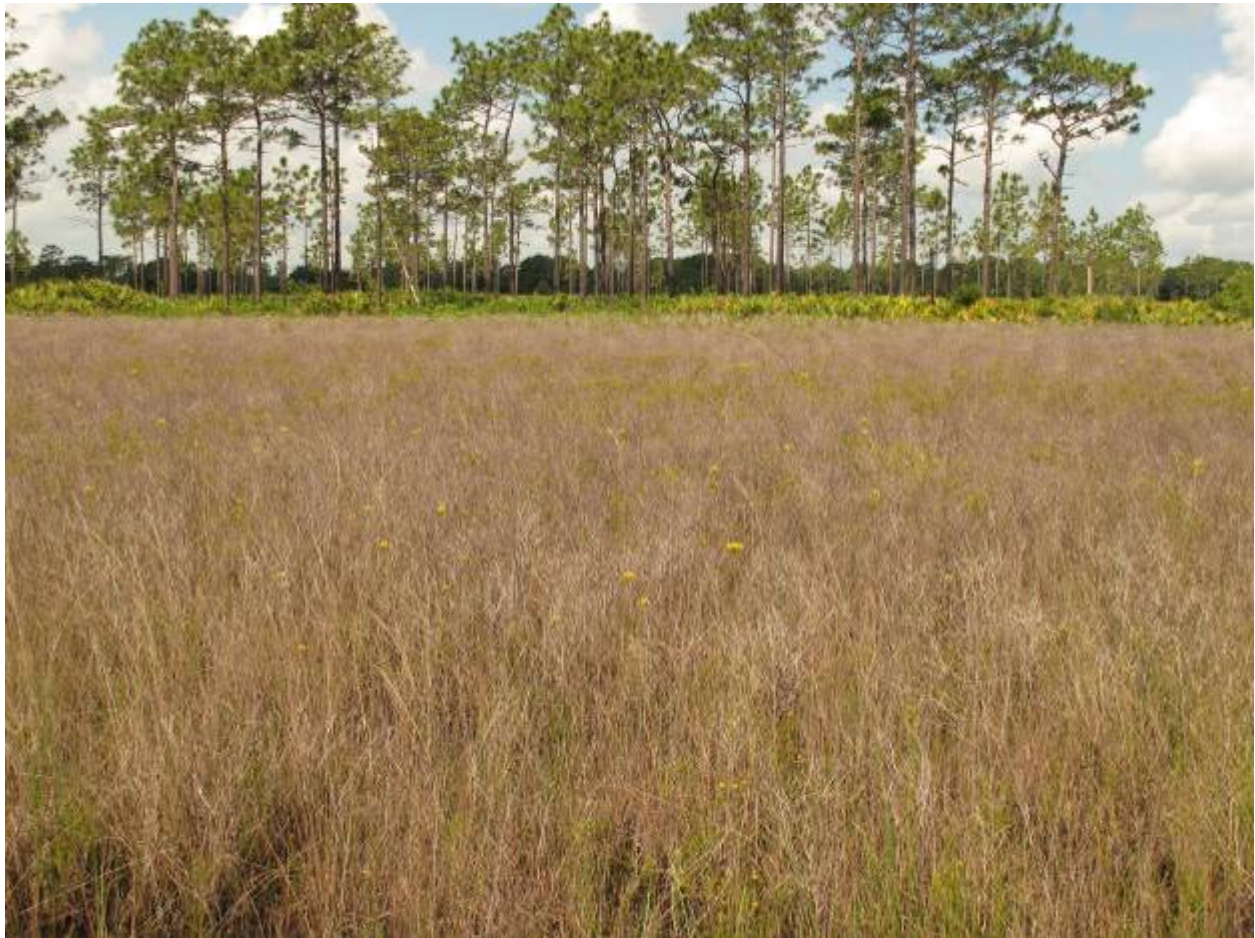
**Wetland ID: 38-05**

**Description:** This wetland is a 0.4 ha ephemeral marsh. There is no tree canopy or midstory cover. *Hypericum* is abundant in the wetland interior. Sedges/grasses grow throughout the wetland, and cover >75% of the basin. There is evidence of cattle in the wetland, particularly on the east side. The adjacent uplands are scrubby flatwoods that are managed with prescribed fire.

**Wetland Concerns:** Cattle

**Restoration Action Recommended:** The uplands in this MU are in good ecological condition, although we have observed some cattle-related effects in both wetlands and uplands in some areas. We recommend removing cattle from this unit to prevent destruction of the intact flatwoods community and the embedded wetlands.
