# **Inventory, Assessment, and Restoration Potential of Ephemeral Wetlands on FFWCC Wildlife Management Areas**

## **Triple N Ranch WMA Final Report**

Submitted by: Rebecca P.M. Means<sup>1</sup>, Ryan C. Means<sup>1</sup>, Steven A. Johnson<sup>2</sup>

15 May 2010 – 15 August 2010

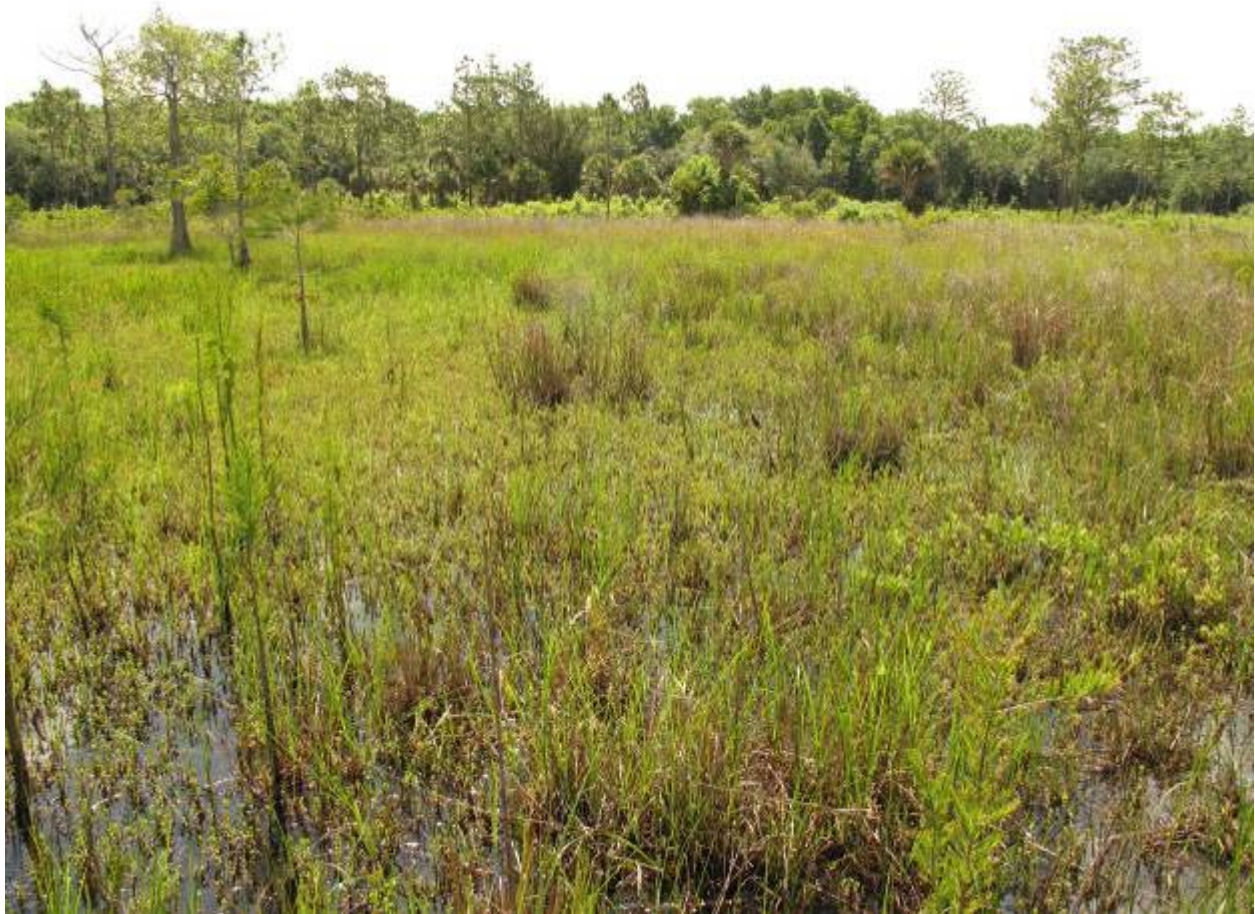
**Wetland ID: 38-06**

**Description:** This wetland is a 0.3 ha ephemeral marsh. There is no tree canopy or midstory cover. *Hypericum* grows in a ring around the wetland. Maidencane grows in the deeper wetland center and a high diversity of sedges/grasses grows throughout the wetland. The herbaceous vegetation covers >75% of the basin. There are cattle trails through the wetland. The adjacent uplands are scrubby flatwoods that are managed with prescribed fire.

**Wetland Concerns:** Cattle

**Restoration Action Recommended:** The uplands in this MU are in good ecological condition, although we have observed some cattle-related effects in both wetlands and uplands in some areas. We recommend removing cattle from this unit to prevent destruction of the intact flatwoods community and the embedded wetlands.

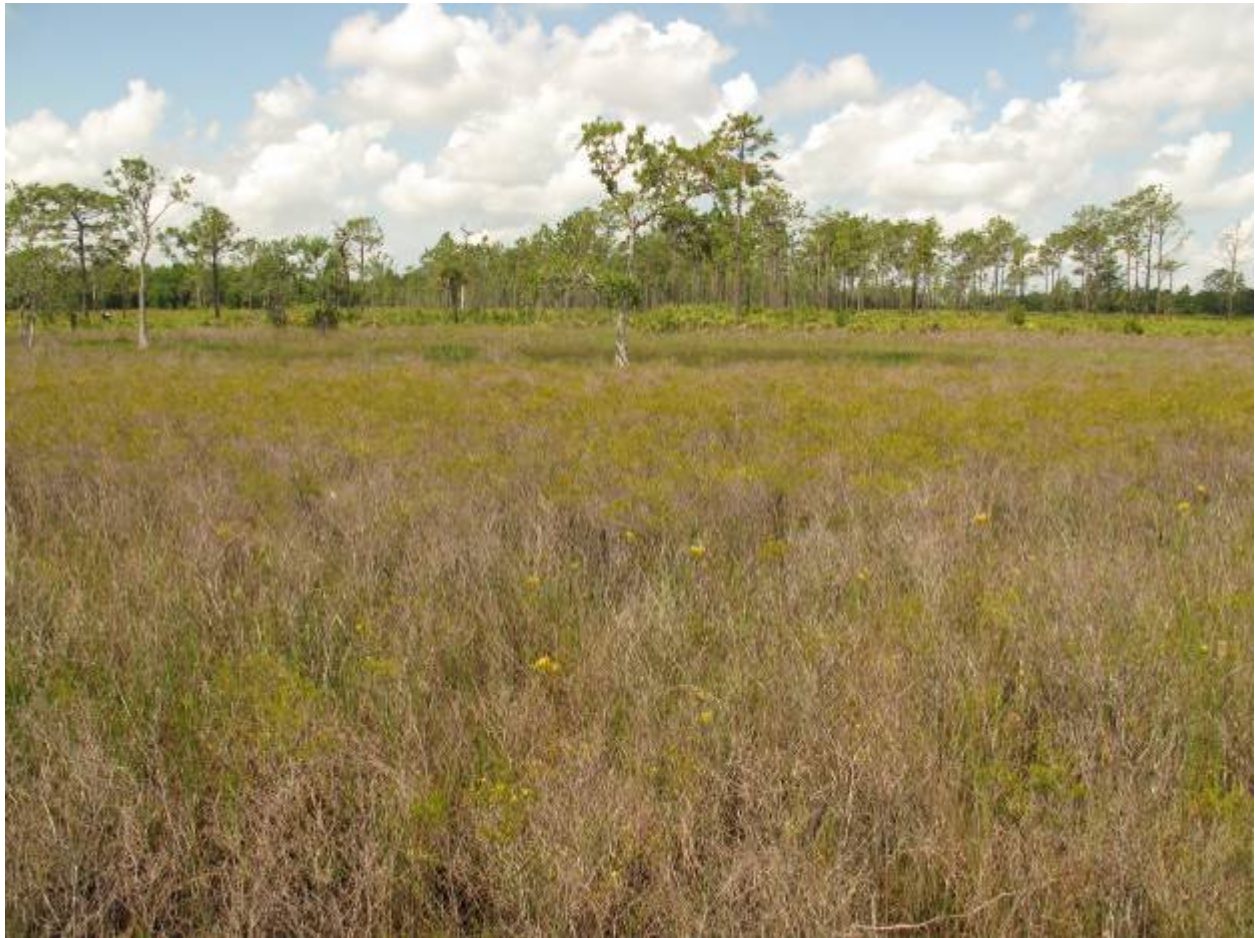
**Wetland ID: 38-07**

**Description:** This wetland is a 0.9 ha ephemeral marsh. There is no tree canopy or midstory cover. *Hypericum* is common in the wetland. Sedges/grasses grow throughout the wetland, and cover >75% of the basin. There are cattle trails and feces within the wetland. The adjacent uplands are scrubby flatwoods that are managed with prescribed fire.

**Wetland Concerns:** Cattle

**Restoration Action Recommended:** The uplands in this MU are in good ecological condition, although we have observed some cattle-related effects in both wetlands and uplands in some areas. We recommend removing cattle from this unit to prevent destruction of the intact flatwoods community and the embedded wetlands.

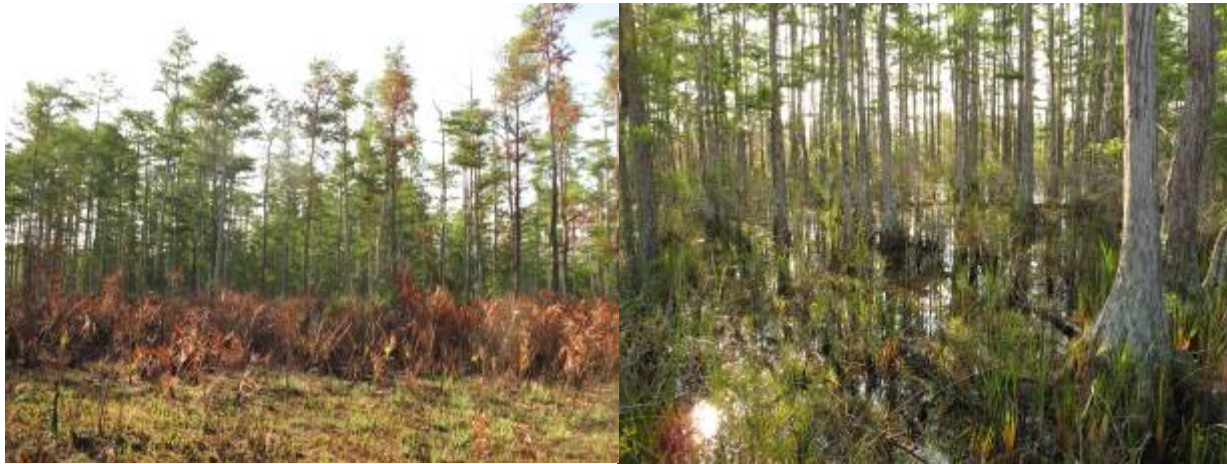
**Wetland ID: 39-01**

**Description:** This wetland is a 0.8 ha ephemeral forested swamp. Cypress trees dominate the canopy, and cover >75% of the basin. There is no midstory cover. Maidencane and sedges/grasses grow throughout the wetland, and cover >75% of the basin. A recent fire burned to the wetland edges. The adjacent uplands are scrubby flatwoods that are managed with prescribed fire.

**Wetland Concerns:** None

**Restoration Action Recommended:** The uplands in this MU are in good ecological condition, although we have observed some cattle-related effects in both wetlands and uplands in some areas. We recommend removing cattle from this unit to prevent destruction of the intact flatwoods community and the embedded wetlands.

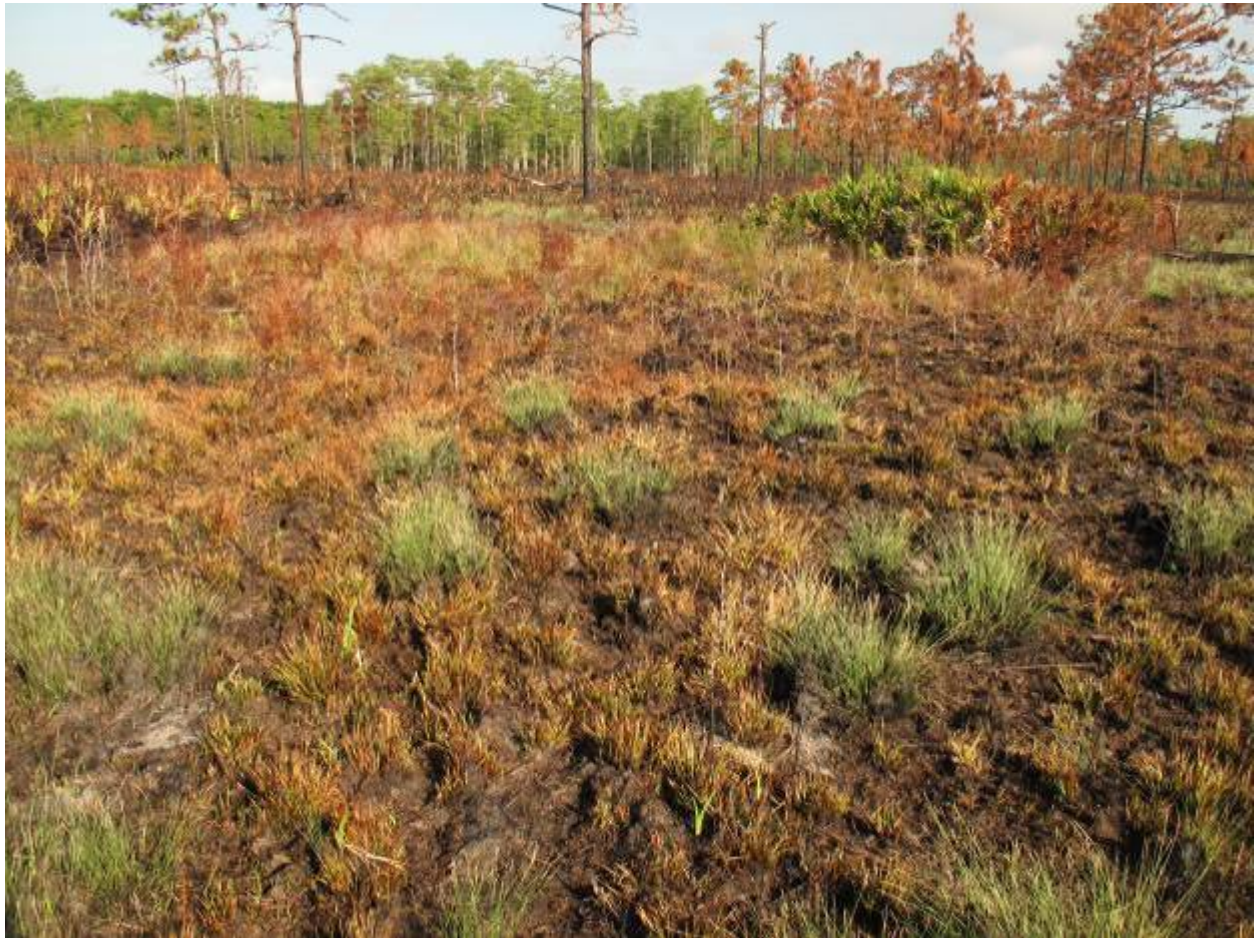
**Wetland ID: 39-02**

**Description:** This wetland is a 0.1 ha highly ephemeral marsh. There is no tree canopy or midstory cover. Sedges/grasses and redroot grow throughout the wetland, and cover >75% of the basin. A recent fire burned entirely through the wetland basin. Feral hog damage is moderate and patchy. This wetland has been trampled by cattle and the herbaceous vegetation has been grazed. There is an old fireline ditch near the east side of the wetland. The adjacent uplands are scrubby flatwoods that are managed with prescribed fire.

**Wetland Concerns:** Feral hog damage, Cattle

**Restoration Action Recommended:** The uplands in this MU are in good ecological condition, although we have observed some cattle-related effects in both wetlands and uplands in some areas. We recommend removing cattle from this unit to prevent destruction of the intact flatwoods community and the embedded wetlands.

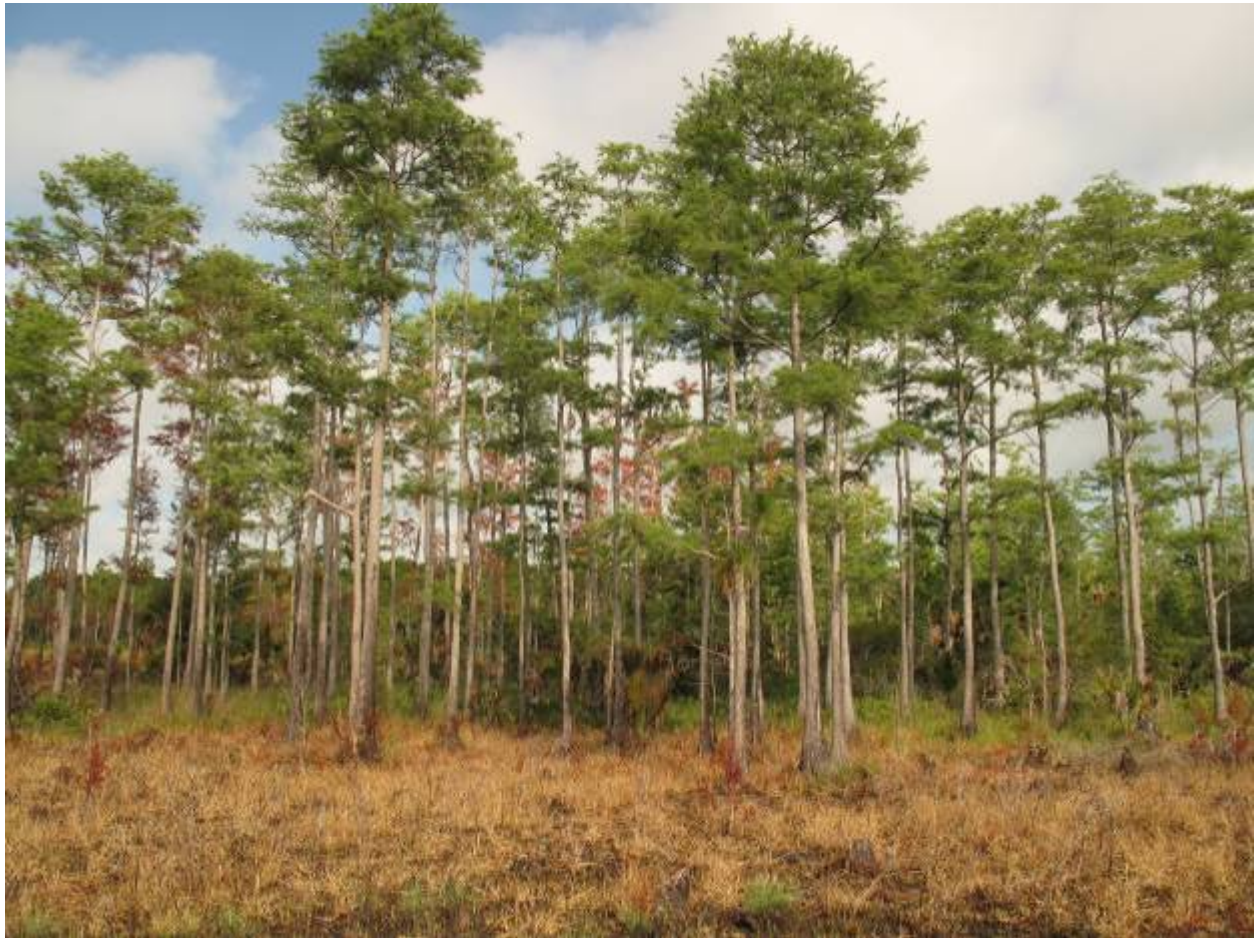
**Wetland ID: 39-03**

**Description:** This wetland is a 0.5 ha ephemeral forested swamp. Cypress trees dominate the canopy, and cover 50-75% of the basin. The midstory is dominated by small palm trees, and covers 5-25% of the wetland. Fern, *Sphagnum*, and sedges/grasses grow throughout the wetland, and cover >75% of the basin. A recent fire burned to the wetland edges. There are cattle tracks and trails around the wetland edge. The adjacent uplands are scrubby flatwoods that are managed with prescribed fire.

**Wetland Concerns:** Cattle

**Restoration Action Recommended:** The uplands in this MU are in good ecological condition, although we have observed some cattle-related effects in both wetlands and uplands in some areas. We recommend removing cattle from this unit to prevent destruction of the intact flatwoods community and the embedded wetlands.

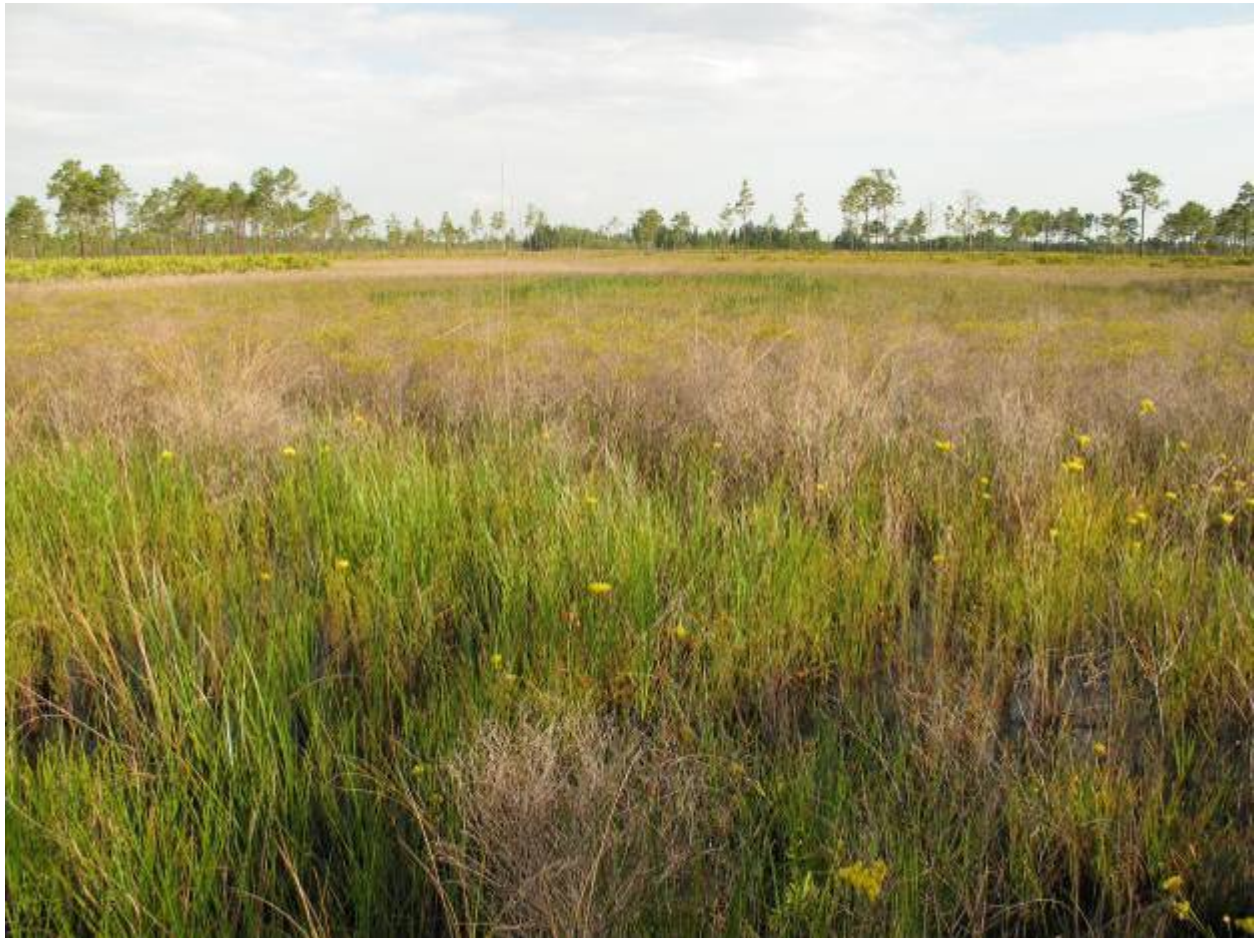
**Wetland ID: 45-01**

**Description:** This wetland is a 0.8 ha ephemeral marsh. There is no tree canopy or midstory cover. *Hypericum* is common within the wetland. Emergent vegetation grows in the wetland center, and sedges/grasses grow throughout the wetland. The herbaceous vegetation covers >75% of the basin. There is a distinct game trail along the south side of the wetland. The adjacent uplands are mostly scrubby flatwoods that are managed with prescribed fire.

**Wetland Concerns:** None

**Restoration Action Recommended:** None

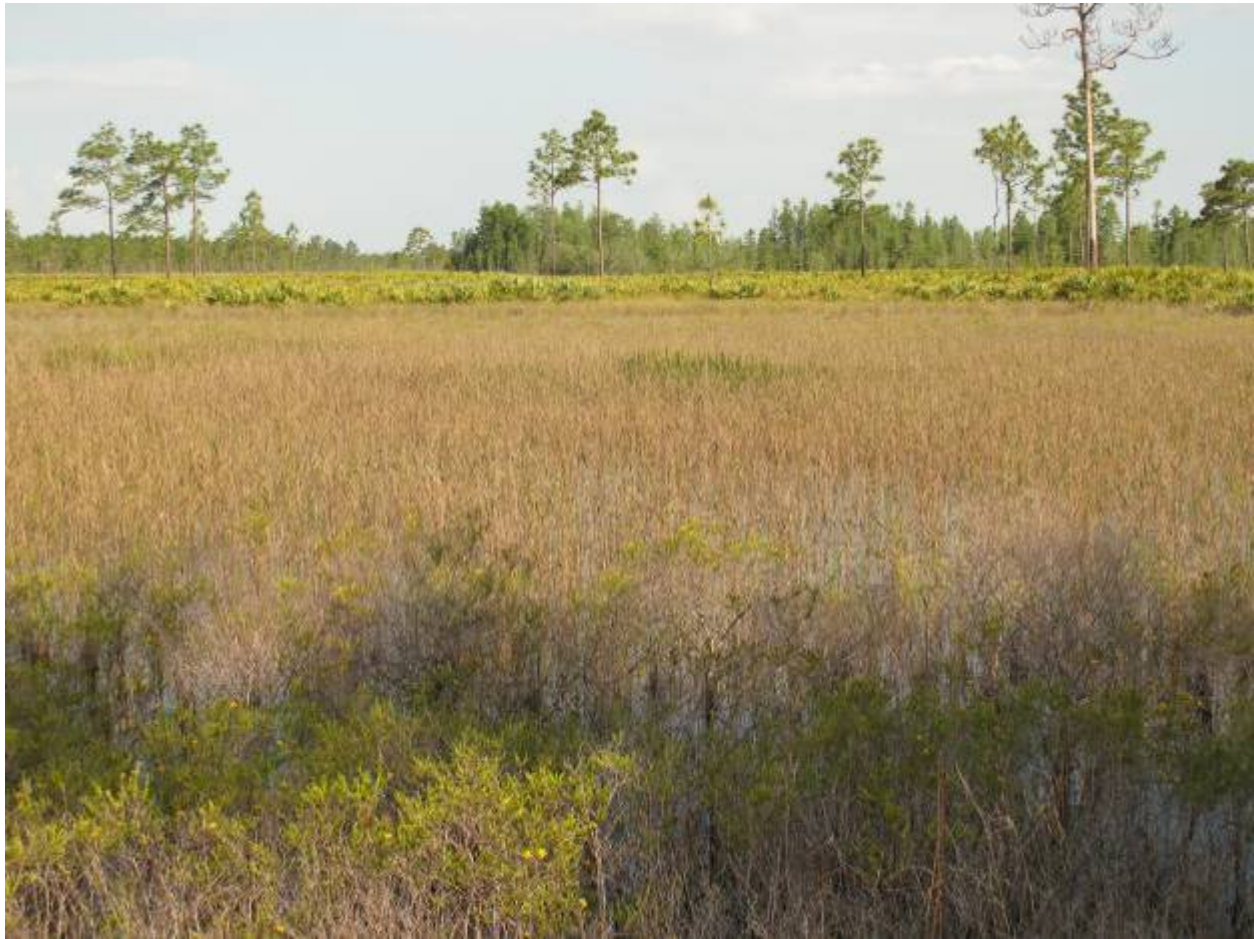
**Description:** This wetland is a 0.5 ha ephemeral marsh. There is no tree canopy or midstory cover. *Hypericum* grows in a ring around the outer edge of the wetland. Maidencane grows in the wetland center, and sedges/grasses grow around the wetland edge. The herbaceous vegetation covers >75% of the basin. There is a distinct game trail around the edge of the wetland. The adjacent uplands are scrubby flatwoods that are managed with prescribed fire.

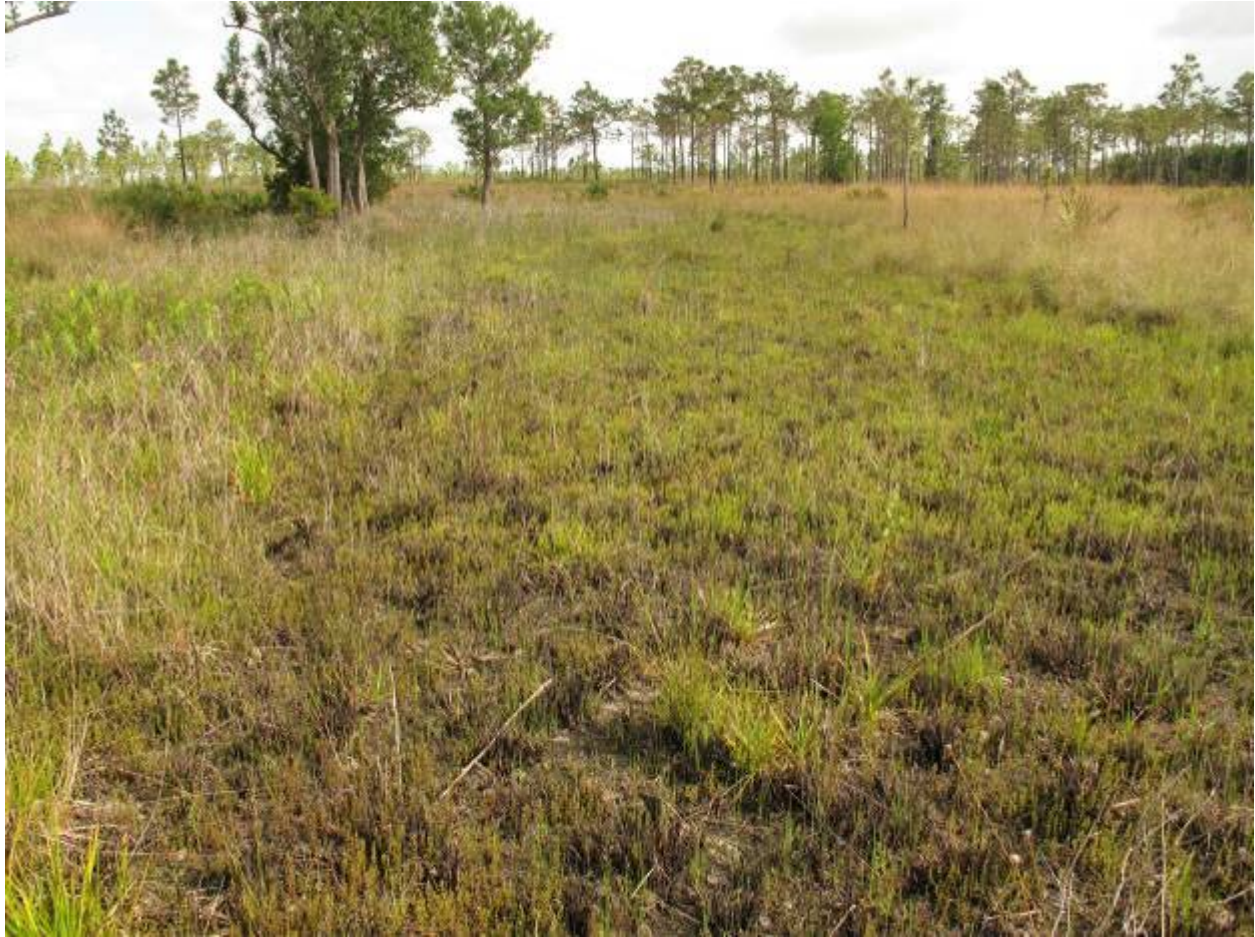
**Wetland ID: 46-01**

**Description:** This wetland is a 0.1 ha ephemeral marsh. Gum trees grow in the north and south ends of the wetland, and cover 5-25% of the basin. There is no midstory cover. Sedges/grasses grow throughout the wetland, and cover >75% of the basin. Fern are now growing on old, patchy feral hog damage. The adjacent uplands are mesic flatwoods that are managed with prescribed fire.

**Wetland Concerns:** Feral hog damage

**Restoration Action Recommended:** None

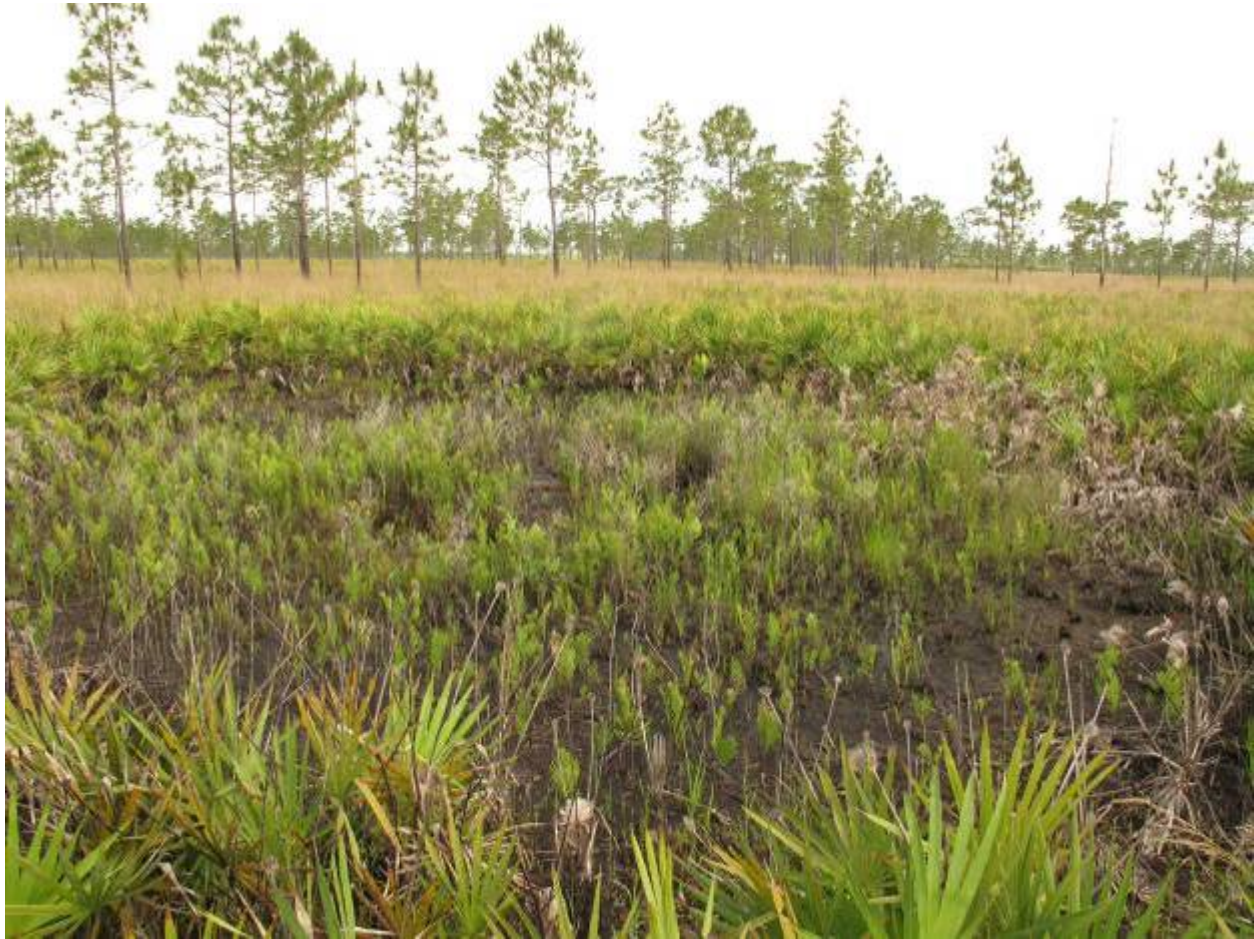
**Description:** This wetland is a <0.1 ha ephemeral marsh. There is no tree canopy or midstory cover. Fern grow throughout the wetland, and redroot and sedges/grasses also are common. The herbaceous vegetation covers 50-75% of the basin. Feral hog damage is old and growing over with vegetation. The wetland had dried just before the day of our visit. The adjacent uplands are mesic flatwoods that are managed with prescribed fire.

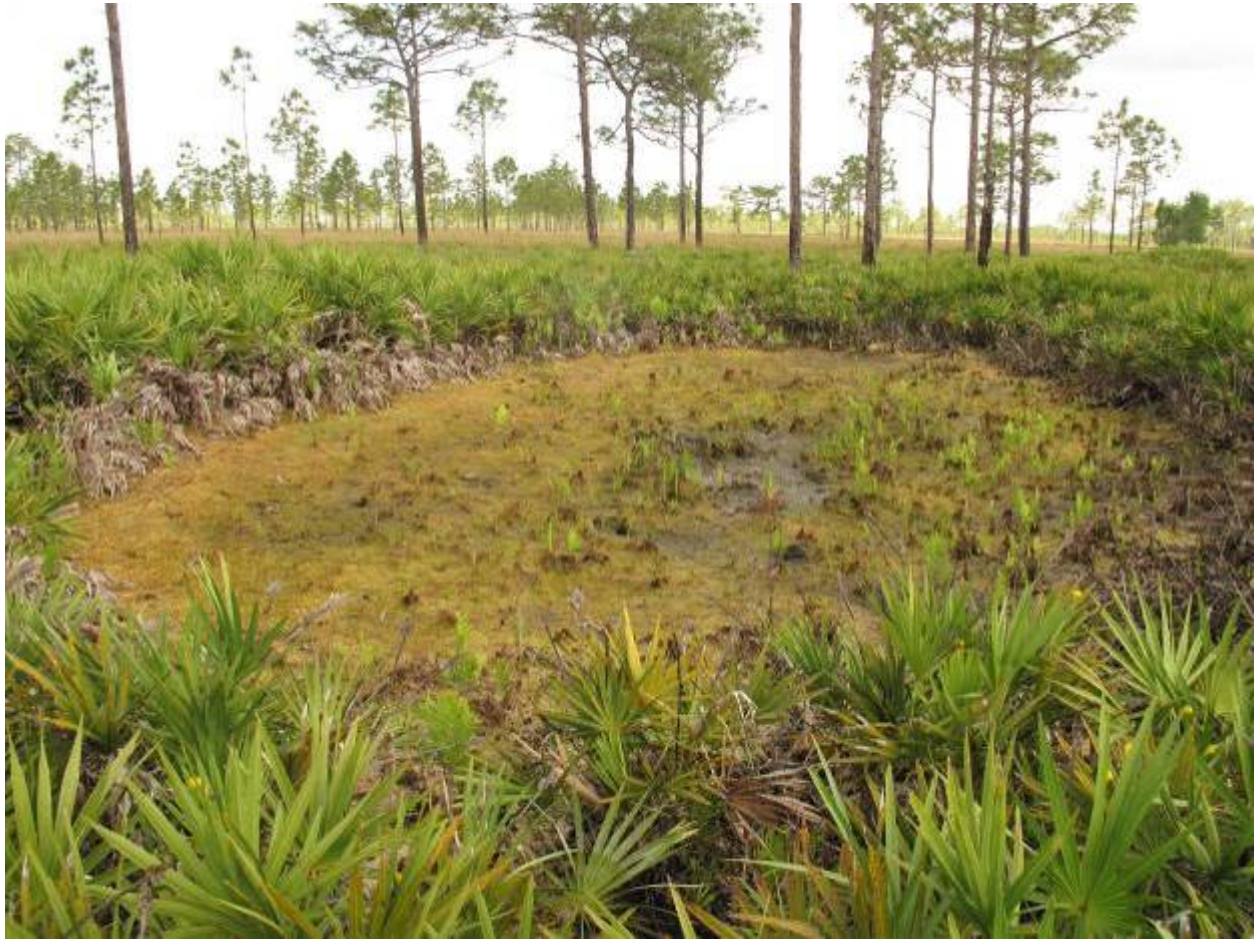
**Description:** This wetland is a <0.1 ha ephemeral marsh. There is no tree canopy or midstory cover. *Sphagnum* grows throughout the wetland and fern and redroot grow in scattered patches. The herbaceous vegetation covers >75% of the basin. The adjacent uplands are mesic flatwoods that are managed with prescribed fire.

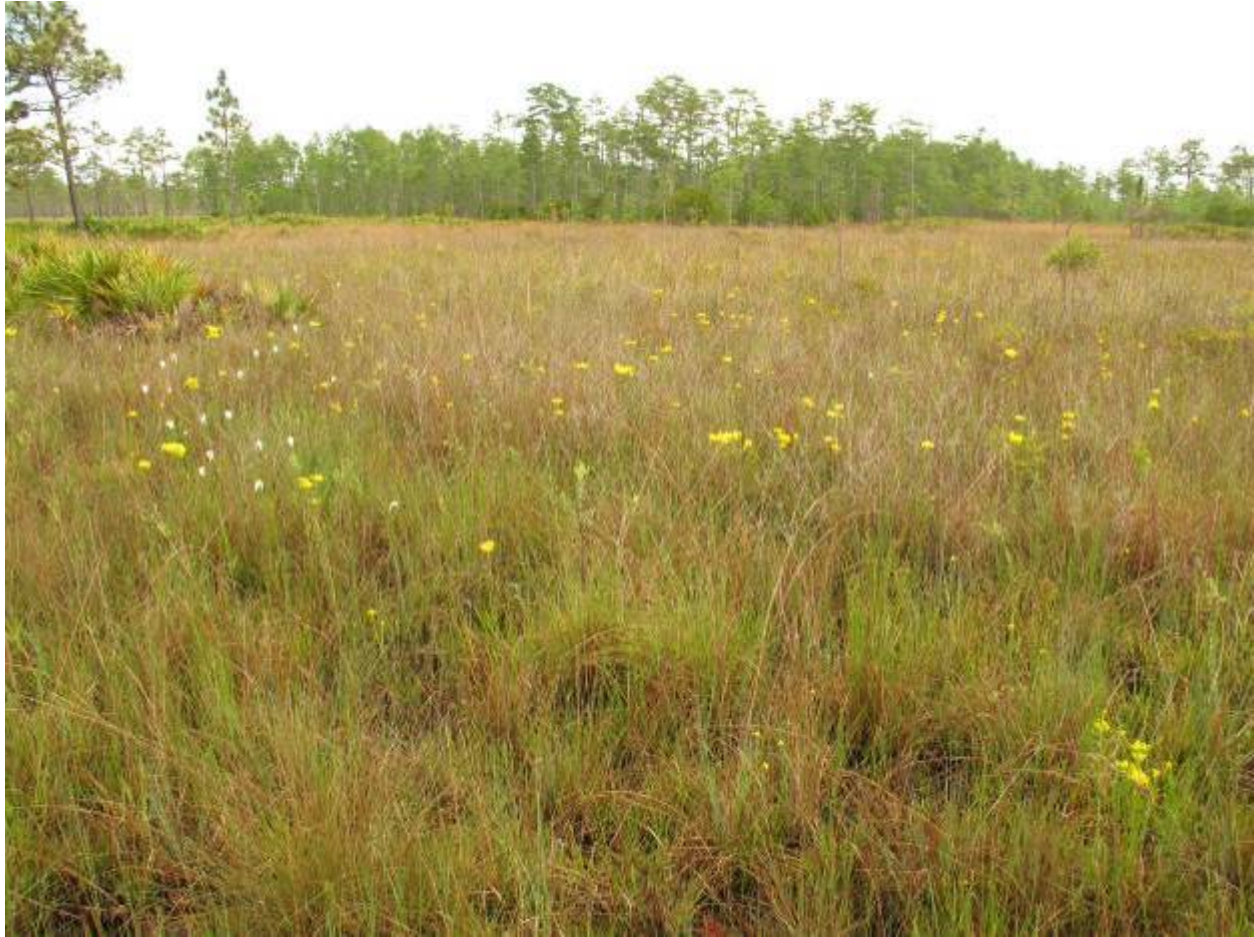
**Wetland ID: 46-04**

**Description:** This wetland is a 0.2 ha ephemeral marsh. There is no tree canopy or midstory cover. *Hypericum* is common within the wetland. A high diversity of herbaceous vegetation grows throughout the wetland, and covers >75% of the basin. This wetland may connect to a semi-permanent swamp to the north during times of high water. The adjacent uplands are mesic flatwoods that are managed with prescribed fire.

**Wetland Concerns:** None

**Restoration Action Recommended:** None

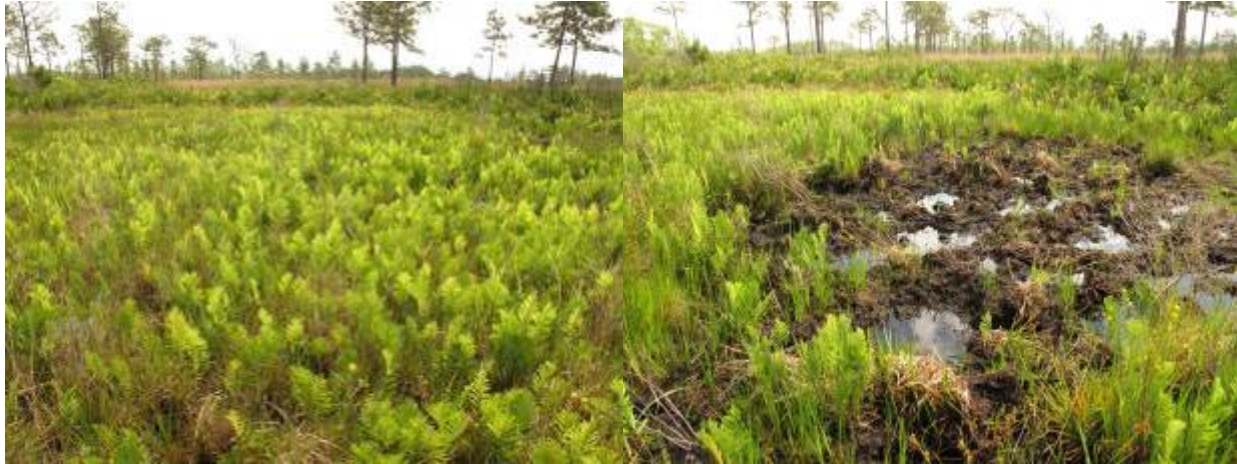
**Wetland ID: 46-05**

**Description:** This wetland is a 0.1 ha ephemeral marsh. There is no tree canopy or midstory cover. Fern and sedges/grasses grow throughout the wetland, and cover >75% of the basin. Feral hog damage is extensive. The adjacent uplands are mesic flatwoods that are managed with prescribed fire.

**Wetland Concerns:** Feral hog damage

**Restoration Action Recommended:** None

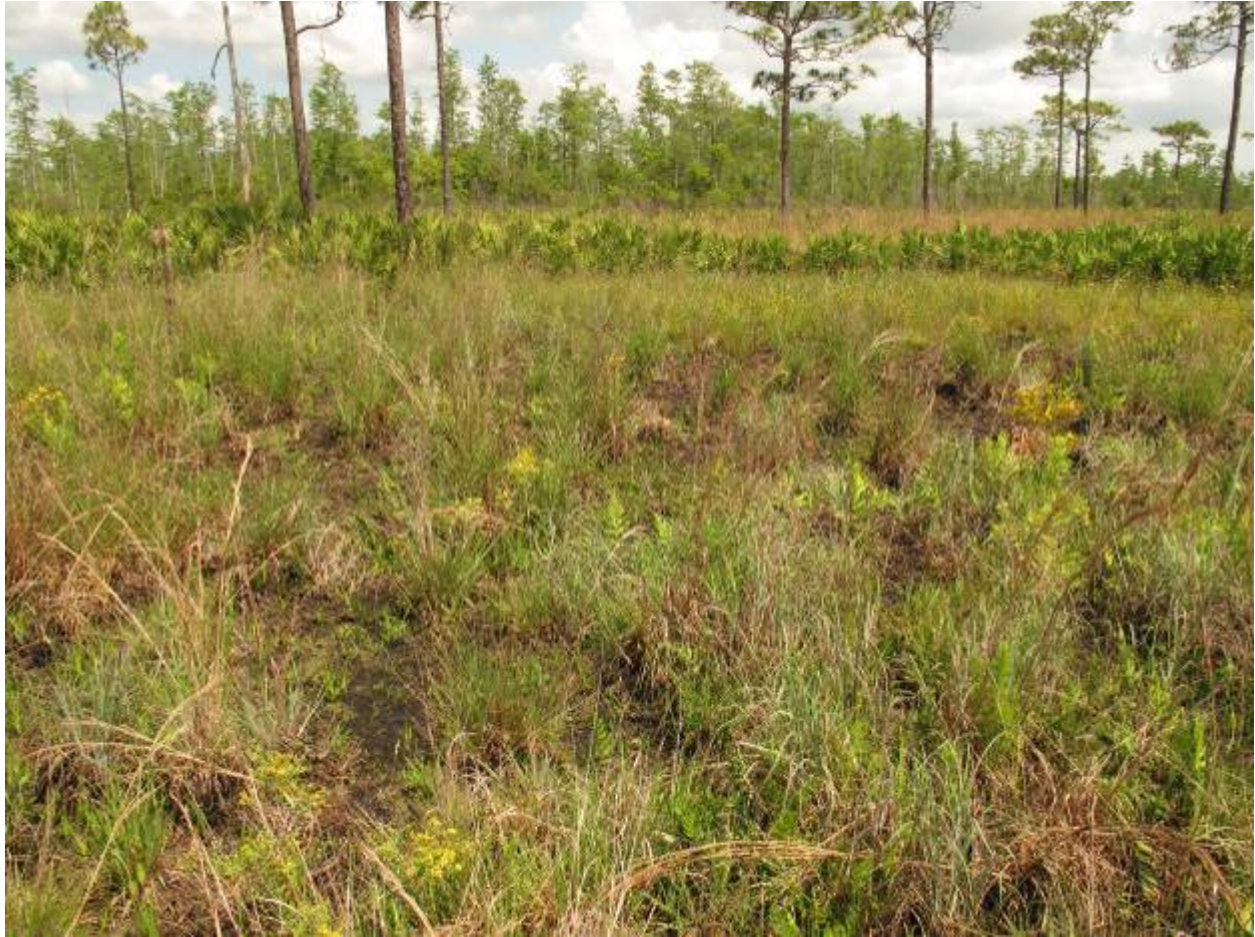
**Wetland ID: 46-06**

**Description:** This wetland is a 0.1 ha ephemeral marsh. There is no tree canopy or midstory cover. A high diversity sedges/grasses, fern, and redroot grows throughout the wetland, and covers 50-75% of the basin. Feral hog damage is recent and widespread. The adjacent uplands are mesic flatwoods that are managed with prescribed fire.

**Wetland Concerns:** Feral hog damage

**Restoration Action Recommended:** None

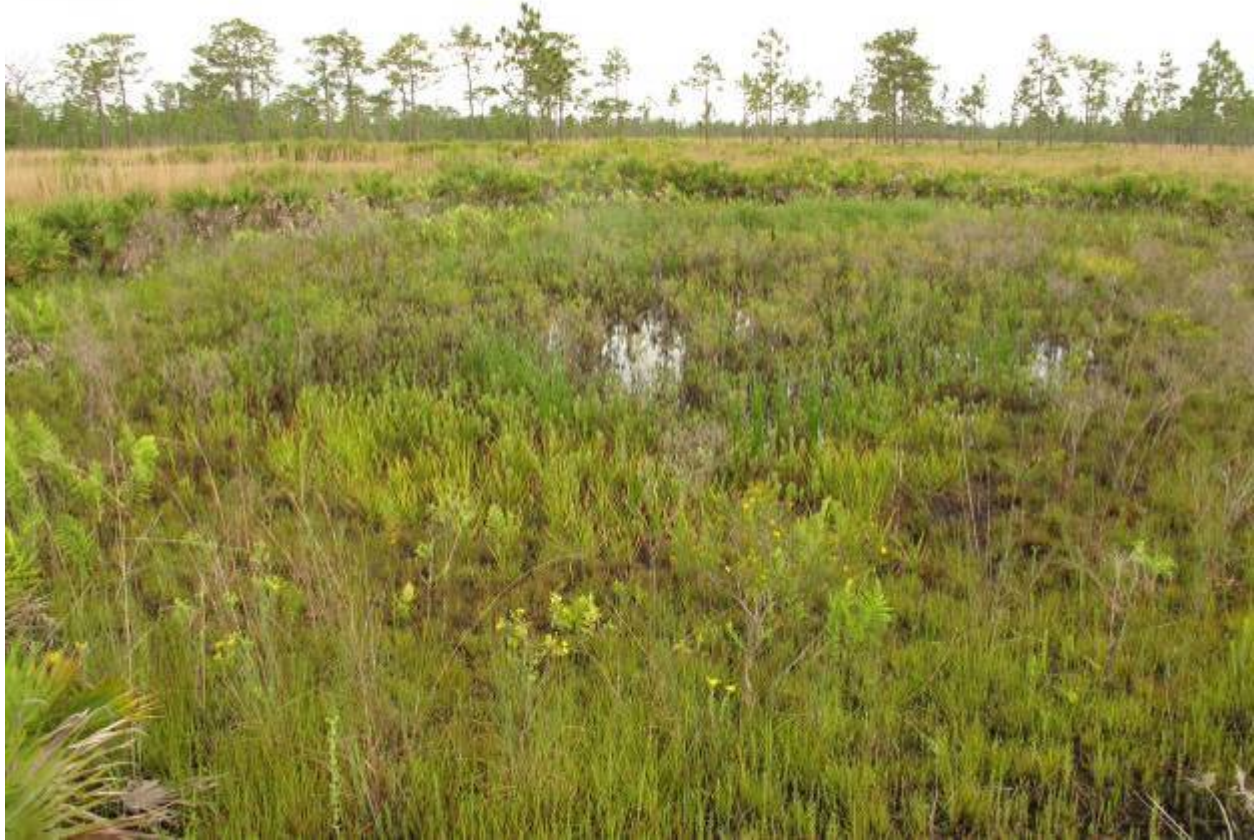
**Wetland ID: 46-07**

**Description:** This wetland is a <0.1 ha ephemeral marsh. There is no tree canopy or midstory cover. *Hypericum* is common within the wetland. Sedges/grasses grow throughout the wetland, and cover >75% of the basin. The adjacent uplands are mesic flatwoods that are managed with prescribed fire.

**Wetland Concerns:** None

**Restoration Action Recommended:** None

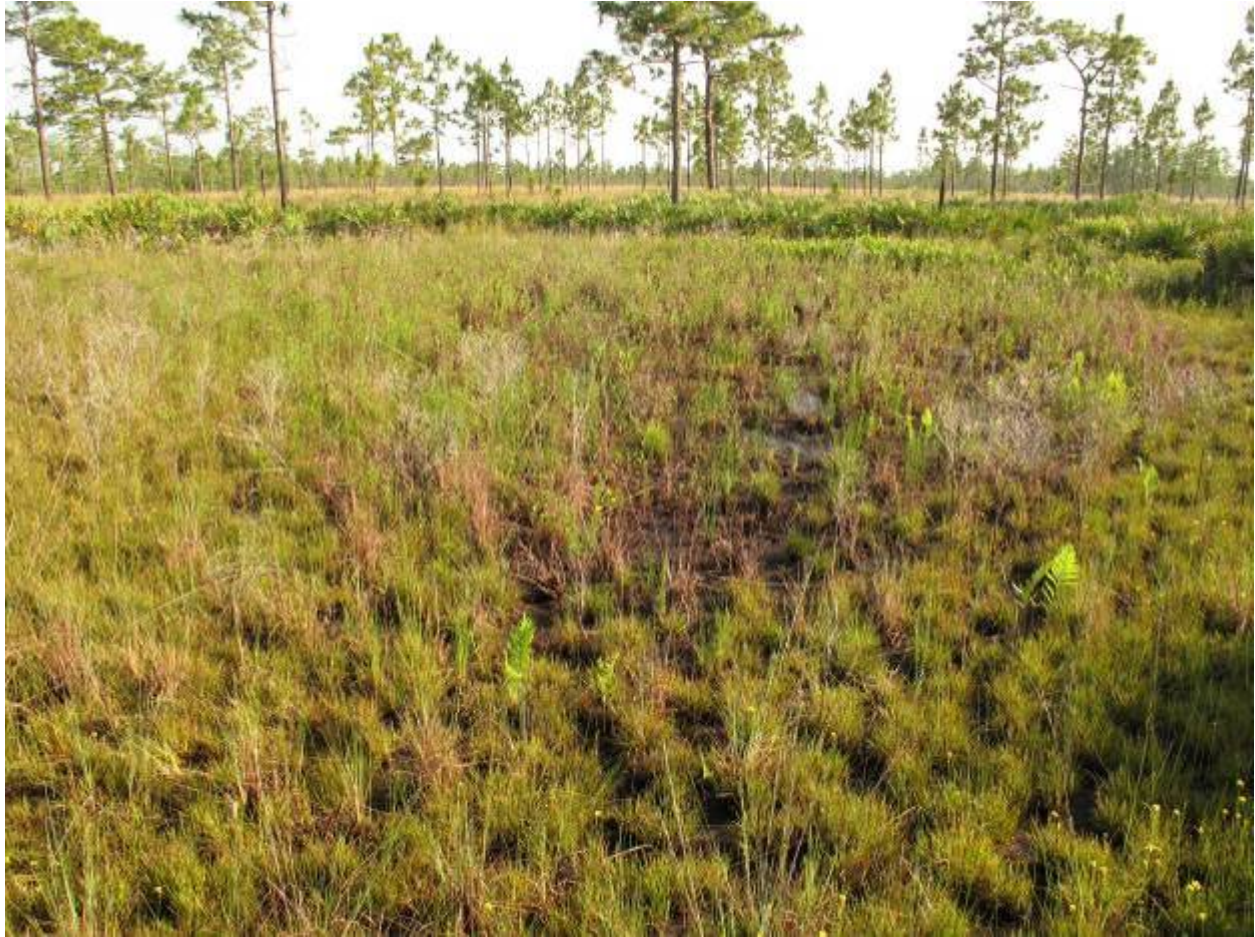
**Wetland ID: 46-08**

**Description:** This wetland is a <0.1 ha ephemeral marsh. There is no tree canopy or midstory cover. A high diversity of herbaceous vegetation grows throughout the wetland, and covers >75% of the basin. Feral hog damage is old and patchy. The adjacent uplands are mesic flatwoods that are managed with prescribed fire.

**Wetland Concerns:** Feral hog damage

**Restoration Action Recommended:** None

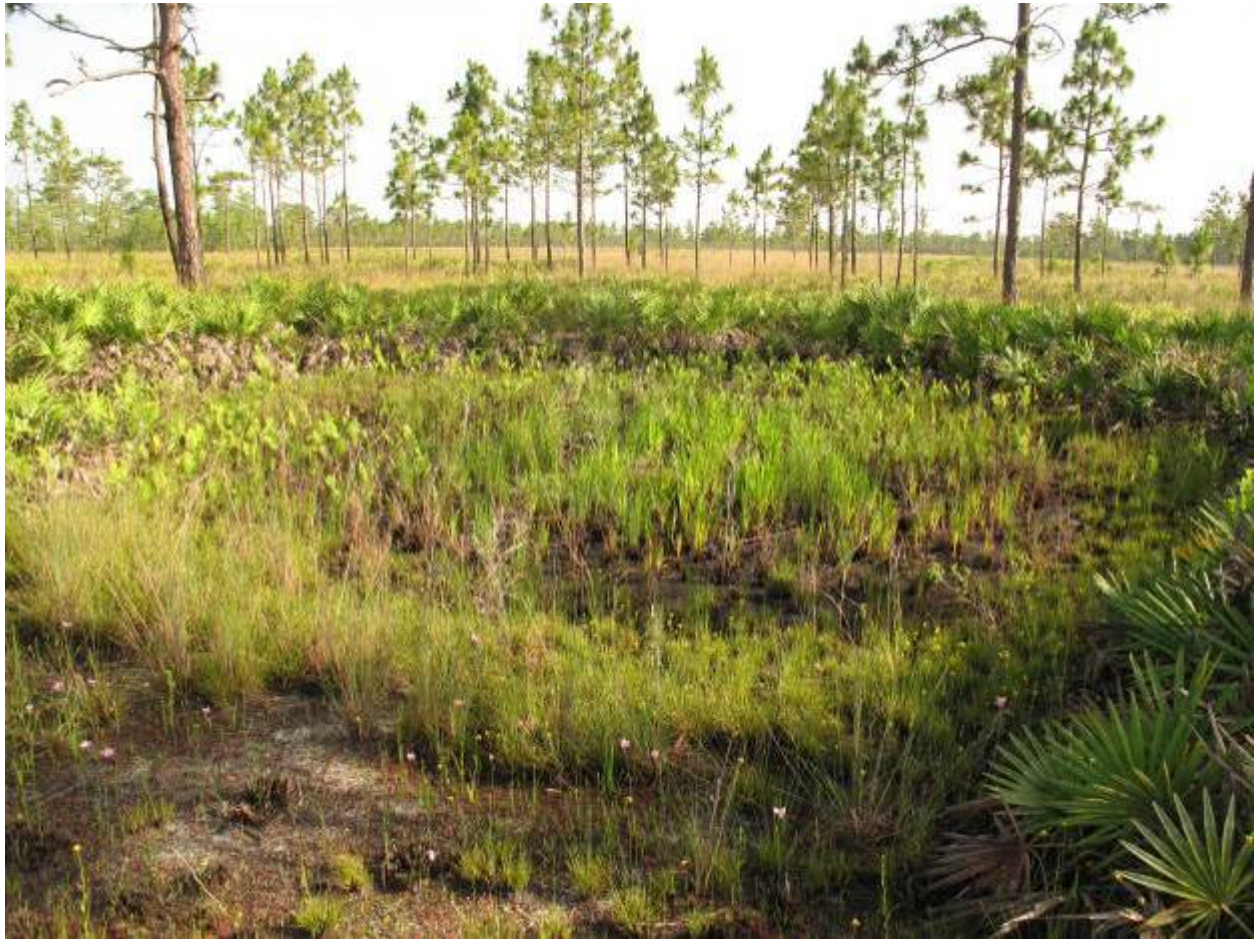
**Description:** This wetland is a <0.1 ha ephemeral marsh. There is no tree canopy or midstory cover. Redroot grows in the wetland interior and sedges/grasses grow throughout the wetland. The herbaceous vegetation covers >75% of the basin. The adjacent uplands are mesic flatwoods that are managed with prescribed fire.

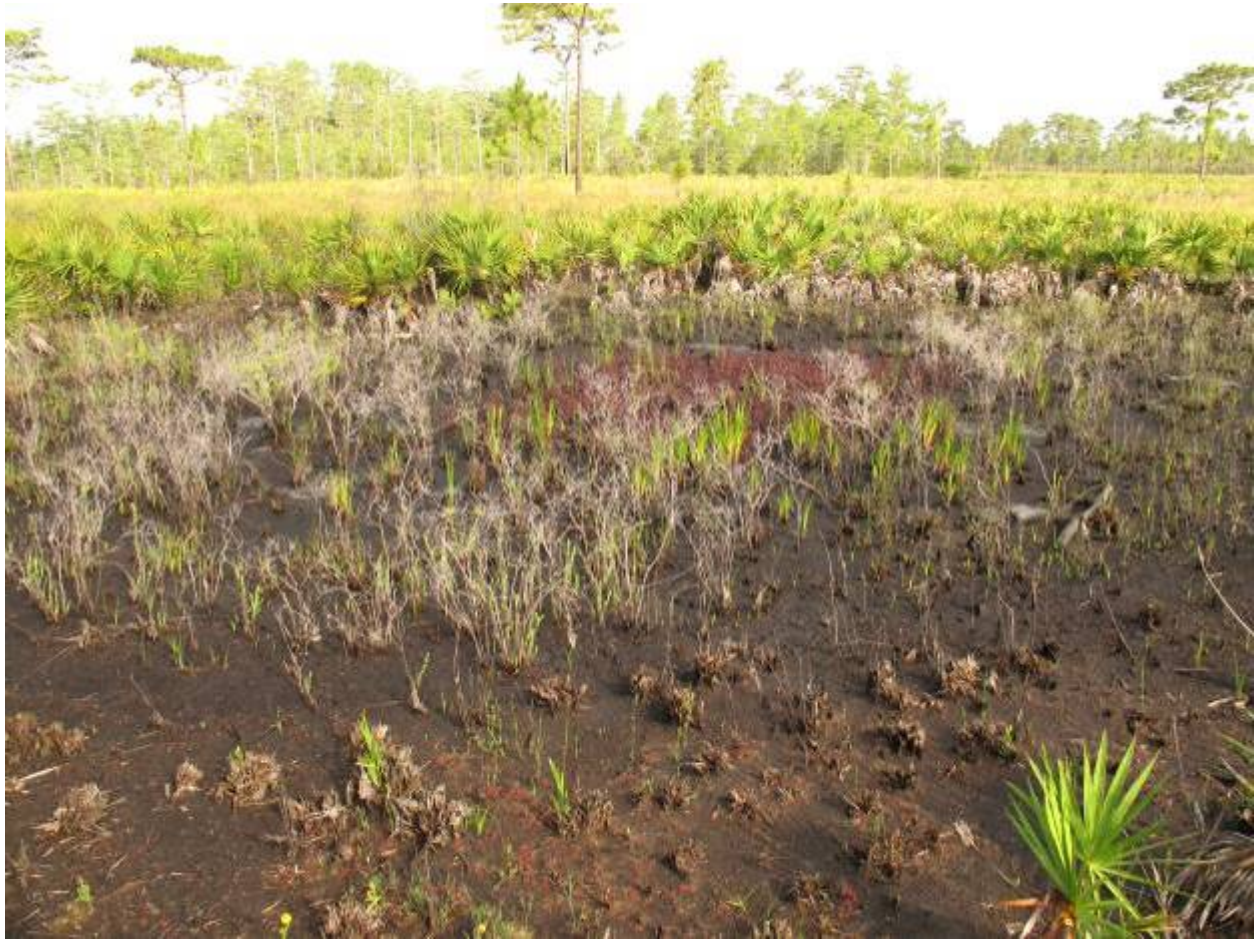
**Description:** This wetland is a <0.1 ha ephemeral marsh. There is no tree canopy or midstory cover. It appears that a fire burned through the wetland basin and then the wetland was inundated with water. On the day of our visit, the wetland had recently dried, exposing bare soil. Emergent vegetation grows in the wetland interior and sedges/grasses grow sparsely throughout the wetland. The herbaceous vegetation covers 25-50% of the basin. The adjacent uplands are a mix of scrubby and mesic flatwoods that are managed with prescribed fire.

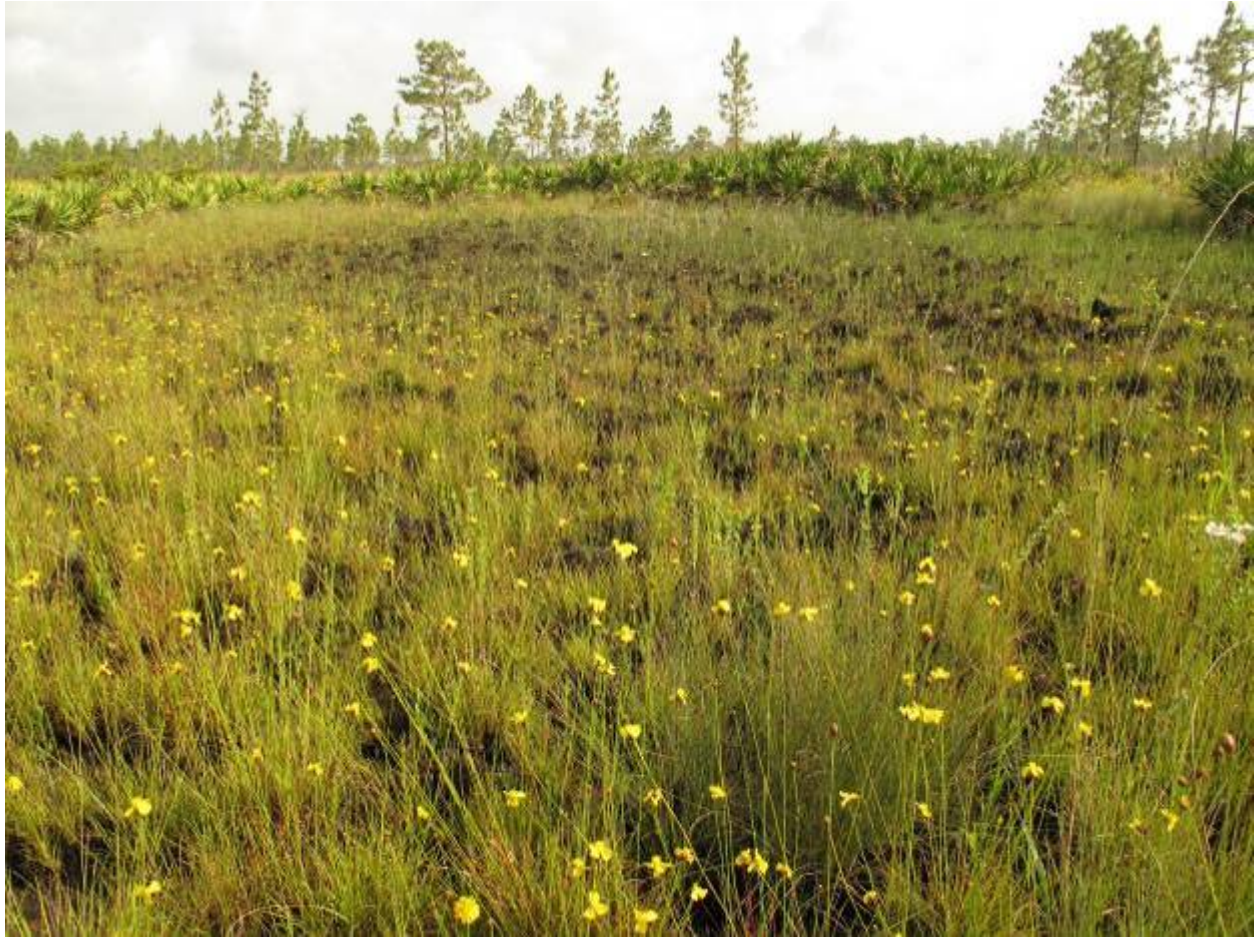
**Wetland ID: 46-11**

**Description:** This wetland is a <0.1 ha ephemeral marsh. There is no tree canopy or midstory cover. It appears that a fire burned through the wetland basin and then the wetland was inundated with water. On the day of our visit, the wetland had recently dried, exposing bare soil. Sedges/grasses grow throughout the wetland, and cover >75% of the basin. The adjacent uplands are a mix of scrubby and mesic flatwoods that are managed with prescribed fire.

**Wetland Concerns:** None

**Restoration Action Recommended:** None
