# **Inventory, Assessment, and Restoration Potential of Ephemeral Wetlands on FFWCC Wildlife Management Areas**

## **Triple N Ranch WMA Final Report**

Submitted by: Rebecca P.M. Means<sup>1</sup>, Ryan C. Means<sup>1</sup>, Steven A. Johnson<sup>2</sup>

15 May 2010 – 15 August 2010

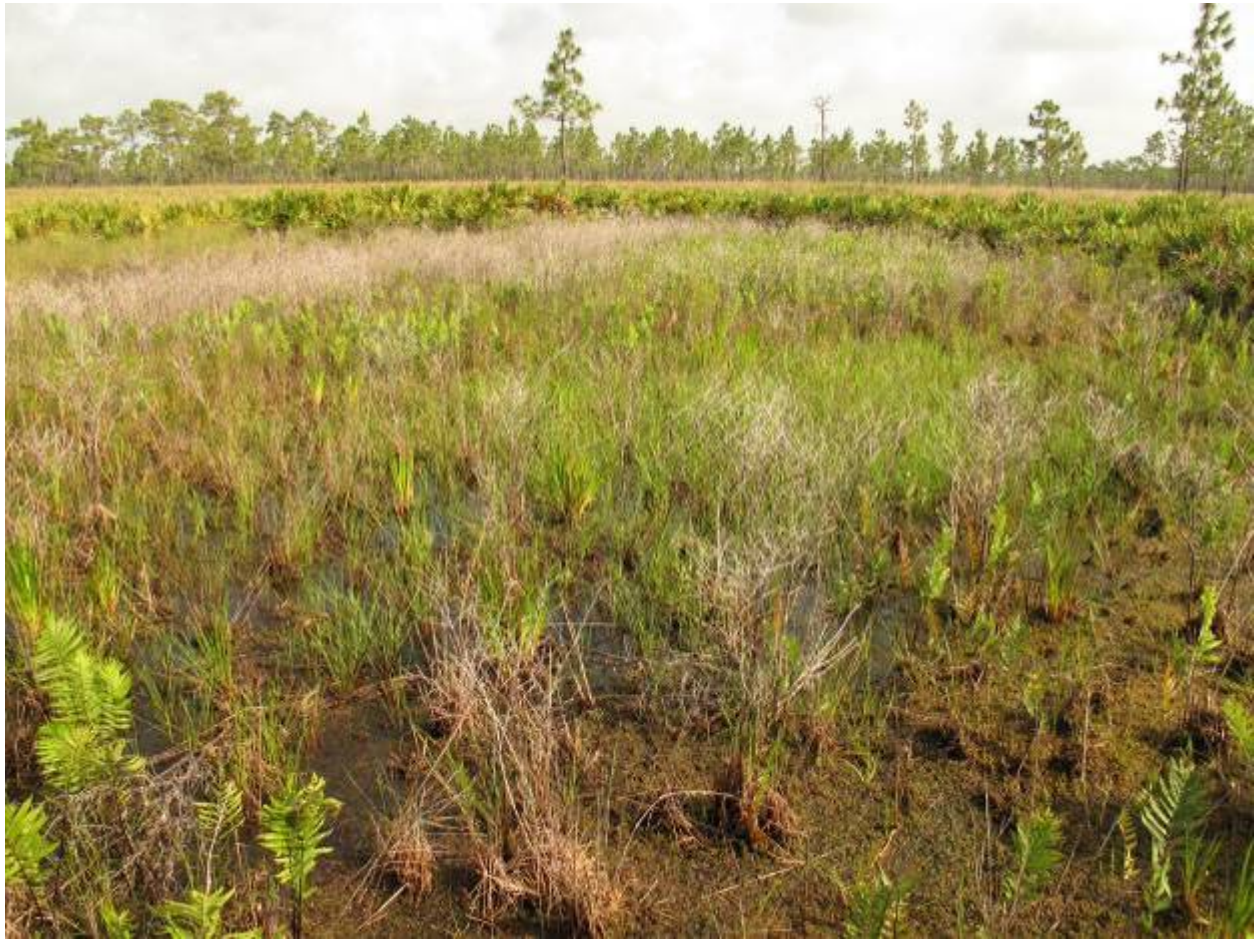
**Description:** This wetland is a <0.1 ha ephemeral marsh. There is no tree canopy or midstory cover. Fern grow in the wetland center and sedges/grasses grow throughout the wetland. The herbaceous vegetation covers >75% of the basin. Feral hog damage, both old and new, is patchy in the wetland. The adjacent uplands are a mix of scrubby and mesic flatwoods that are managed with prescribed fire.

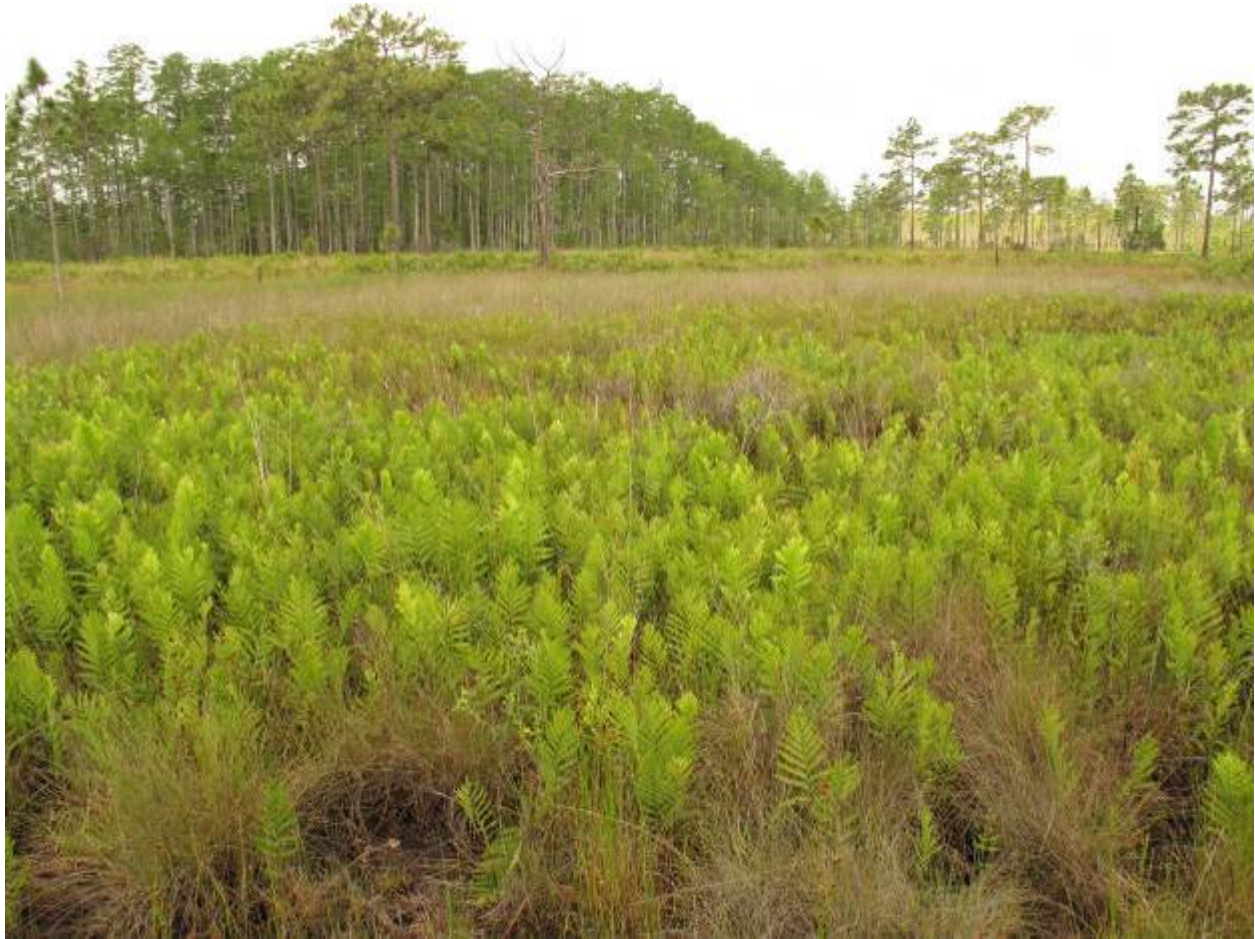
**Description:** This wetland is a 0.2 ha ephemeral marsh. There is no tree canopy or midstory cover. Fern grow on areas damaged by feral hogs and sedges/grasses grow throughout the wetland. The herbaceous vegetation covers >75% of the basin. The adjacent uplands are a mix of scrubby and mesic flatwoods that are managed with prescribed fire.

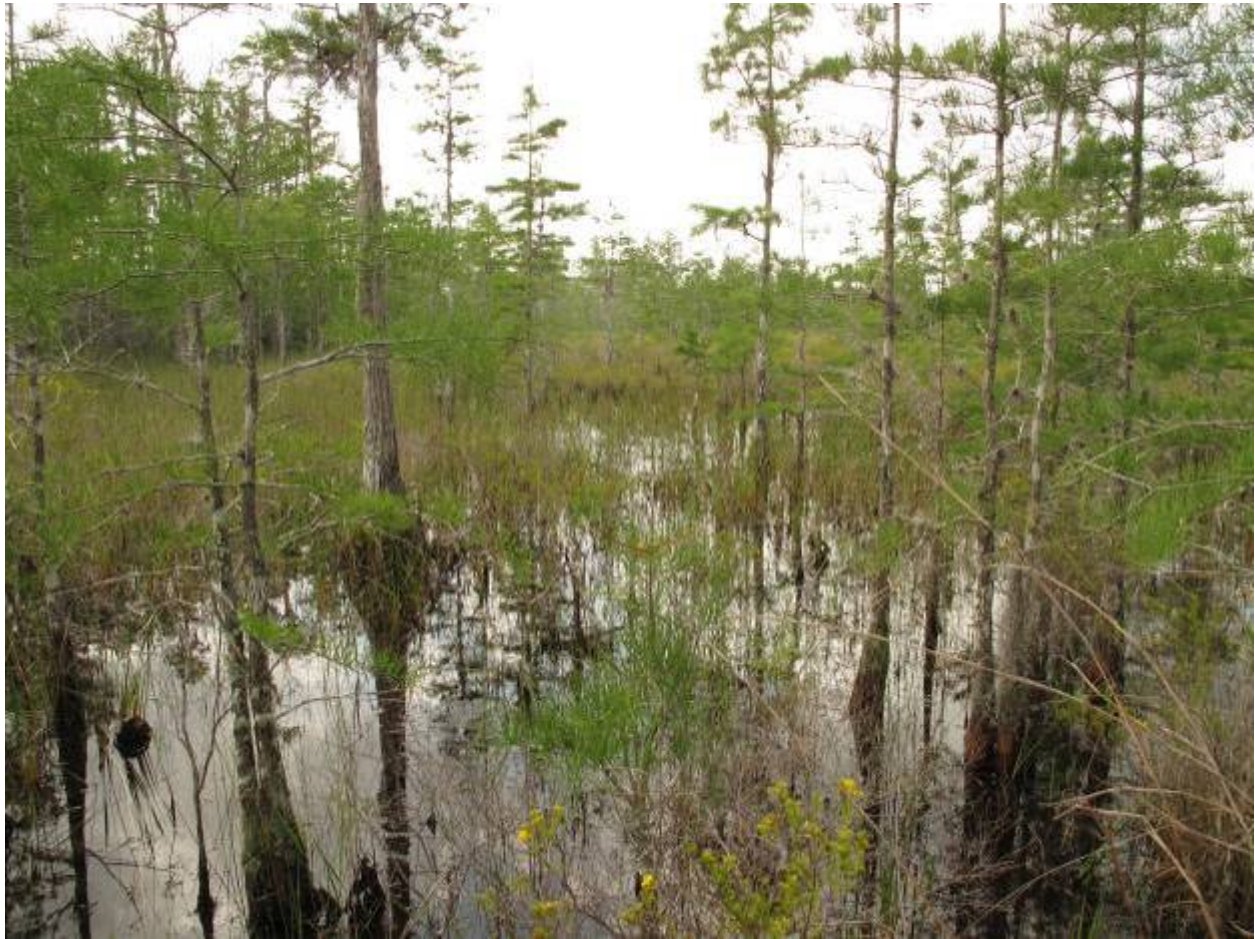
**Description:** This wetland is a 3.6 ha semi-permanent mixed marsh and forested swamp. It appears to be a marsh succeeding to a cypress dome. Cypress trees dominate the canopy, and cover 25-50% of the basin. The midstory is dominated by small cypress trees, and covers 5-25% of the wetland. A large diversity of maidencane, *Sphagnum*, and sedges/grasses grows throughout the wetland, and covers >75% of the basin. Small fish were present on the day of our visit. The adjacent uplands are a mix of scrubby and mesic flatwoods that are managed with prescribed fire.

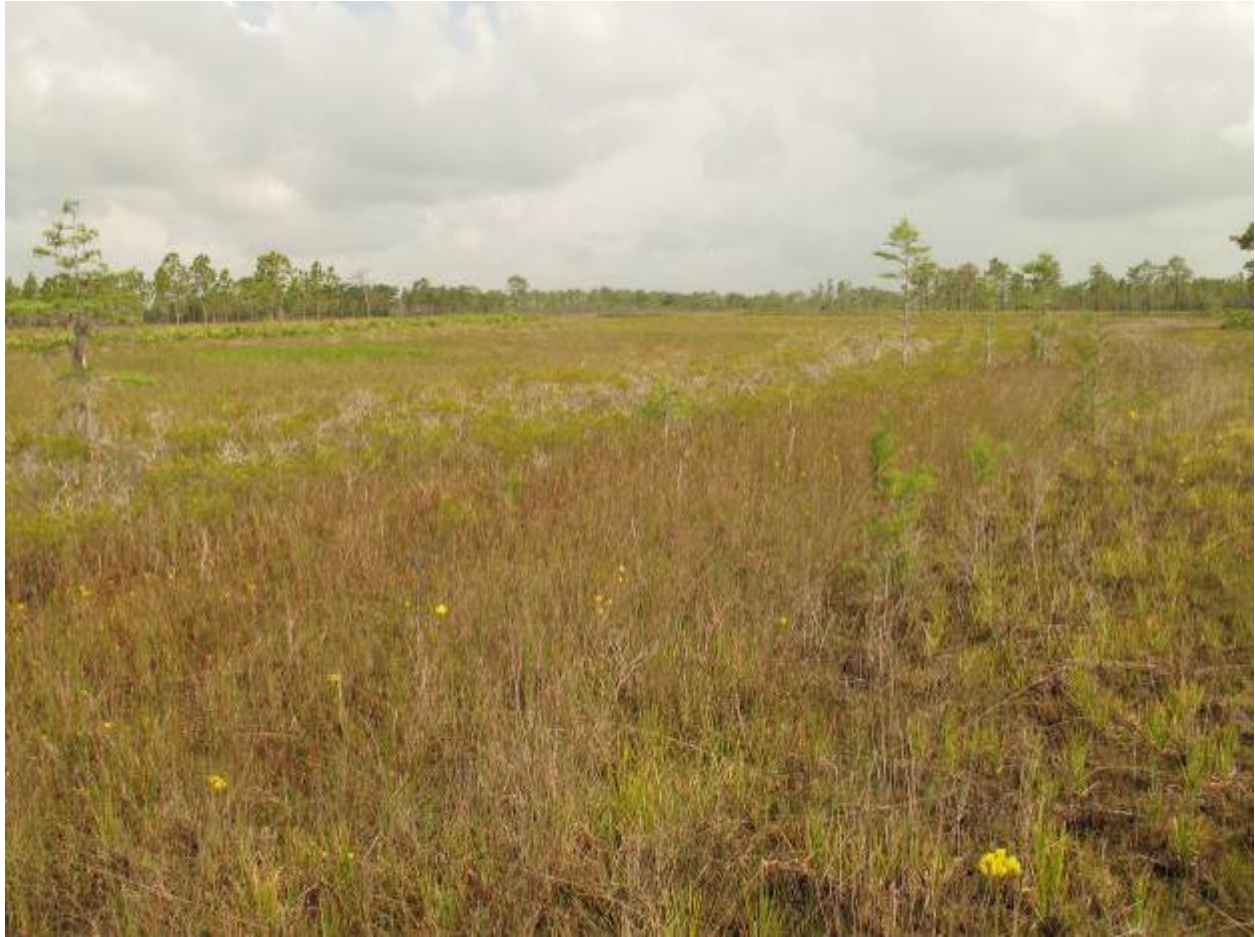
**Wetland ID: 46-15**

**Description:** This wetland is a 3.0 ha ephemeral marsh. There is a cypress dome on the south end of the wetland, the cypress trees cover 5-25% of the basin. There is no midstory cover. *Hypericum* grows in a ring around the wetland center. Maidencane grows in the wetland interior, and sedges/grasses grow in an outer ring around the wetland interior. The herbaceous vegetation covers >75% of the basin. The adjacent uplands are a mix of scrubby and mesic flatwoods that are managed with prescribed fire.

**Wetland Concerns:** None

**Restoration Action Recommended:** None

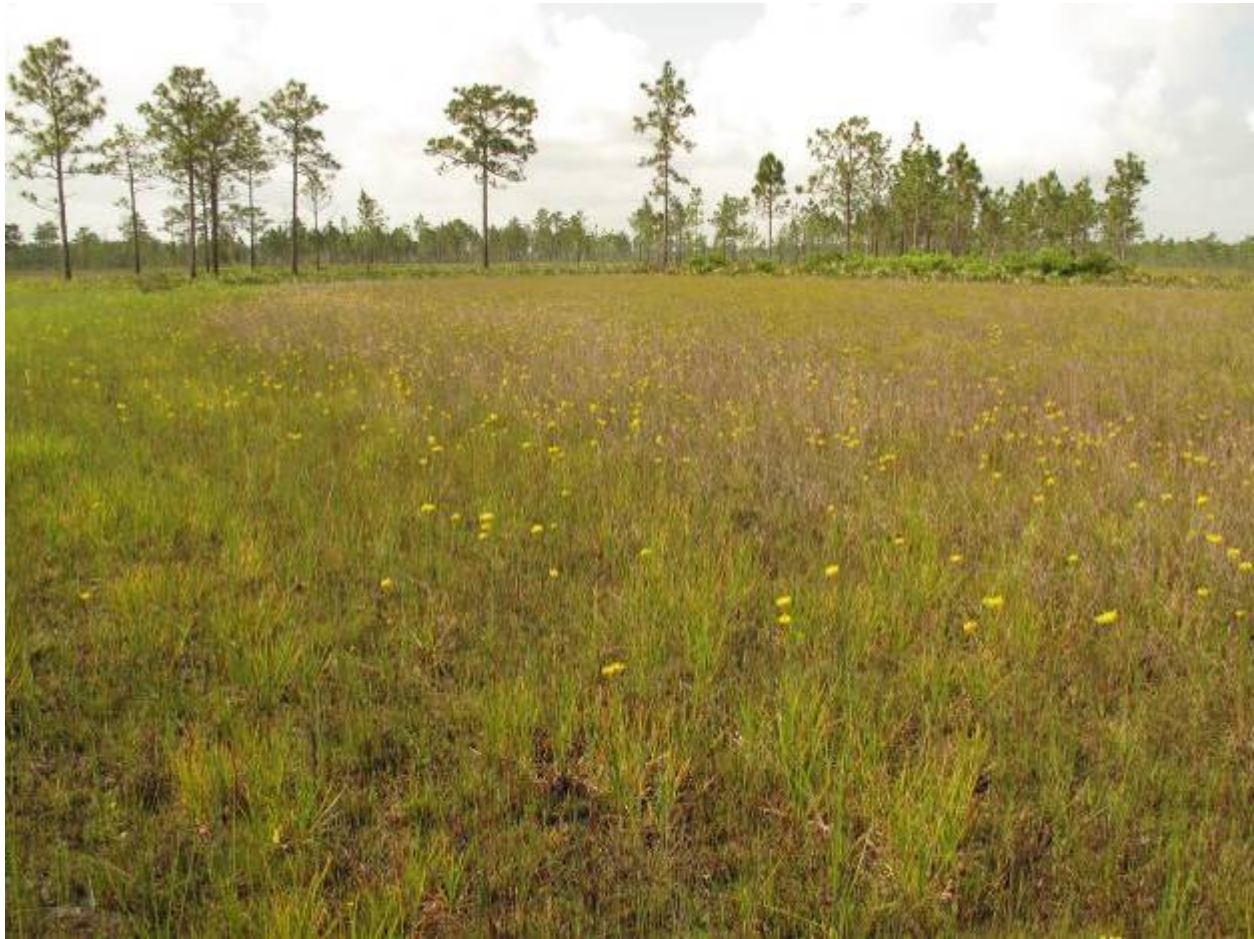
**Description:** This wetland is a 0.4 ha ephemeral marsh. There is no tree canopy or midstory cover. *Hypericum* is common in the wetland. Maidencane grows in the wetland interior and a diverse array of sedges/grasses grows in an outer ring around the wetland interior. The herbaceous vegetation covers >75% of the basin. The adjacent uplands are a mix of scrubby and mesic flatwoods that are managed with prescribed fire.

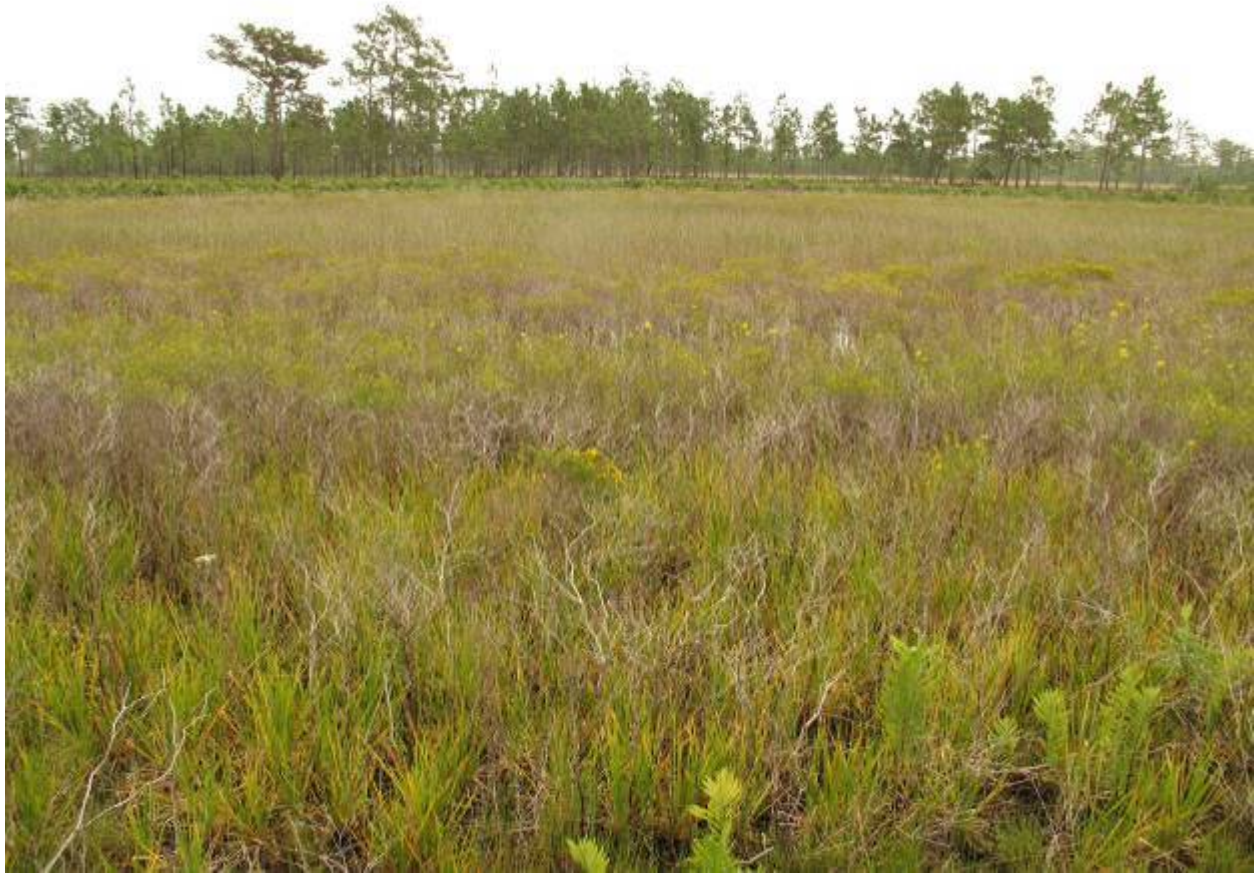
**Wetland ID: 47-02**

**Description:** This wetland is a 0.5 ha ephemeral marsh. There is no tree canopy or midstory cover. *Hypericum* is common in the wetland. Maidencane grows in the wetland interior and sedges/grasses grow in an outer ring around the wetland interior. The herbaceous vegetation covers >75% of the basin. The adjacent uplands are a mix of scrubby and mesic flatwoods that are managed with prescribed fire.

**Wetland Concerns:** None

**Restoration Action Recommended:** None

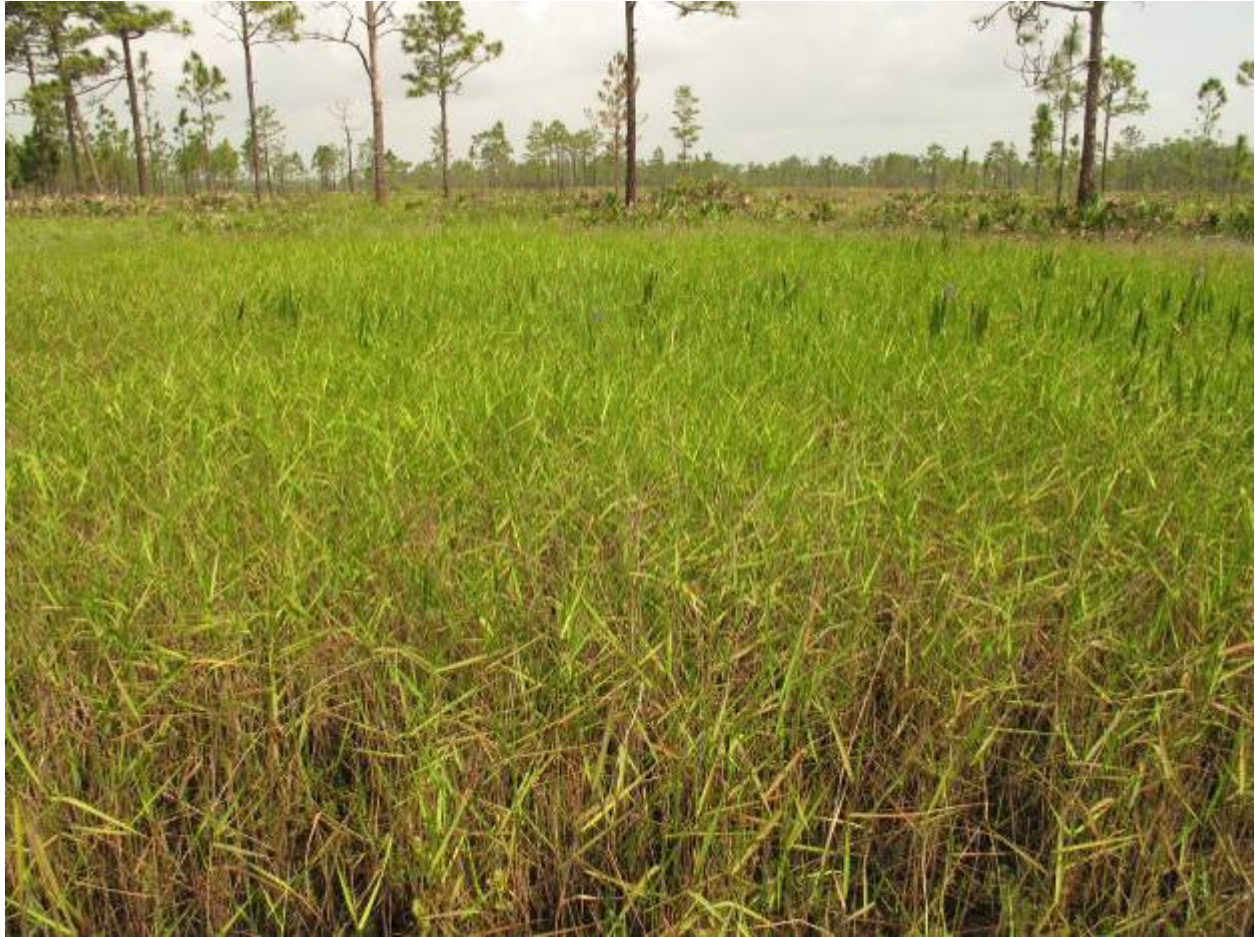
**Wetland ID: 47-03**

**Description:** This wetland is a <0.1 ha ephemeral marsh. There is no tree canopy or midstory cover. Maidencane grows densely throughout the wetland, and covers >75% of the basin. Small fish were present on the day of our visit. The adjacent uplands are a mix of scrubby and mesic flatwoods that are managed with prescribed fire.

**Wetland Concerns:** None

**Restoration Action Recommended:** None

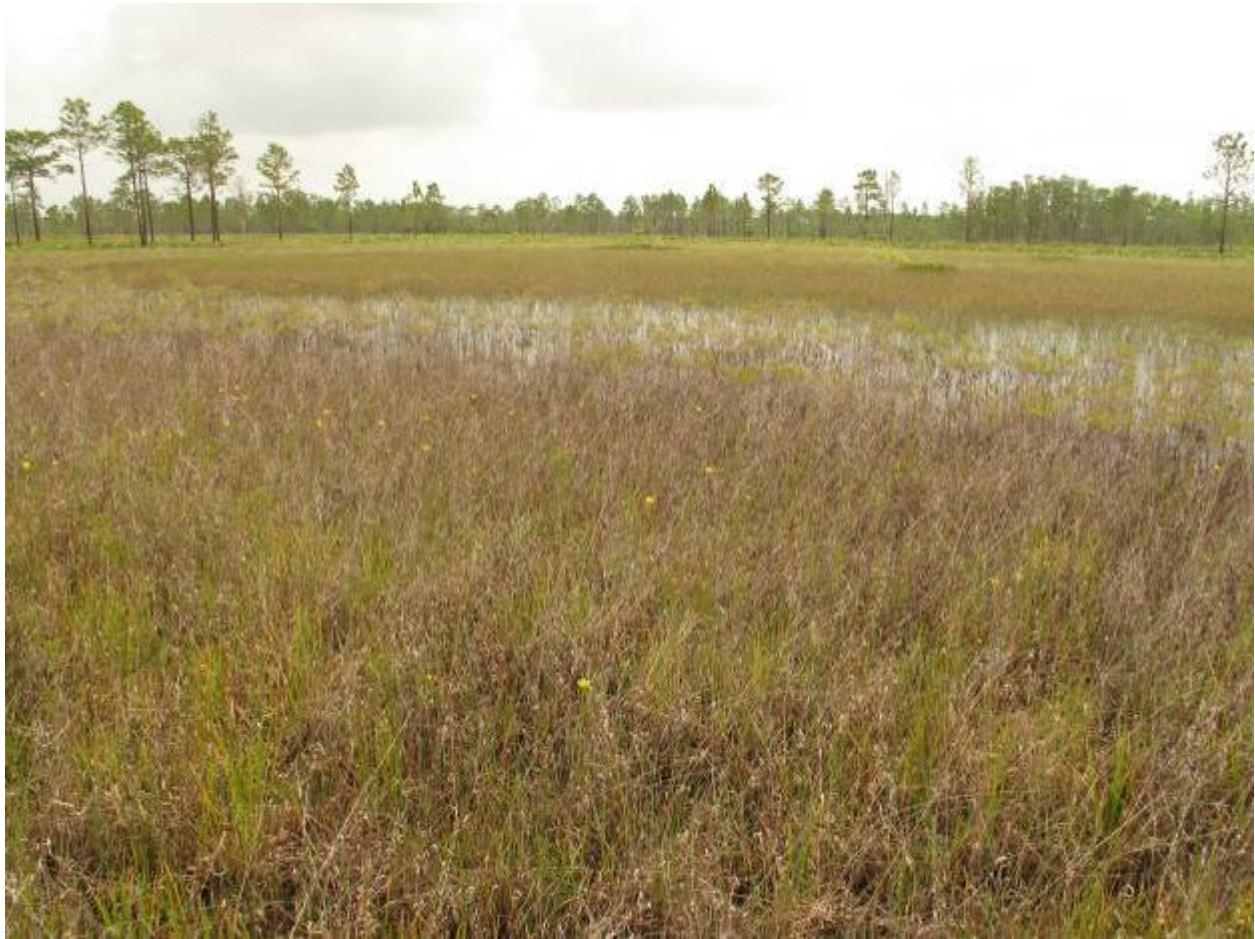
**Description:** This wetland is a 1.3 ha ephemeral marsh. There is no tree canopy or midstory cover. Maidencane grows in the wetland interior and sedges/grasses grow in an outer ring around the wetland interior. The herbaceous vegetation covers >75% of the basin. The adjacent uplands are a mix of scrubby and mesic flatwoods that are managed with prescribed fire.

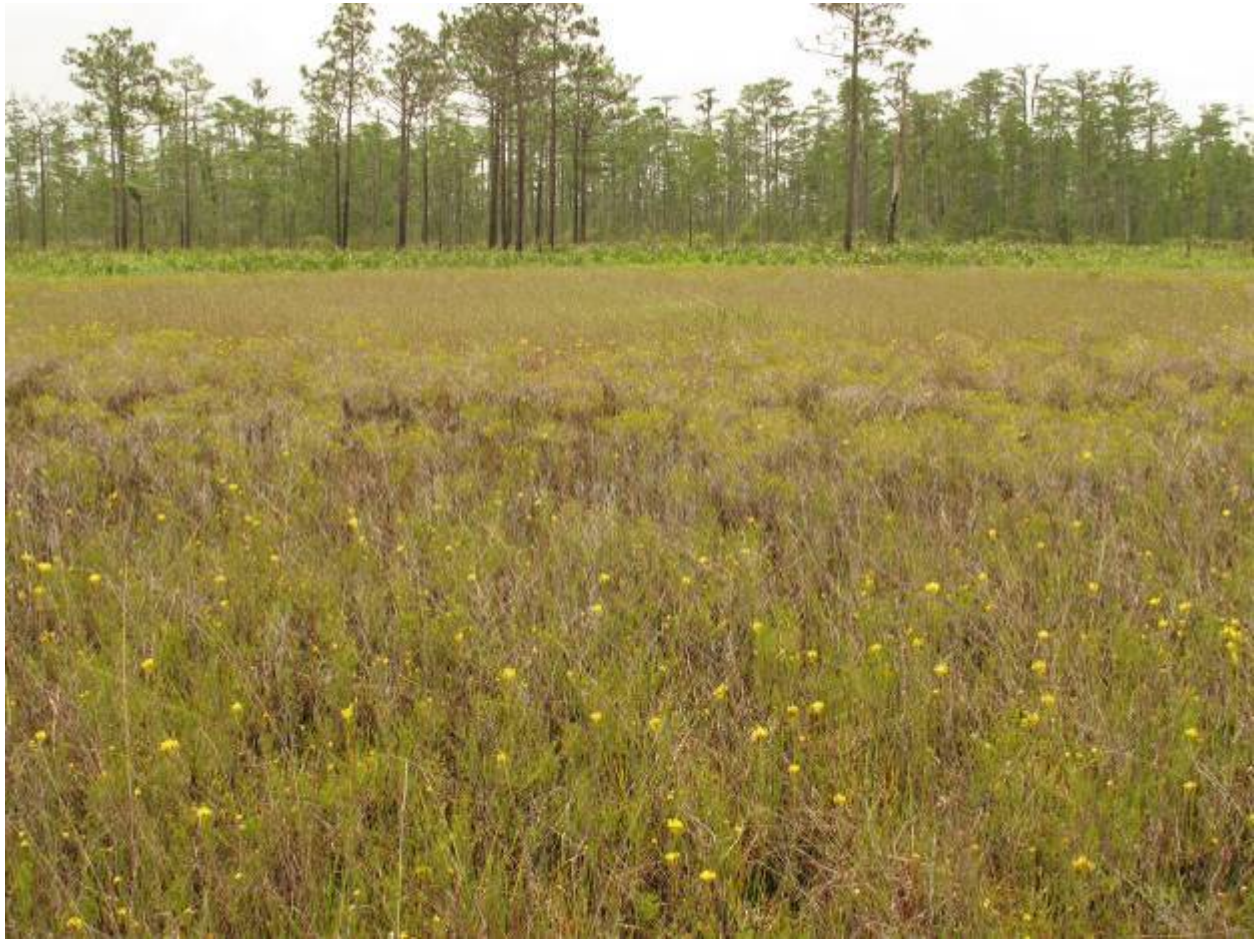
**Description:** This wetland is a 0.4 ha ephemeral marsh. There is no tree canopy or midstory cover. Maidencane grows in the wetland interior and sedges/grasses grow in an outer ring around the wetland interior. The herbaceous vegetation covers >75% of the basin. The adjacent uplands are a mix of scrubby and mesic flatwoods that are managed with prescribed fire.

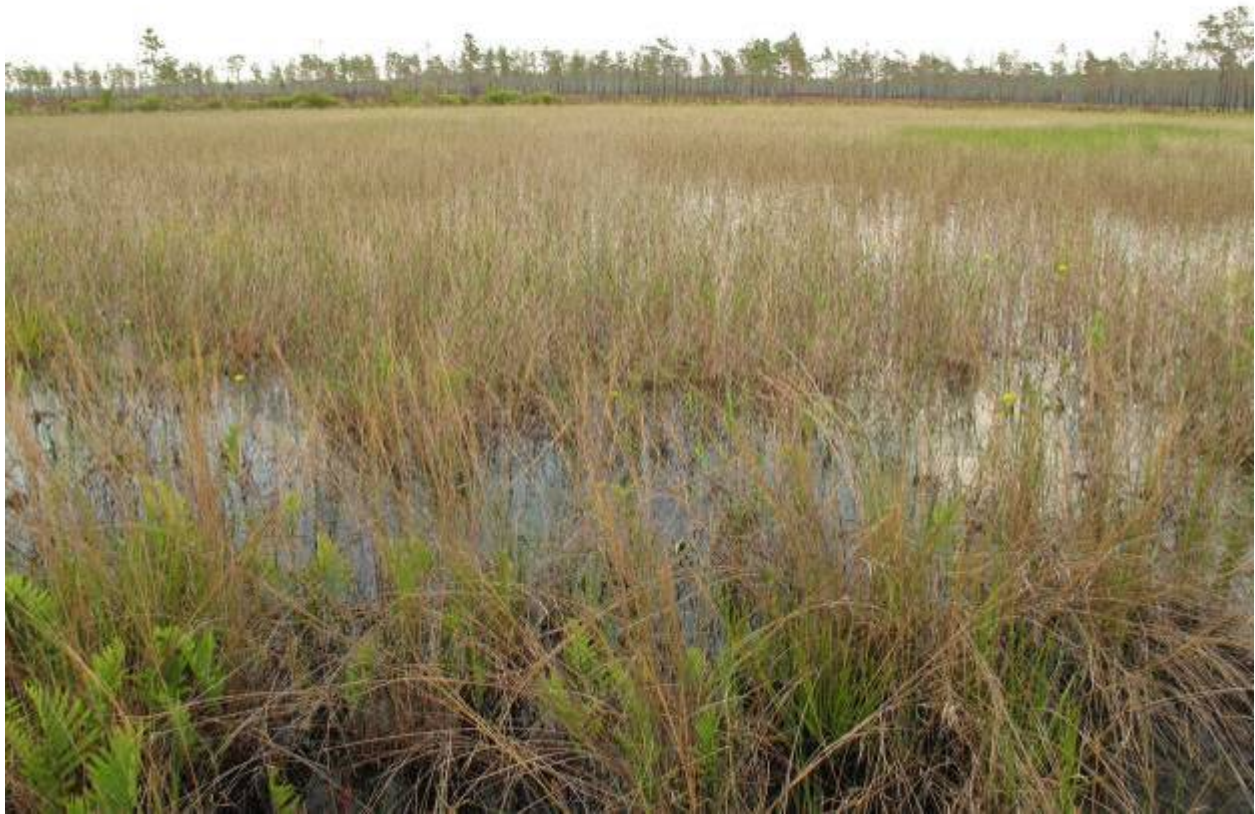
**Wetland ID: 49-01**

**Description:** This wetland is a 1.1 ha ephemeral marsh. There is no tree canopy or midstory cover. Maidencane is the dominant herbaceous vegetation, and it covers >75% of the basin. The adjacent uplands are mesic flatwoods that are managed with prescribed fire.

**Wetland Concerns:** None

**Restoration Action Recommended:** None

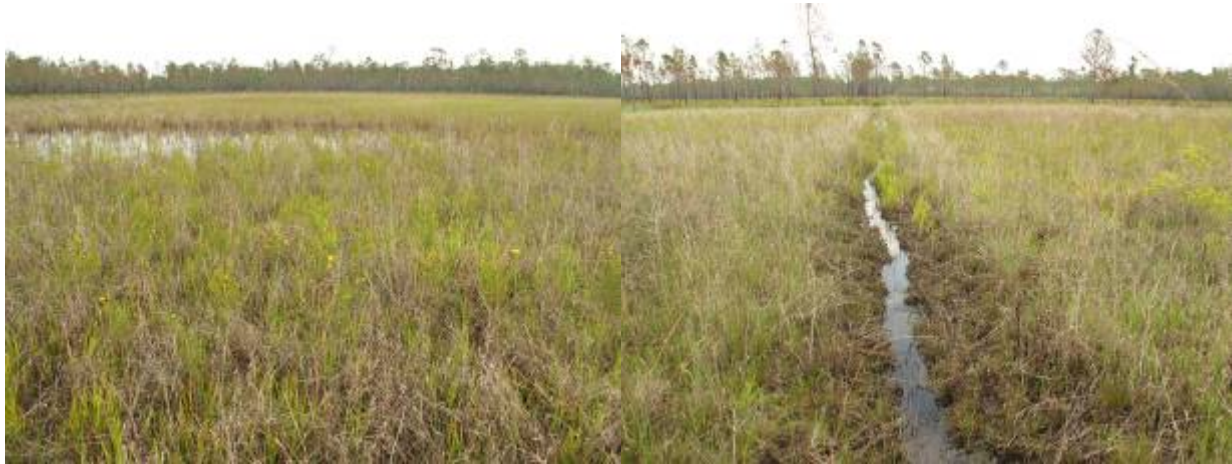
**Wetland ID: 49-02**

**Description:** This wetland is a 1.5 ha ephemeral marsh. There is no tree canopy or midstory cover. This wetland has high plant diversity, but it is dominated by maidencane. The herbaceous vegetation covers >75% of the basin. A small upland land bridge separates this wetland from 49-01. A dug linear feature bisects the north end of the wetland, possibly an old fireline ditch. The ditch does not appear to be impacting the wetland hydrology and will erode over time. The adjacent uplands are a mix of scrubby and mesic flatwoods that are managed with prescribed fire.

**Wetland Concerns:** Ditching

**Restoration Action Recommended:** None

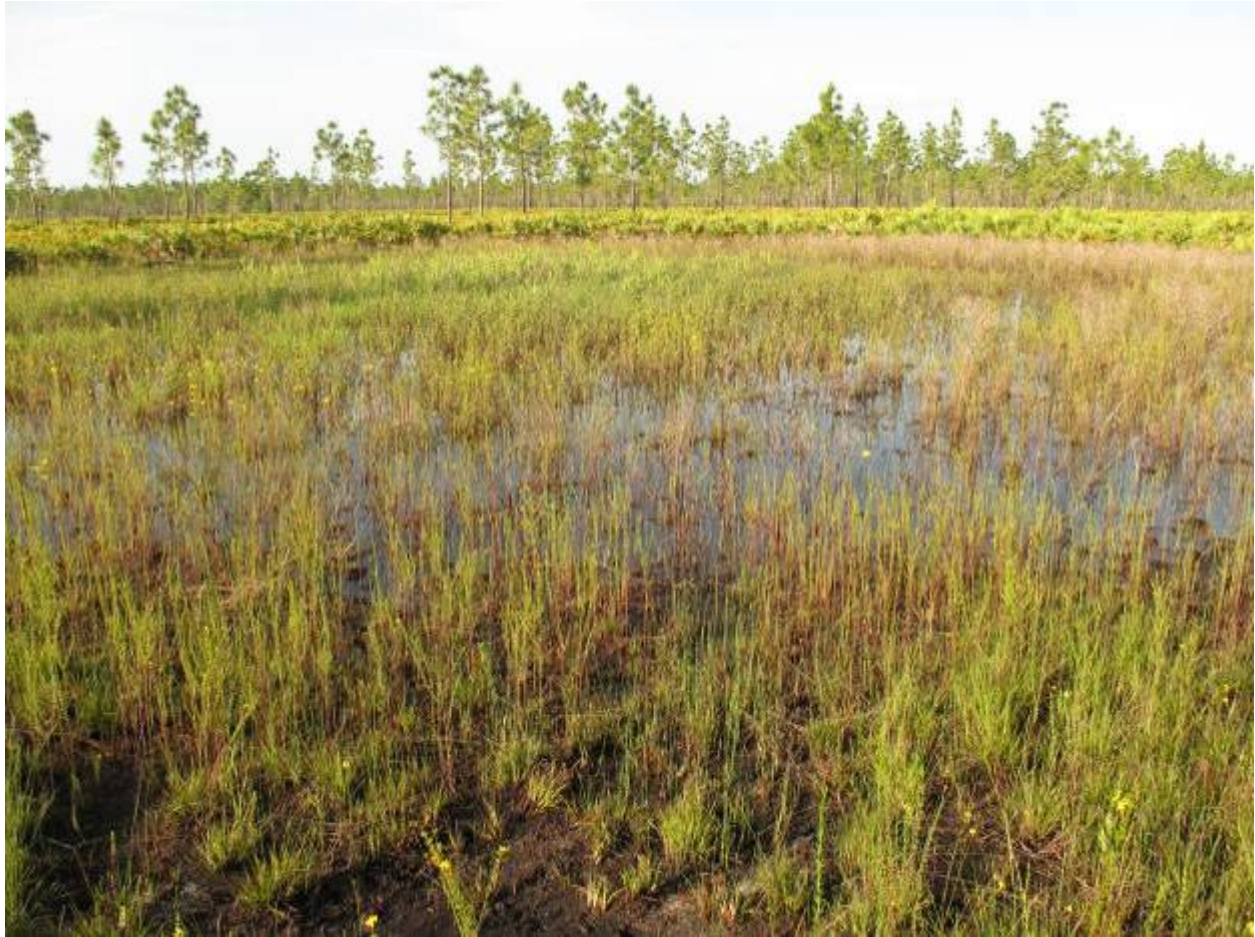
**Wetland ID: 51-01**

**Description:** This wetland is a 0.1 ha ephemeral marsh. There is no tree canopy or midstory cover. *Hypericum* is common in the wetland interior. Sedges/grasses grow throughout the wetland, and cover >75% of the basin. Feral hog damage is patchy. The adjacent uplands are a scrubby flatwoods that are managed with prescribed fire.

**Wetland Concerns:** Feral hog damage

**Restoration Action Recommended:** None

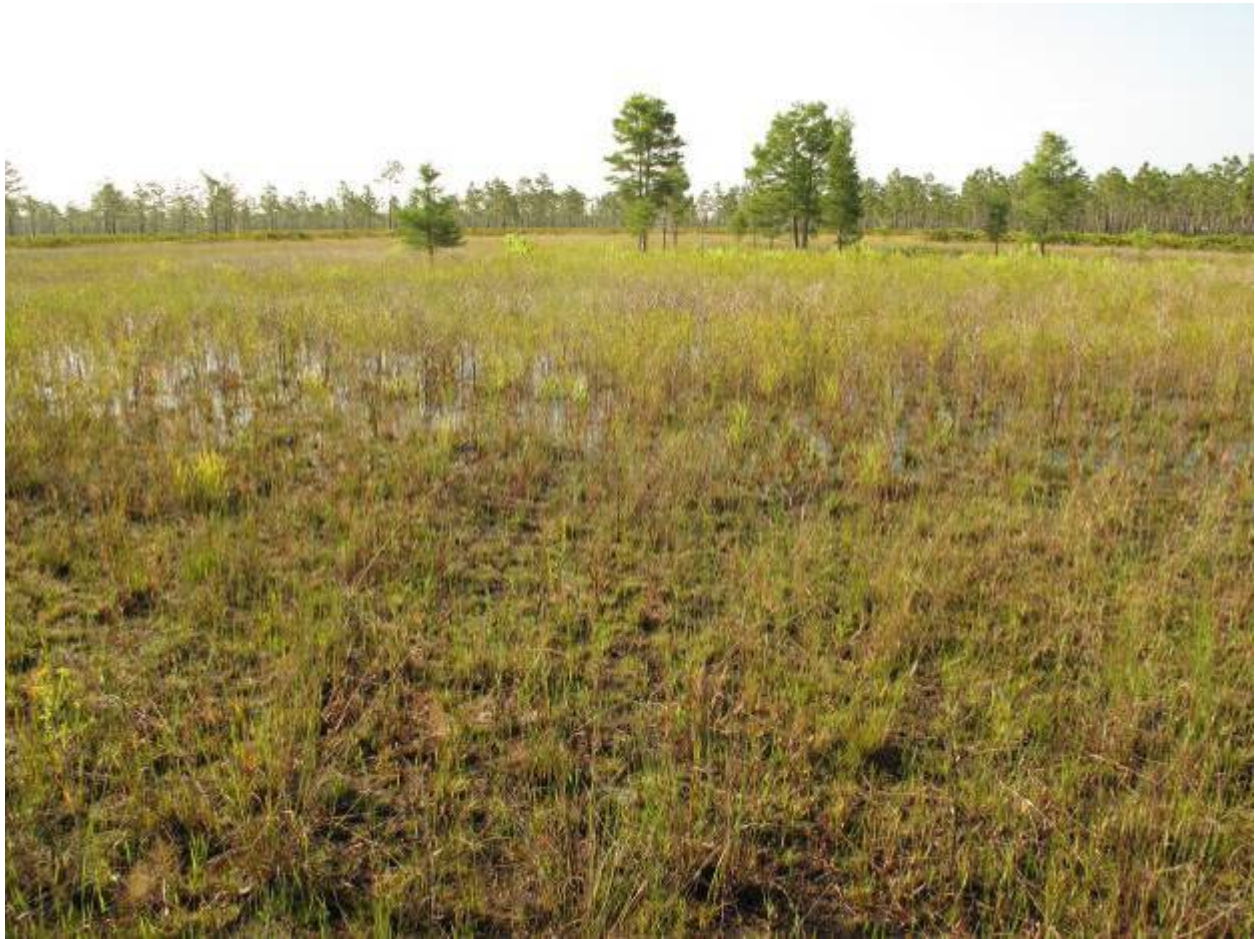
**Description:** This wetland is a 0.9 ha ephemeral marsh. A small cluster of cypress trees grows near the wetland center, but covers <5% of the basin. There is no midstory cover. *Hypericum* is common within the wetland. The herbaceous vegetation is diverse and covers >75% of the basin. The adjacent uplands are scrubby flatwoods that are managed with prescribed fire.

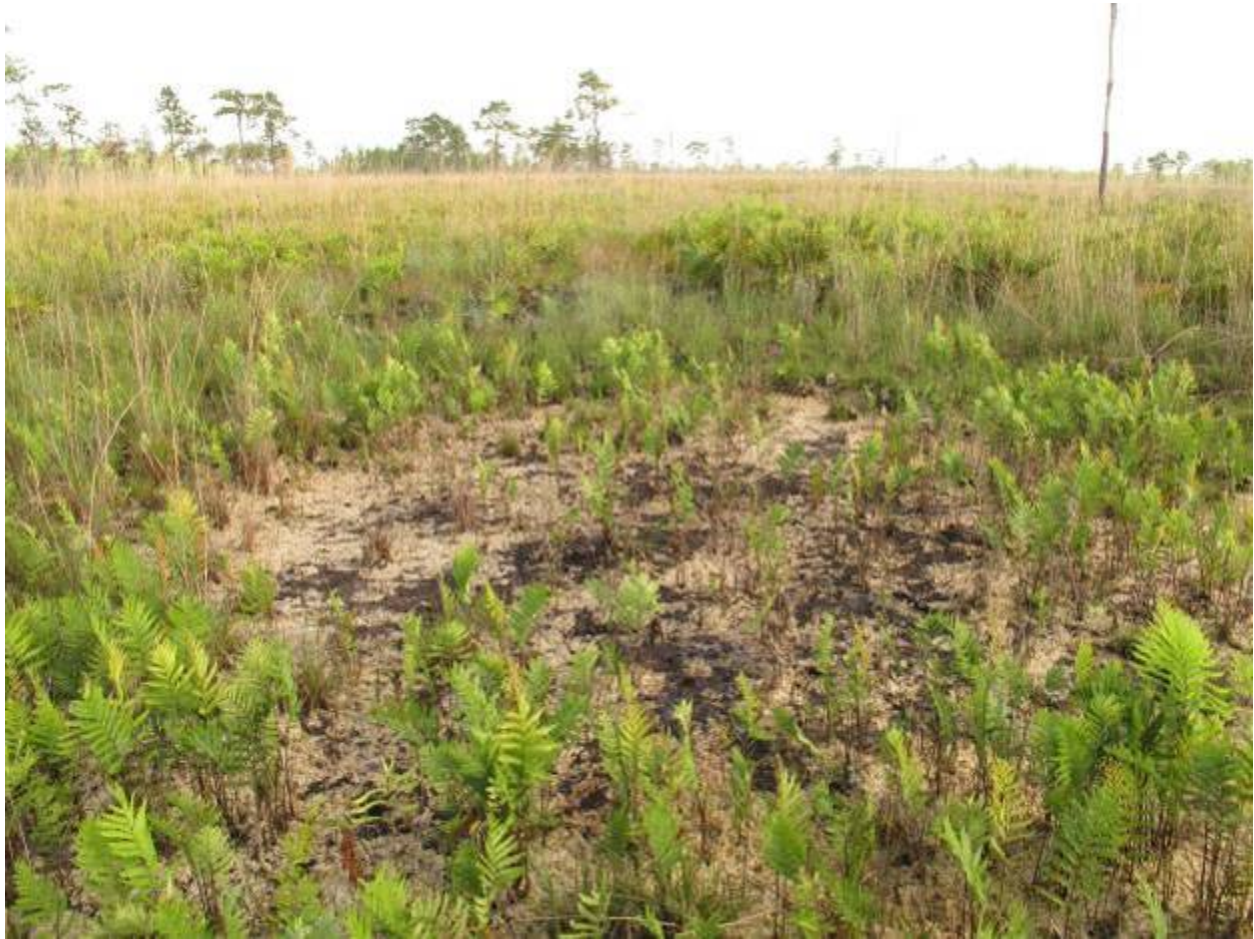
**Description:** This wetland is a <0.1 ha ephemeral marsh. There is no tree canopy or midstory cover. The wetland appears to have dried shortly before our visit. *Sphagnum* and fern grow in the wetland interior and are surrounded by a sedge/grass ring. The herbaceous vegetation covers >75% of the basin. The adjacent uplands are mesic flatwoods that are managed with prescribed fire.

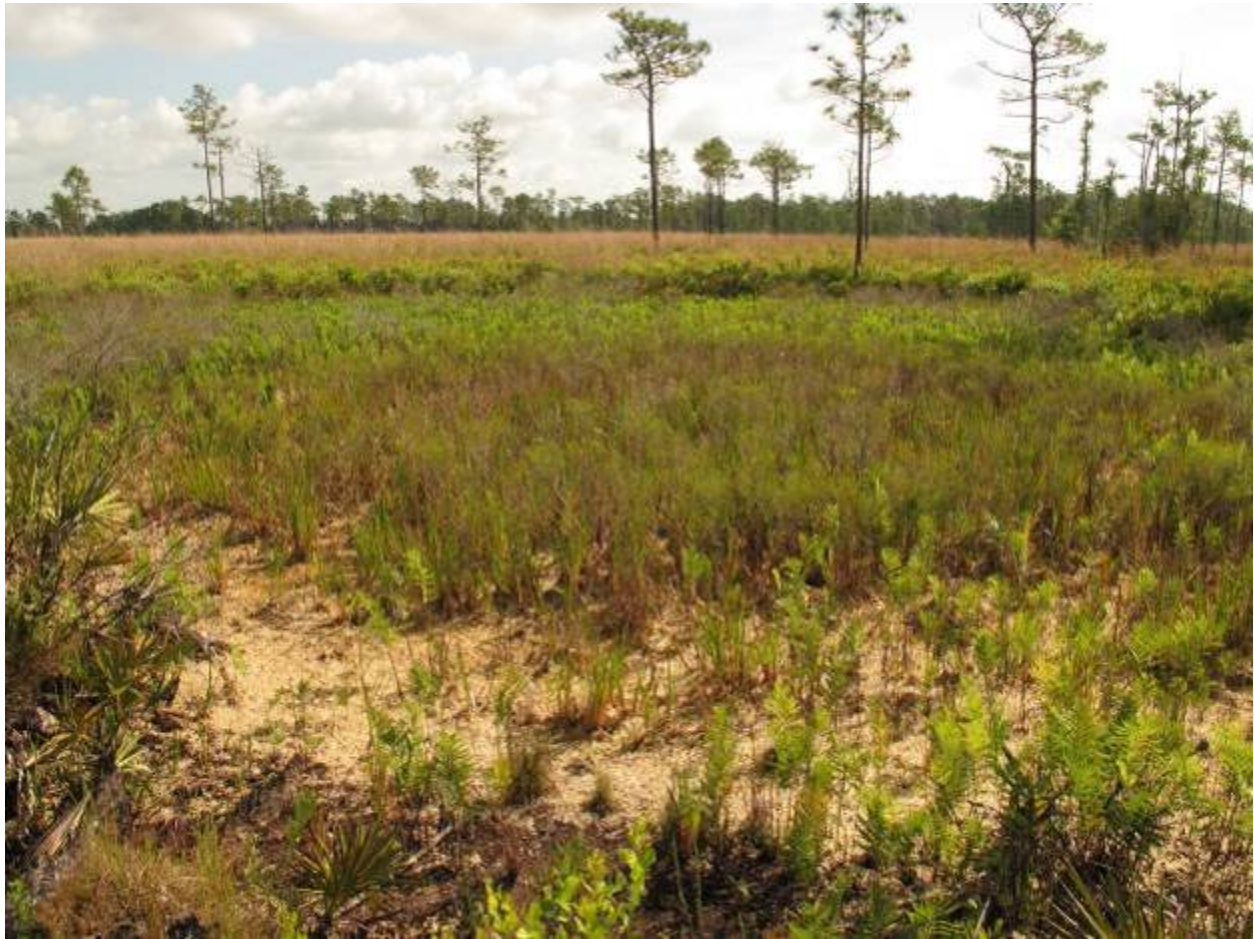
**Description:** This wetland is a <0.1 ha ephemeral marsh. There is no tree canopy or midstory cover. *Hypericum* is common in the wetland basin. *Sphagnum*, fern, and redroot grow throughout the wetland, and cover >75% of the basin. The adjacent uplands are mesic flatwoods that are managed with prescribed fire.

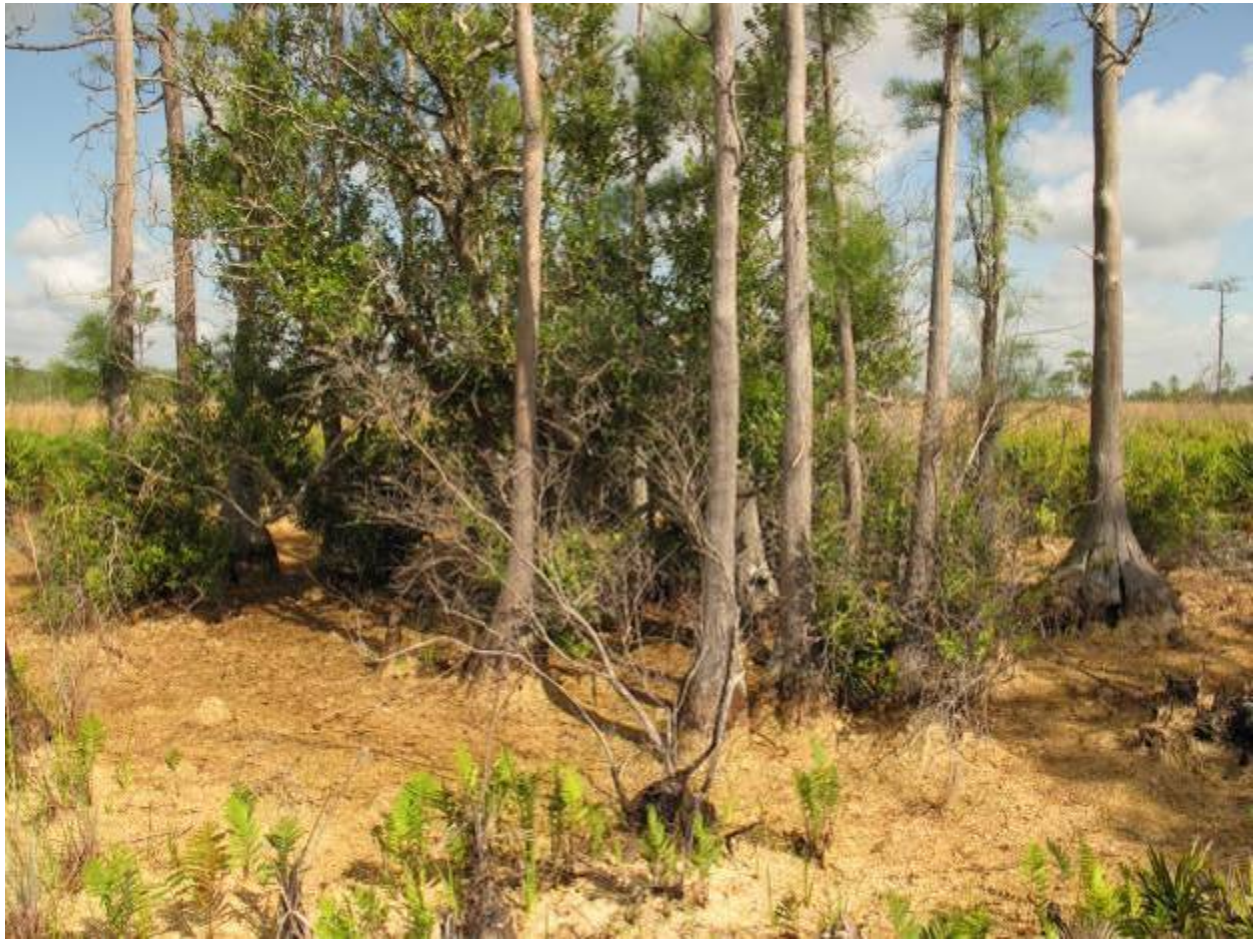
**Description:** This wetland is a <0.1 ha ephemeral forested swamp. Cypress trees dominate the canopy, and cover 50-75% of the wetland. The midstory is dominated by fetterbush, and covers 5-25% of the wetland. *Sphagnum* grows throughout, and covers >75% of the basin. The adjacent uplands are mesic flatwoods that are managed with prescribed fire.

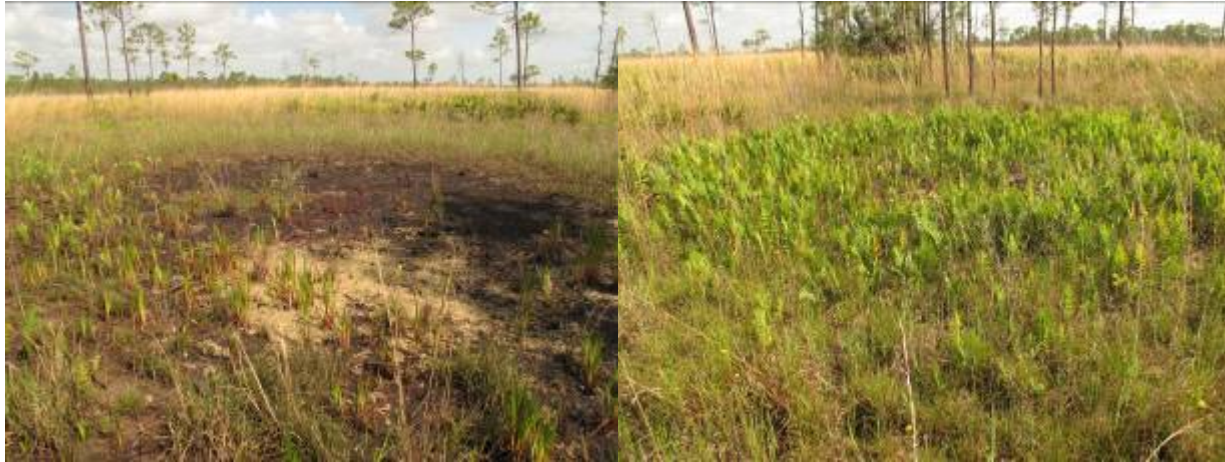
**Wetland ID: 52-04**

**Description:** This wetland is a <0.1 ha ephemeral marsh. There is no tree canopy or midstory cover. Fern are abundant throughout the north lobe of the wetland, which is drier than the southern lobe. The southern lobe is deeper and had dried just before our visit. A diversity of maidencane, *Sphagnum*, fern, and sedges/grasses covers >75% of the basin. The adjacent uplands are mesic flatwoods that are managed with prescribed fire.

**Wetland Concerns:** None

**Restoration Action Recommended:** None

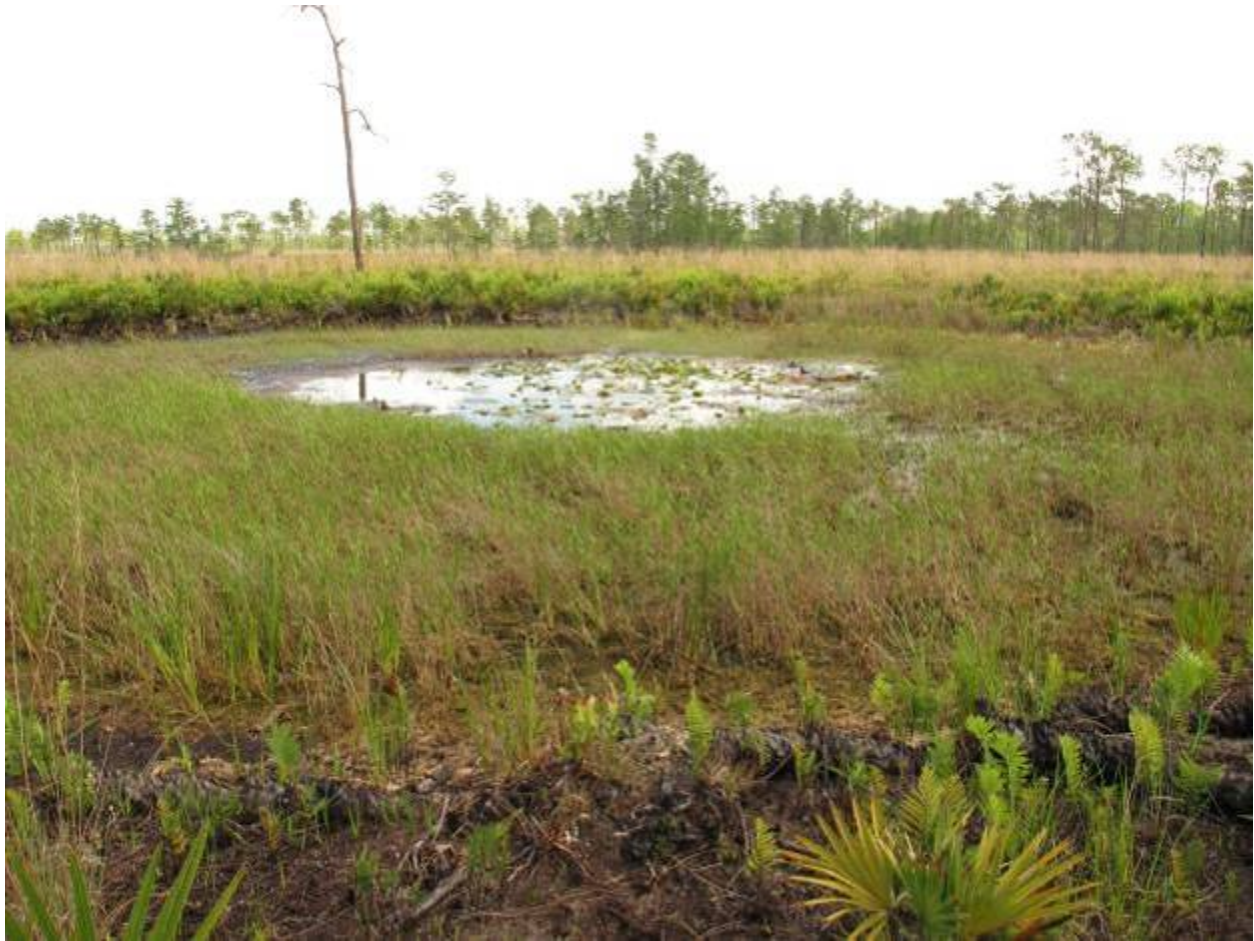
**Description:** This wetland is a <0.1 ha semi-permanent marsh. There is no tree canopy or midstory cover. Emergent vegetation grows in the deep wetland center; maidencane and *Sphagnum* grow in a ring around the deep hole. The herbaceous vegetation covers >75% of the basin. The adjacent uplands are mesic flatwoods that are managed with prescribed fire.

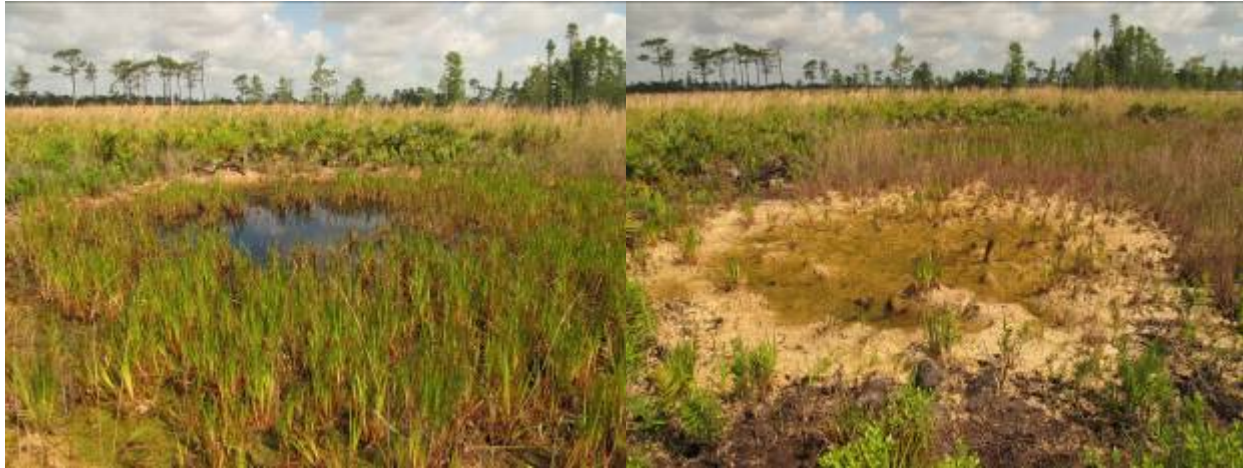
**Wetland ID: 52-06**

**Description:** This wetland is a <0.1 ha ephemeral marsh. It has two lobes. The north lobe is deeper and still held water on the day of our visit. Sphagnum, redroot, and sedges/grasses grow throughout the north lobe. The south lobe was dry on the day of our visit and covered with *Sphagnum*. The herbaceous vegetation covers >75% of the basin. The adjacent uplands are mesic flatwoods that are managed with prescribed fire.

**Wetland Concerns:** None

**Restoration Action Recommended:** None
