# **Inventory, Assessment, and Restoration Potential of Ephemeral Wetlands on FFWCC Wildlife Management Areas**

## **Triple N Ranch WMA Final Report**

Submitted by: Rebecca P.M. Means<sup>1</sup>, Ryan C. Means<sup>1</sup>, Steven A. Johnson<sup>2</sup>

15 May 2010 – 15 August 2010

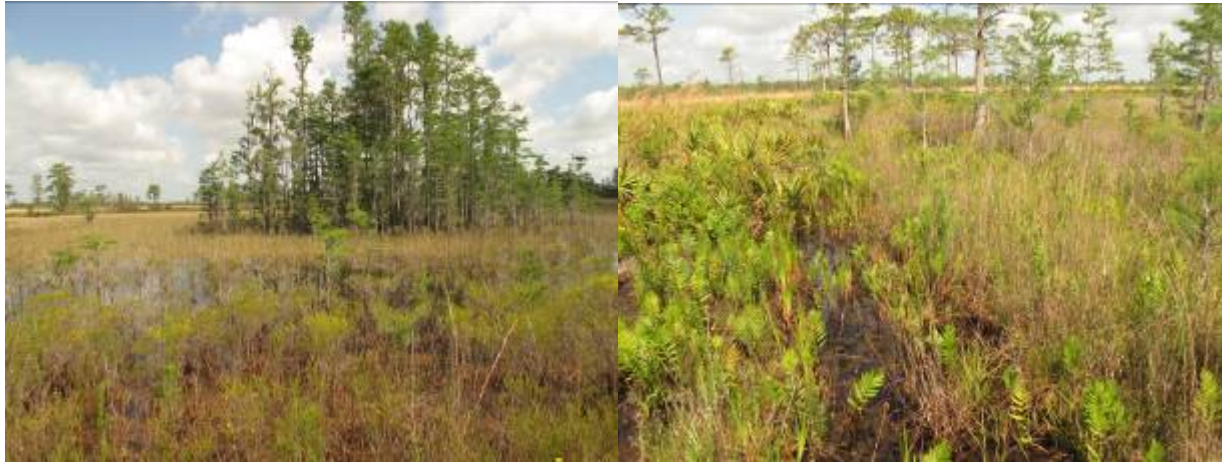
**Wetland ID: 52-07**

**Description:** This wetland is a 1.3 ha ephemeral marsh. A few cypress trees have sprouted along the south end of the wetland and a cypress dome is forming in the wetland center. Cypress trees cover 5-25% of the basin. Maidencane grows in the wetland center and a diversity of sedges/grasses grows throughout the wetland. The herbaceous vegetation covers >75% of the basin. An old fireline ditch is still evident around the south end of the wetland. The adjacent uplands are mesic flatwoods that are managed with prescribed fire.

**Wetland Concerns:** Fireline

**Restoration Action Recommended:** The old fireline may still be serving as a firebreak, as evidenced by the presence of young cypress trees in the area. The wetland may need to be custom burned in the future.

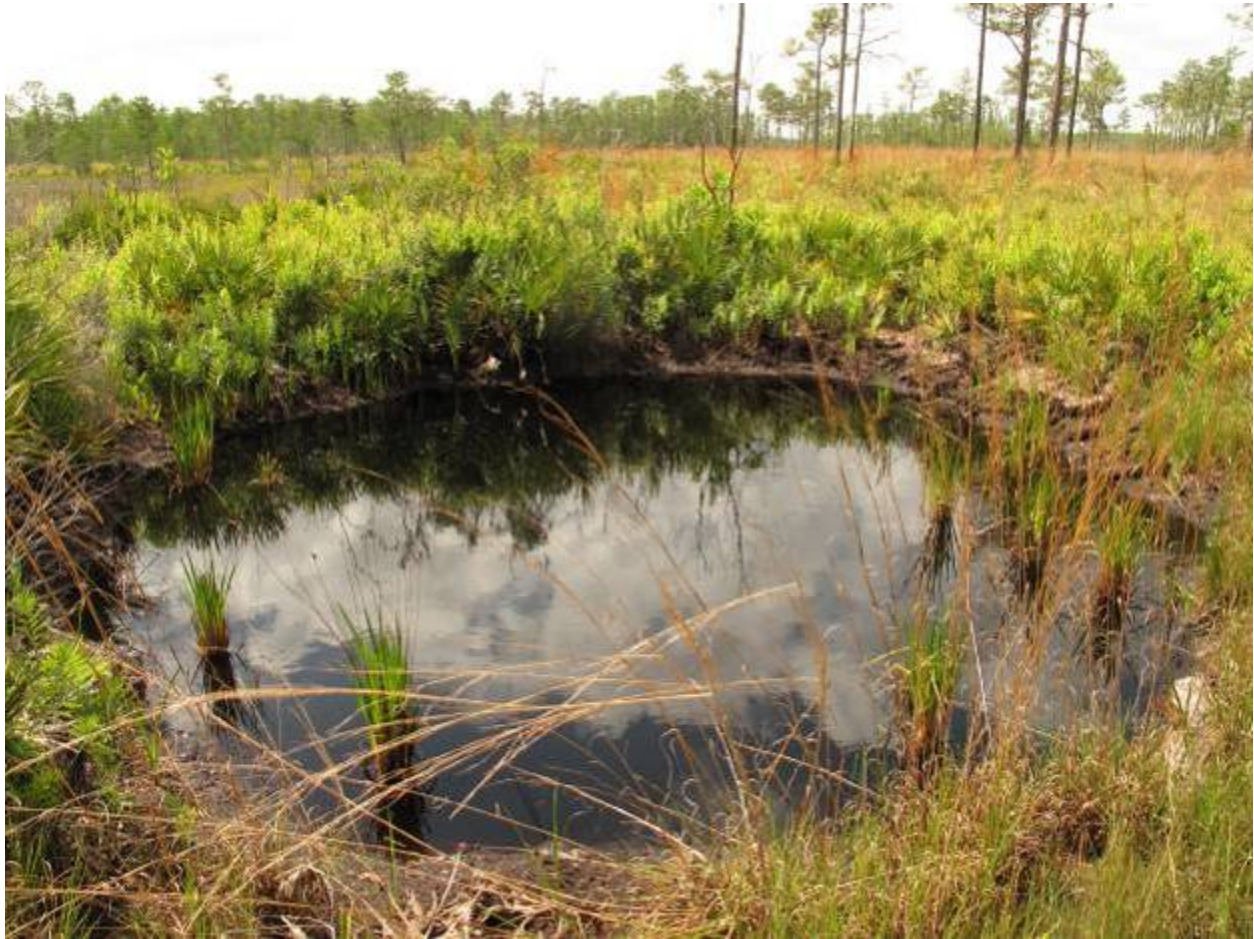
**Description:** This wetland is a <0.1 ha ephemeral marsh. It is likely a karst depression and has dark, tannic water. There is no tree canopy or midstory cover. The wetland is almost entirely open water with no emergent vegetation. Sedges/grasses grow around the wetland edge, and cover 5-25% of the basin. The adjacent uplands are mesic flatwoods that are managed with prescribed fire.

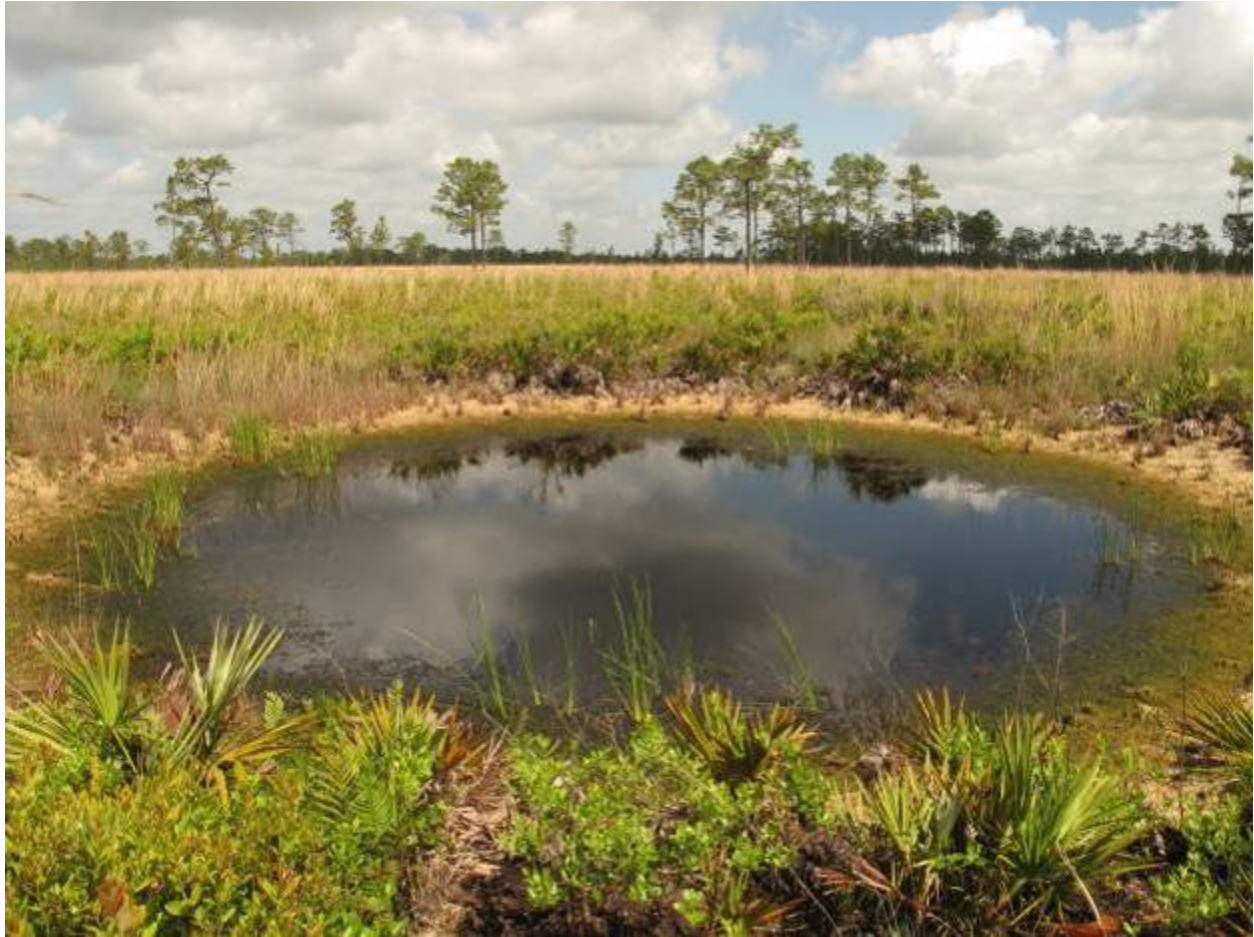
**Wetland ID: 52-09**

**Description:** This wetland is a <0.1 ha ephemeral marsh. It is a karst depression and has dark, tannic water. There is no tree canopy or midstory cover. The wetland is almost entirely open water with no emergent vegetation. *Sphagnum* grows around the wetland edge, and covers 25-50% of the basin. The adjacent uplands are mesic flatwoods that are managed with prescribed fire.

**Wetland Concerns:** None

**Restoration Action Recommended:** None

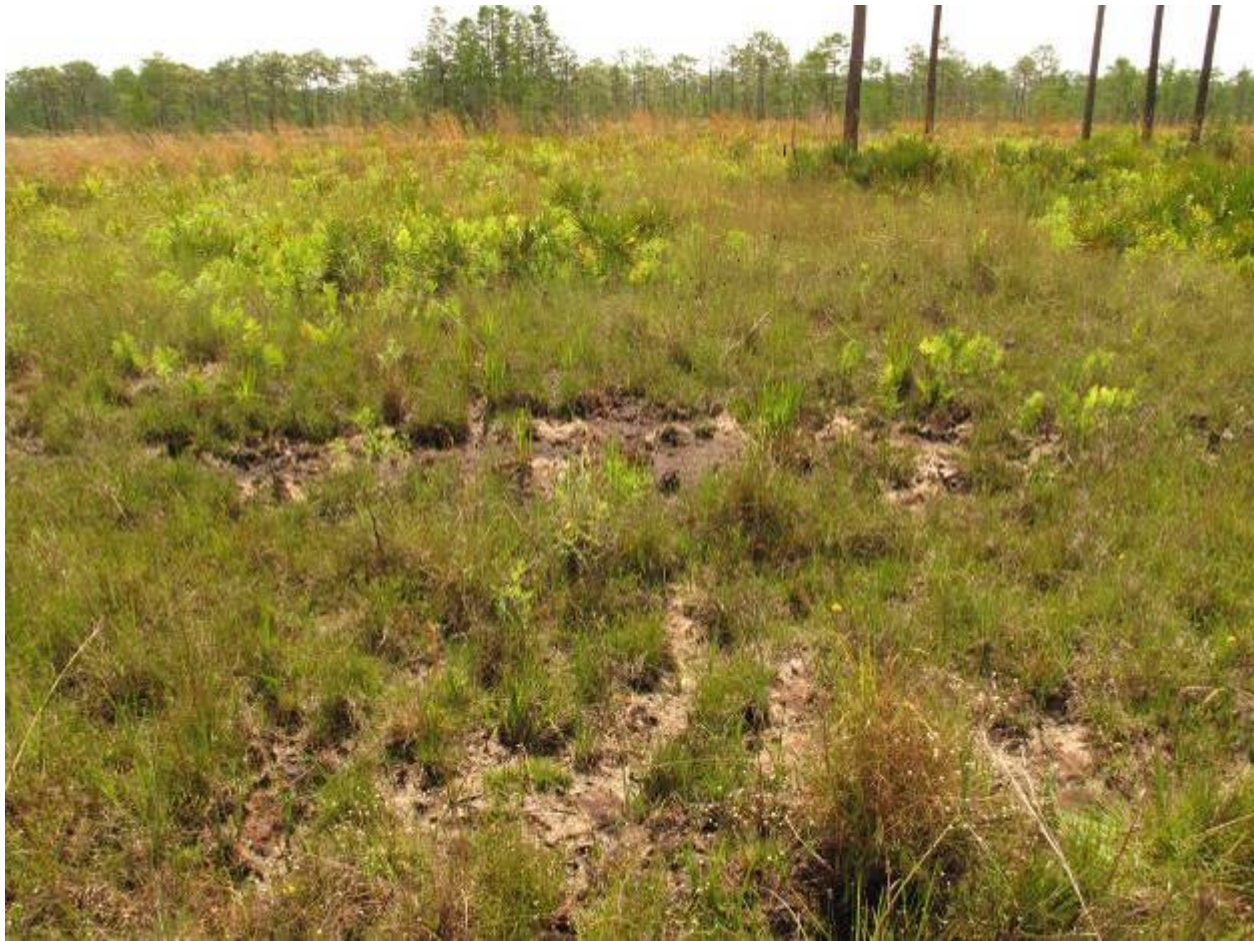
**Description:** This wetland is a <0.1 ha ephemeral marsh. There is no tree canopy or midstory cover. Sedges/grasses grow throughout the wetland, and cover >75% of the basin. It appears a roller-chopper was driven through the middle of the wetland. The adjacent uplands are mesic flatwoods that are managed with prescribed fire.

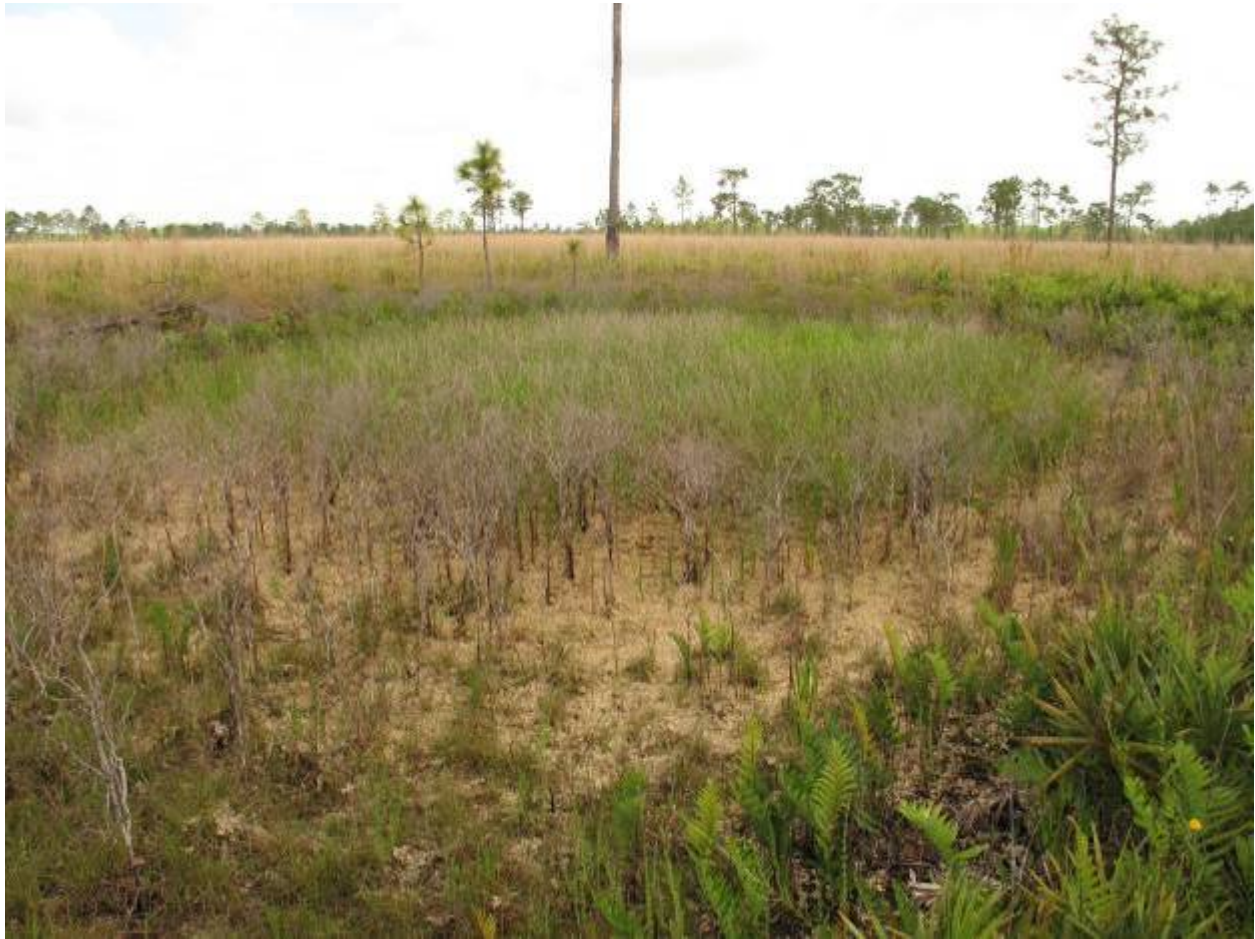
**Description:** This wetland is a <0.1 ha ephemeral marsh. There is no tree canopy or midstory cover. *Hypericum* grows in a ring around the wetland. Maidencane grows in the wetland center and *Sphagnum* is distributed around the outer ring of the wetland. The herbaceous vegetation covers >75% of the basin. The adjacent uplands are mesic flatwoods that are managed with prescribed fire.

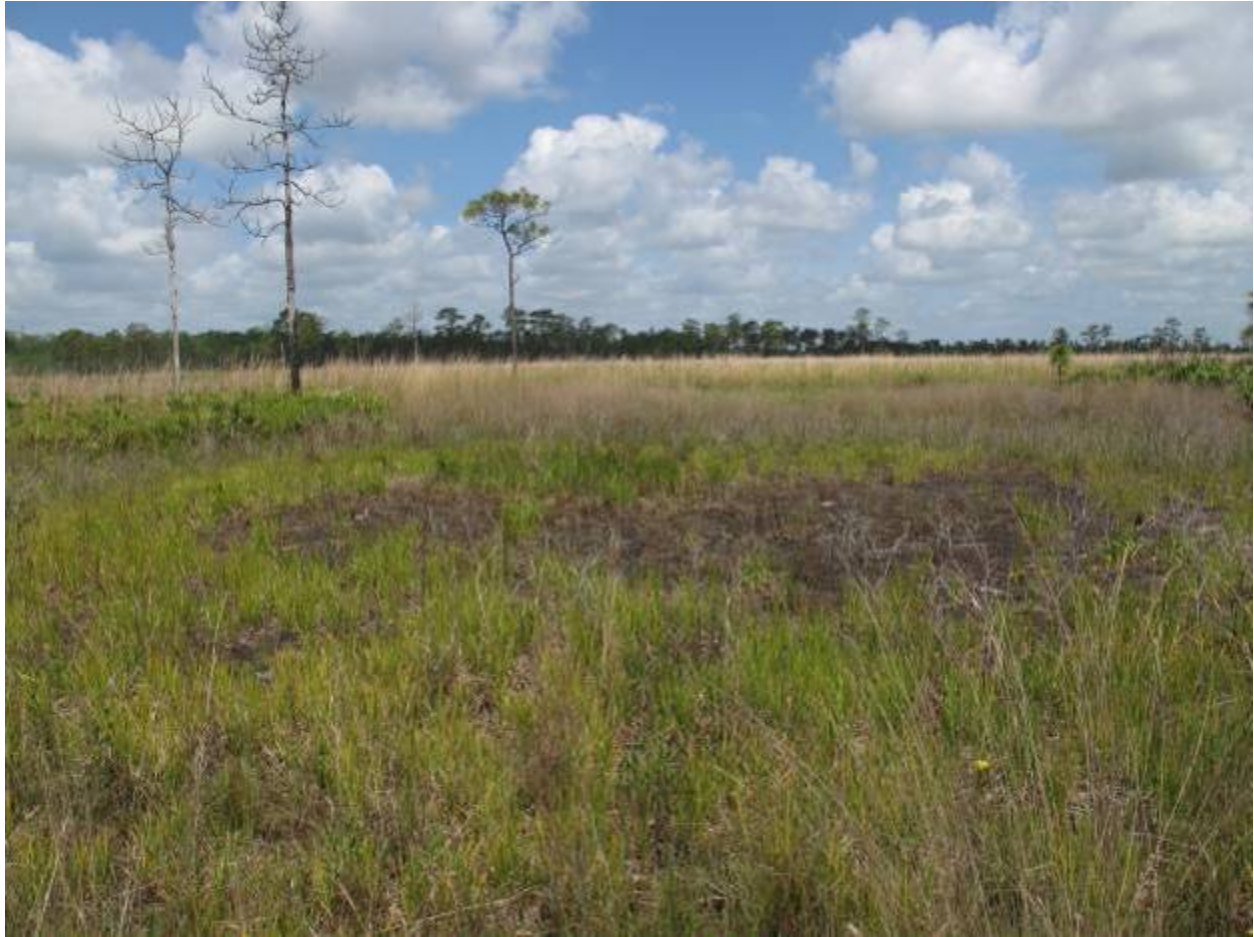
**Wetland ID: 52-12**

**Description:** This wetland is a <0.1 ha ephemeral marsh. There is no tree canopy or midstory cover. A diverse array of herbaceous vegetation grows throughout the wetland, and covers >75% of the basin. The wetland had dried just before our visit, and exposed bare soil. The adjacent uplands are mesic flatwoods that are managed with prescribed fire.

**Wetland Concerns:** None

**Restoration Action Recommended:** None

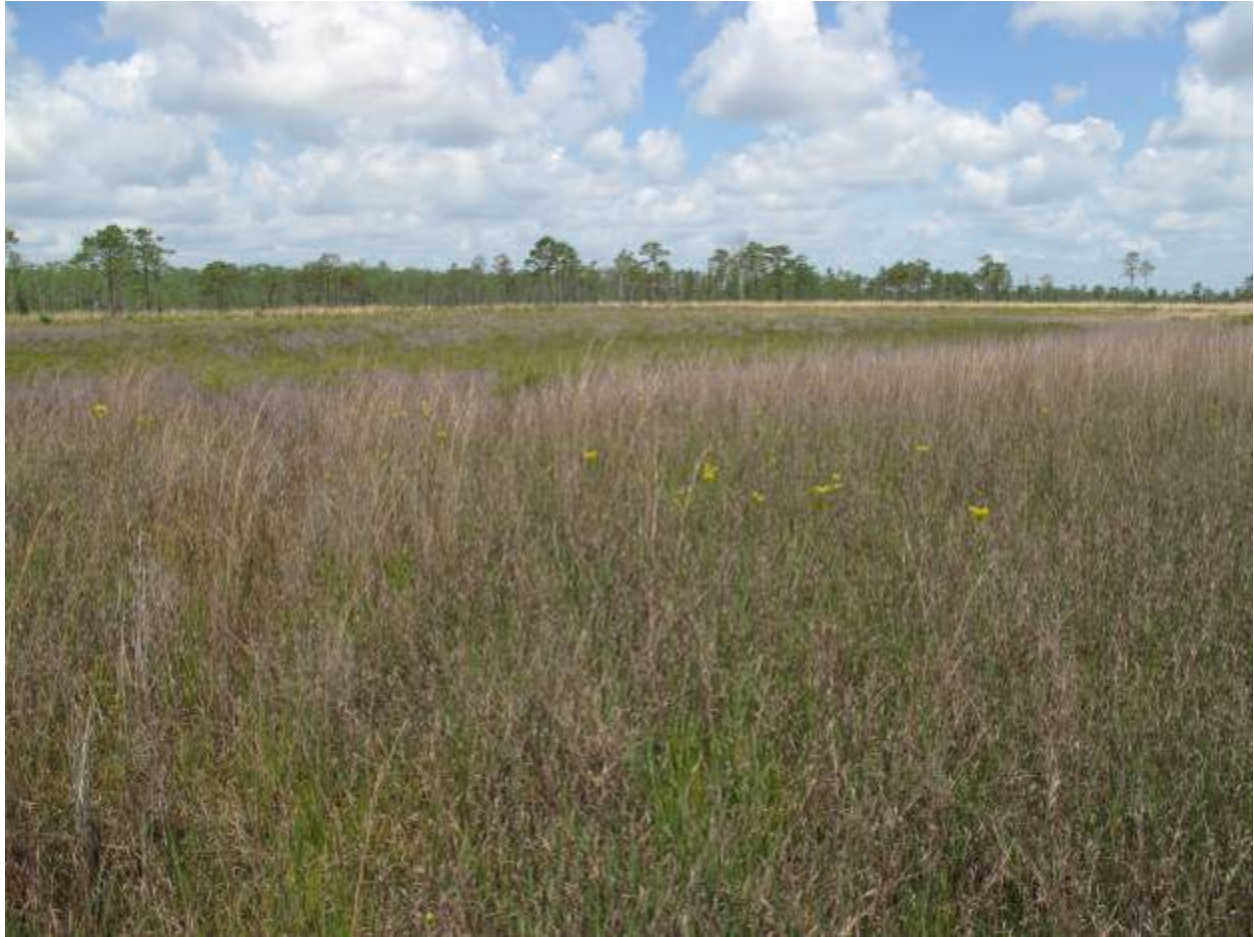
**Wetland ID: 52-13**

**Description:** This wetland is a 1.1 ha ephemeral marsh. There is no tree canopy or midstory cover. *Hypericum* is common within the wetland interior. A rich diversity of herbaceous vegetation grows throughout the wetland, and covers >75% of the basin. The adjacent uplands are mesic flatwoods that are managed with prescribed fire.

**Wetland Concerns:** None

**Restoration Action Recommended:** None

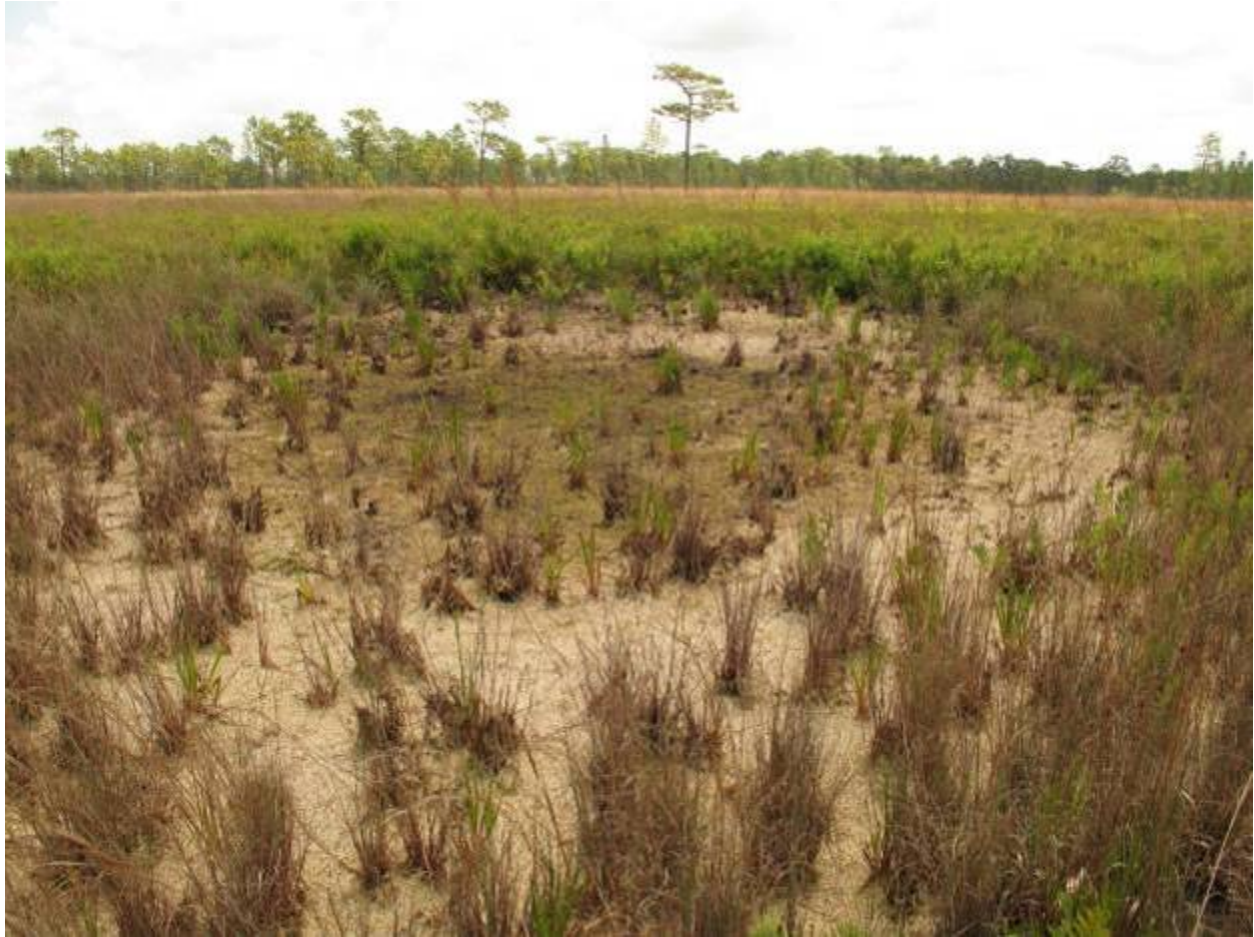
**Wetland ID: 52-14**

**Description:** This wetland is a <0.1 ha ephemeral marsh. There is no tree canopy or midstory cover. *Sphagnum* grows in the wetland's deeper center and sedges/grasses grow throughout the wetland. The herbaceous vegetation covers >75% of the basin. The adjacent uplands are mesic flatwoods that are managed with prescribed fire.

**Wetland Concerns:** None

**Restoration Action Recommended:** None

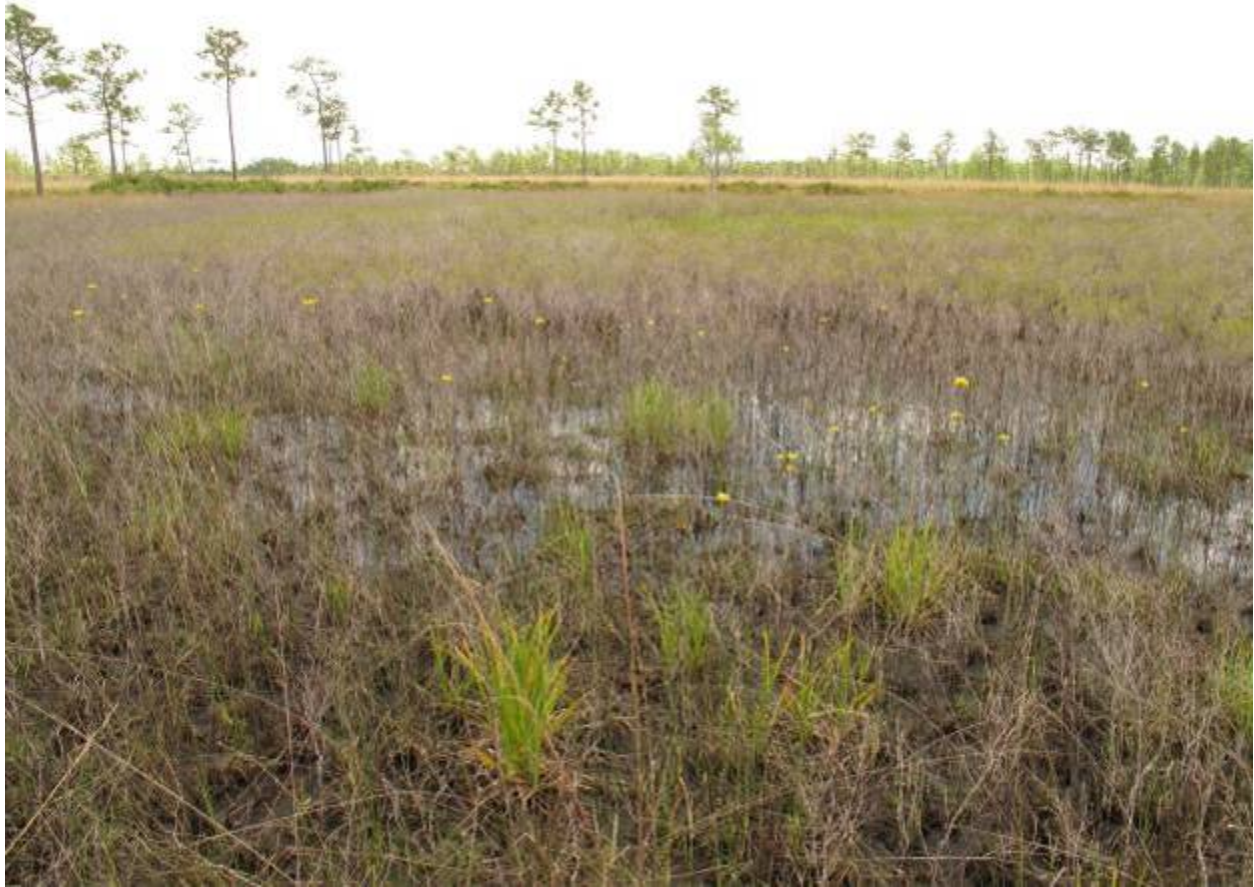
**Wetland ID: 52-15**

**Description:** This wetland is a 0.9 ha ephemeral marsh. There is no tree canopy or midstory cover. *Hypericum* is common within the wetland. Emergent vegetation grows in a deeper area of the wetland on the west side and a rich diversity of grasses and flowering plants grow throughout the wetland. The herbaceous vegetation covers >75% of the basin. The adjacent uplands are mesic flatwoods that are managed with prescribed fire.

**Wetland Concerns:** None

**Restoration Action Recommended:** None

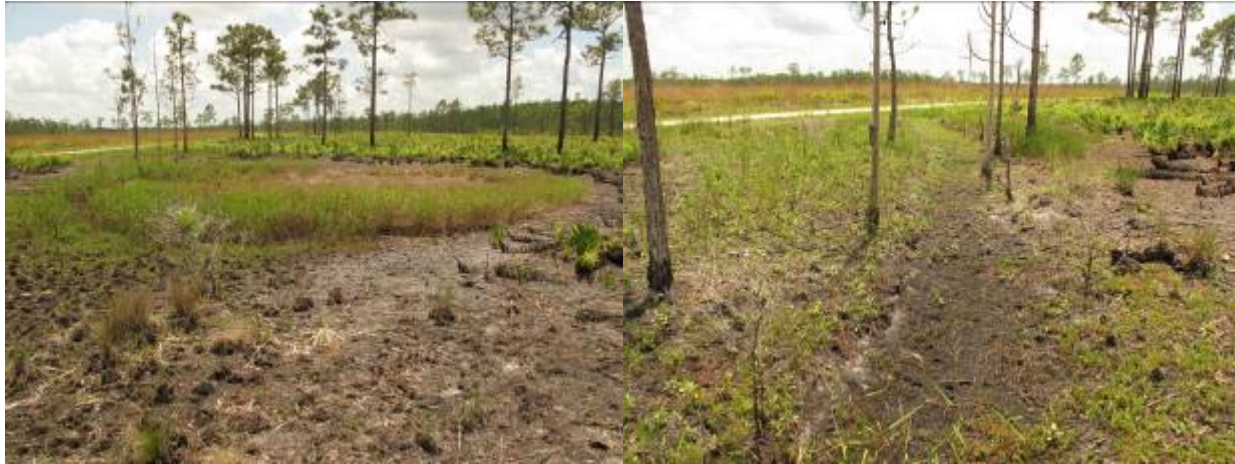
**Wetland ID: 52-16**

**Description:** This wetland is a <0.1 ha ephemeral marsh. There is no tree canopy or midstory cover. Maidencane grows throughout the wetland, and covers >75% of the basin. A recent fire burned into the wetland edges. A shallow ditch connects the wetland to a nearby roadside ditch system. The adjacent uplands are mesic flatwoods that are managed with prescribed fire.

**Wetland Concerns:** Ditching

**Restoration Action Recommended:** Fill the ditch to restore the wetland's isolation.

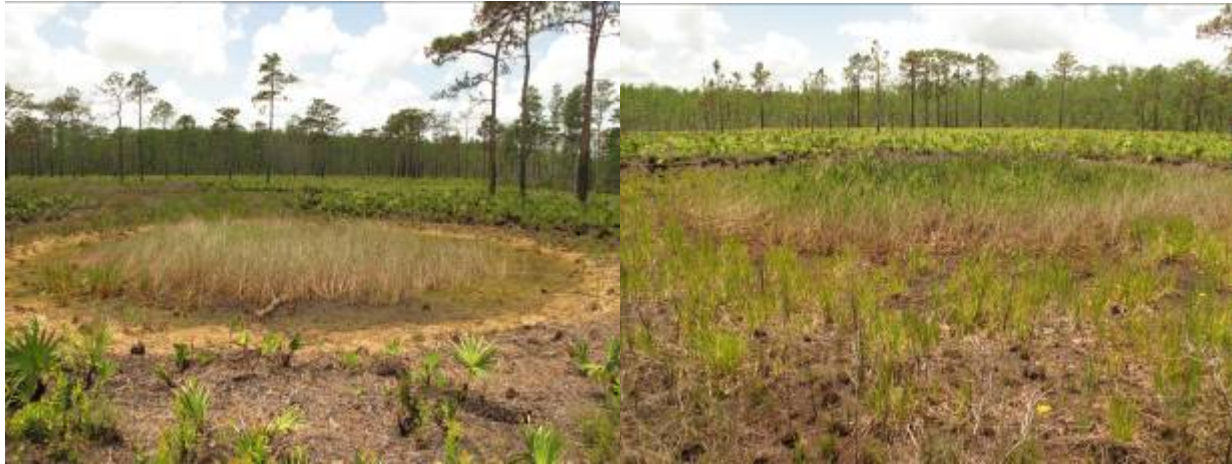
**Wetland ID: 52-17**

**Description:** This wetland is a 0.3 ha ephemeral marsh. It has 4 distinct deep holes spaced evenly throughout the wetland basin. There is no tree canopy or midstory cover. Because of the different character of each pothole, the herbaceous vegetation varies across the wetland basin and includes maidencane, sedges/grasses, and emergent vegetation. The herbaceous vegetation covers >75% of the basin. The adjacent uplands are mesic flatwoods that are managed with prescribed fire.

**Wetland Concerns:** None

**Restoration Action Recommended:** None

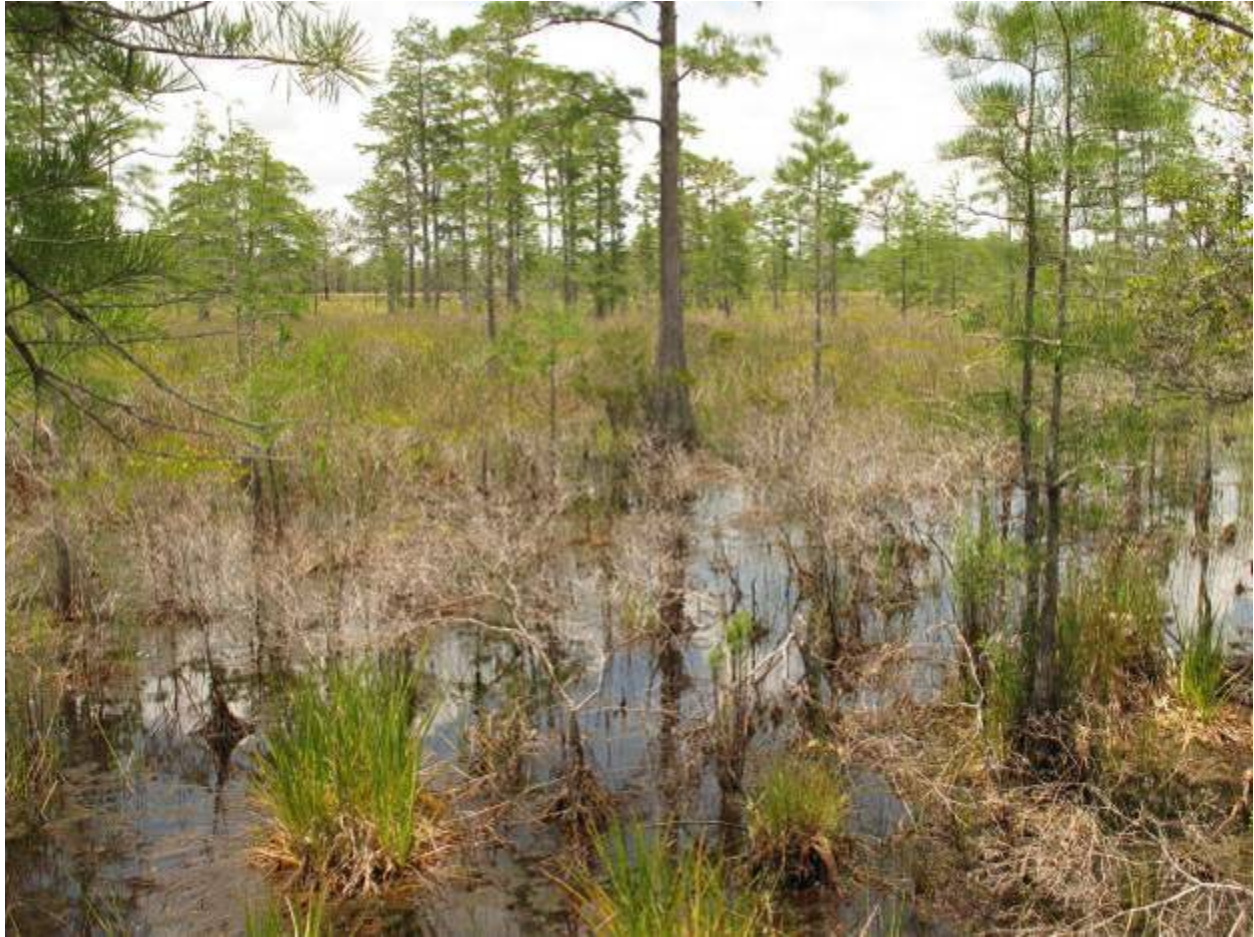
**Wetland ID: 52-18**

**Description:** This wetland is a 1.6 ha ephemeral forested swamp. It has distinct 3 lobes. The north lobe is more marsh-like in character with scattered cypress trees, the south lobe also is more open, and the center lobe has a denser midstory. The entire wetland tree canopy is dominated by cypress trees, and covers 50-75% of the basin. The midstory is dominated by wax myrtle and fetterbush, and covers 5-25% of the wetland. Maidencane grows throughout, and covers >75% of the basin. The adjacent uplands are mesic flatwoods that are managed with prescribed fire.

**Wetland Concerns:** None

**Restoration Action Recommended:** None

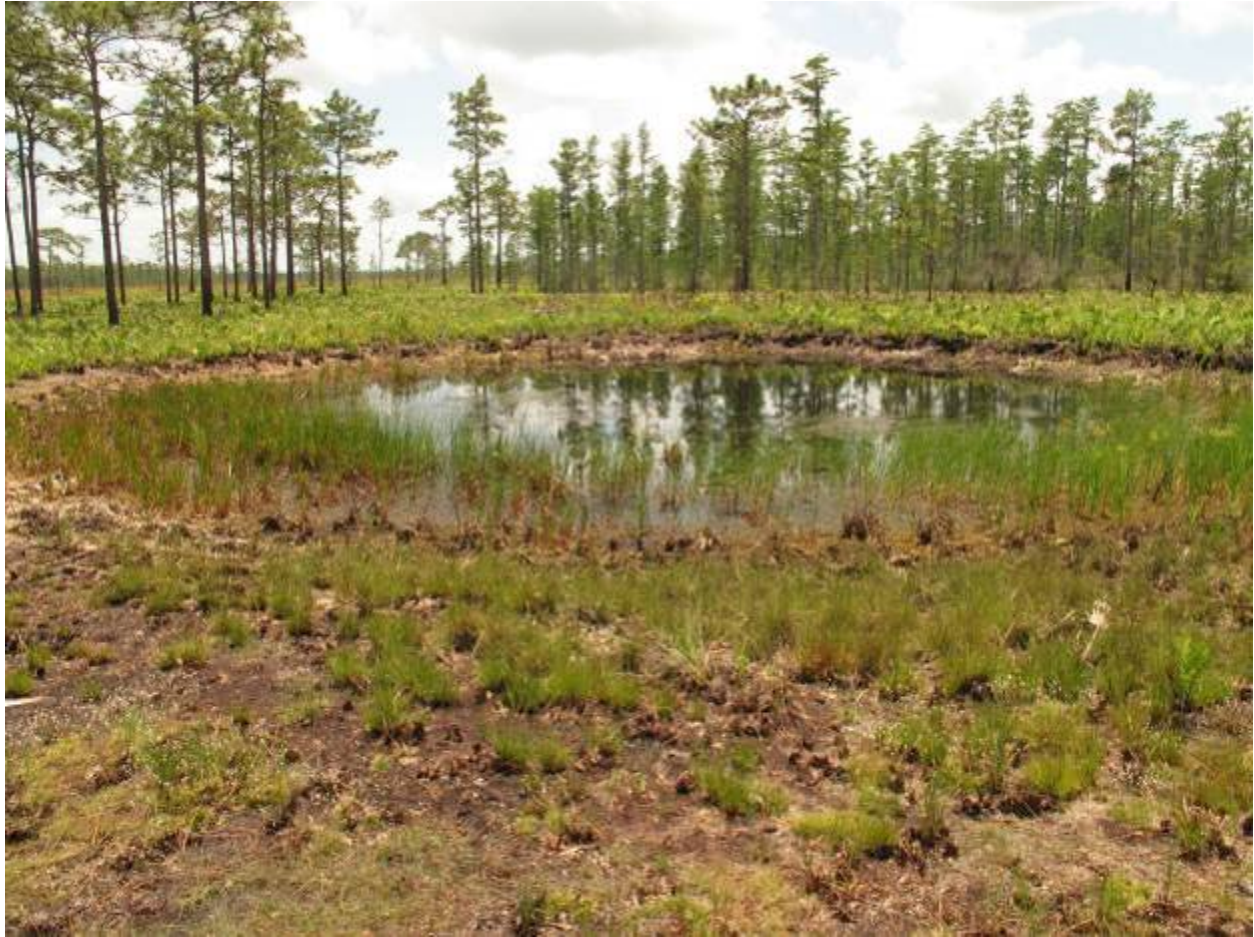
**Wetland ID: 52-19**

**Description:** This wetland is a <0.1 ha ephemeral marsh. It is a karst depression with dark, tannic water and an open-water center. There is no tree canopy or midstory cover. Sedges/grasses grow throughout the wetland, except in the deepest center, and cover >75% of the basin. A recent fire burned deep into the interior of the wetland. The adjacent uplands are mesic flatwoods that are managed with prescribed fire.

**Wetland Concerns:** None

**Restoration Action Recommended:** None

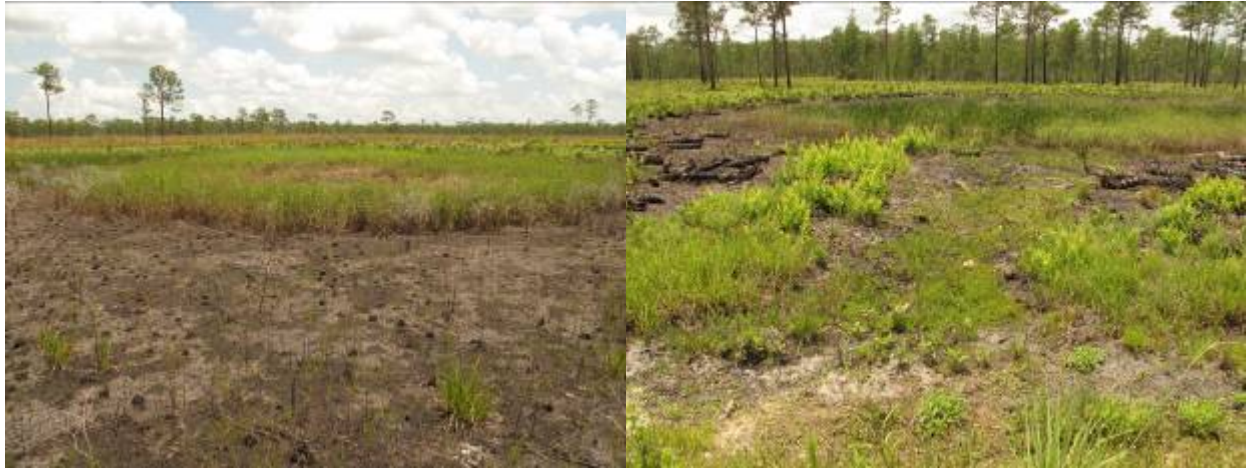
**Wetland ID: 52-20**

**Description:** This wetland is a 0.5 ha ephemeral marsh. It is a comma-shaped wetland with deeper holes at each end. There is no tree canopy or midstory cover. The north end has abundant maidencane; the south end has a deeper hole in which emergent vegetation grows. The herbaceous vegetation covers >75% of the basin. A recent fire burned through the wetland basin, except in the deeper hole. A shallow ditch connects the east side of the south hole with a nearby roadside ditch system. The adjacent uplands are mesic flatwoods that are managed with prescribed fire.

**Wetland Concerns:** Ditching

**Restoration Action Recommended:** Fill the ditch to restore the wetland's isolation.

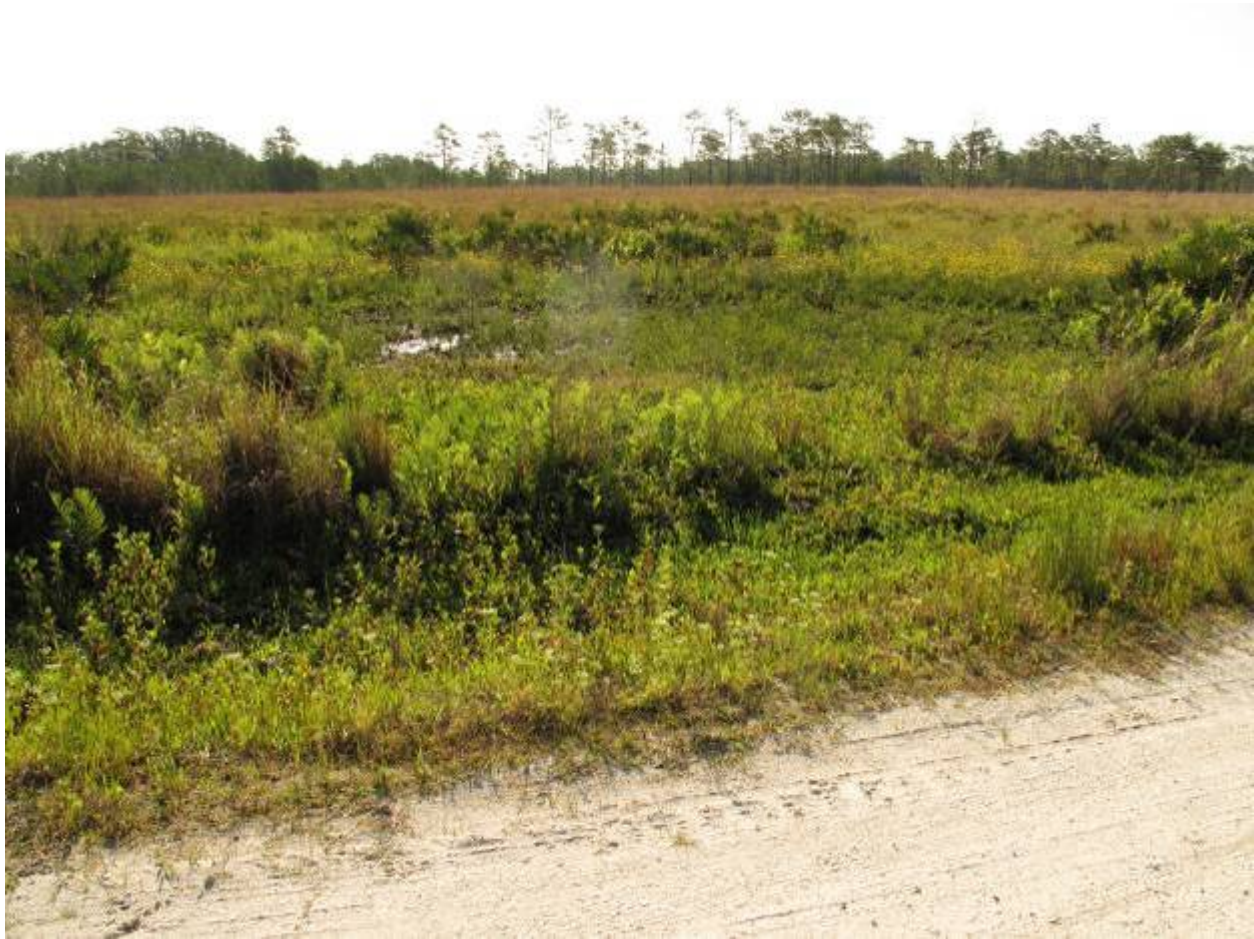
**Description:** This wetland is a <0.1 ha ephemeral marsh. It is the east end of a single pond that was bisected by Road 8. The road construction created 2 separate wetlands, this one and 52-22. There is no tree canopy or midstory cover. A high diversity of herbaceous vegetation covers >75% of the basin. There is minor feral hog damage in the wetland. A shallow ditch connects this wetland to the adjacent, ephemeral roadside ditch system. The adjacent uplands are mesic flatwoods that are managed with prescribed fire.

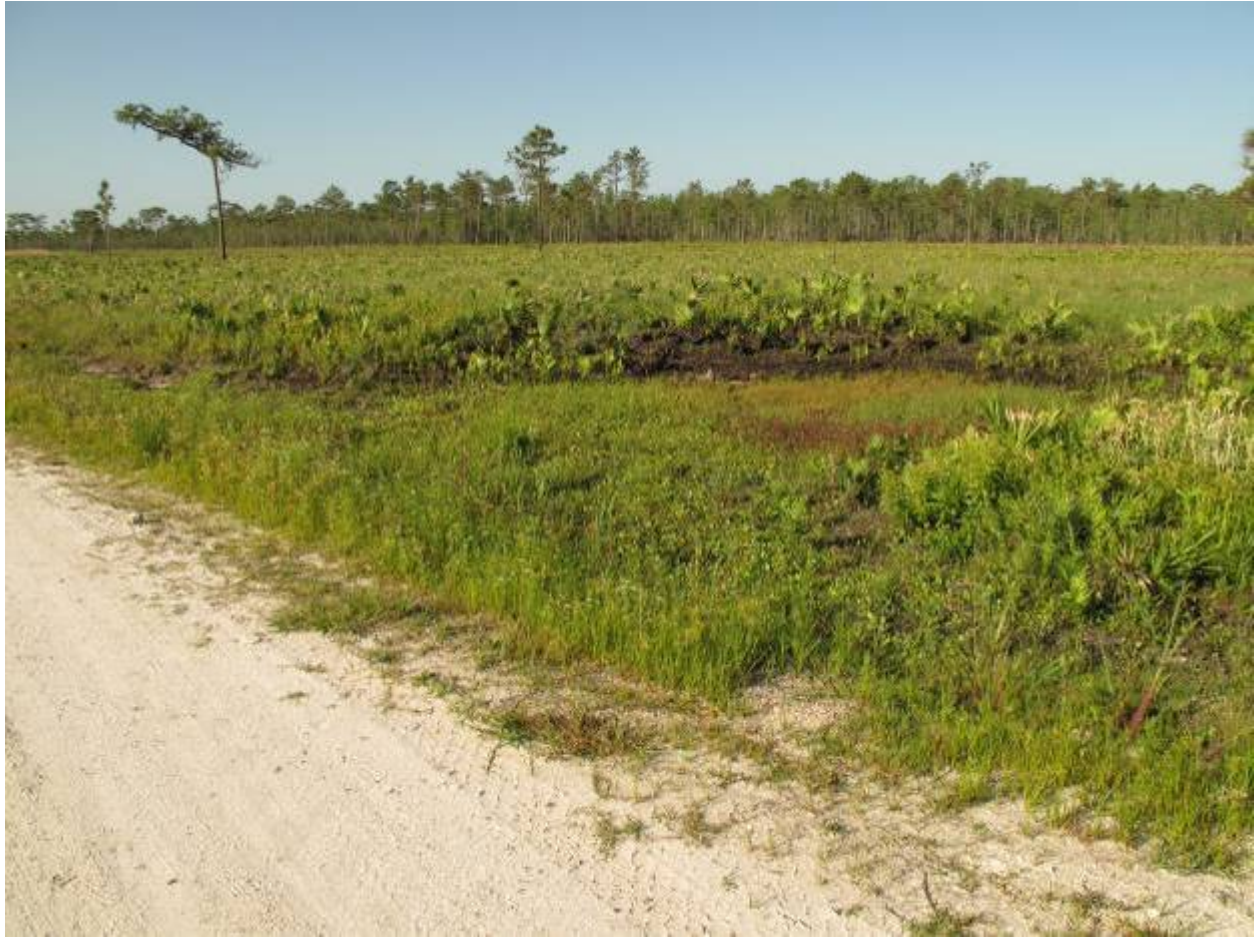
**Wetland ID: 52-22**

**Description:** This wetland is a <0.1 ha ephemeral marsh. It is the west end of a single pond that was bisected by Road 8. The road construction created 2 separate wetlands, this one and 52-21. There is no tree canopy or midstory cover. A high diversity of herbaceous vegetation covers >75% of the basin. There is a patch of what appears to be torpedograss in the wetland. There is minor feral hog damage in the wetland. This wetland is connected to an ephemeral roadside ditch system. The adjacent uplands are mesic flatwoods that are managed with prescribed fire.

**Wetland Concerns:** Invasive species, Road, Ditching

**Restoration Action Recommended:** Because the ditch connects to an ephemeral roadside ditch system, it likely is not impacting the wetland. However, we recommend filling all ditches connected to wetlands if restoration is a goal.

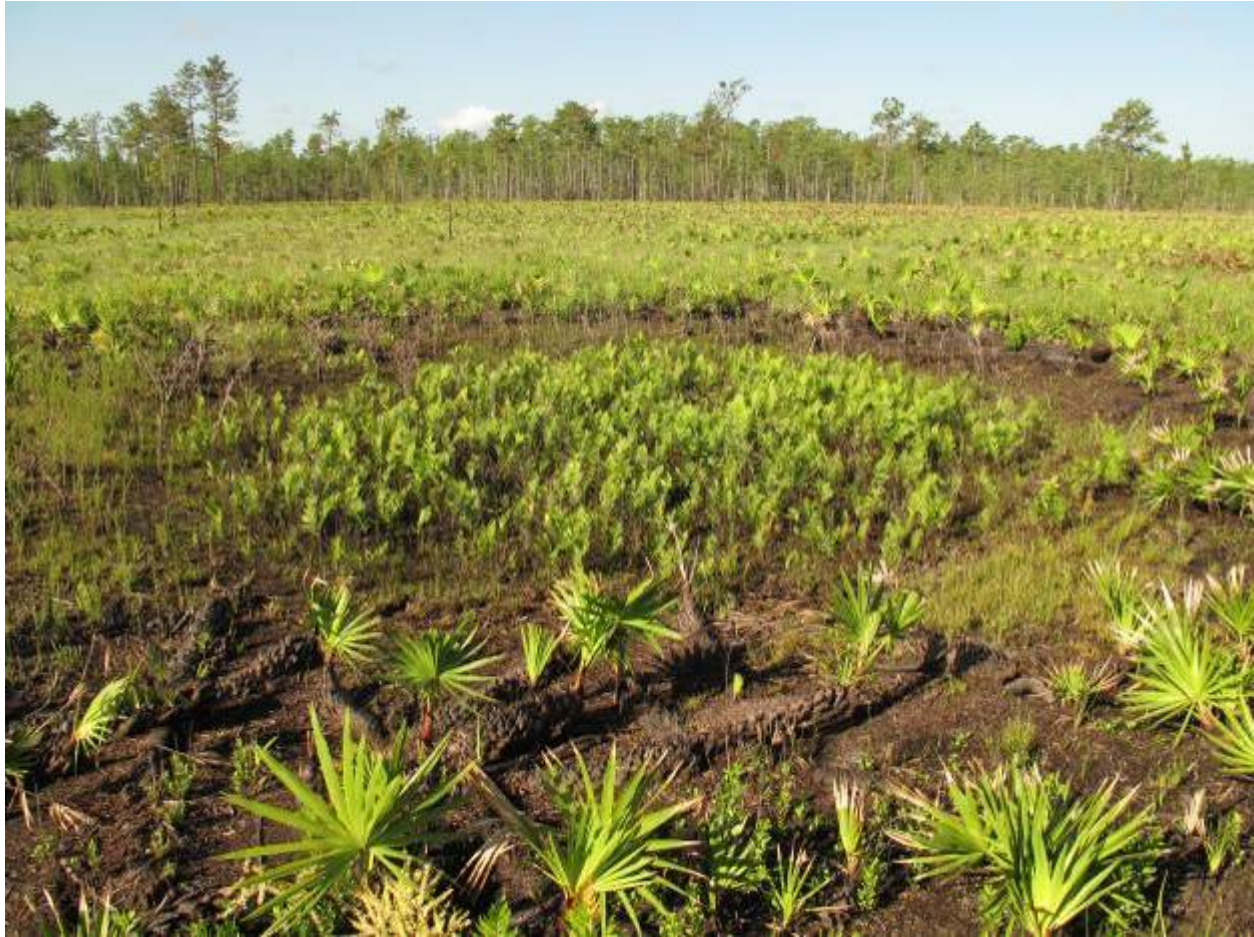
**Wetland ID: 52-23**

**Description:** This wetland is a <0.1 ha ephemeral marsh. There is no tree canopy or midstory cover. Fern and sedges/grasses grow throughout the wetland, and cover >75% of the basin. There is minor feral hog damage in the wetland that is now grown over with fern. The wetland had dried recently before our visit. The adjacent uplands are mesic flatwoods that are managed with prescribed fire.

**Wetland Concerns:** Feral hog damage

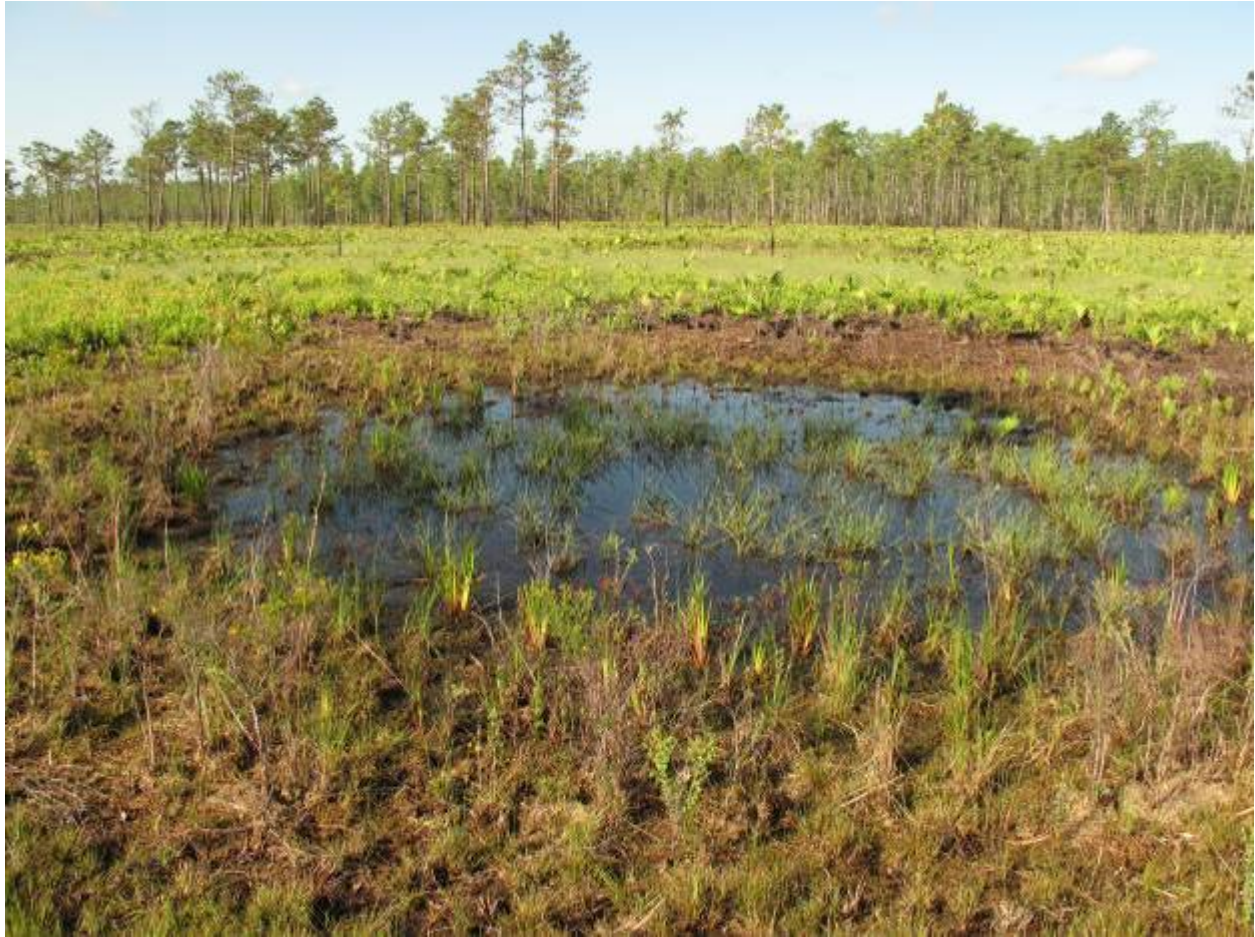
**Wetland ID: 52-24**

**Description:** This wetland is a <0.1 ha ephemeral marsh. There is no tree canopy or midstory cover. Emergent vegetation grows in the deeper wetland center, sedges/grasses are more common around the outer ring of the wetland, and *Sphagnum* grows throughout the wetland. The herbaceous vegetation covers >75% of the basin. The adjacent uplands are mesic flatwoods that are managed with prescribed fire.

**Wetland Concerns:** None

**Restoration Action Recommended:** None

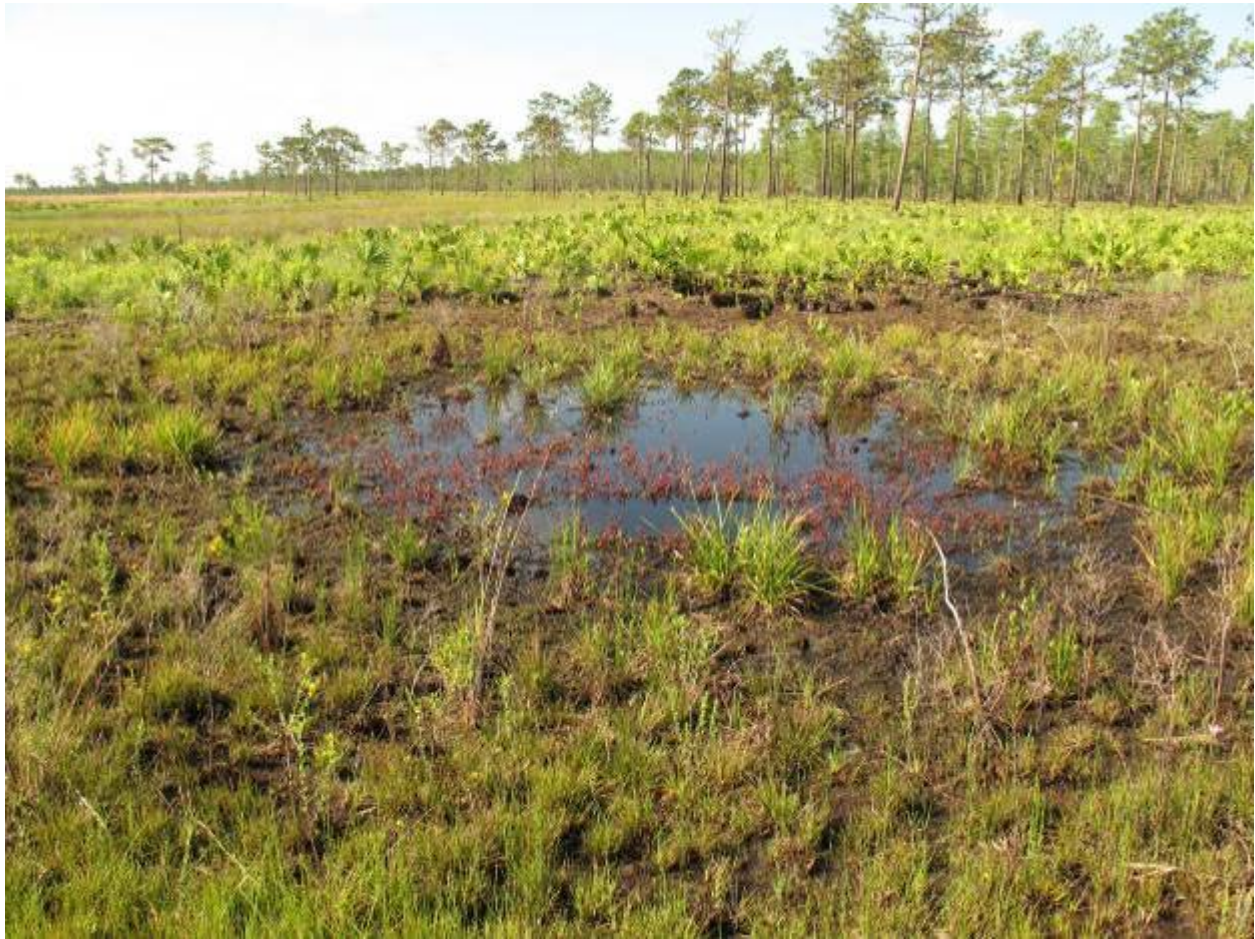
**Description:** This wetland is a <0.1 ha ephemeral marsh. There is no tree canopy or midstory cover. Emergent vegetation grows in the deeper wetland center; sedges/grasses are more common around the outer ring of the wetland. The herbaceous vegetation is diverse and covers >75% of the basin. The adjacent uplands are mesic flatwoods that are managed with prescribed fire.
