# **Inventory, Assessment, and Restoration Potential of Ephemeral Wetlands on FFWCC Wildlife Management Areas**

## **Triple N Ranch WMA Final Report**

Submitted by: Rebecca P.M. Means<sup>1</sup>, Ryan C. Means<sup>1</sup>, Steven A. Johnson<sup>2</sup>

15 May 2010 – 15 August 2010

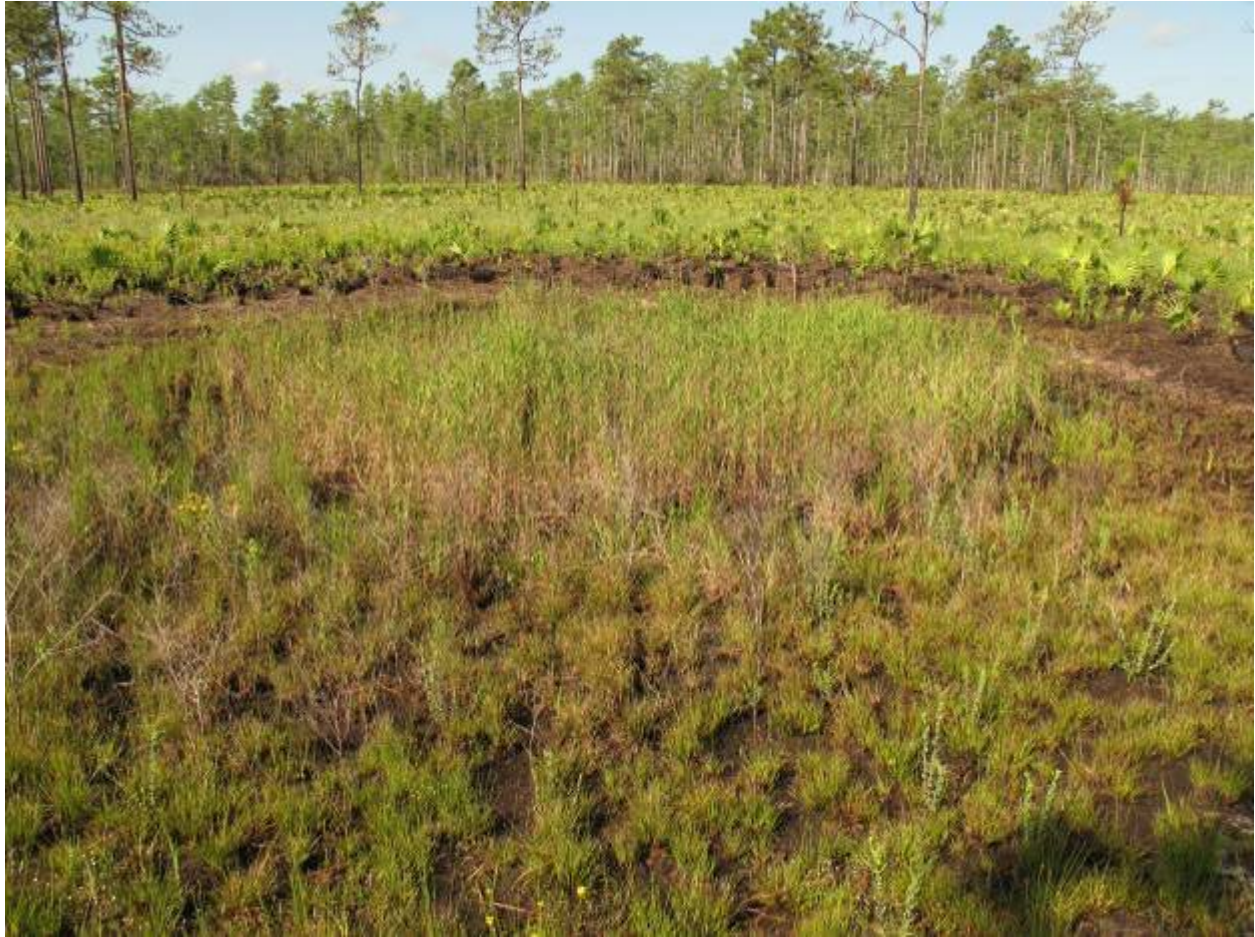
**Wetland ID: 52-26**

**Description:** This wetland is a <0.1 ha ephemeral marsh. There is no tree canopy or midstory cover. Maidencane grows in the deeper wetland center; sedges/grasses are more common around the outer ring of the wetland. The herbaceous vegetation covers >75% of the basin. A recent fire burned into the wetland edges. The adjacent uplands are mesic flatwoods that are managed with prescribed fire.

**Wetland Concerns:** None

**Restoration Action Recommended:** None

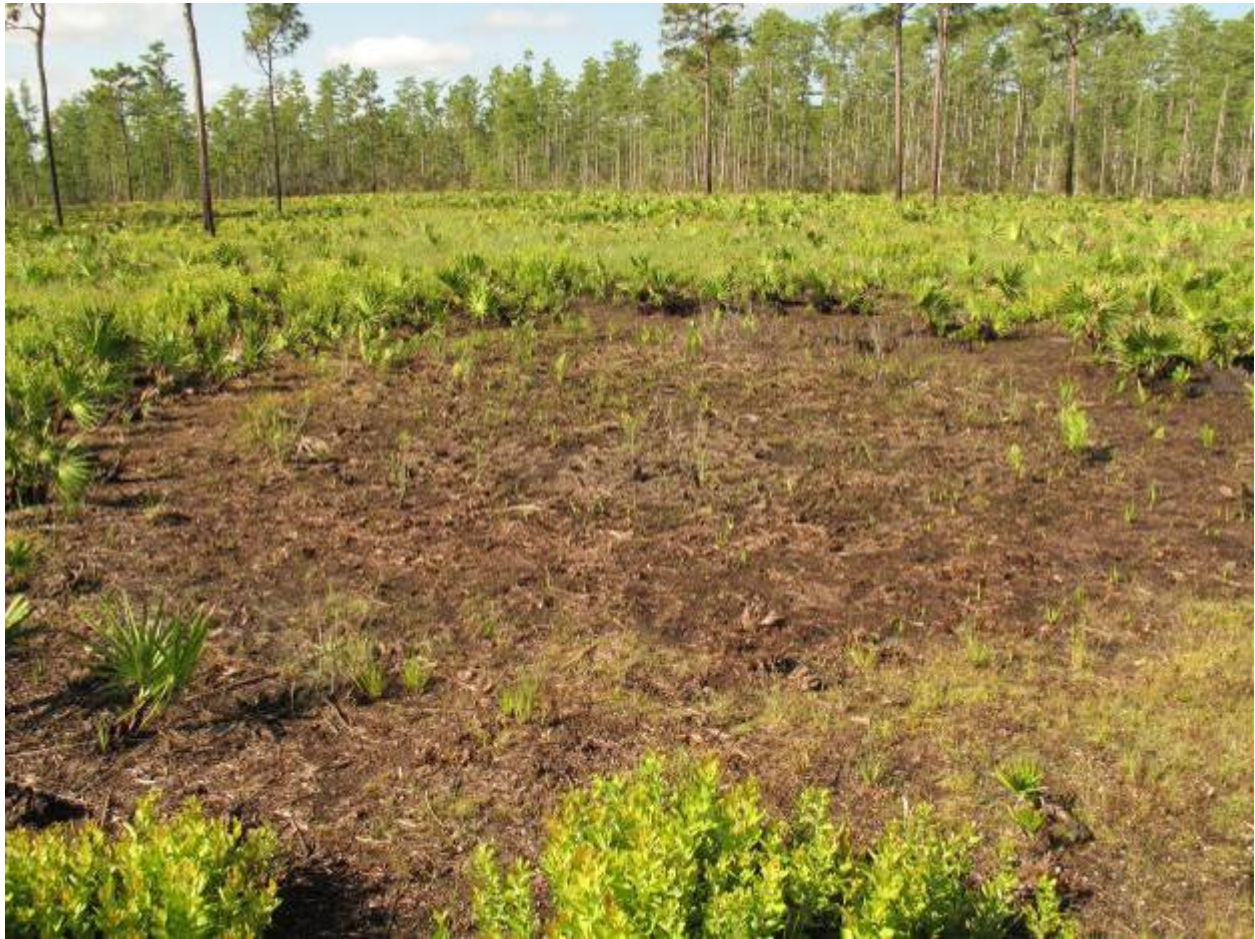
**Description:** This wetland is a <0.1 ha ephemeral marsh. There is no tree canopy or midstory cover. The wetland dried just before the day of our visit, exposing bare soil. Sedges/grasses grow sparsely throughout the wetland, and cover 5-25% of the basin. The adjacent uplands are mesic flatwoods that are managed with prescribed fire.

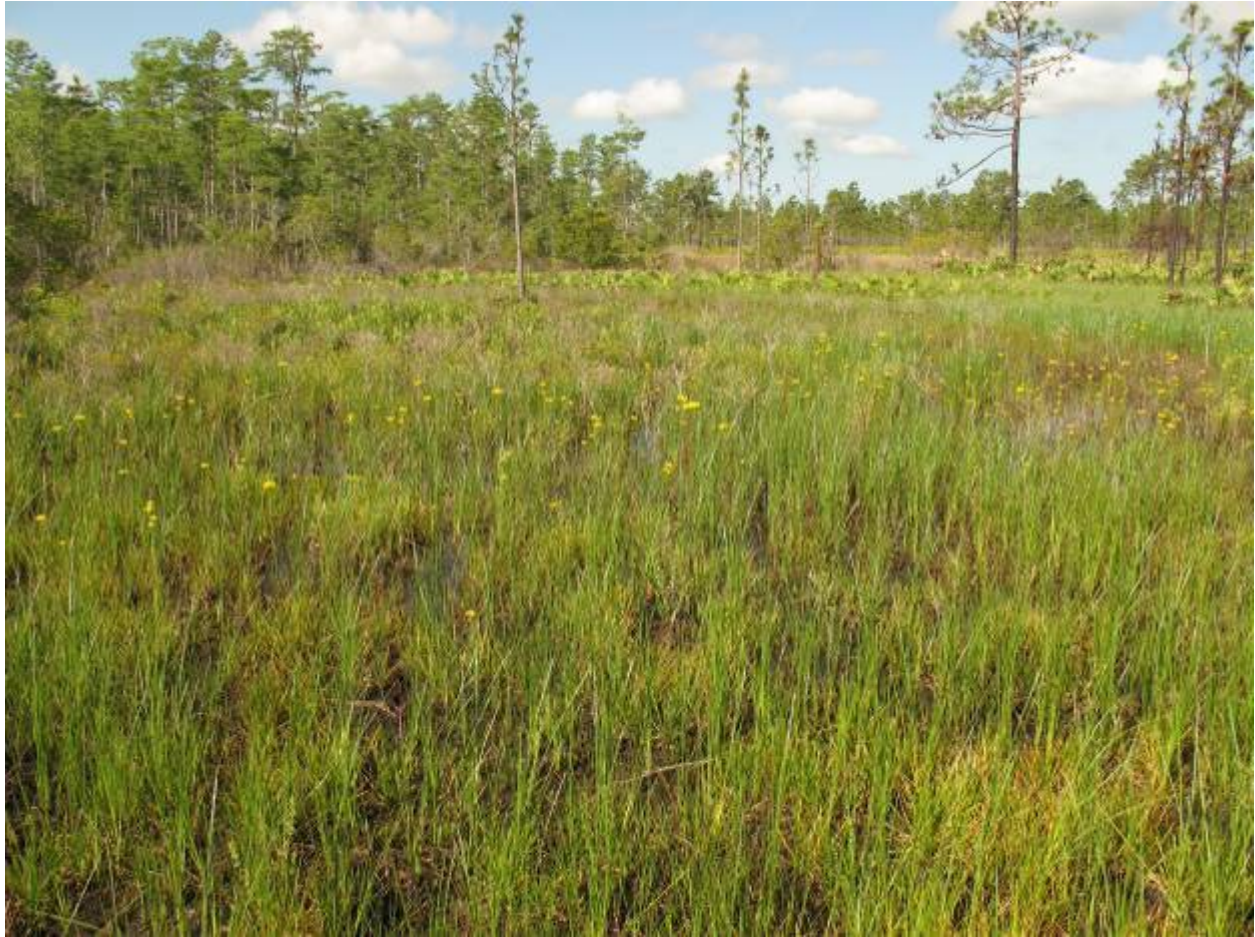
**Wetland ID: 52-28**

**Description:** This wetland is a 0.1 ha ephemeral marsh. There is no tree canopy or midstory cover. Sedges/grasses grow throughout the wetland, and cover >75% of the basin. There is a 0.2 m tall and 0.5 m wide dead grass mound in the wetland, possibly a nest. The wetland is adjacent to a large swamp to the south. The adjacent uplands are mesic flatwoods that are managed with prescribed fire.

**Wetland Concerns:** None

**Restoration Action Recommended:** None

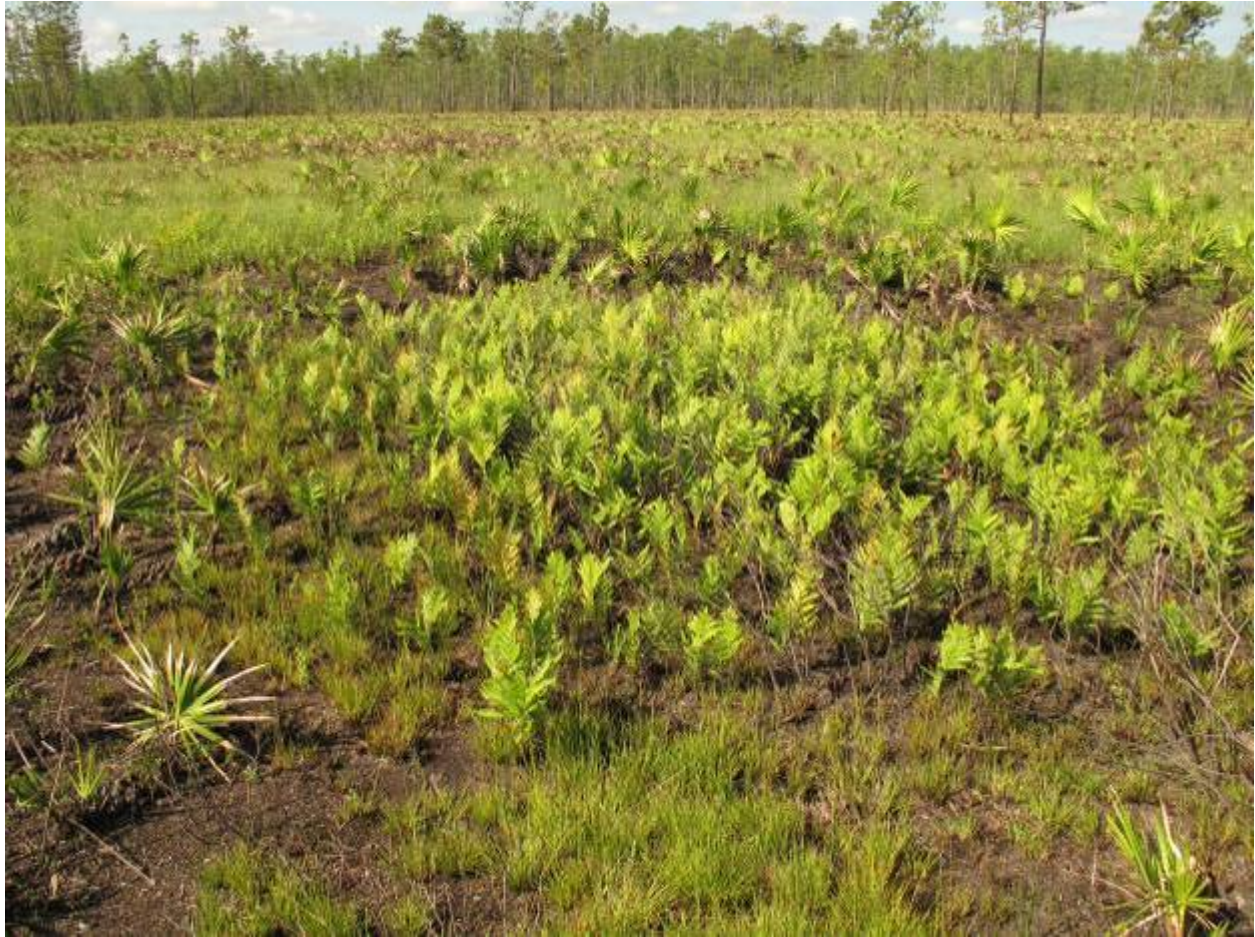
**Wetland ID: 52-29**

**Description:** This wetland is a <0.1 ha ephemeral marsh. There is no tree canopy or midstory cover. Fern grows in the wetland interior and sedges/grasses grow in a ring around the outer edge. The herbaceous vegetation covers >75% of the basin. Feral hog damage is old and almost eroded flat. The adjacent uplands are mesic flatwoods that are managed with prescribed fire.

**Wetland Concerns:** Feral hog damage

**Restoration Action Recommended:** None

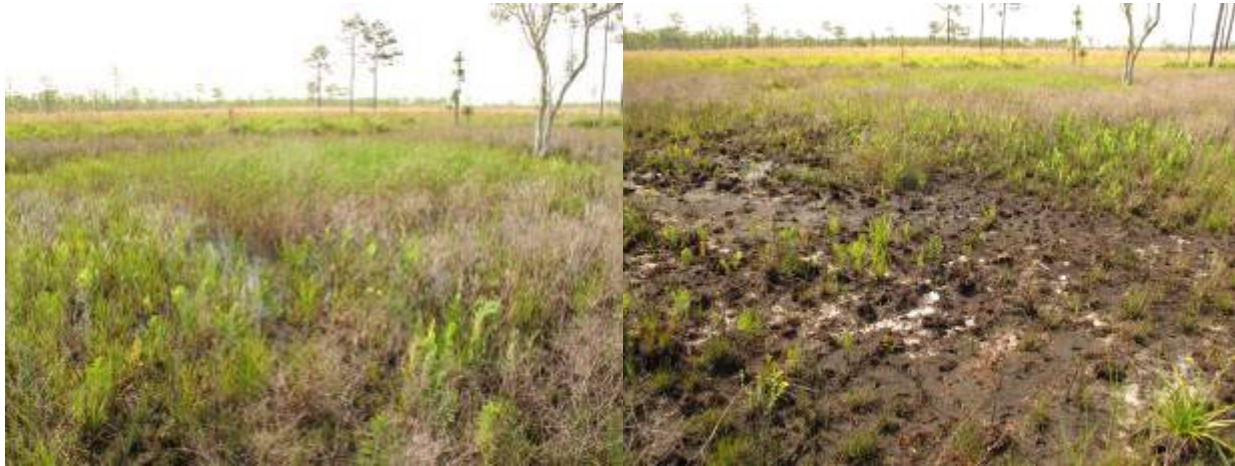
**Wetland ID: 52-30**

**Description:** This wetland is a 0.1 ha ephemeral marsh. There is no tree canopy or midstory cover. Maidencane grows in the deeper wetland center and sedges/grasses grow in the shallower areas. The herbaceous vegetation covers >75% of the basin. The vegetation and soil on the north end of the wetland have been damaged by what appears to be a roller chopper. Feral hogs have rooted in the vehicle tracks. The adjacent uplands are mesic flatwoods that are managed with prescribed fire.

**Wetland Concerns:** Feral hog damage, Vehicular damage

**Restoration Action Recommended:** Avoid driving machinery around the wetland edges. If necessary, flag the wetland edges before contractors perform mechanical activity in the uplands. Consider trapping or hunting feral hogs in this area because of the prevalence of feral hog damage and the high quality of the marshes.

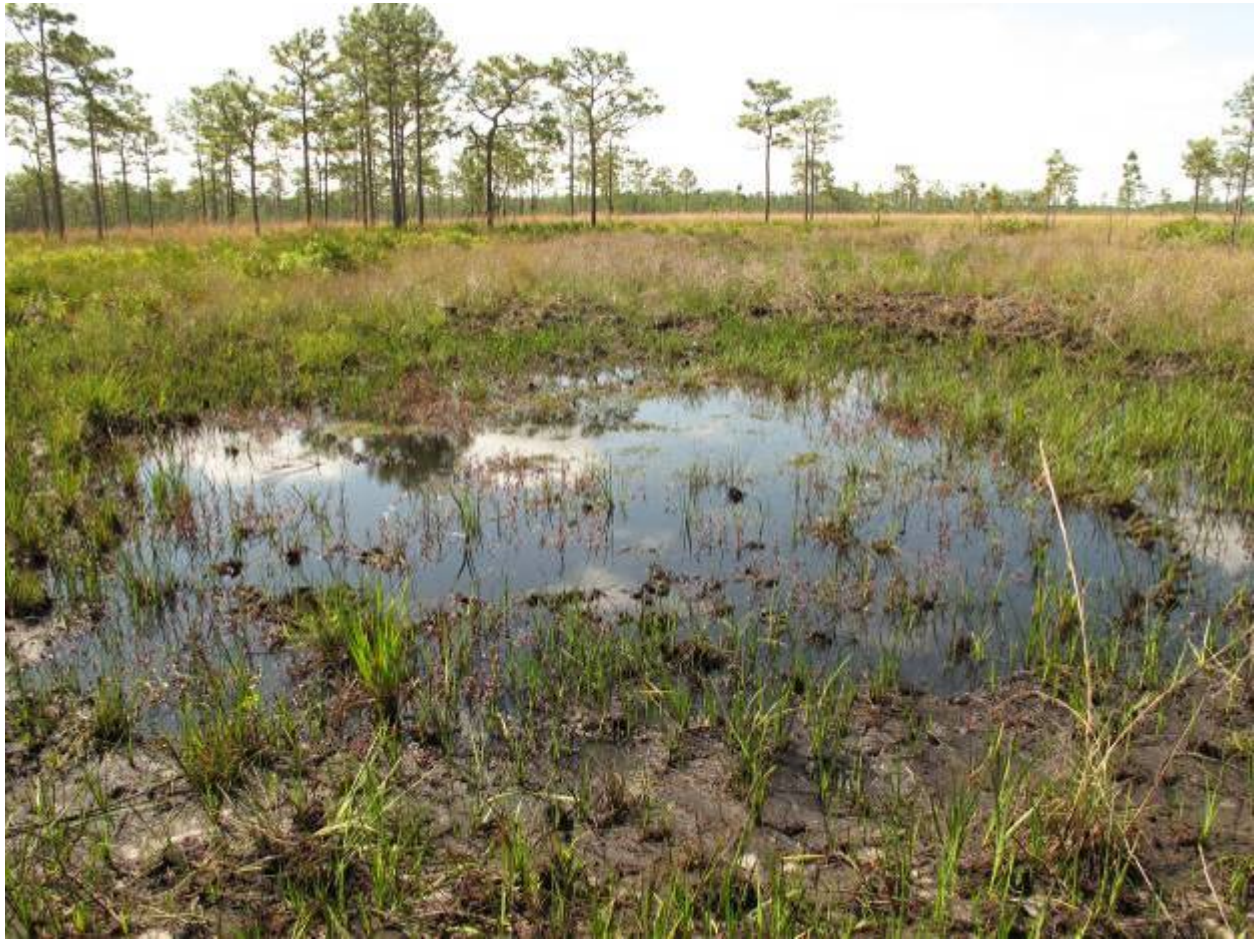
**Description:** This wetland is a 0.2 ha ephemeral marsh. There is no tree canopy or midstory cover. Sedges/grasses and redroot grow throughout the wetland, and cover 50-75% of the basin. Feral hog damage is widespread and severe. A game trail connects 52-30 to 52-31 through the uplands. The adjacent uplands are mesic flatwoods that are managed with prescribed fire.

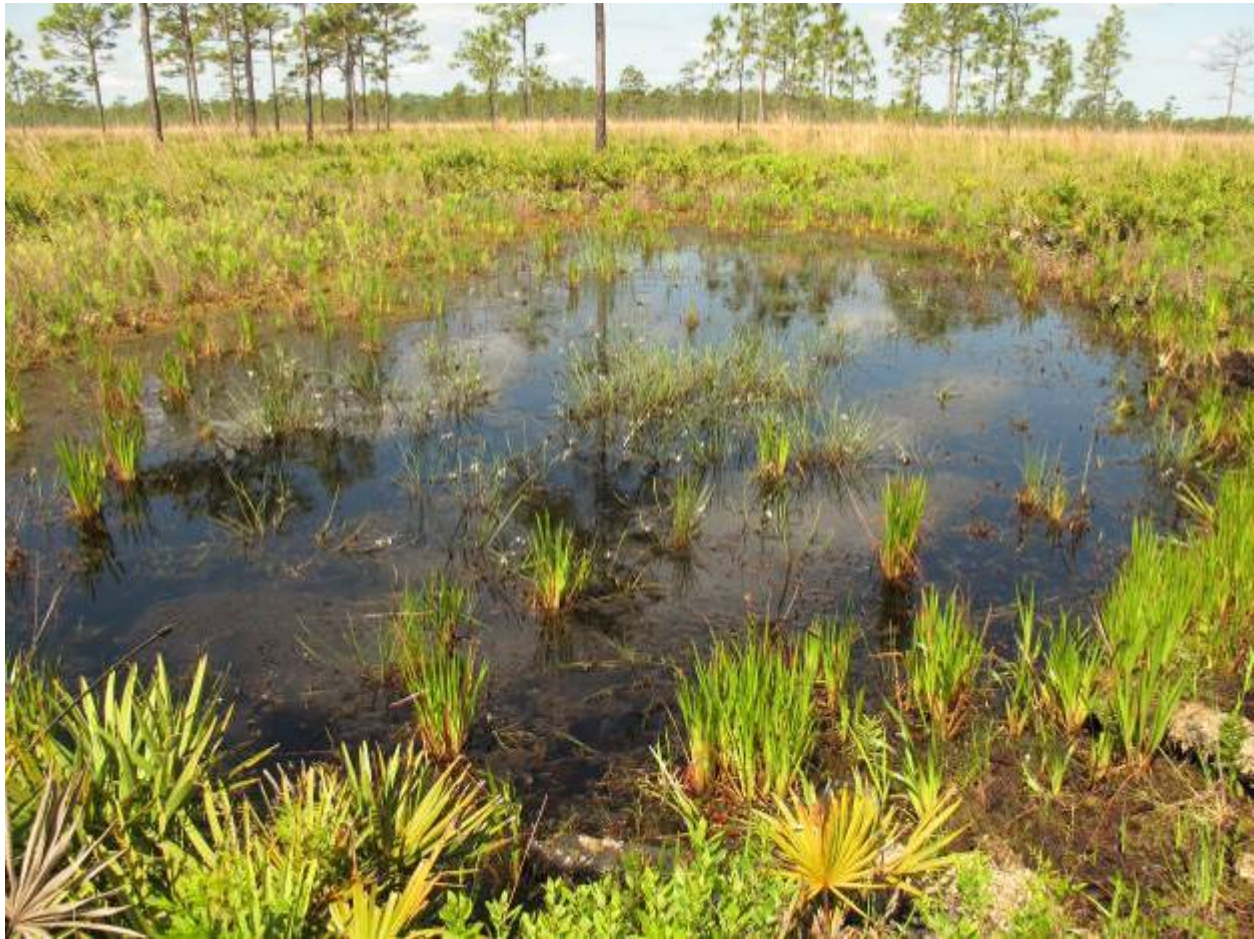
**Description:** This wetland is a <0.1 ha ephemeral marsh. There is no tree canopy or midstory cover. Sedges/grasses grow throughout the wetland and *Sphagnum* is common around the wetland edge. The herbaceous vegetation is diverse and covers >75% of the basin. Feral hog damage is minor and confined to the wetland edges. The adjacent uplands are mesic flatwoods that are managed with prescribed fire.

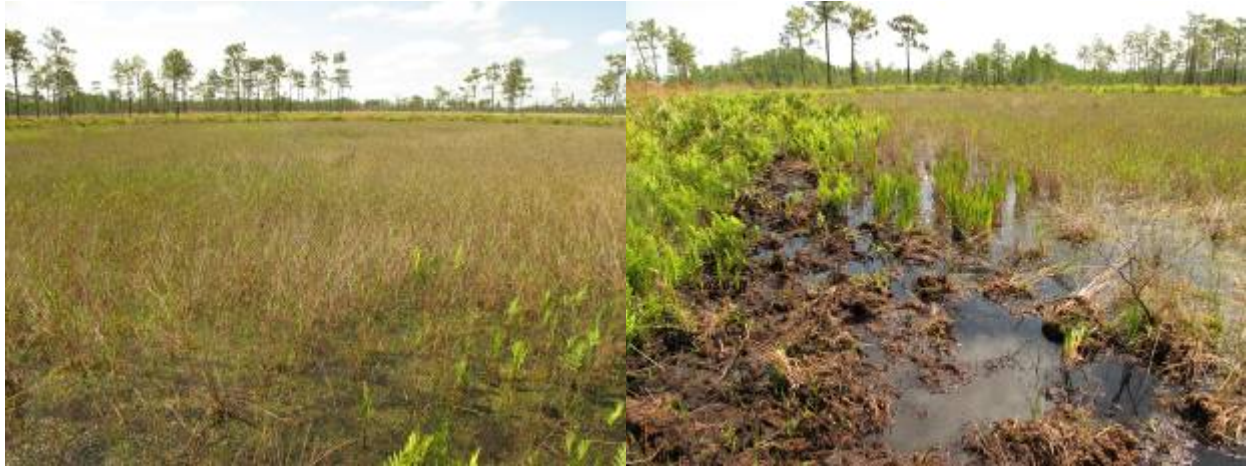
**Wetland ID: 53-02**

**Description:** This wetland is a 0.4 ha ephemeral marsh. There is no tree canopy or midstory cover. Maidencane grows throughout the wetland, and covers >75% of the basin. Feral hog damage is patchy along the wetland edges. The adjacent uplands are mesic flatwoods that are managed with prescribed fire.

**Wetland Concerns:** Feral hog damage

**Restoration Action Recommended:** Consider trapping or hunting feral hogs in this area because of the prevalence of feral hog damage and the high quality of the marshes.

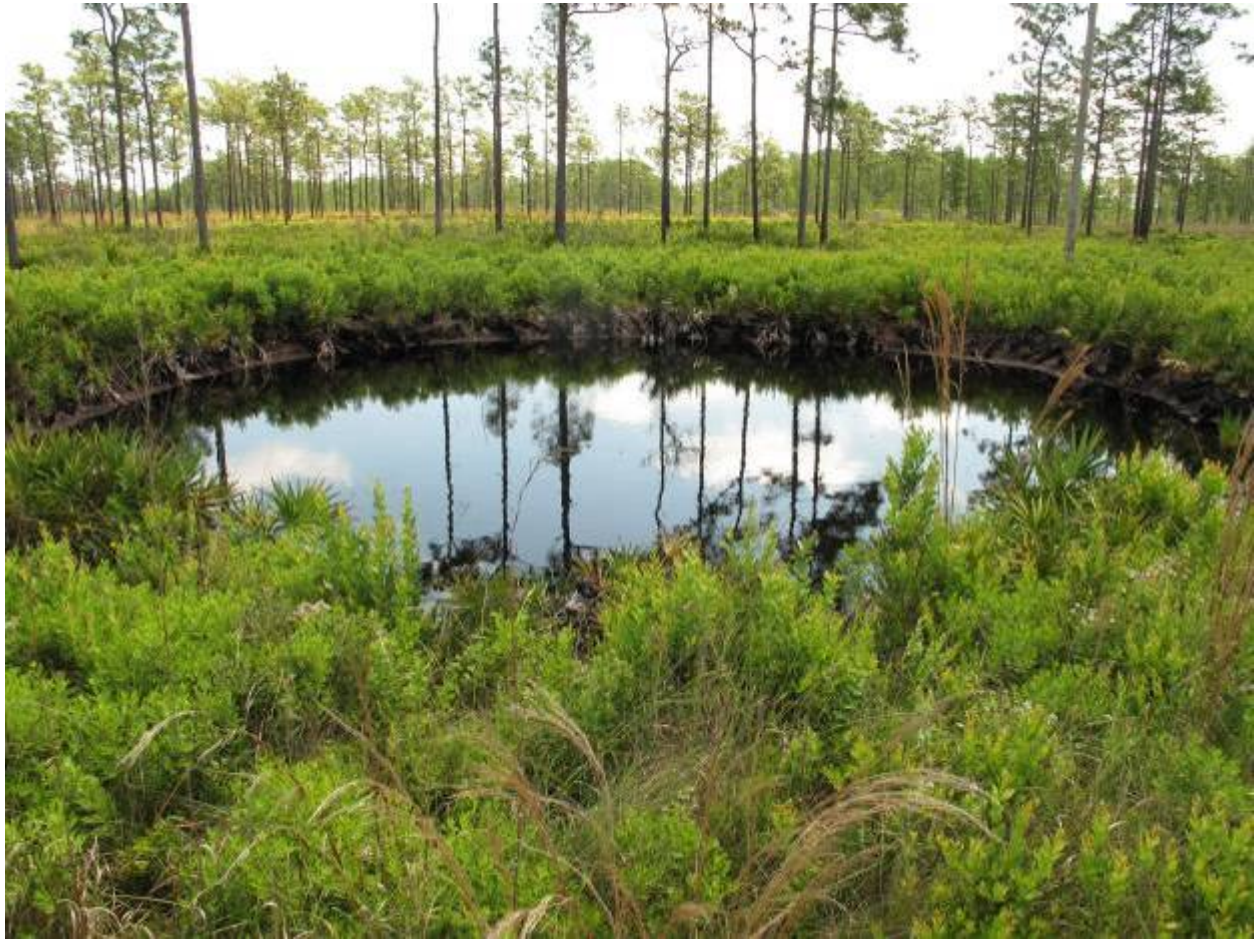
**Description:** This wetland is a <0.1 ha ephemeral marsh. It is a perfectly circular sink karst depression with dark, black water. There is no tree canopy or midstory cover and no visible herbaceous vegetation. The adjacent uplands are mesic flatwoods that are managed with prescribed fire.

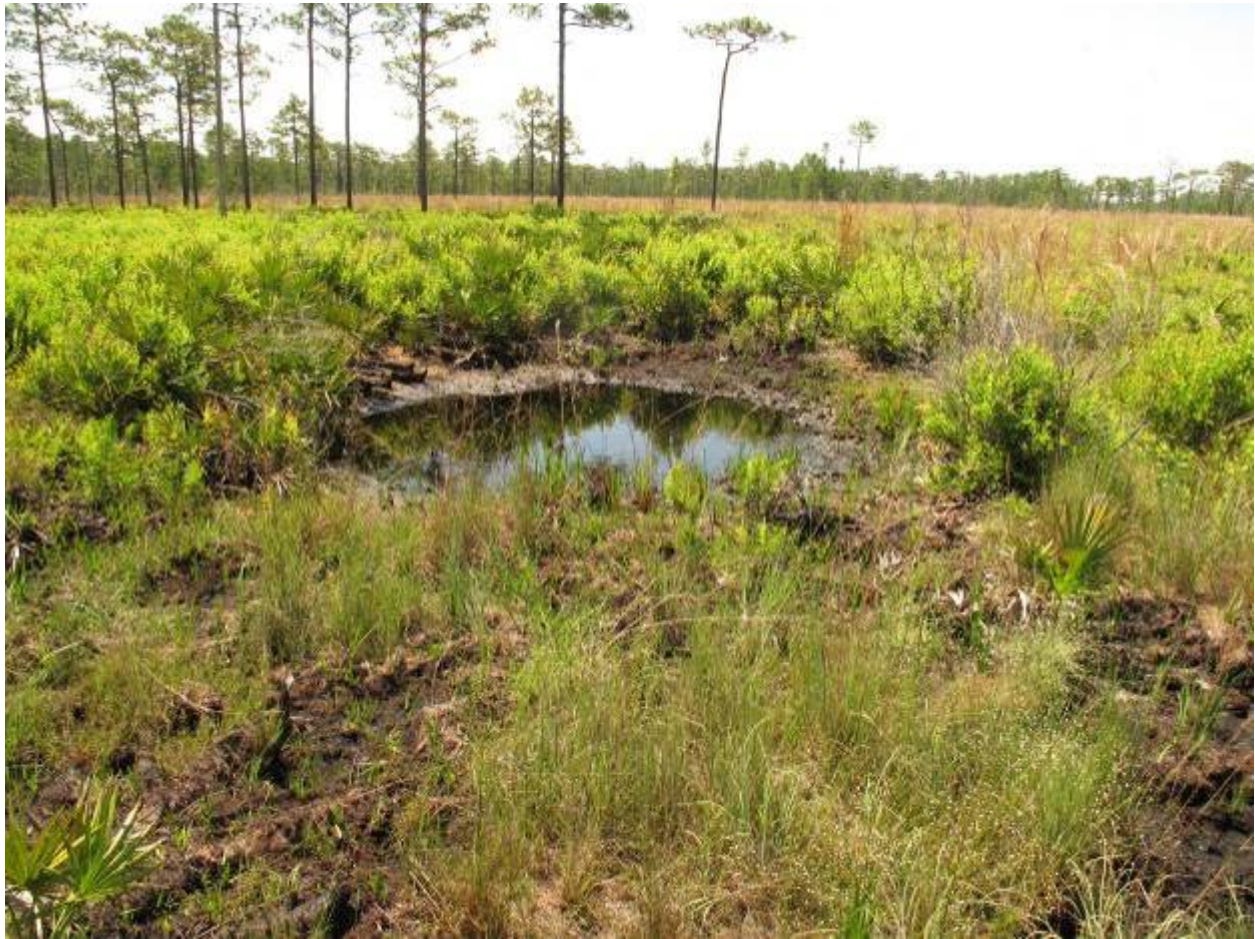
**Description:** This wetland is a <0.1 ha ephemeral marsh. This small, oval marsh has a deeper hole in the south end. There is no tree canopy or midstory cover. Emergent vegetation and *Sphagnum* grow around the edge of the hole, and sedges/grasses grow throughout the rest of the wetland. The herbaceous vegetation covers 50-75% of the basin. There is feral hog damage throughout most of the wetland. The adjacent uplands are mesic flatwoods that are managed with prescribed fire.

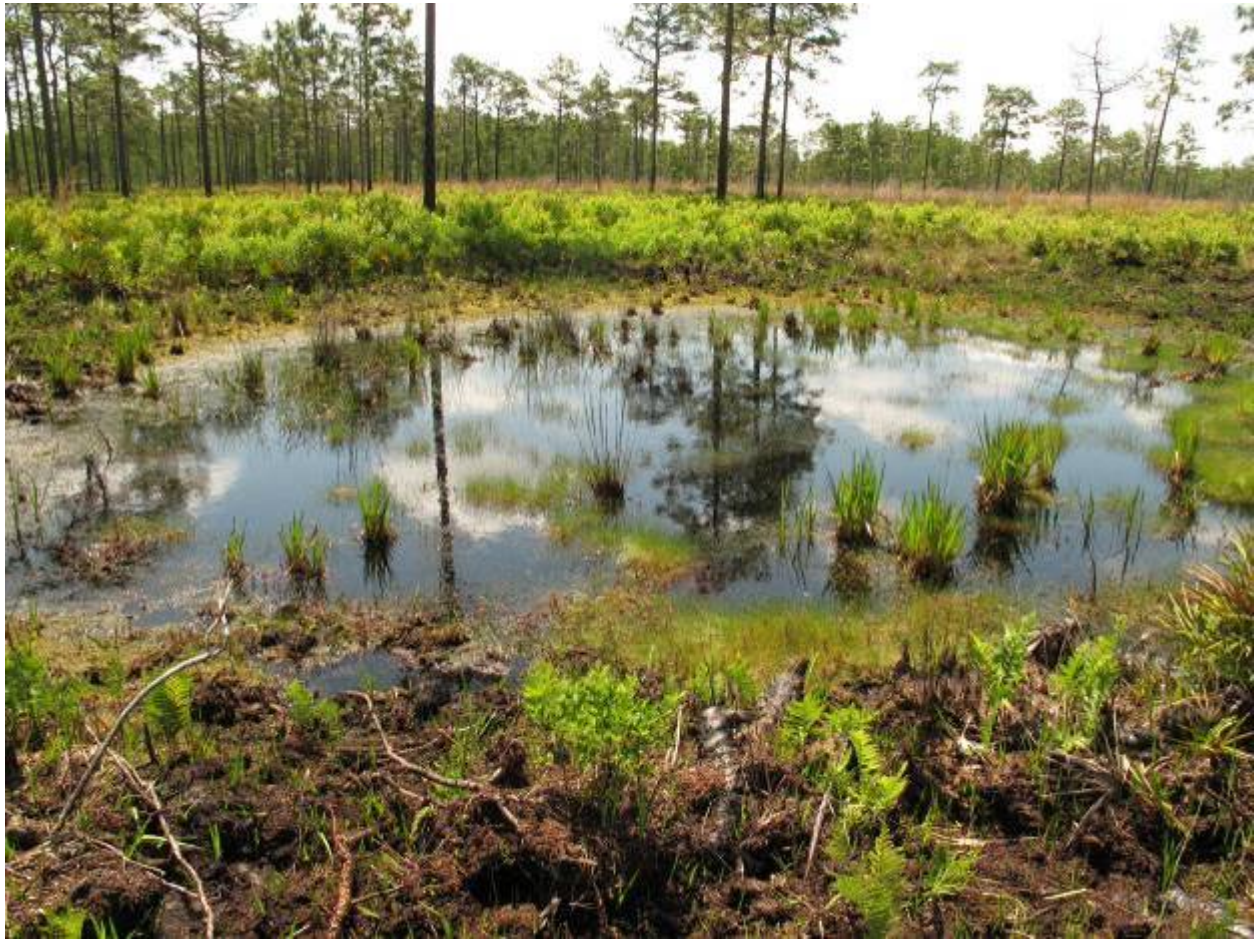
**Description:** This wetland is a <0.1 ha ephemeral marsh. There is no tree canopy or midstory cover. Sedges/grasses grow throughout the wetland and *Sphagnum* is common around the wetland edge. The herbaceous vegetation covers >75% of the basin. Feral hog damage is patchy around the wetland edge. The adjacent uplands are mesic flatwoods that are managed with prescribed fire.

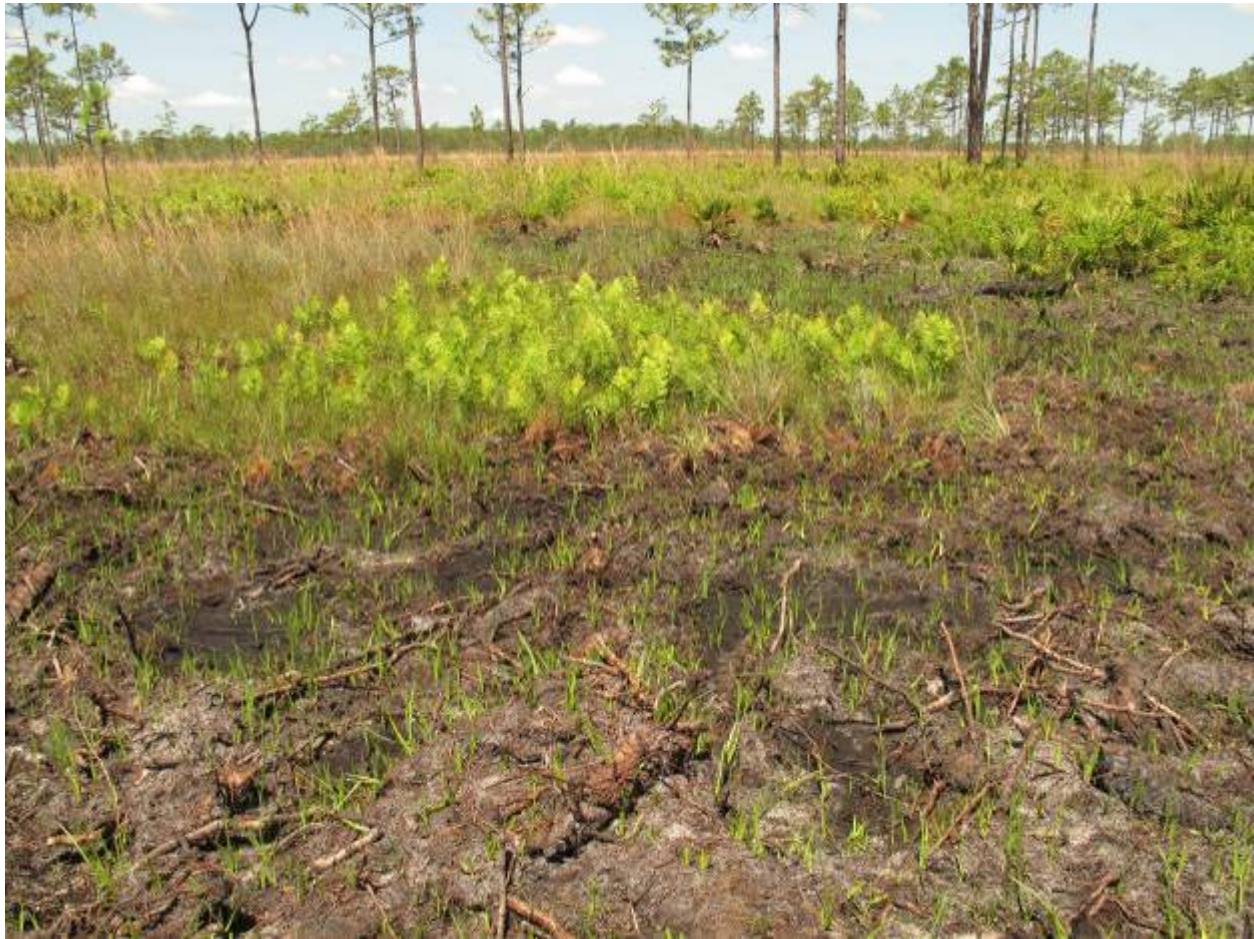
**Description:** This wetland is a <0.1 ha highly ephemeral marsh. There is no tree canopy or midstory cover. Sedges/grasses and fern grow throughout the wetland, and redroot grows over areas damaged by feral hogs. The herbaceous vegetation covers >75% of the basin. Feral hog damage is extensive over half of the wetland. The adjacent uplands are mesic flatwoods that are managed with prescribed fire.

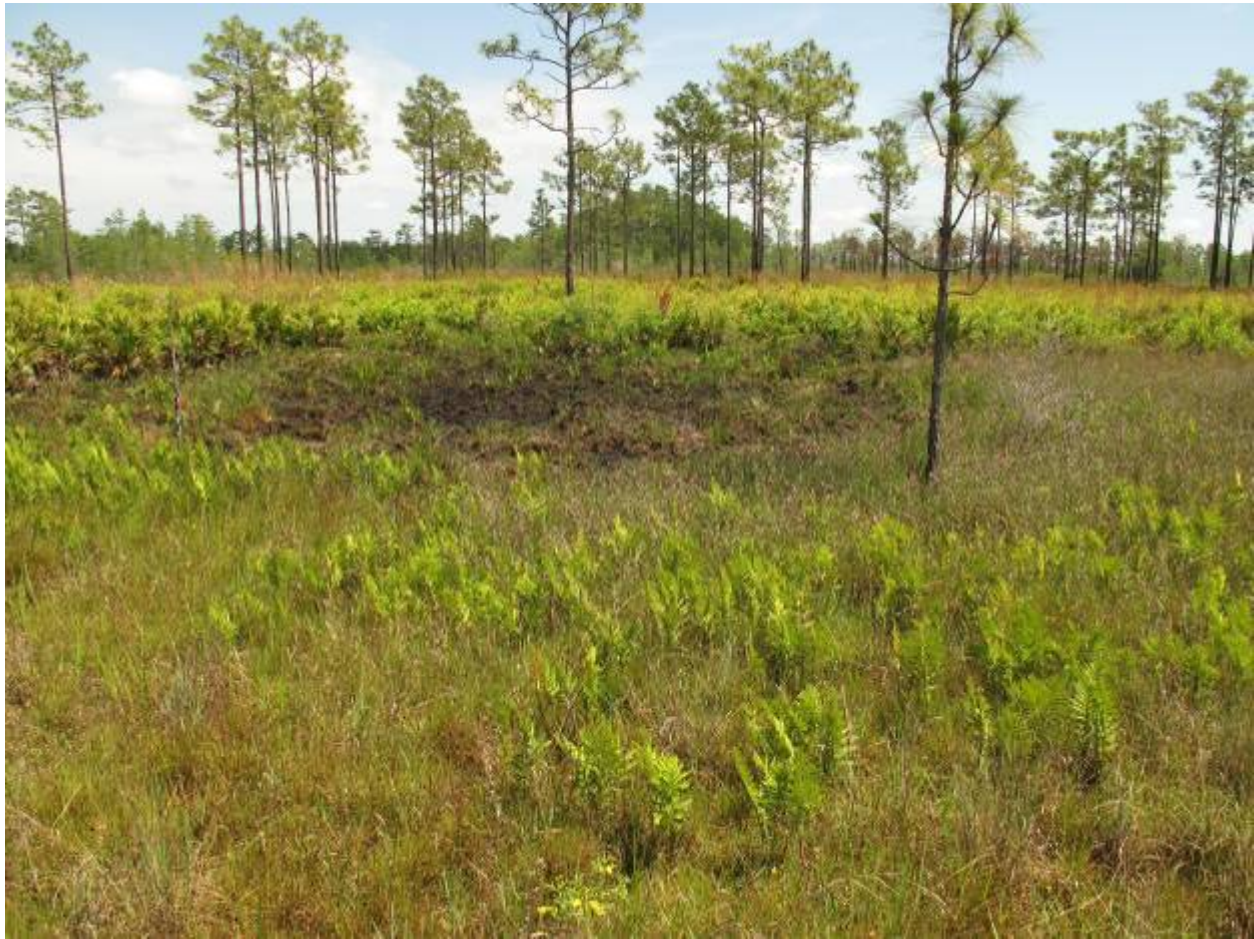
**Description:** This wetland is a 0.1 ha ephemeral marsh. There is no tree canopy or midstory cover. Sedges/grasses and maidencane grow throughout most of the wetland and redroot is sprouting over feral hog damage. The herbaceous vegetation covers 50-75% of the basin. Feral hog damage is severe over a third of the wetland. The adjacent uplands are mesic flatwoods that are managed with prescribed fire.

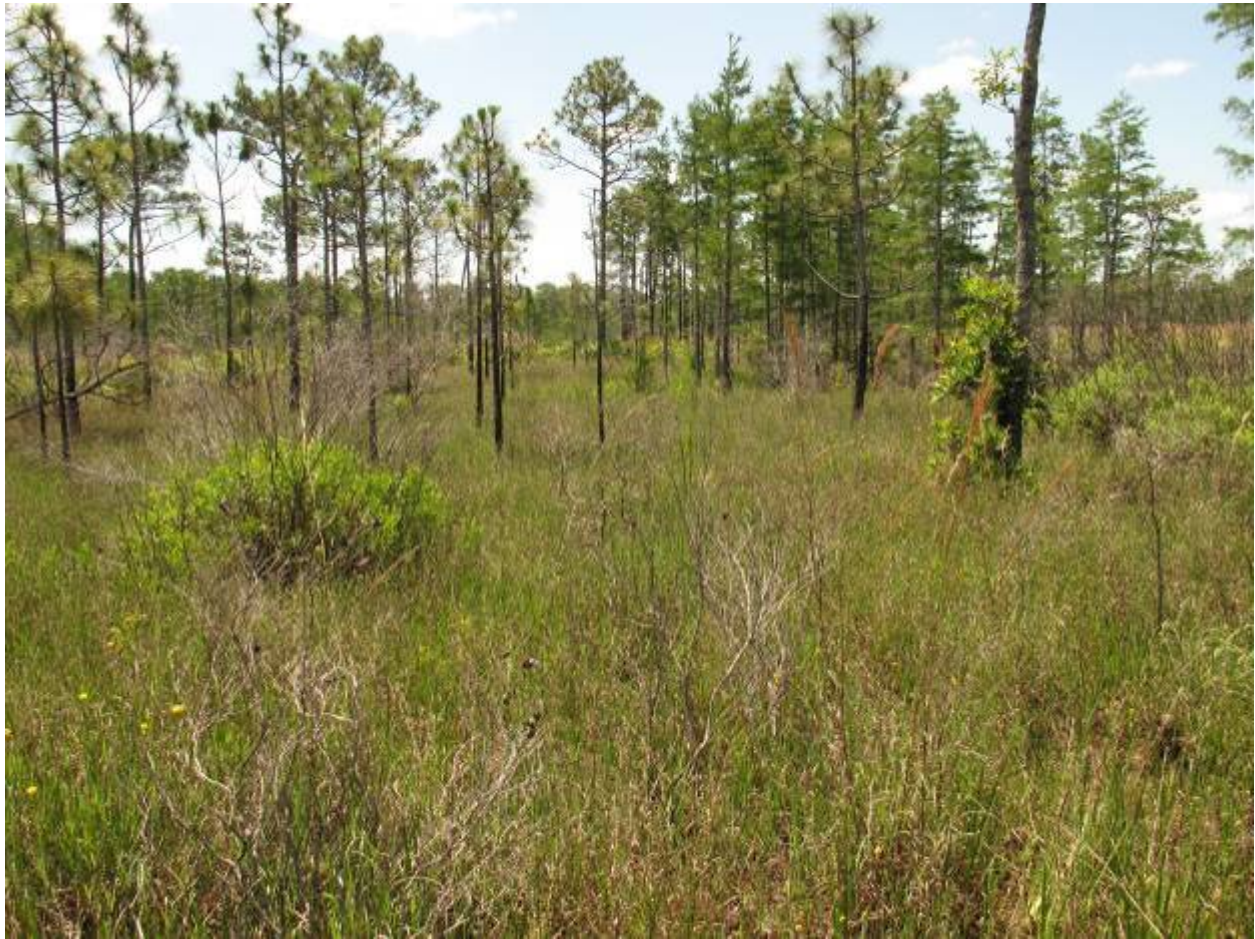
**Description:** This wetland is a 0.4 ha ephemeral marsh. The north end of the wetland is deeper with a developing cypress swamp. Cypress trees cover 25-50% of the total wetland. A recent fire burned through the wetland, pruning the encroaching feterbush. The remaining feterbush covers 5-25% of the wetland. A diversity of maidencane, sedges/grasses, fern, and *Sphagnum* grows throughout the wetland, and covers >75% of the basin. Feral hog damage is patchy. The adjacent uplands are mesic flatwoods that are managed with prescribed fire.

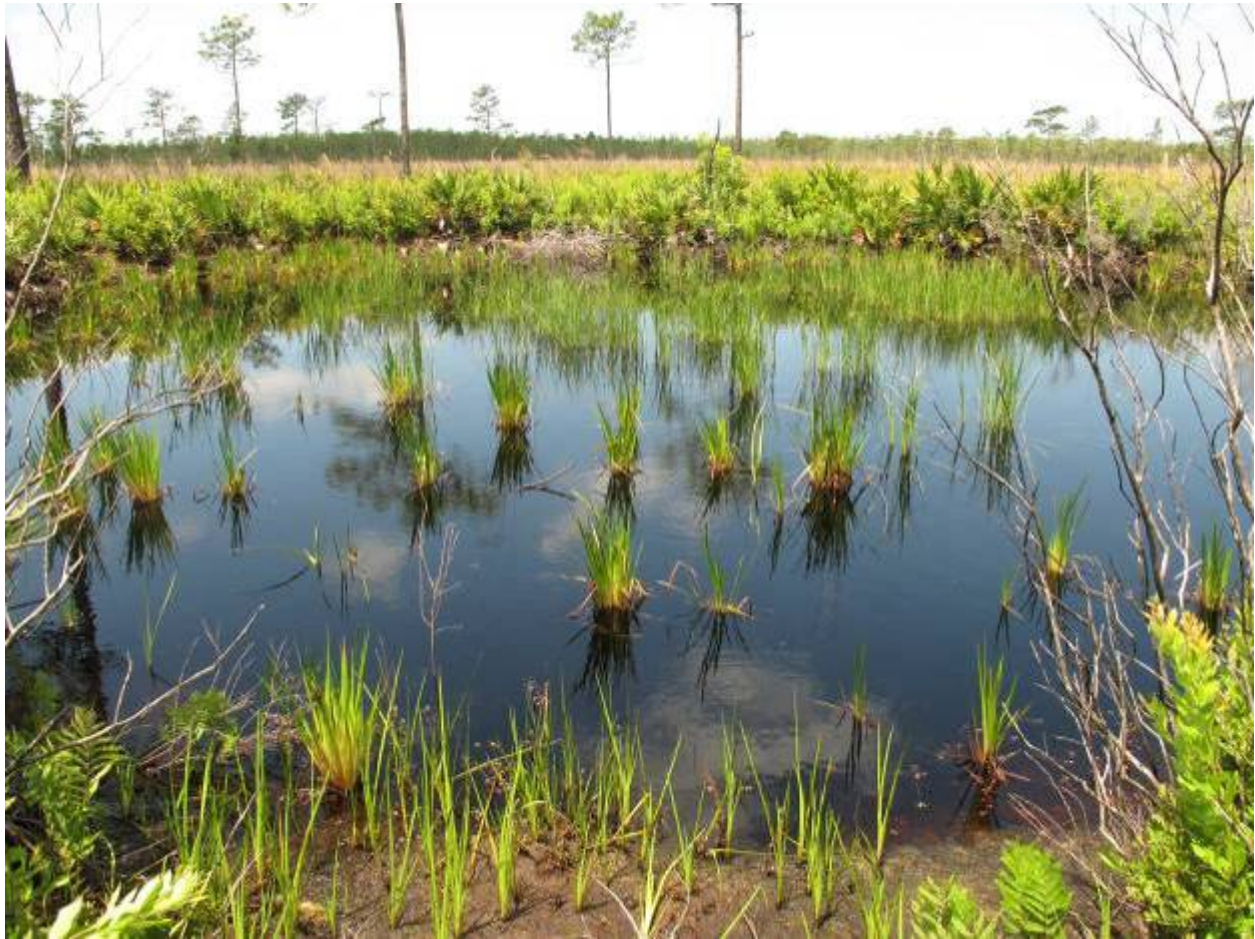
**Description:** This wetland is a <0.1 ha ephemeral marsh. It is a circular sink depressional pond with black water. There is no tree canopy or midstory cover. Sedges/grasses and redroot grow sparsely throughout the wetland, and cover 5-25% of the basin. Feral hog damage is patchy and confined to the wetland edges. The adjacent uplands are mesic flatwoods that are managed with prescribed fire.

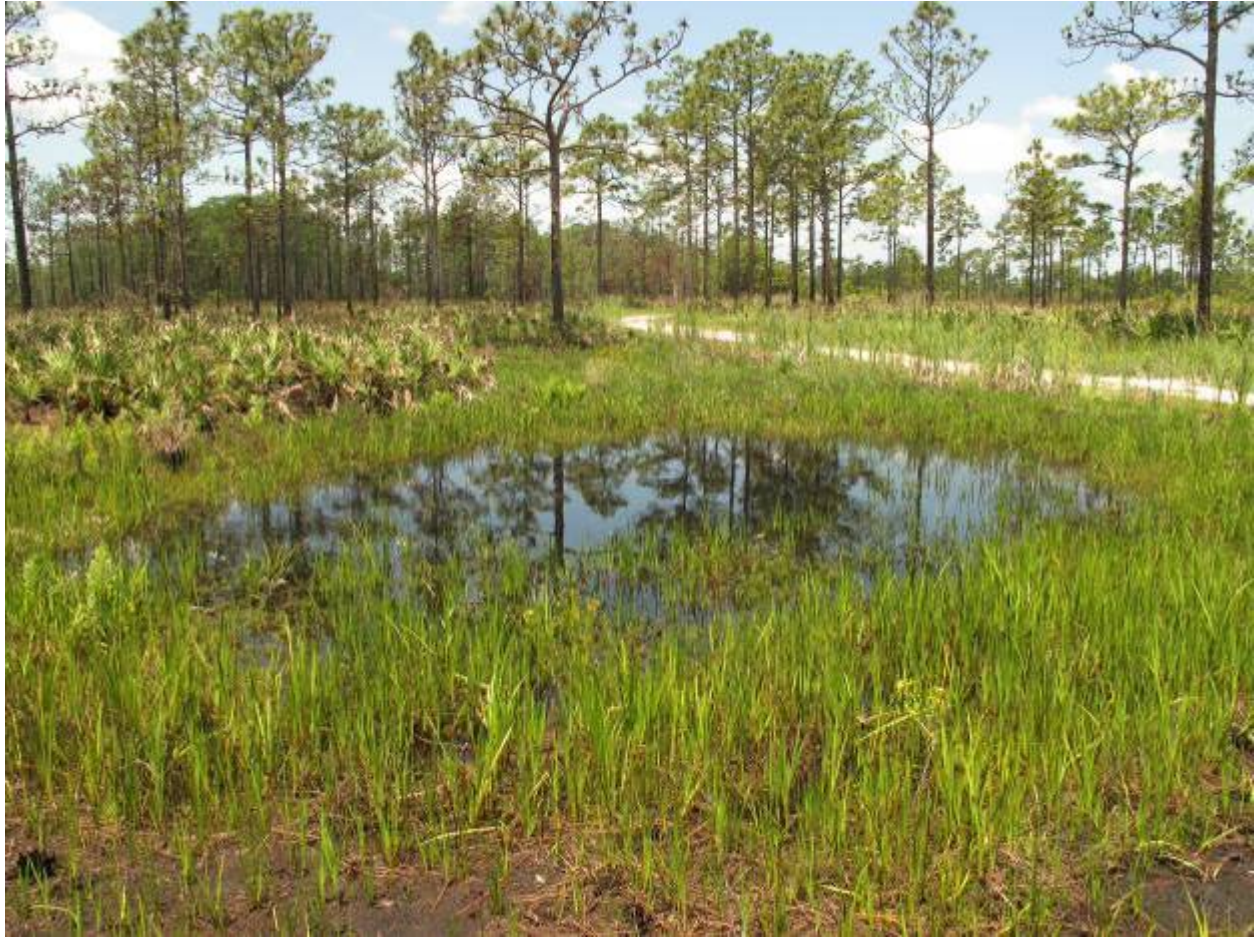
**Wetland ID: 53-10**

**Description:** This wetland is a <0.1 ha ephemeral marsh. There is no tree canopy or midstory cover. Emergent vegetation grows in the wetland center and redroot grows on areas damaged by feral hogs. The herbaceous vegetation covers >75% of the basin. Feral hog damage is widespread and grown over with vegetation. The wetland is adjacent to Access Road 9 and is connected to the shallow roadside ditches. The ditches appear to be more ephemeral than the wetland. The adjacent uplands are mesic flatwoods that are managed with prescribed fire.

**Wetland Concerns:** Feral hog damage, Roadside ditches

**Restoration Action Recommended:** Consider trapping or hunting feral hogs in this area because of the prevalence of feral hog damage and the high quality of the marshes. Because the ditch connects to an ephemeral roadside ditch system, it likely is not impacting the wetland. However, we recommend filling all ditches connected to wetlands if restoration is a goal.

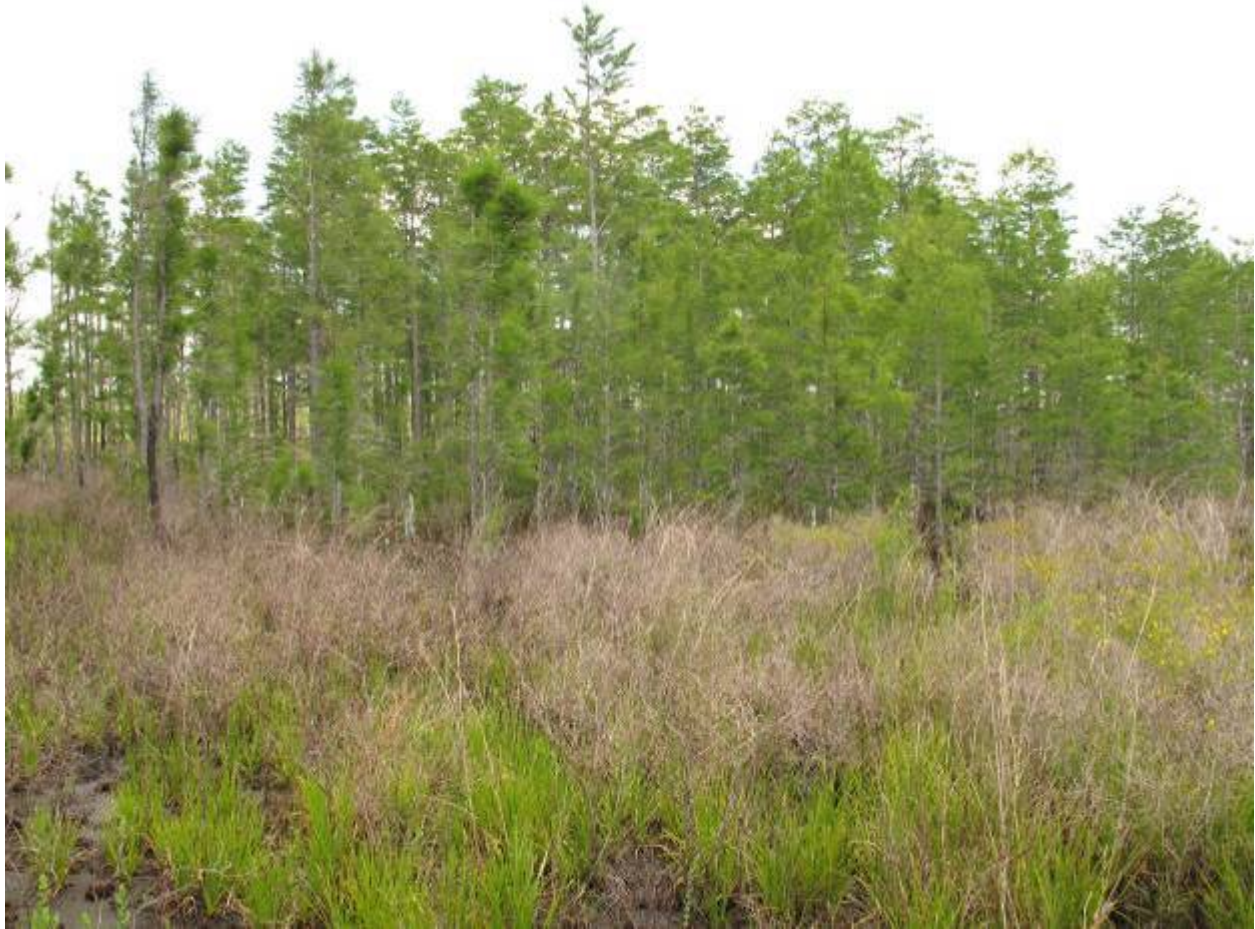
**Wetland ID: 53-11**

**Description:** This wetland is a 0.4 ha ephemeral forested swamp. Cypress trees cover 50-75% of the wetland. Sedges/grasses, fern, and redroot grow throughout the wetland, and cover >75% of the basin. This wetland may represent a marsh succeeding to a cypress dome. The adjacent uplands are mesic flatwoods that are managed with prescribed fire.

**Wetland Concerns:** None

**Restoration Action Recommended:** None

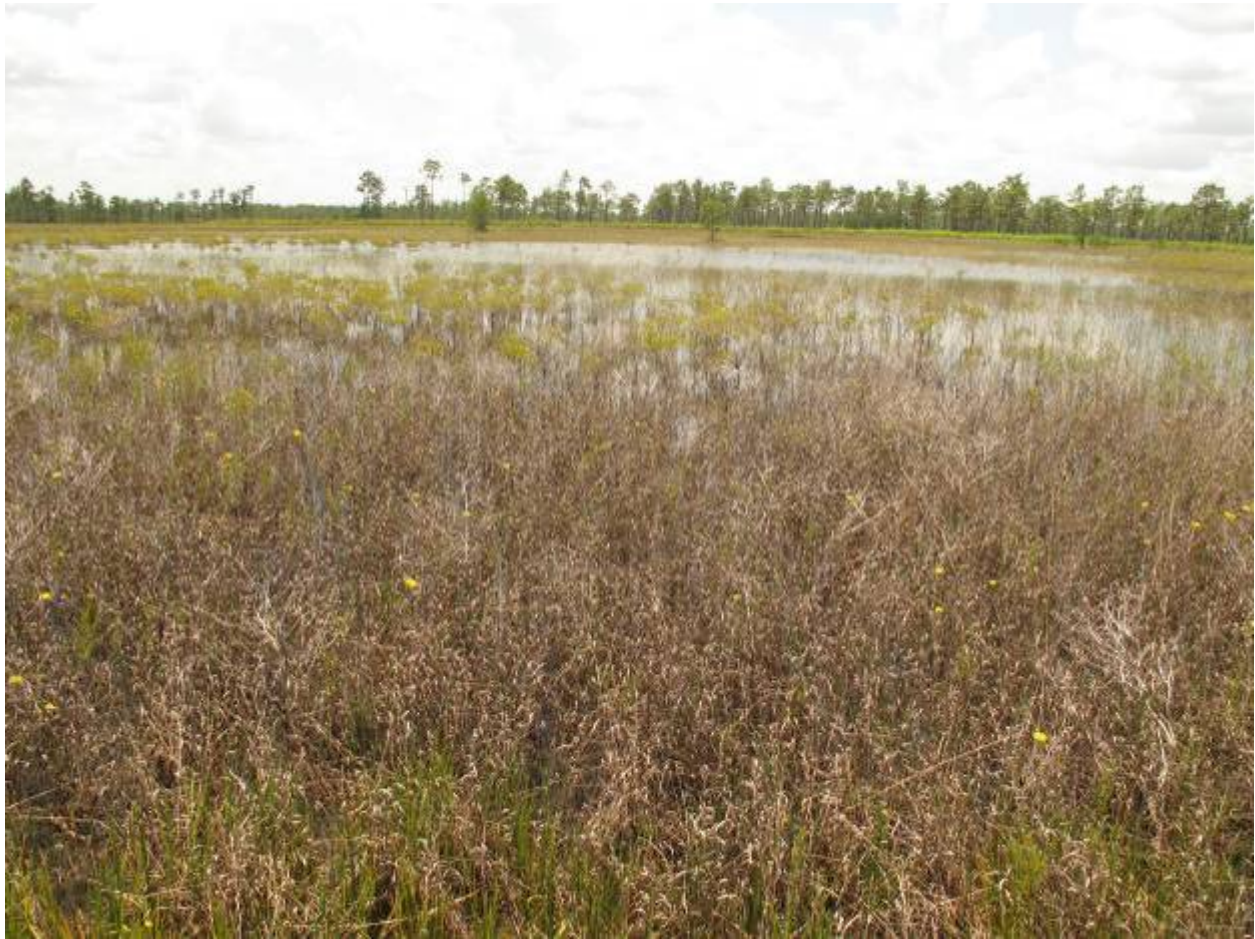
**Description:** This wetland is a 6.4 ha ephemeral marsh. A few cypress trees have established in the central and south ends of the wetland. The tree canopy covers 5-25% of the wetland. There is no midstory cover. *Hypericum* grows in a ring around the wetland center. A diverse array of maidencane, sedges/grasses, and other herbaceous vegetation grows throughout the wetland, and covers >75% of the basin. The adjacent uplands are mesic flatwoods that are managed with prescribed fire.
