# **Inventory, Assessment, and Restoration Potential of Ephemeral Wetlands on FFWCC Wildlife Management Areas**

## **Triple N Ranch WMA Final Report**

Submitted by: Rebecca P.M. Means<sup>1</sup>, Ryan C. Means<sup>1</sup>, Steven A. Johnson<sup>2</sup>

15 May 2010 – 15 August 2010

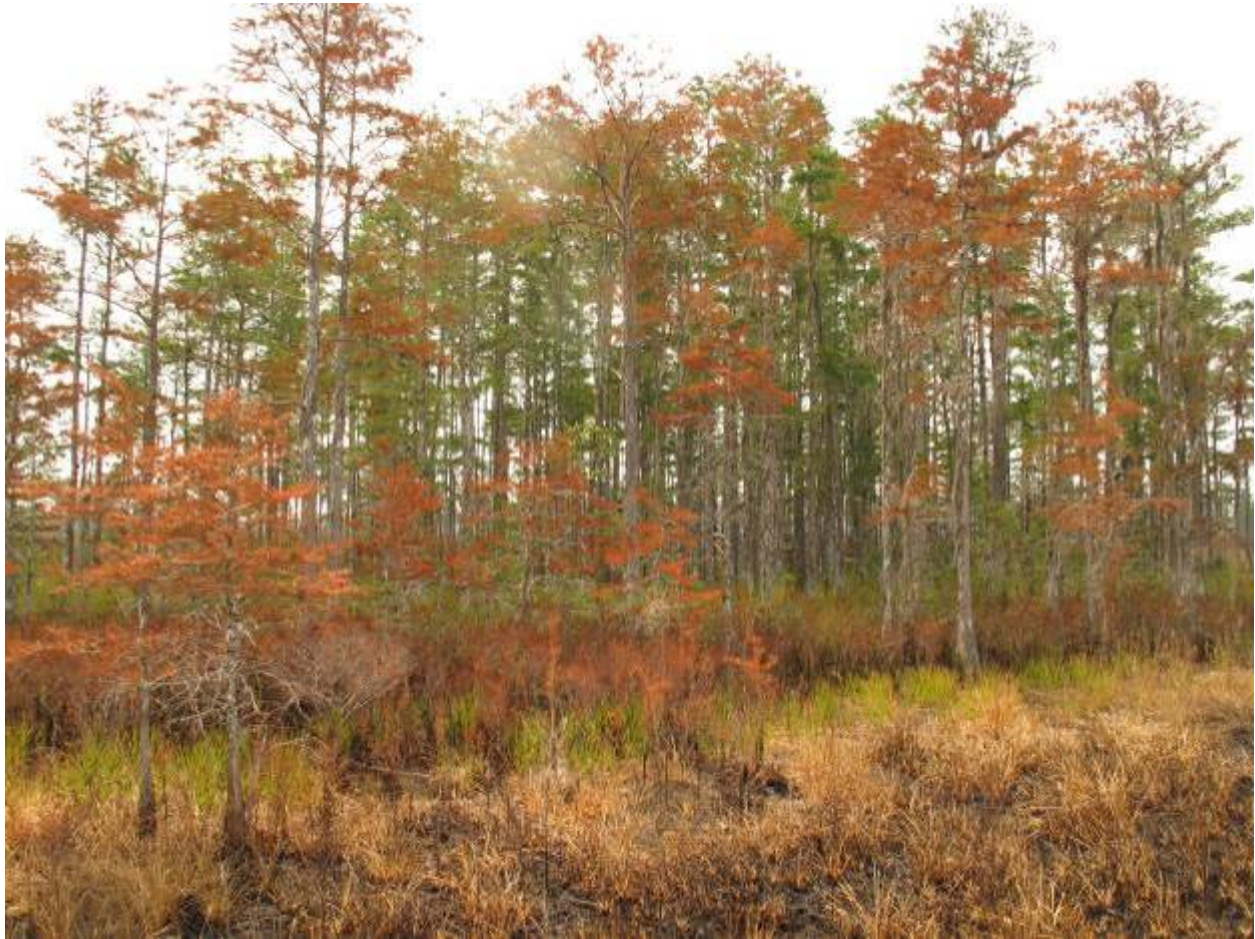
**Description:** This wetland is a 0.4 ha ephemeral forested swamp. Cypress trees dominate the canopy, and cover >75% of the wetland. There is no midstory cover. Maidencane and sedges/grasses grow throughout the wetland, and cover >75% of the basin. A recent fire burned into the wetland edges. Dead mosquito fish (*Gambusia*) were present in recent dry-up holes. The adjacent uplands are mesic flatwoods that are managed with prescribed fire.

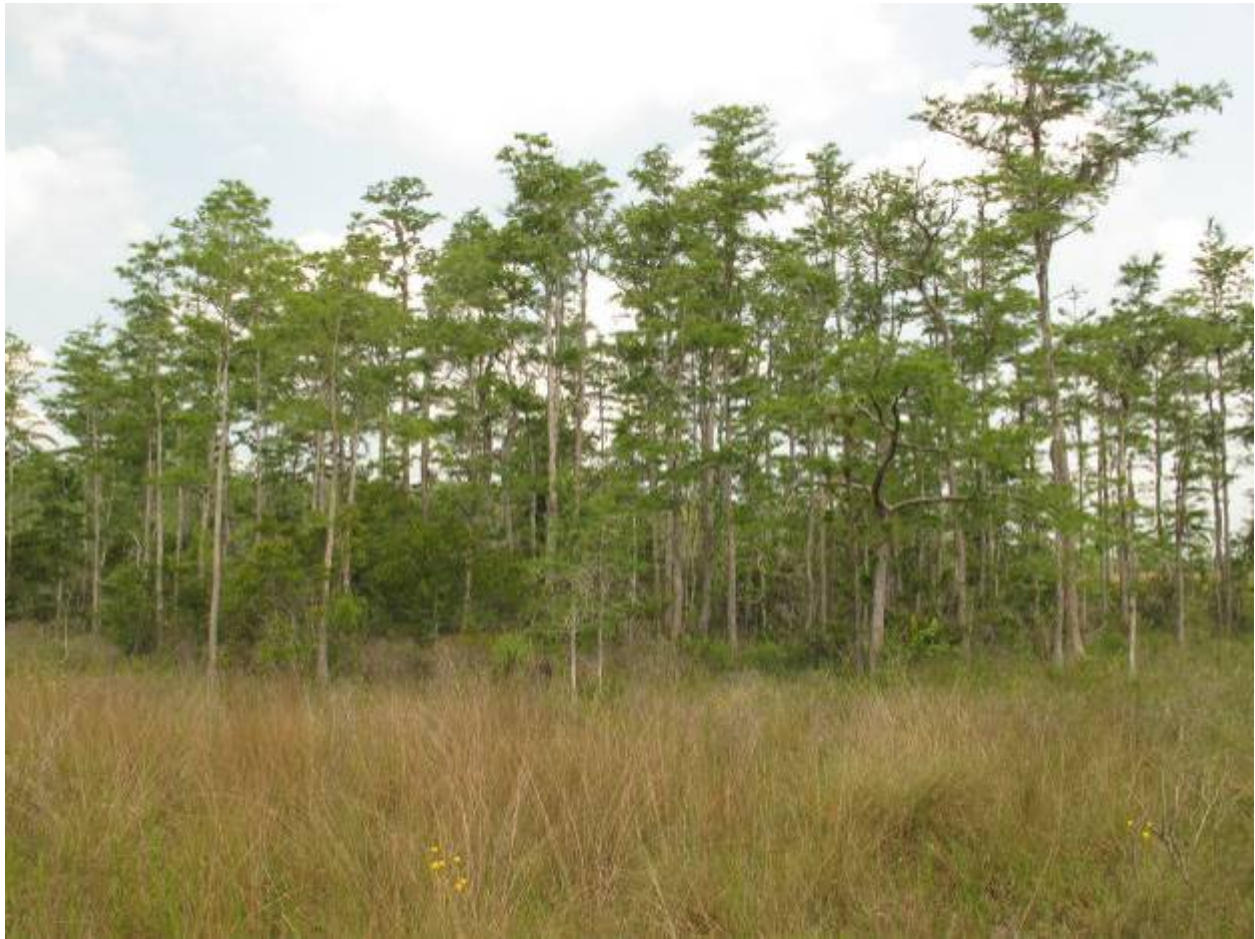
**Description:** This wetland is a 0.1 ha ephemeral forested swamp. Cypress trees dominate the canopy, and cover >75% of the wetland. The midstory is dominated by wax myrtle, and covers 25-50% of the basin. Fern grow in the wetland center and sedges/grasses grow in a ring around the outer edge. The herbaceous vegetation covers >75% of the basin. The adjacent uplands are mesic flatwoods that are managed with prescribed fire.

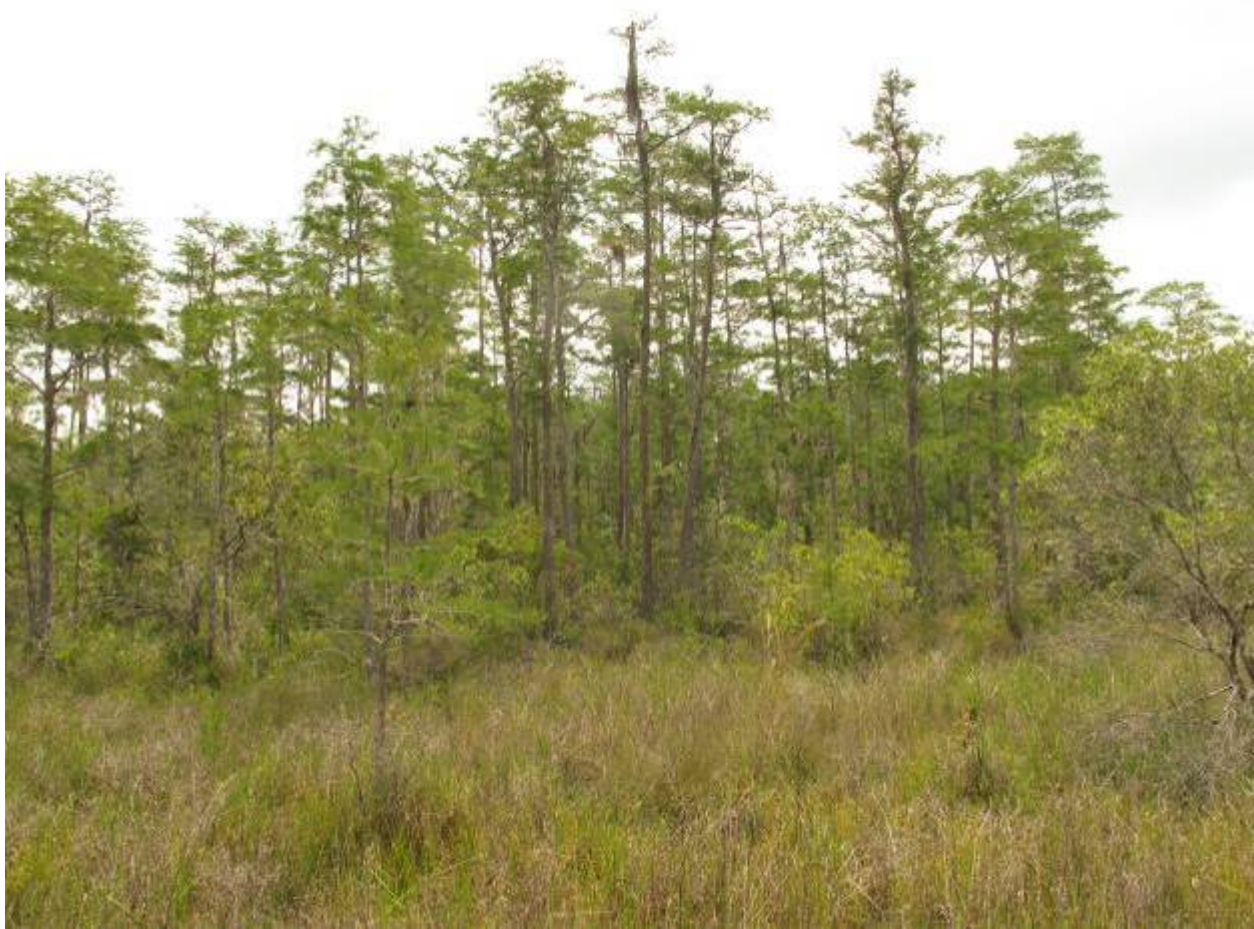
**Wetland ID: 57-02**

**Description:** This wetland is a 0.3 ha ephemeral forested swamp. Cypress trees dominate the canopy, and cover >75% of the wetland. The midstory is dominated by fetterbush, and covers 25-50% of the basin. Fern grow throughout the wetland and sedges/grasses grow in a ring around the outer edge. The diverse herbaceous vegetation covers >75% of the basin. The adjacent uplands are mesic flatwoods that are managed with prescribed fire.

**Wetland Concerns:** None

**Restoration Action Recommended:** None

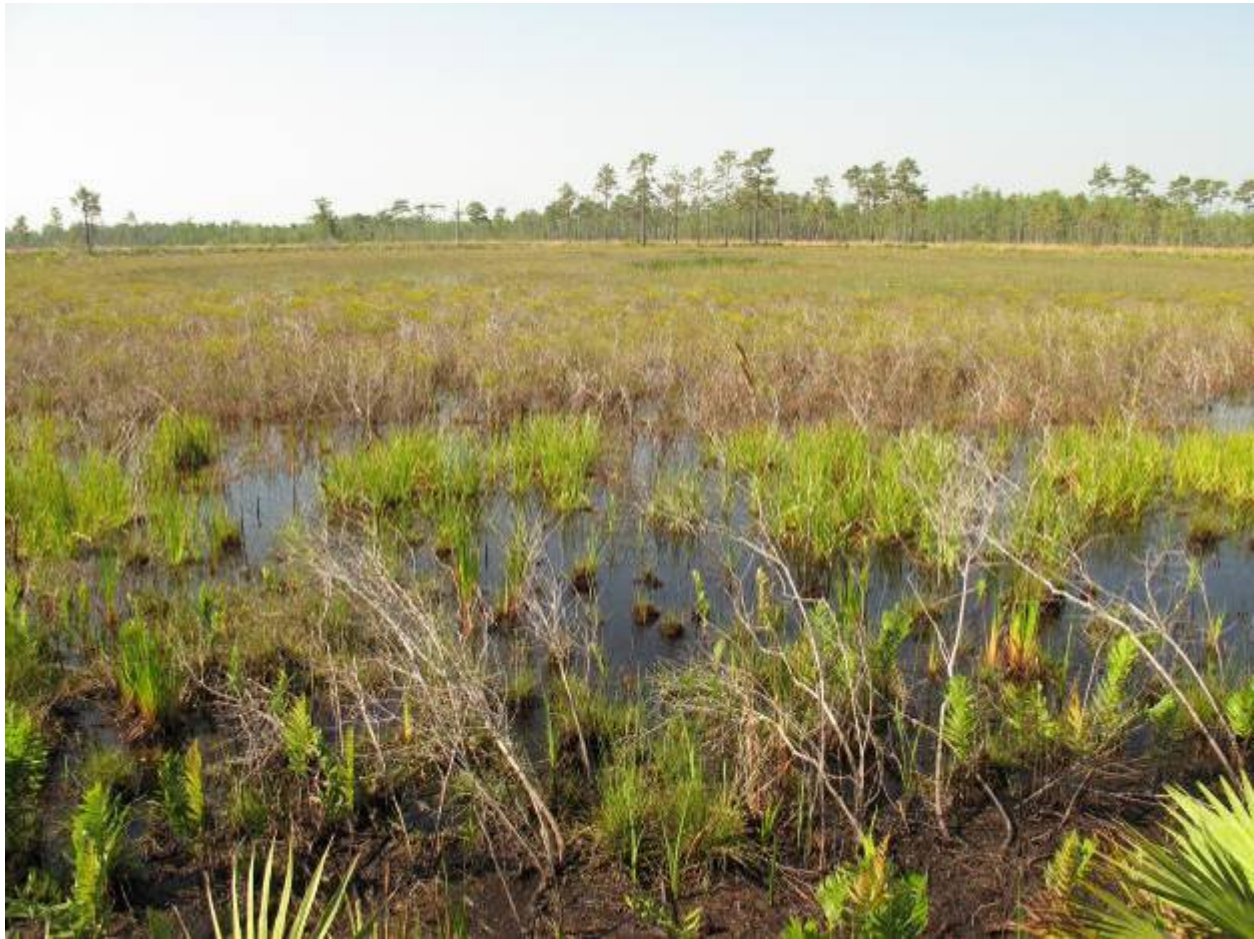
**Description:** This wetland is a 1.3 ha ephemeral marsh. There is no tree canopy or midstory cover. *Hypericum* grows in a ring around the wetland center. Maidencane grows in the wetland center and a diverse array of sedges/grasses and other herbaceous vegetation grow around the outer ring of the wetland. The herbaceous vegetation covers >75% of the basin. The adjacent uplands are mesic flatwoods that are managed with prescribed fire.

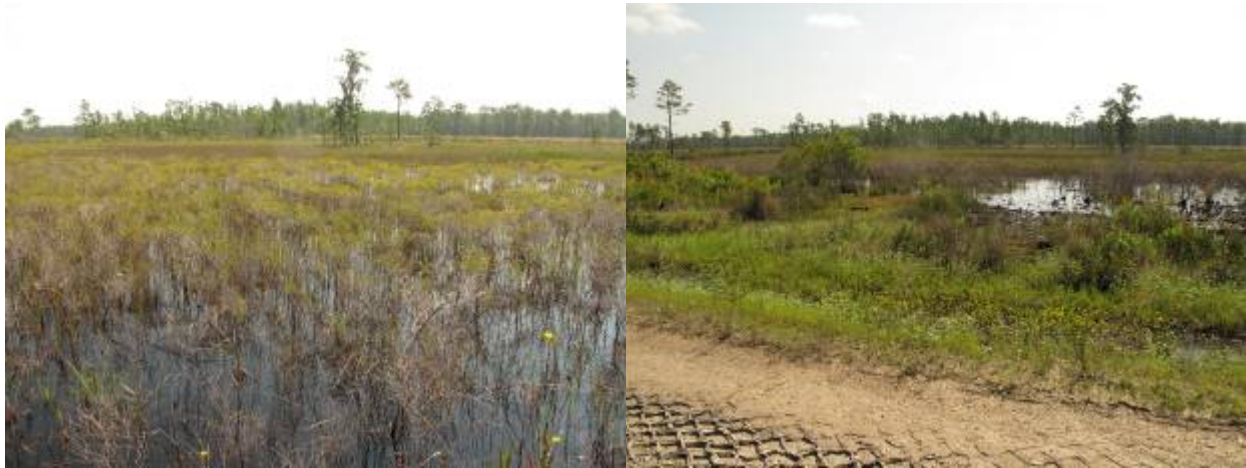
**Wetland ID: 60-02**

**Description:** This wetland is a 1.1 ha ephemeral marsh. There is no tree canopy or midstory cover. *Hypericum* grows in a ring around the wetland center. Maidencane grows in the wetland center and a diverse array of sedges/grasses, emergent and other herbaceous vegetation grow around the outer ring of the wetland. The herbaceous vegetation covers 50-75% of the basin. Small fish were present on the day of our visit. A shallow ditch on the west side connects this wetland to nearby roadside ditches. The adjacent uplands are mesic flatwoods that are managed with prescribed fire.

**Wetland Concerns:** Ditching

**Restoration Action Recommended:** Fill the ditch to restore the wetland's isolation.

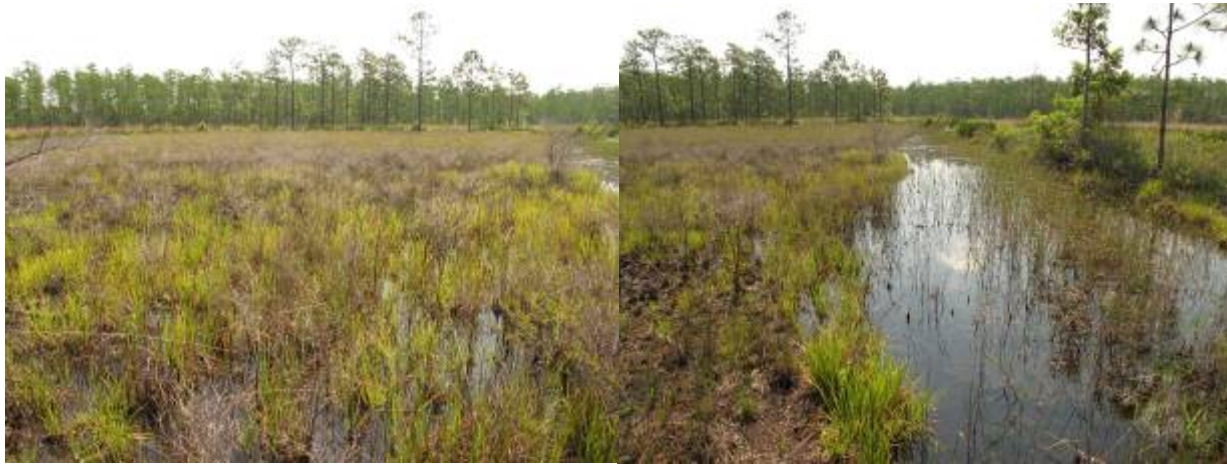
**Wetland ID: 60-03**

**Description:** This wetland is a 0.3 ha semi-permanent marsh. There is no tree canopy or midstory cover. *Hypericum* is common within the wetland. Sedges/grasses and other herbaceous plants grow throughout the wetland, and cover >75% of the basin. Fish were present on the day of our visit. A ditch was created along the south end of the wetland when the MU boundary was constructed. The MU boundary/road bisects the wetland, a small portion of which remains to the south. The adjacent uplands are mesic flatwoods that are managed with prescribed fire.

**Wetland Concerns:** Ditching, MU boundary/fireline

**Restoration Action Recommended:** Fill the ditch with sand to restore the wetland hydroperiod. If feasible, re-route the MU boundary/road to the south away from the wetland.

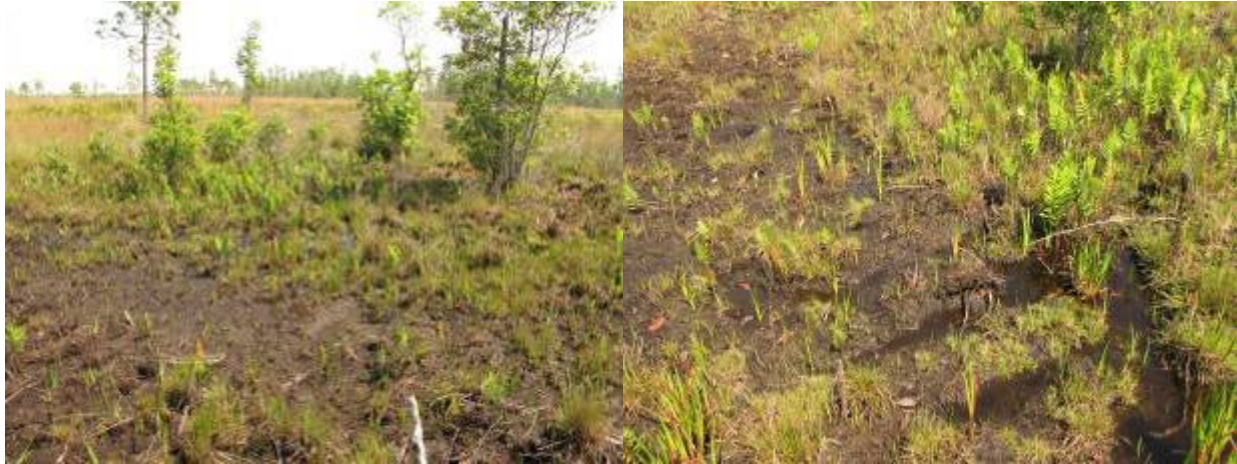
**Wetland ID: 60-04**

**Description:** This wetland is a 0.1 ha ephemeral marsh. There is no tree canopy cover. Several small loblolly pine trees are establishing in the wetland, and cover 5-25% of the basin. Fern grow in the wetland center and sedges/grasses grow throughout the wetland. The herbaceous vegetation covers >75% of the basin. Vehicular tracks, likely from a roller-chopper, have damaged the soil throughout the wetland. The adjacent uplands are mesic flatwoods that are managed with prescribed fire.

**Wetland Concerns:** Vehicular damage

**Restoration Action Recommended:** None - the tracks will heal over time. Avoid driving machinery around the wetland edges. If necessary, flag the wetland edges before contractors perform mechanical activity in the uplands.

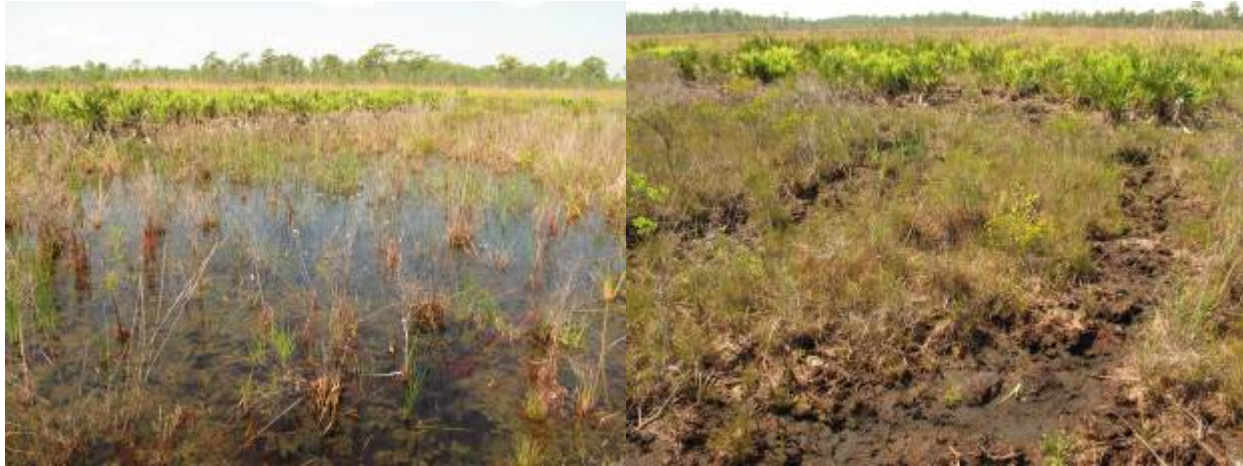
**Wetland ID: 60-05**

**Description:** This wetland is a <0.1 ha ephemeral marsh. There is no tree canopy or midstory cover. *Sphagnum* grows in the deeper hole on the east end of the wetland and sedges/grasses grow throughout the wetland. The herbaceous vegetation covers >75% of the basin. The perimeter and west ends have vehicular damage, likely from a roller-chopper. Feral hogs have taken advantage of the open soil and caused further damage. The adjacent uplands are mesic flatwoods that are managed with prescribed fire.

**Wetland Concerns:** Feral hog damage, Vehicular damage

**Restoration Action Recommended:** Avoid driving machinery around the wetland edges. If necessary, flag the wetland edges before contractors perform mechanical activity in the uplands.

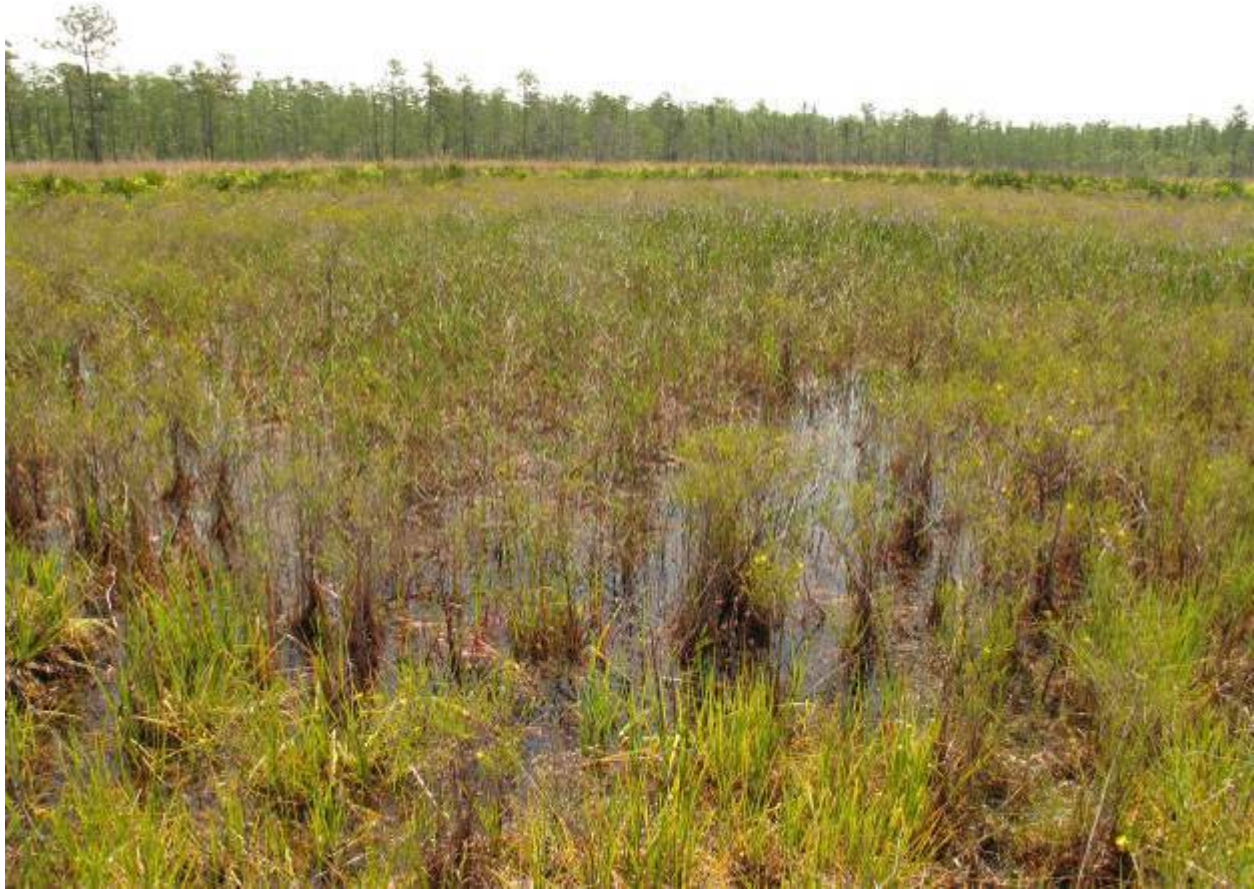
**Wetland ID: 60-06**

**Description:** This wetland is a 0.2 ha ephemeral marsh. It is an open marsh with multiple deeper holes. There is no tree canopy or midstory cover. *Hypericum* is abundant throughout the wetland. Maidencane grows in the deeper hole on the southeast end and a diverse array of sedges/grasses grows throughout the wetland. The herbaceous vegetation covers >75% of the basin. A game trail runs along the wetland edge. The adjacent uplands are mesic flatwoods that are managed with prescribed fire.

**Wetland Concerns:** None

**Restoration Action Recommended:** None

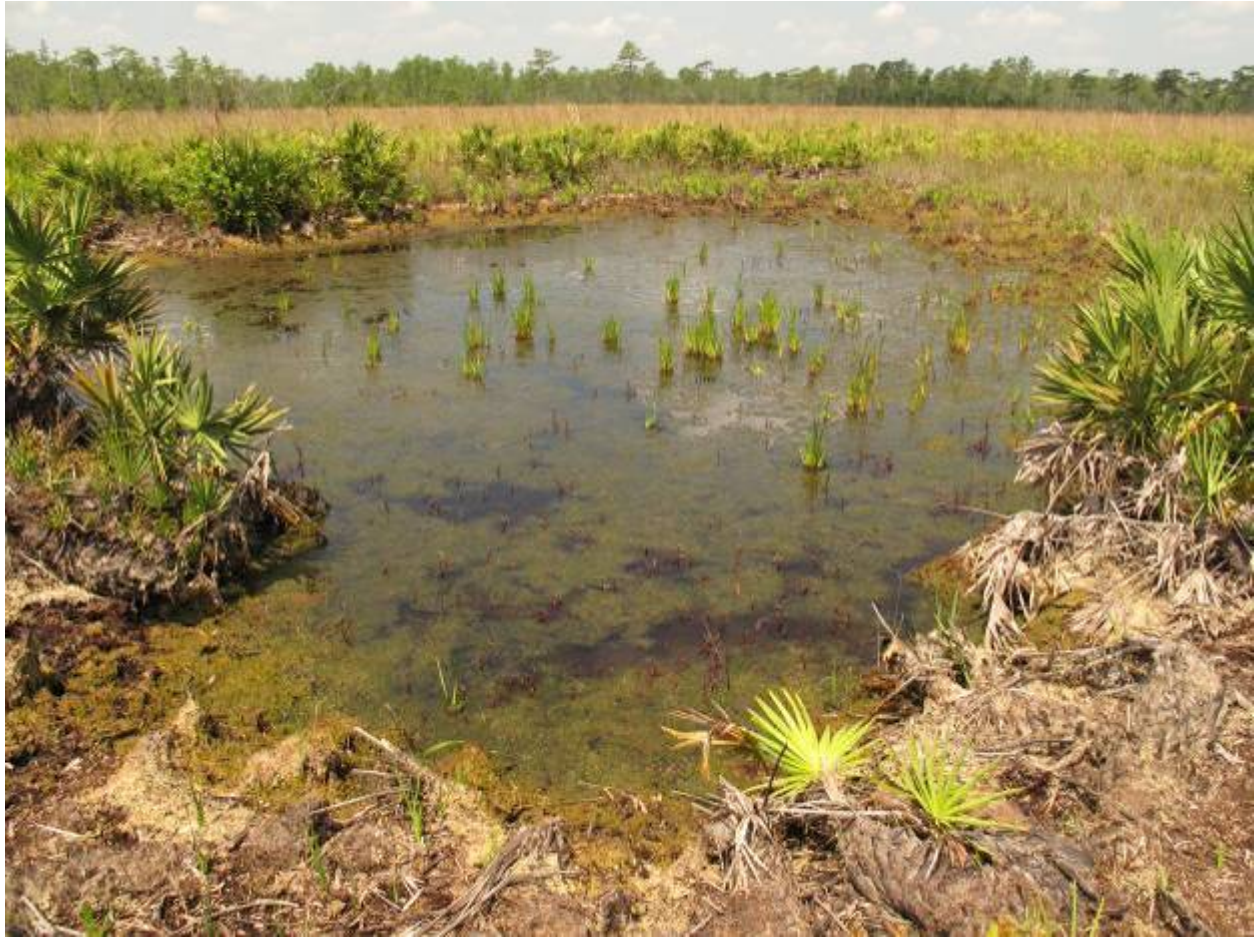
**Wetland ID: 60-07**

**Description:** This wetland is a <0.1 ha ephemeral marsh. There is no tree canopy or midstory cover. *Sphagnum* carpets the wetland floor and small emergent vegetation grows throughout the wetland. The herbaceous vegetation covers >75% of the basin. The adjacent uplands are mesic flatwoods that are managed with prescribed fire.

**Wetland Concerns:** None

**Restoration Action Recommended:** None

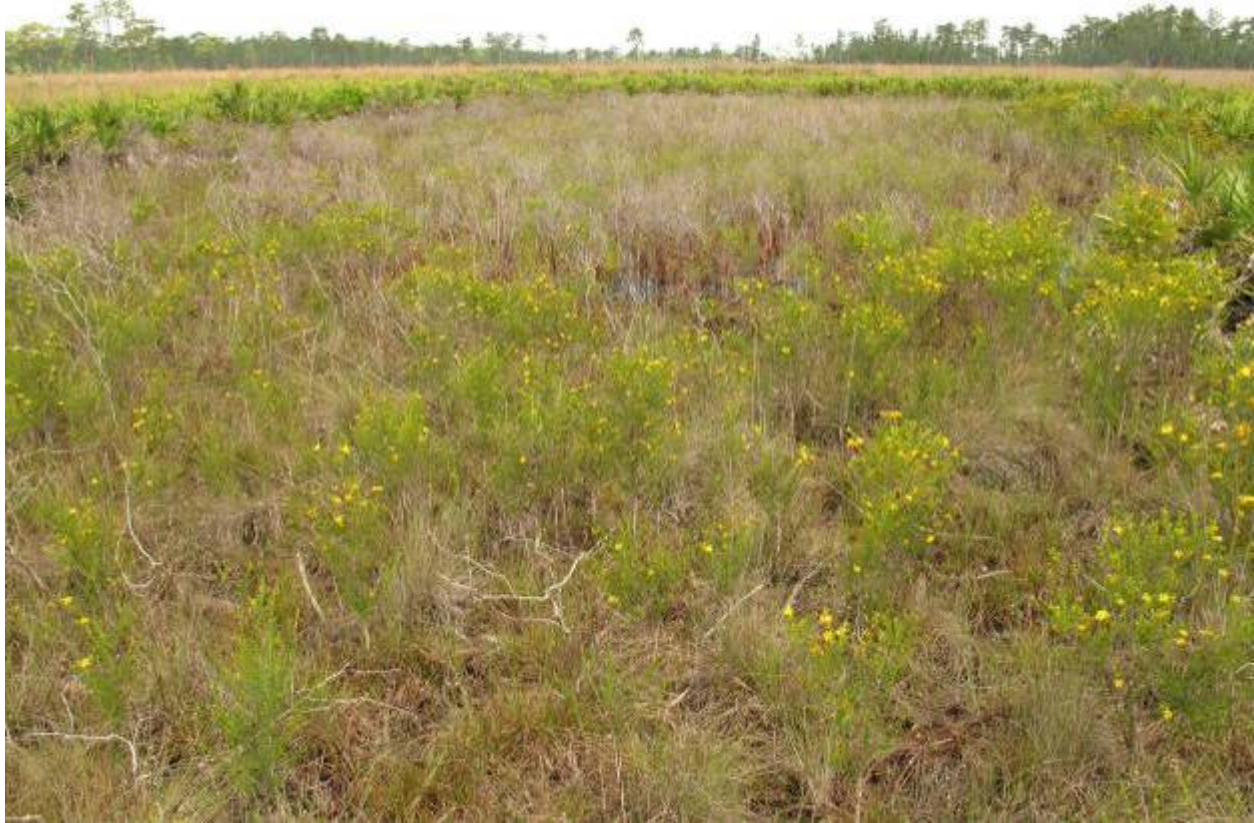
**Wetland ID: 60-08**

**Description:** This wetland is a 0.1 ha ephemeral marsh. It is elongate with 3 deeper holes. There is no tree canopy or midstory cover. *Hypericum* is abundant within the wetland. Sedges/grasses grow throughout the wetland, and fern, redroot, and other herbaceous plants grow in the deeper holes. The herbaceous vegetation covers >75% of the basin. Feral hog damage is minor and patchy. The adjacent uplands are mesic flatwoods that are managed with prescribed fire.

**Wetland Concerns:** Feral hog damage

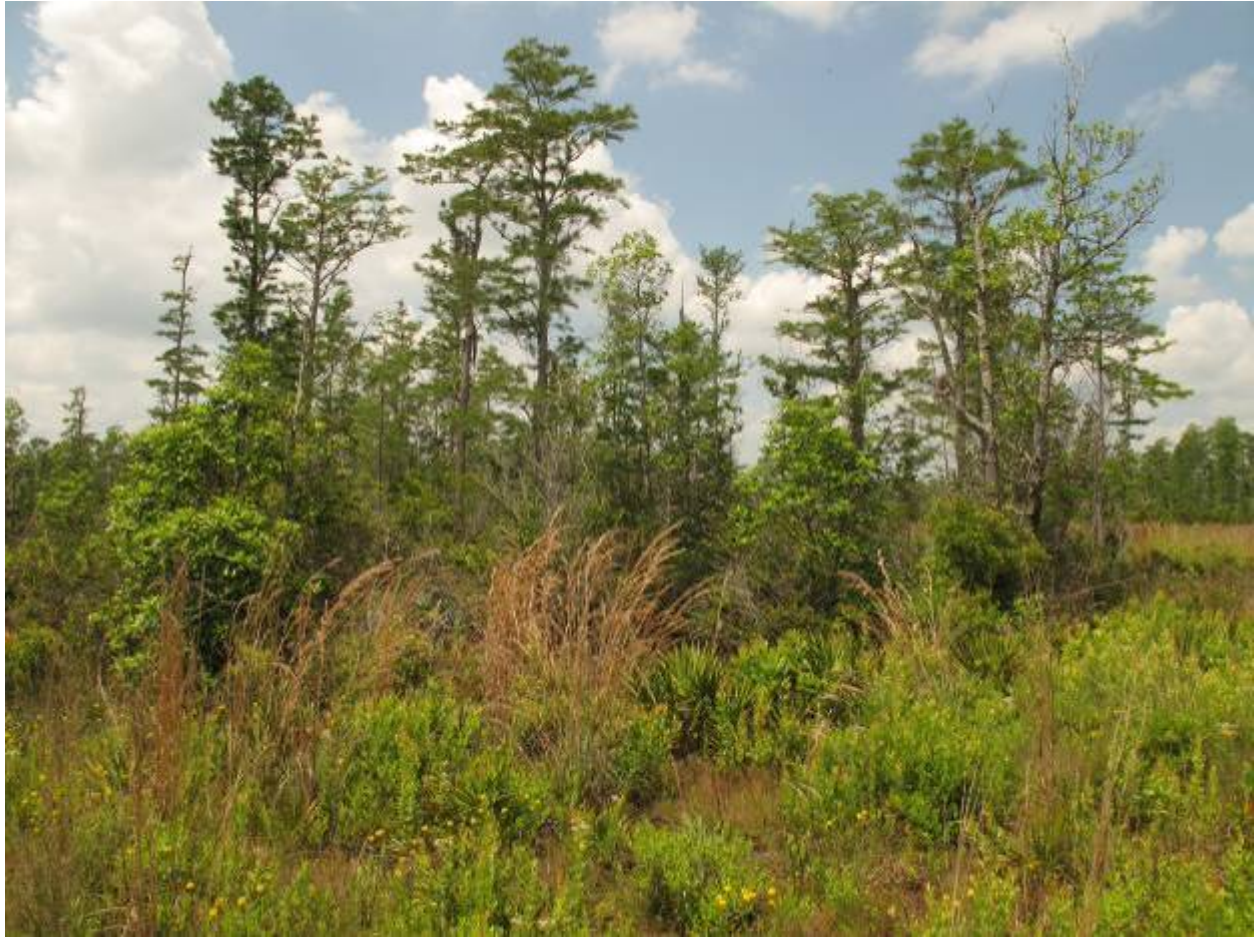
**Wetland ID: 60-09**

**Description:** This wetland is a 0.2 ha ephemeral forested swamp. Cypress and loblolly bay trees dominate the canopy, and cover 25-50% of the basin. The midstory is dominated by fetterbush, and covers 25-50% of the wetland. *Sphagnum* grows throughout the wetland, and fern grow in scattered patches. The herbaceous vegetation covers >75% of the basin. The adjacent uplands are mesic flatwoods that are managed with prescribed fire.

**Wetland Concerns:** None

**Restoration Action Recommended:** None

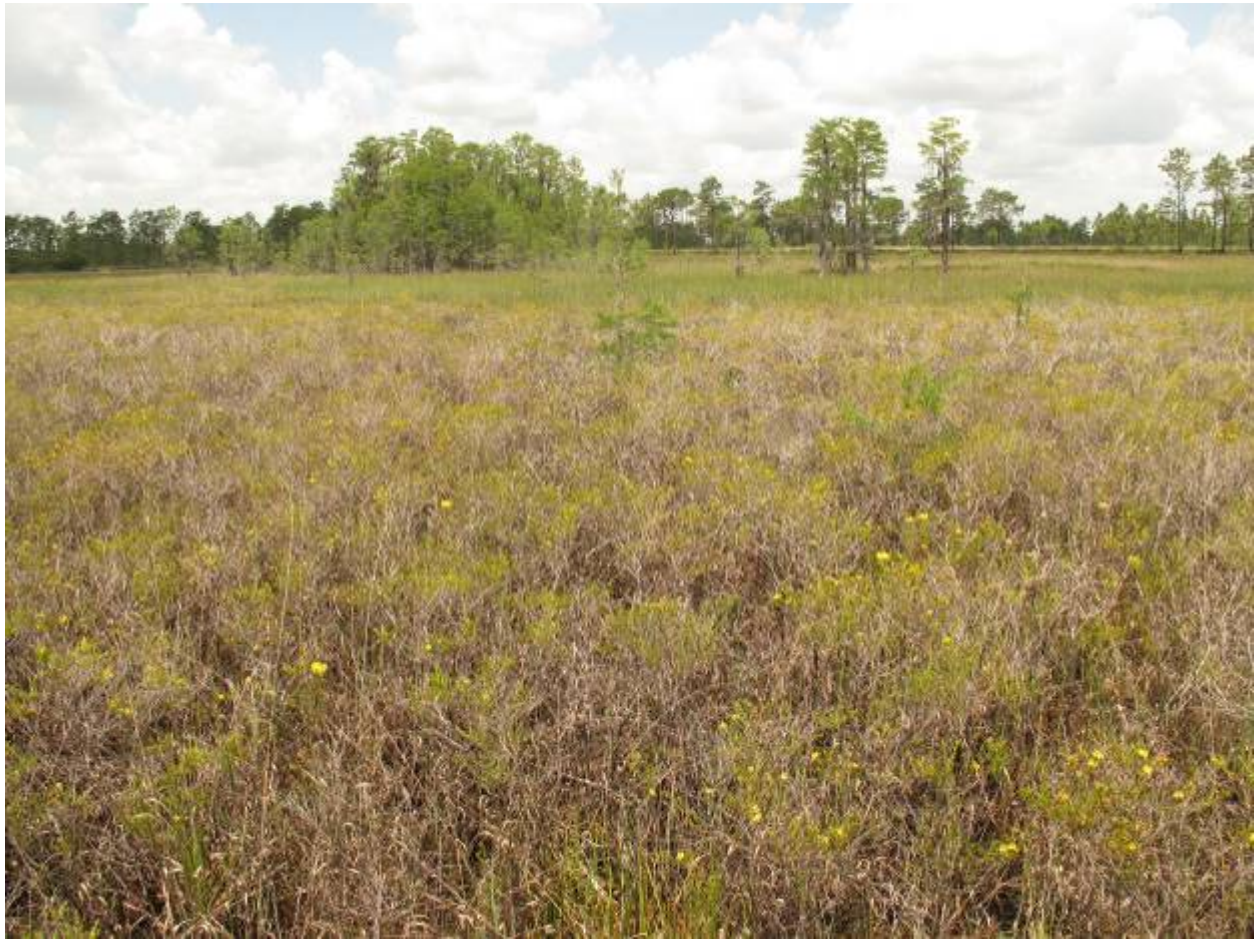
**Wetland ID: 60-10**

**Description:** This wetland is a 3.0 ha ephemeral marsh. A small cypress dome grows in the wetland center but covers <5% of the basin. There is no midstory cover. *Hypericum* is common around the outer edge of the wetland. Maidencane grows in the wetland center and a diverse array of sedges/grasses and other herbaceous vegetation grow around the outer ring of the wetland. The herbaceous vegetation covers >75% of the basin. The adjacent uplands are a mix of scrubby and mesic flatwoods that are managed with prescribed fire.

**Wetland Concerns:** None

**Restoration Action Recommended:** None

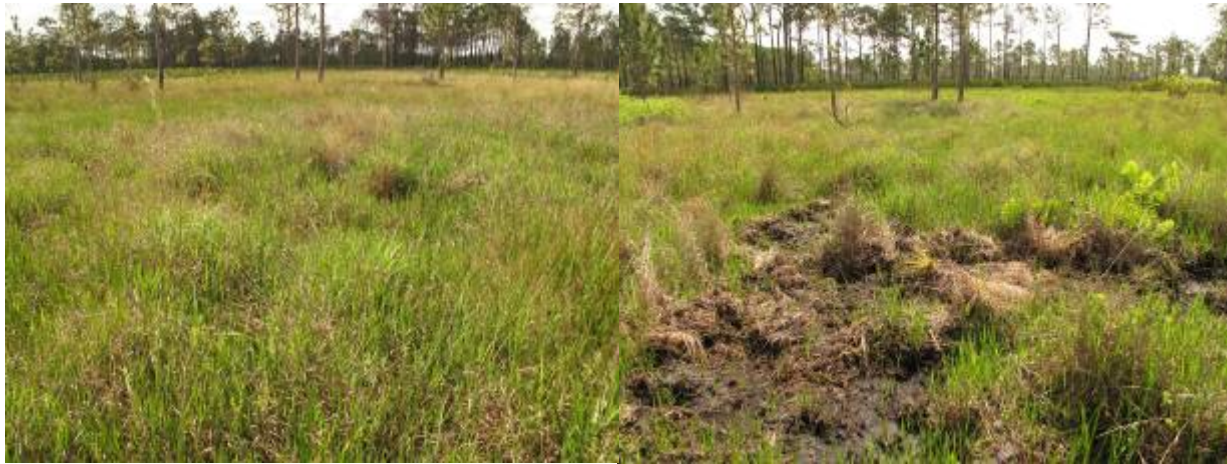
**Wetland ID: 61-01**

**Description:** This wetland is a 0.2 ha ephemeral marsh. It is a diffuse, shallow marsh with edges that are broad ecotones with the surrounding flatwoods. There is no tree canopy or midstory cover. Maidencane and sedges/grasses grow throughout the wetland, and cover >75% of the basin. Old feral hog damage is severe, and left deep gouges and hillocks. New feral hog damage is predominately in the wetland center. The adjacent uplands are mesic flatwoods that are managed with prescribed fire.

**Wetland Concerns:** Feral hog damage

**Restoration Action Recommended:** Consider trapping or hunting feral hogs in this area because of the prevalence of feral hog damage and the high quality of the marshes.

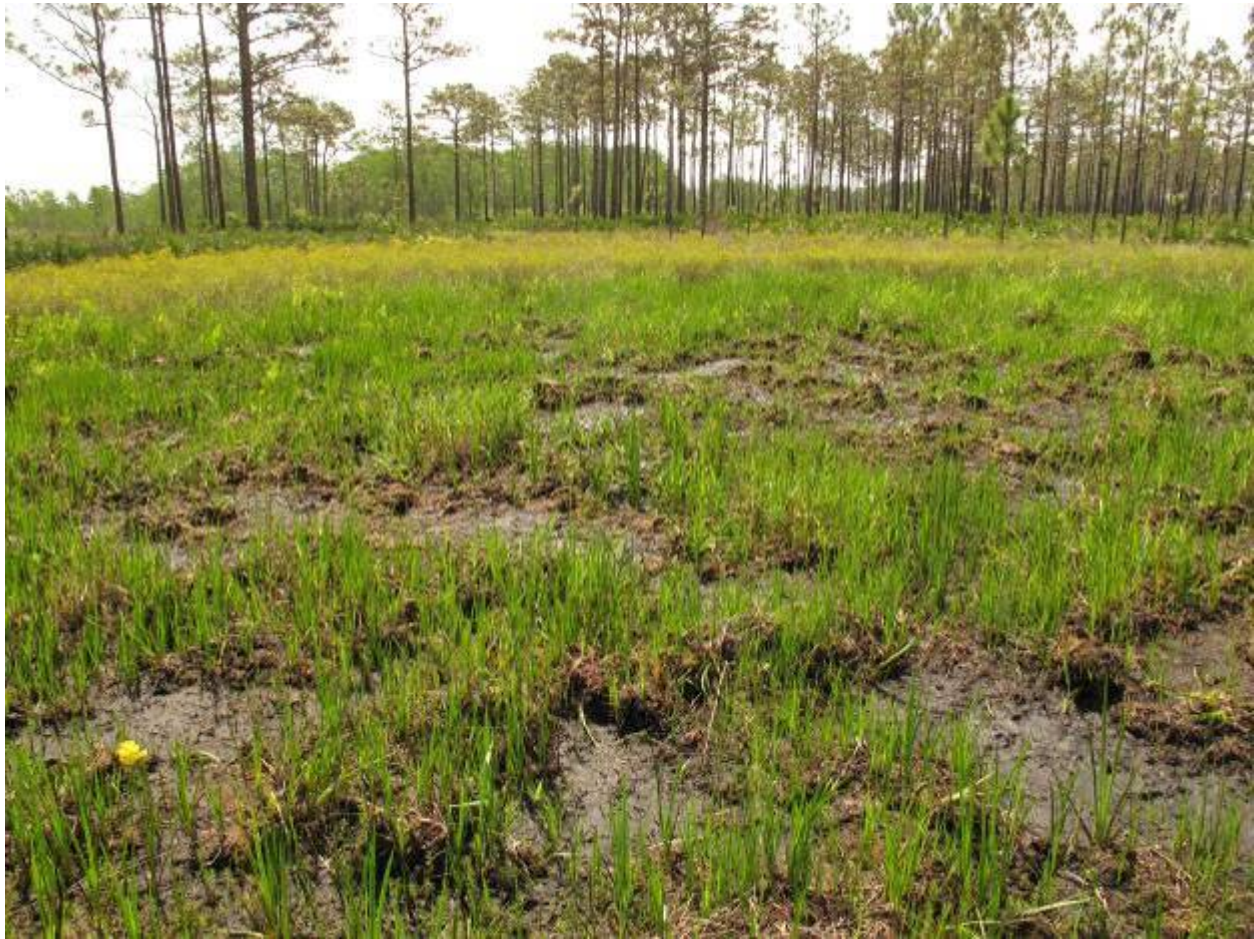
**Wetland ID: 61-02**

**Description:** This wetland is a 0.2 ha ephemeral marsh. There is no tree canopy or midstory cover. *Hypericum* grows in a ring around the wetland center. Redroot grows in the wetland center and sedges/grasses grow around the outer ring of the wetland. The herbaceous vegetation covers >75% of the basin. Feral hog damage is severe in the wetland center. The adjacent uplands are mesic flatwoods that are managed with prescribed fire.

**Wetland Concerns:** Feral hog damage

**Restoration Action Recommended:** Consider trapping or hunting feral hogs in this area because of the prevalence of feral hog damage and the high quality of the marshes.

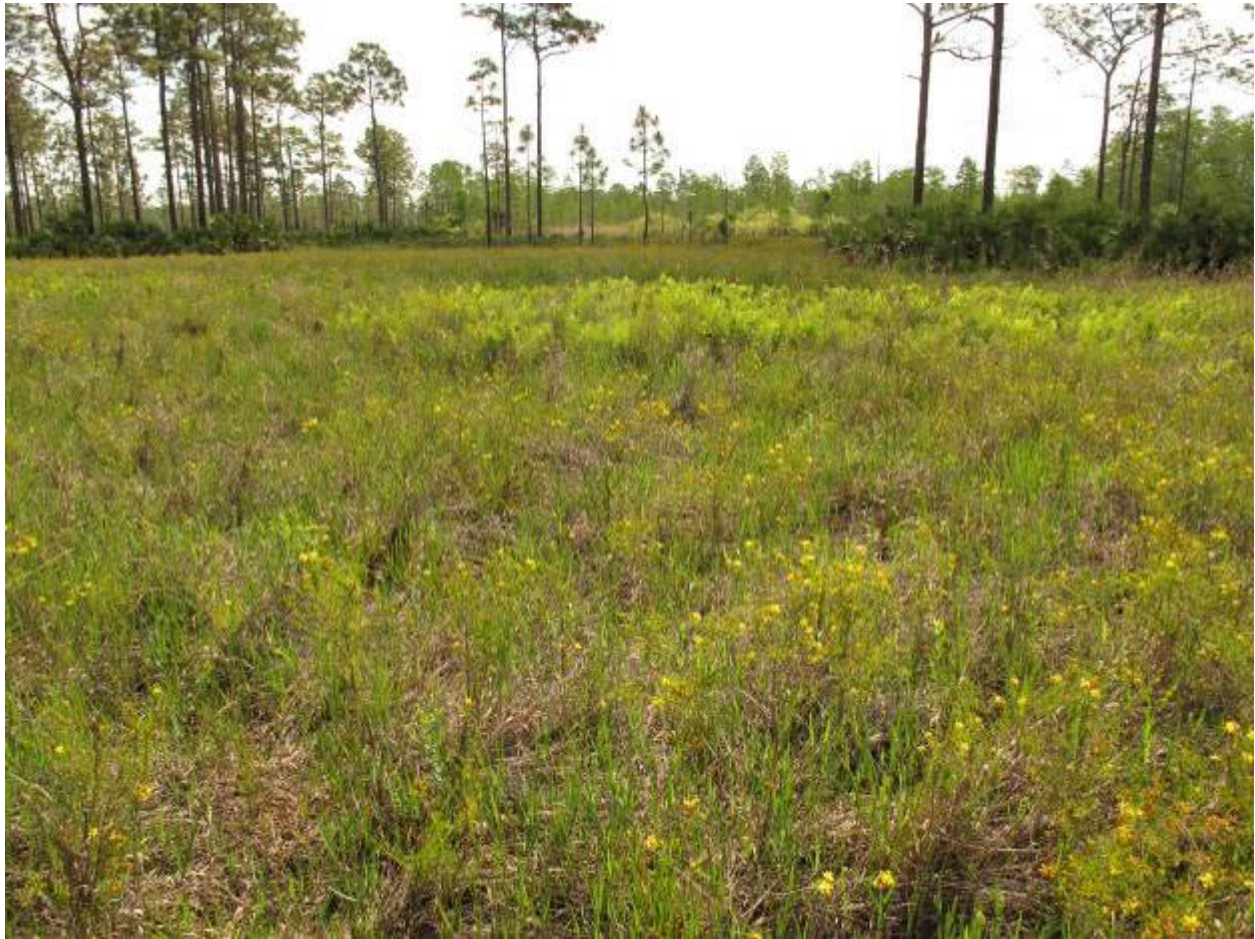
**Wetland ID: 61-03**

**Description:** This wetland is a 0.2 ha ephemeral marsh. There is no tree canopy or midstory cover. *Hypericum* grows in a ring around the wetland edge. Fern grows in scattered patches and sedges/grasses grow throughout the wetland. The herbaceous vegetation covers >75% of the basin. Feral hog damage, both old and new, is minor. The adjacent uplands are mesic flatwoods that are managed with prescribed fire.

**Wetland Concerns:** Feral hog damage

**Restoration Action Recommended:** Consider trapping or hunting feral hogs in this area because of the prevalence of feral hog damage and the high quality of the marshes.

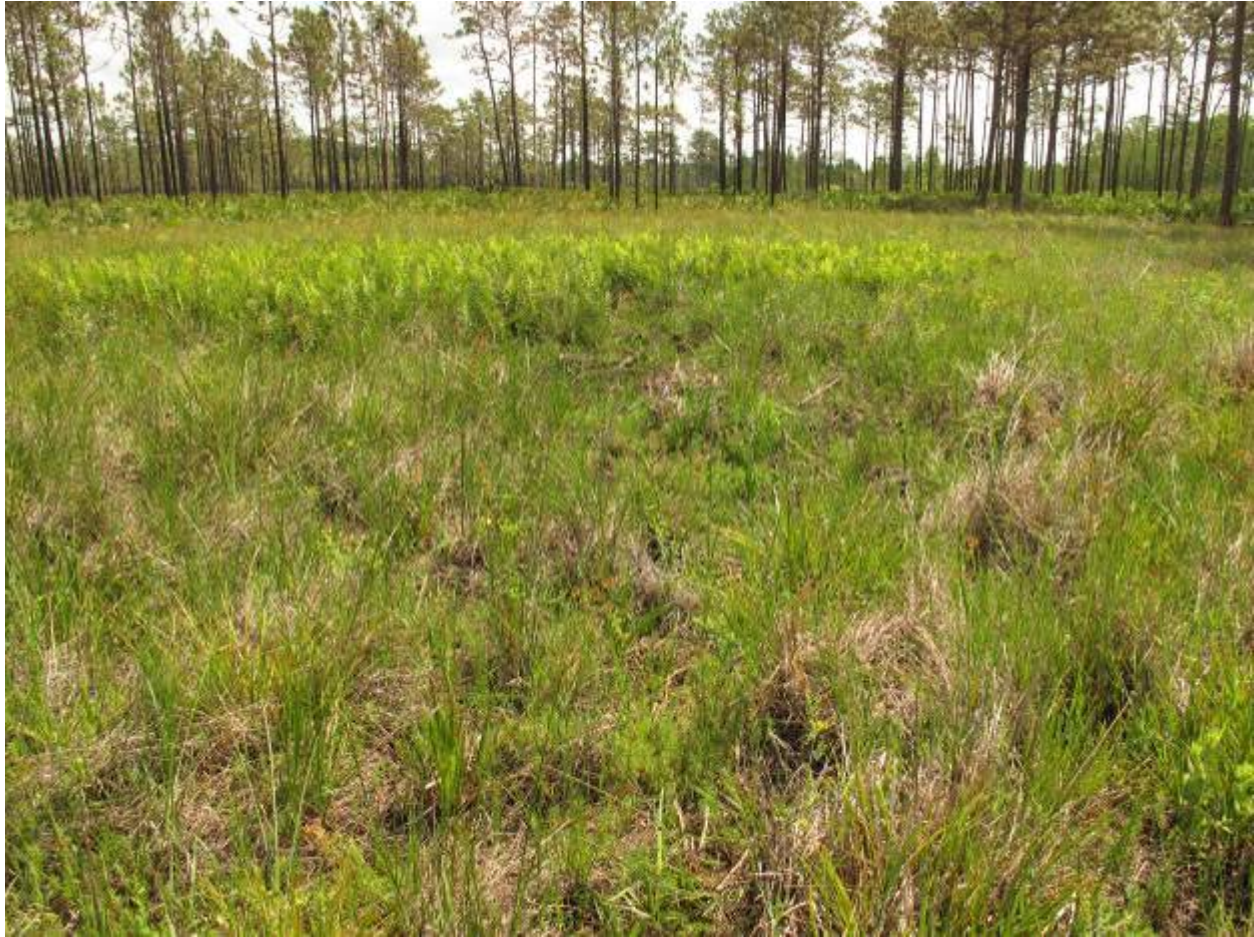
**Wetland ID: 61-04**

**Description:** This wetland is a 0.2 ha ephemeral marsh. There is no tree canopy or midstory cover. A diverse array of herbaceous vegetation grows throughout the wetland, and covers >75% of the basin. Feral hog damage, both old and new, is minor. The adjacent uplands are a mix of scrubby and mesic flatwoods that are managed with prescribed fire.

**Wetland Concerns:** Feral hog damage

**Restoration Action Recommended:** Consider trapping or hunting feral hogs in this area because of the prevalence of feral hog damage and the high quality of the marshes.

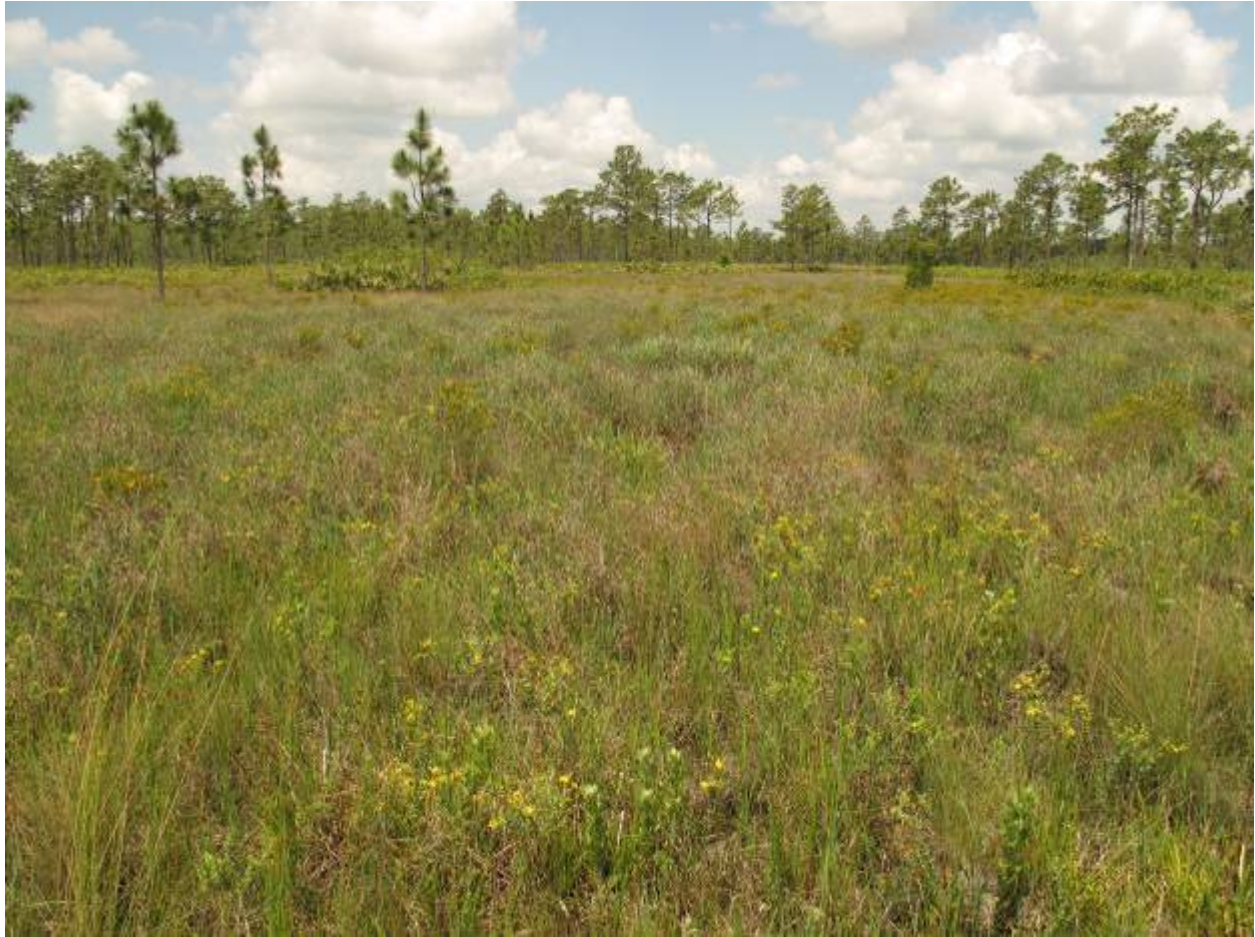
**Wetland ID: 61-05**

**Description:** This wetland is a 0.7 ha ephemeral marsh. There is no tree canopy or midstory cover. *Hypericum* is fairly common throughout the wetland. Maidencane is the dominant herbaceous vegetation, and covers >75% of the basin. Old feral hog damage is widespread and has grown over with vegetation. The adjacent uplands are a mix of scrubby and mesic flatwoods that are managed with prescribed fire.

**Wetland Concerns:** Feral hog damage

**Restoration Action Recommended:** Consider trapping or hunting feral hogs in this area because of the prevalence of feral hog damage and the high quality of the marshes.

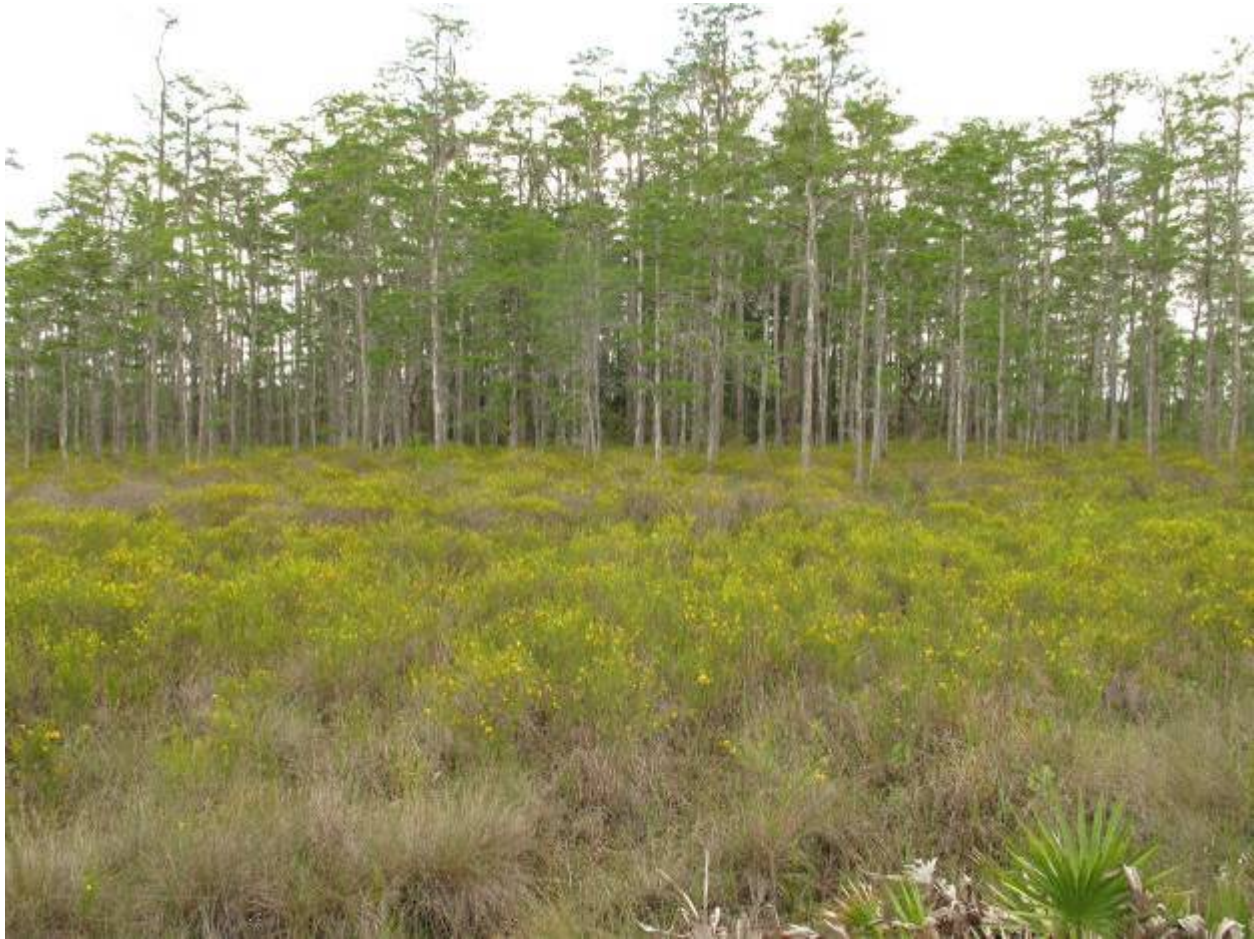
**Wetland ID: 61-06**

**Description:** This wetland is a 1.7 ha ephemeral forested swamp. Cypress trees dominate the canopy, and cover 50-75% of the basin. Fetterbush grows only in the wetland interior, and covers 5-25% of the wetland. *Hypericum* is abundant throughout the wetland. Sedges/grasses grow around the outer ring of the wetland, and cover 50-75% of the basin. The adjacent uplands are a mix of scrubby and mesic flatwoods that are managed with prescribed fire.

**Wetland Concerns:** None

**Restoration Action Recommended:** None
