# **Inventory, Assessment, and Restoration Potential of Ephemeral Wetlands on FFWCC Wildlife Management Areas**

## **Triple N Ranch WMA Final Report**

Submitted by: Rebecca P.M. Means<sup>1</sup>, Ryan C. Means<sup>1</sup>, Steven A. Johnson<sup>2</sup>

15 May 2010 – 15 August 2010

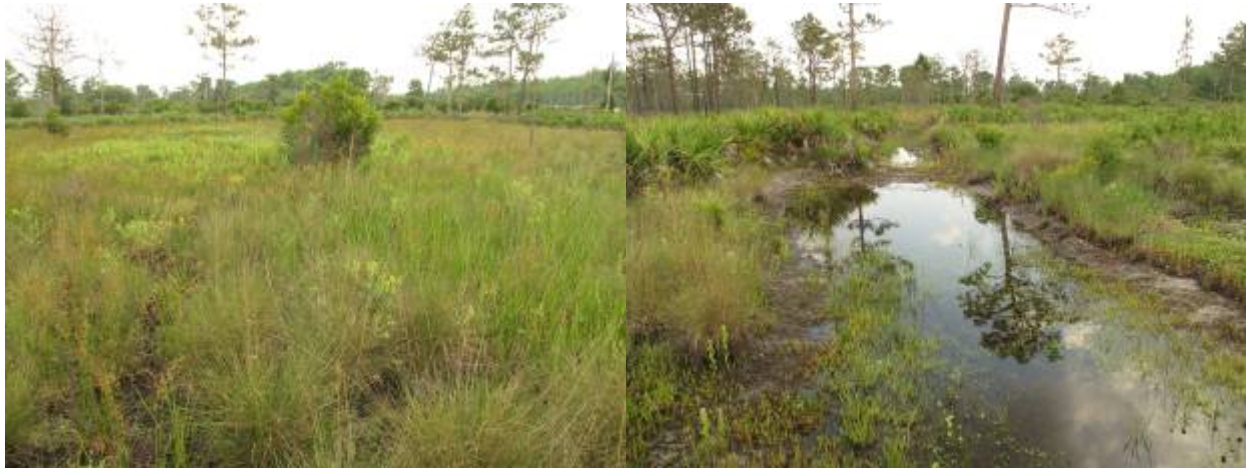
**Wetland ID: 62-01**

**Description:** This wetland is a 0.3 ha ephemeral marsh. There is no tree canopy or midstory cover. Fern and sedges/grasses grow throughout the wetland, and cover >75% of the basin. A 50 m long ditch connects the west side of the wetland to nearby roadside ditches. The adjacent uplands are mesic flatwoods that are managed with prescribed fire.

**Wetland Concerns:** Ditching

**Restoration Action Recommended:** Fill the ditch to restore the wetland's isolation.

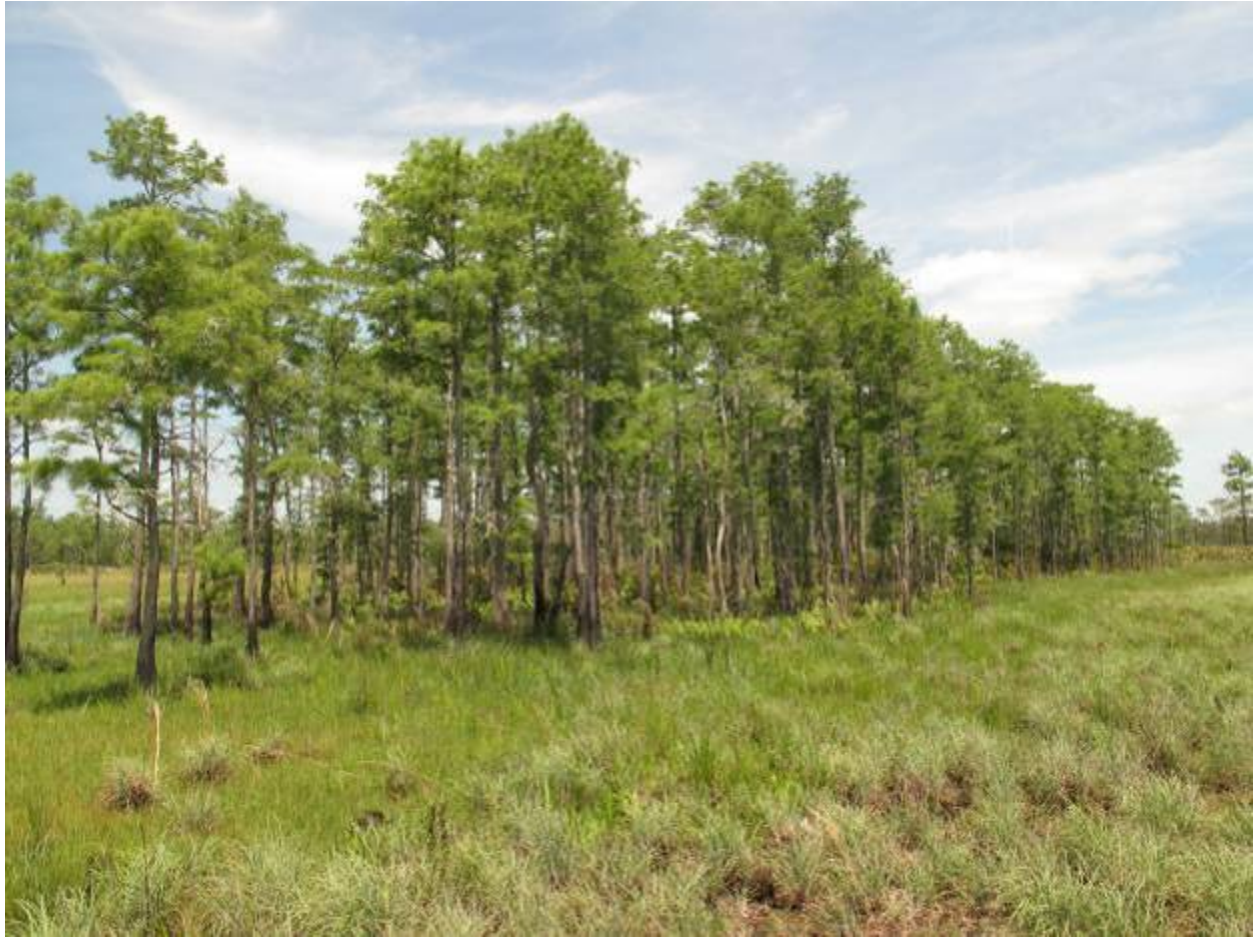
**Wetland ID: 63-01**

**Description:** This wetland is a 0.3 ha ephemeral forested swamp. Cypress trees dominate the canopy, and cover 50-75% of the basin. The midstory is dominated by fetterbush, and covers 5-25% of the wetland. Fern and sedges/grasses grow throughout the wetland, and cover >75% of the basin. The adjacent uplands are pasture created by past cattle grazing. Pasture grasses have encroached into the wetland edges.

**Wetland Concerns:** Invasive species, Upland condition

**Restoration Action Recommended:** Continue providing regular fire to the landscape - in order to restore the full ecological function of the wetland, the uplands will need to be restored.

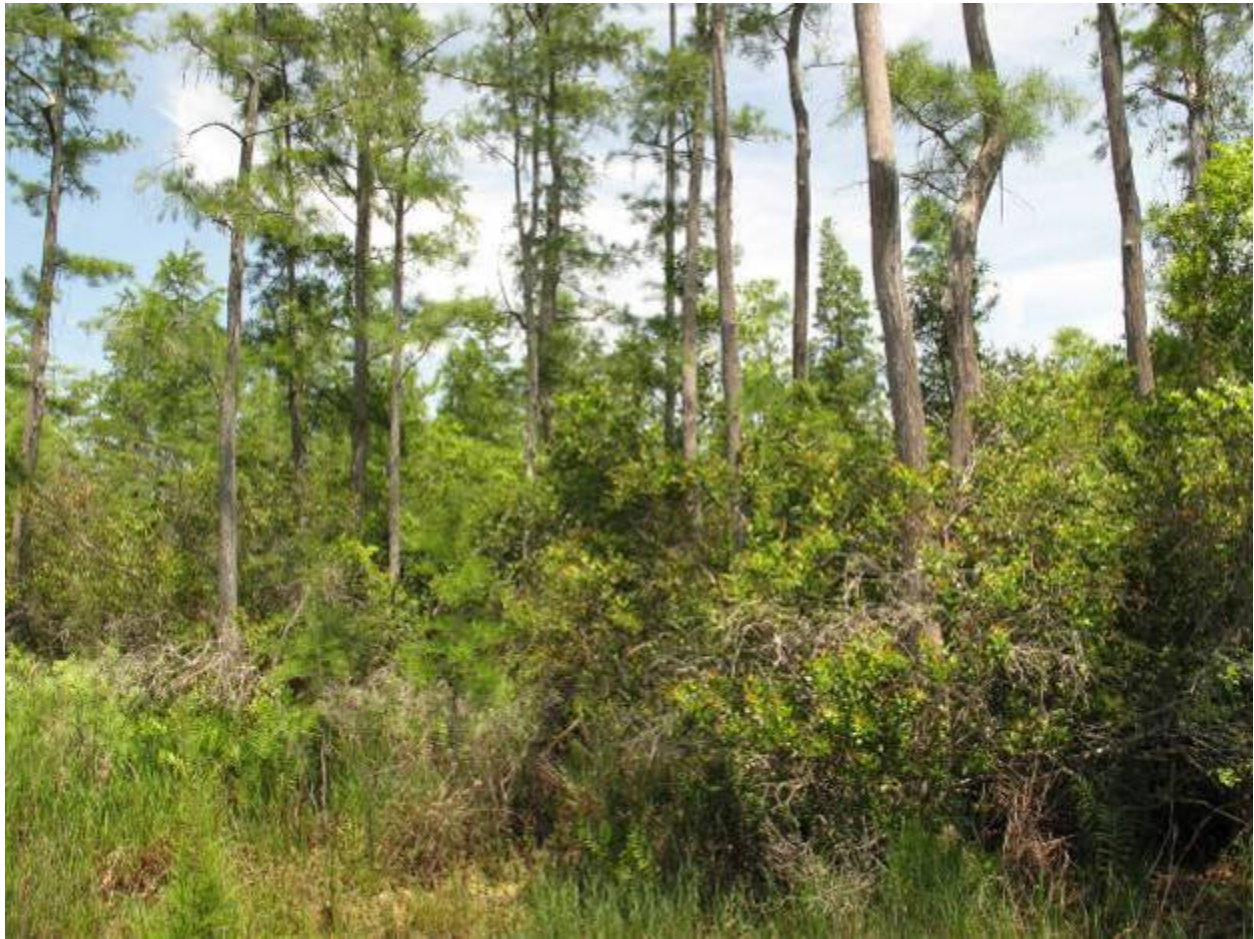
**Wetland ID: 63-02**

**Description:** This wetland is a 0.7 ha ephemeral mixed swamp. Cypress trees dominate the canopy, and cover 50-75% of the basin. The midstory is dominated by fetterbush and wax myrtle, and covers >75% of the wetland. Fern grow sparsely throughout the wetland, and cover 5-25% of the basin. There is evidence of fire around the wetland edges. Old tree stumps are present in the wetland, evidence of past logging. The adjacent uplands are pasture created by past cattle grazing.

**Wetland Concerns:** Feral hog damage, Upland condition

**Restoration Action Recommended:** Continue providing regular fire to the landscape - in order to restore the full ecological function of the wetland, the uplands will need to be restored.

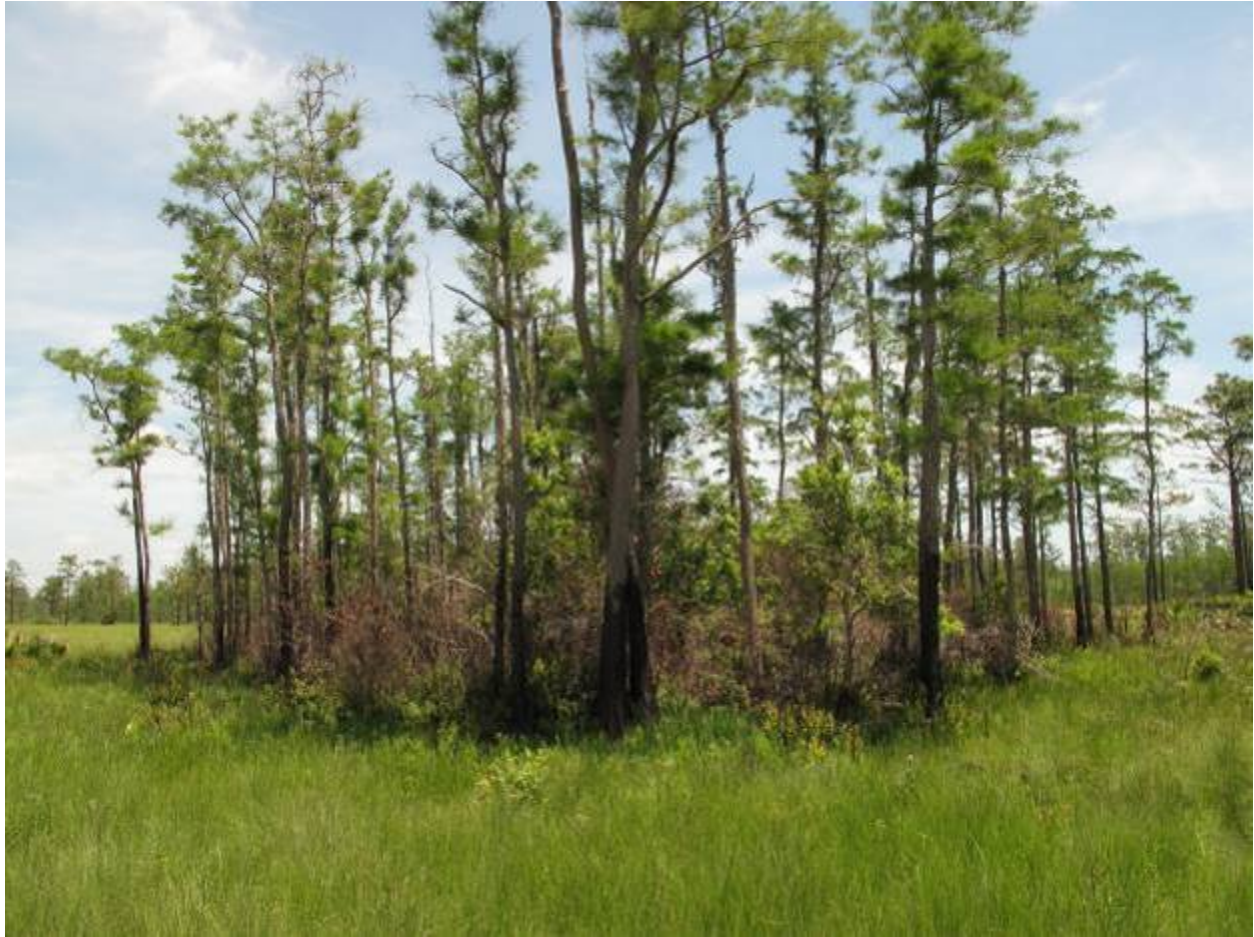
**Wetland ID: 63-03**

**Description:** This wetland is a 0.1 ha ephemeral mixed swamp. Cypress trees dominate the canopy, and cover 25-50% of the basin. The midstory is dominated by wax myrtle and fetterbush, and cover >75% of the basin. Sedges/grasses and fern grow sparsely throughout the wetland, and cover 5-25% of the basin. A shallow ditch leads from the south end of the wetland and connects to 63-04. A recent fire pruned some of the brushy understory. The adjacent uplands are flatwoods and pasture created by past cattle grazing.

**Wetland Concerns:** Ditching, Upland condition

**Restoration Action Recommended:** Fill the ditch to restore the wetland's isolation. Continue providing regular fire to the landscape - in order to restore the full ecological function of the wetland, the uplands will need to be restored.

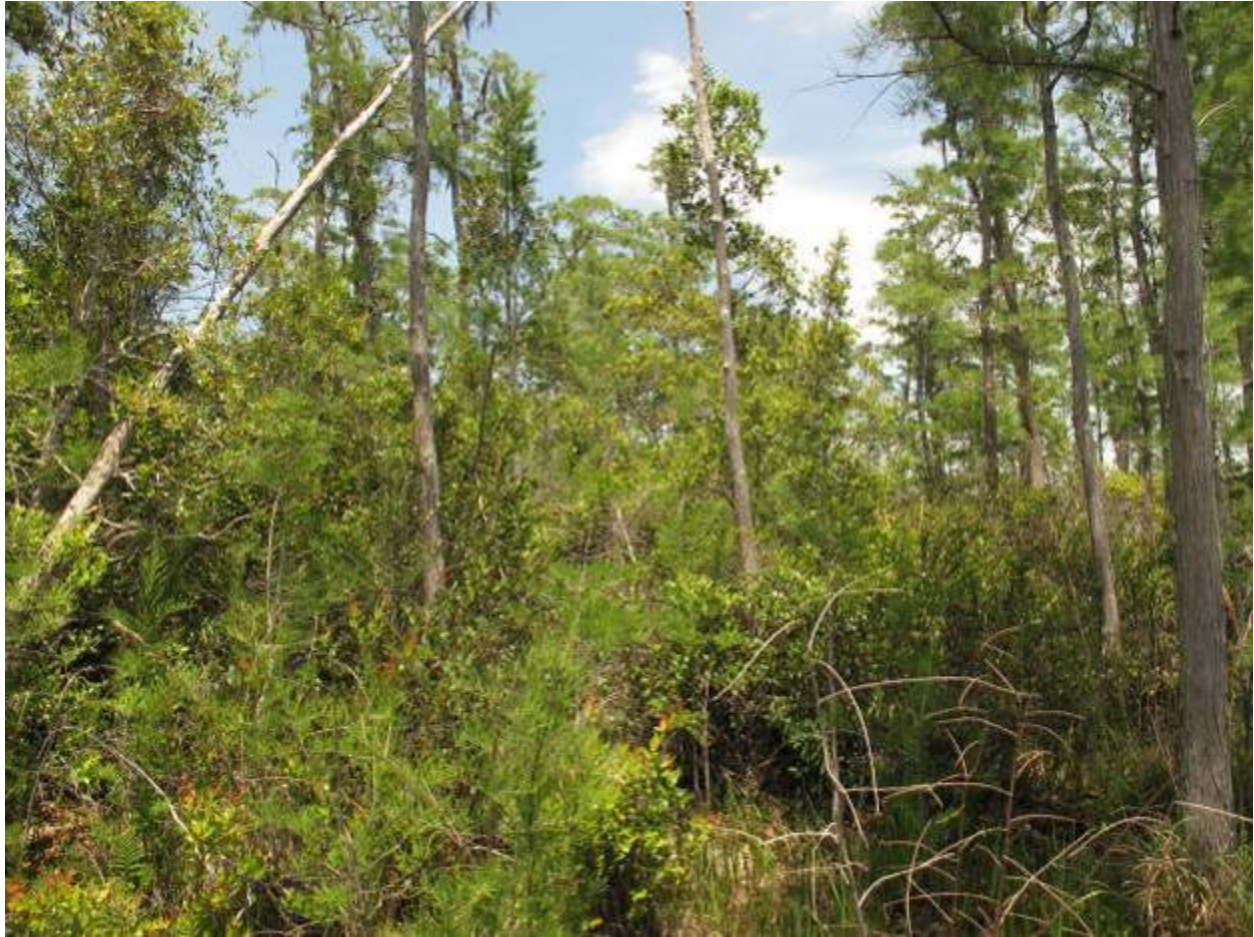
**Wetland ID: 63-04**

**Description:** This wetland is a 1.0 ha ephemeral mixed swamp. Cypress trees dominate the canopy, and cover 50-75% of the basin. The midstory is dominated by fetterbush and wax myrtle, and covers >75% of the wetland. Fern, sedges/grasses, and redroot grow in a ring around the wetland edge and *Sphagnum* grows in scattered patches. The herbaceous vegetation covers 5-25% of the basin. Fetterbush has colonized old stump hummocks. A recent fire burned to the wetland edges. The adjacent uplands are flatwoods and pasture created by past cattle grazing.

**Wetland Concerns:** Feral hog damage, Upland condition, Woody encroachment

**Restoration Action Recommended:** Ensure the next fire burns into the wetland basin. Continue providing regular fire to the landscape - in order to restore the full ecological function of the wetland, the uplands will need to be restored.

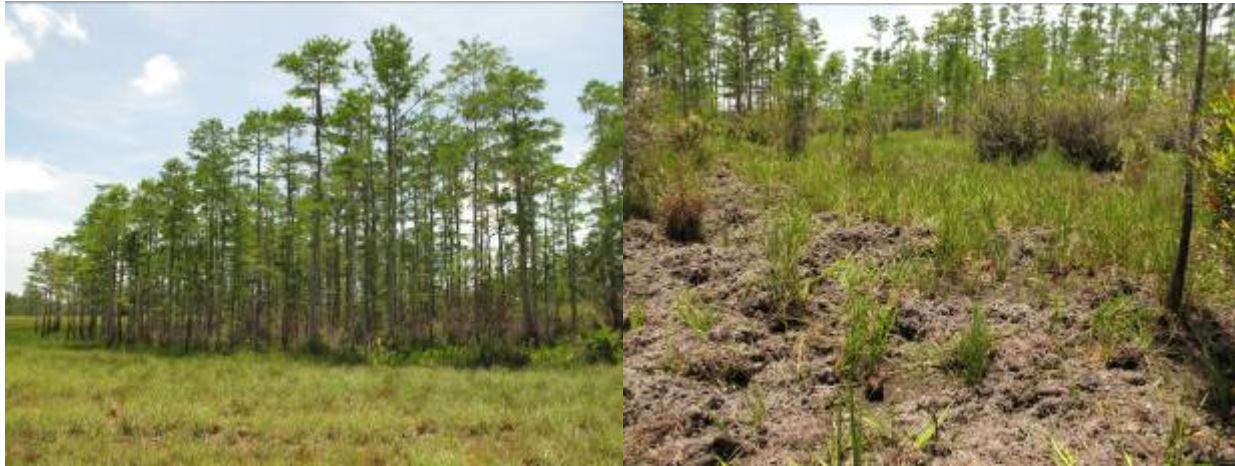
**Wetland ID: 63-05**

**Description:** This wetland is a 0.7 ha ephemeral forested swamp. It has an outer ring of cypress and a largely open interior with very widely scattered cypress trees. The tree canopy covers 25-50% of the basin. The midstory is dominated by fetterbush, and covers 25-50% of the wetland. Maidencane and redroot grow throughout the wetland, and cover >75% of the basin. Feral hog damage is extensive. Fetterbush grows on old stump hummocks. The adjacent uplands are pasture created by past cattle grazing. Pasture grasses have encroached into the wetland edges.

**Wetland Concerns:** Feral hog damage, Invasive species, Upland condition

**Restoration Action Recommended:** Continue providing regular fire to the landscape - in order to restore the full ecological function of the wetland, the uplands will need to be restored.

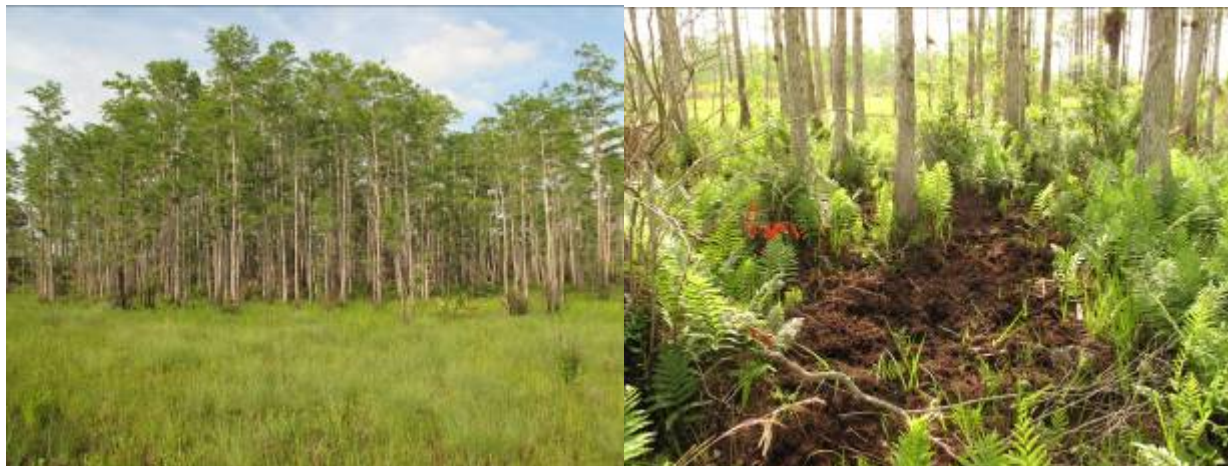
**Wetland ID: 64-01**

**Description:** This wetland is a 0.4 ha ephemeral forested swamp. Cypress trees dominate the canopy, and cover >75% of the basin. The midstory is dominated by various hardwoods, and covers 5-25% of the wetland. Fern and redroot grow throughout the wetland, and cover >75% of the basin. Feral hog damage is widespread and severe. A very shallow ditch clips the west side of the wetland along an access track. A recent fire burned all the way through the wetland. The adjacent uplands are mesic flatwoods managed with prescribed fire.

**Wetland Concerns:** Feral hog damage, Ditching

**Restoration Action Recommended:** Because the ditch connects to an ephemeral roadside ditch system, it likely is not impacting the wetland. However, we recommend filling all ditches connected to wetlands if restoration is a goal.

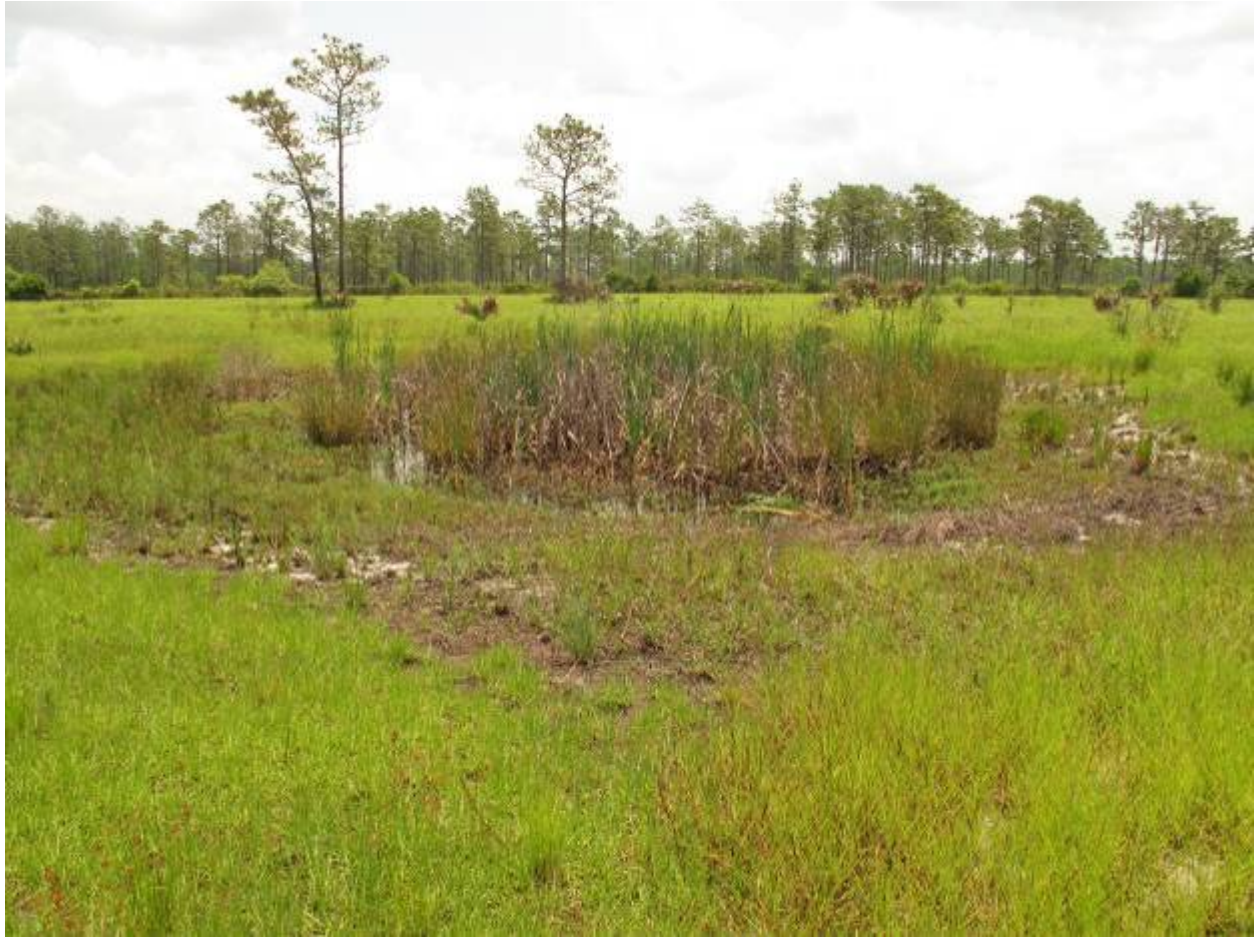
**Wetland ID: 64-02**

**Description:** This wetland is a <0.1 ha semi-permanent marsh. There is no tree canopy or midstory cover. Emergent vegetation, rush, sedges/grasses, and cattail grow throughout the wetland, and cover >75% of the basin. Fish were present on the day of our visit. The adjacent uplands are pasture created by past cattle grazing. Pasture grasses have encroached into the wetland edges.

**Wetland Concerns:** Invasive species, Upland condition

**Restoration Action Recommended:** Continue providing regular fire to the landscape - in order to restore the full ecological function of the wetland, the uplands will need to be restored.

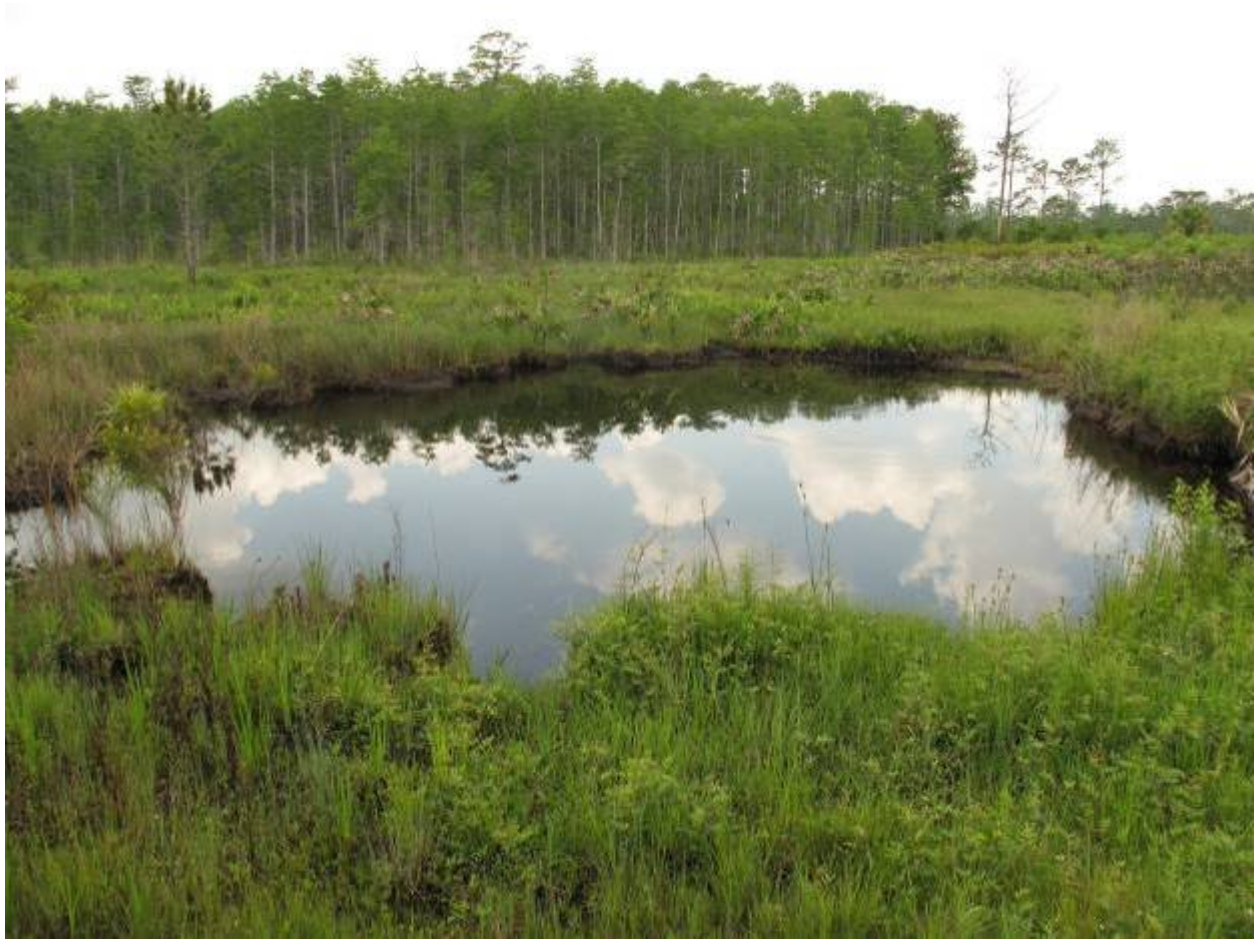
**Wetland ID: 64-03**

**Description:** This wetland is a <0.1 ha semi-permanent dug-out. It has steep edges and a deep center. We could not discern whether this wetland was modified or created from the uplands. There is no tree canopy or midstory cover. Sedges/grasses grow sparsely throughout the wetland, and cover 5-25% of the basin. The adjacent uplands are pasture created by past cattle grazing.

**Wetland Concerns:** Dug-out, Upland condition

**Restoration Action Recommended:** None - Even though this wetland appears to be human-constructed, it now is functioning as an ephemeral wetland. Continue providing regular fire to the landscape - in order to restore the full ecological function of the wetland, the uplands will need to be restored.

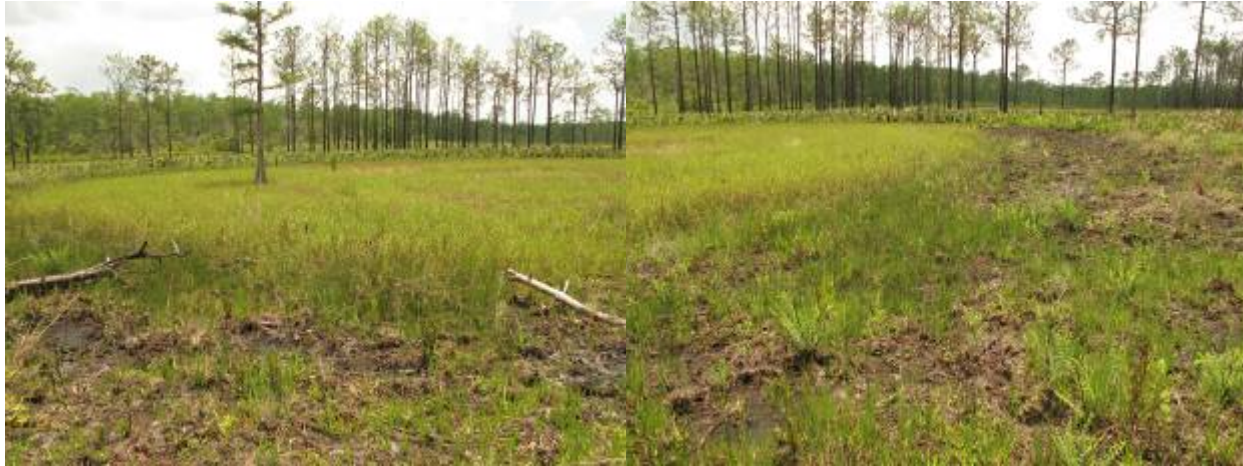
**Wetland ID: 64-04**

**Description:** This wetland is a 0.2 ha ephemeral marsh. There is no tree canopy or midstory cover. Maidencane grows densely throughout the wetland, and covers >75% of the basin. Feral hog damage rings the wetland. There is a small earthen mound in the north end. The adjacent uplands are pasture created by past cattle grazing.

**Wetland Concerns:** Feral hog damage, Upland condition

**Restoration Action Recommended:** Continue providing regular fire to the landscape - in order to restore the full ecological function of the wetland, the uplands will need to be restored.

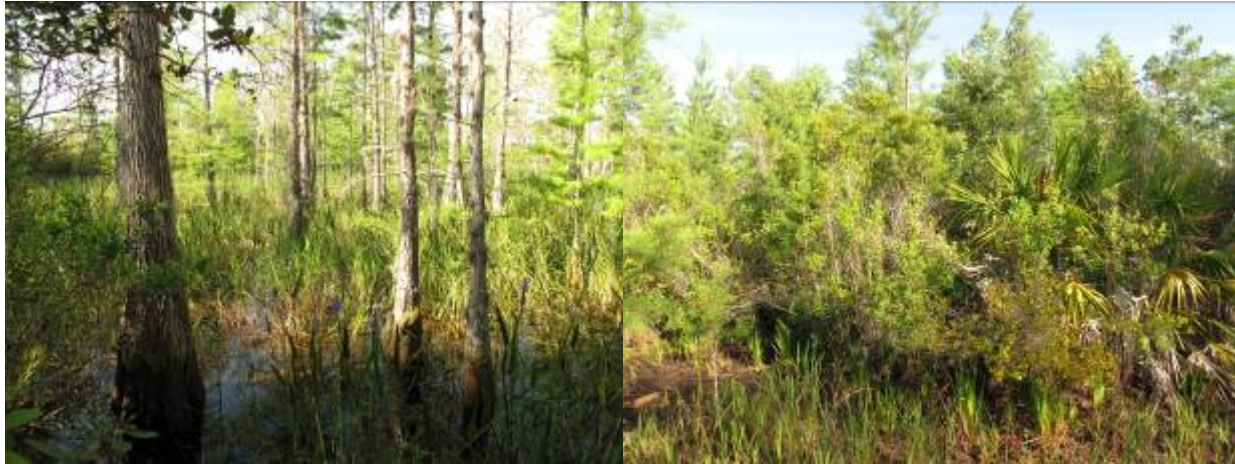
**Wetland ID: 66-01**

**Description:** This wetland is a 0.2 ha ephemeral forested swamp. Cypress trees dominate the canopy, and cover 50-75% of the basin. There is a dense patch of fetterbush and wax myrtle on the south side of the wetland. The midstory covers 5-25% of the wetland. Maidencane, emergent vegetation, and *Sphagnum* cover >75% of the basin. There is some feral hog damage in the wetland. The adjacent uplands are mesic flatwoods and pasture created by past cattle grazing.

**Wetland Concerns:** Feral hog damage, Upland condition

**Restoration Action Recommended:** Continue providing regular fire to the landscape - in order to restore the full ecological function of the wetland, the uplands will need to be restored.

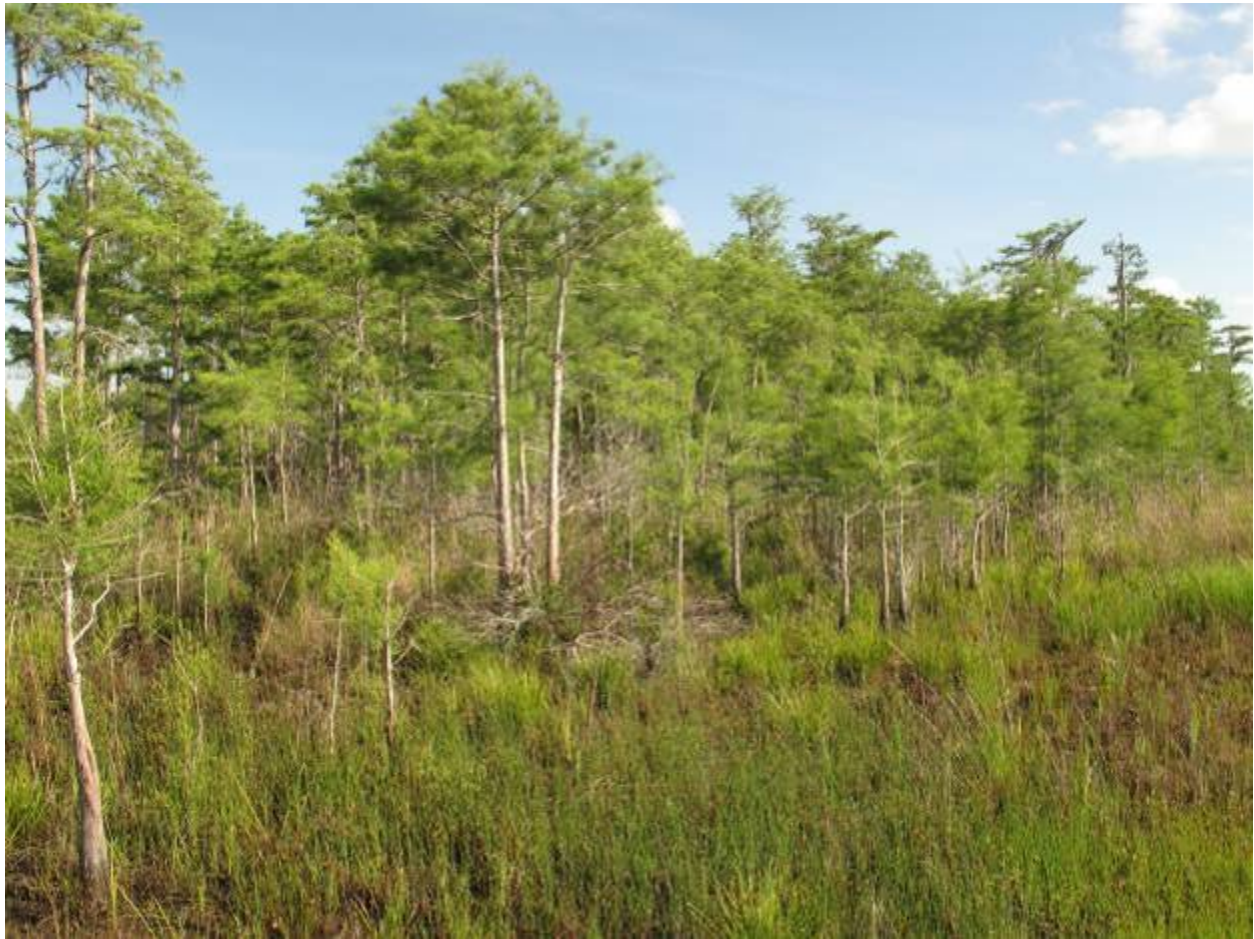
**Wetland ID: 66-02**

**Description:** This wetland is a 0.6 ha ephemeral forested swamp. Cypress trees dominate the canopy, and cover >75% of the basin. The midstory is dominated by wax myrtle, and covers 5-25% of the wetland. Fern and sedges/grasses grow throughout the wetland, and cover >75% of the basin. The adjacent uplands are mesic flatwoods and pasture created by past cattle grazing.

**Wetland Concerns:** Upland condition

**Restoration Action Recommended:** Continue providing regular fire to the landscape - in order to restore the full ecological function of the wetland, the uplands will need to be restored.

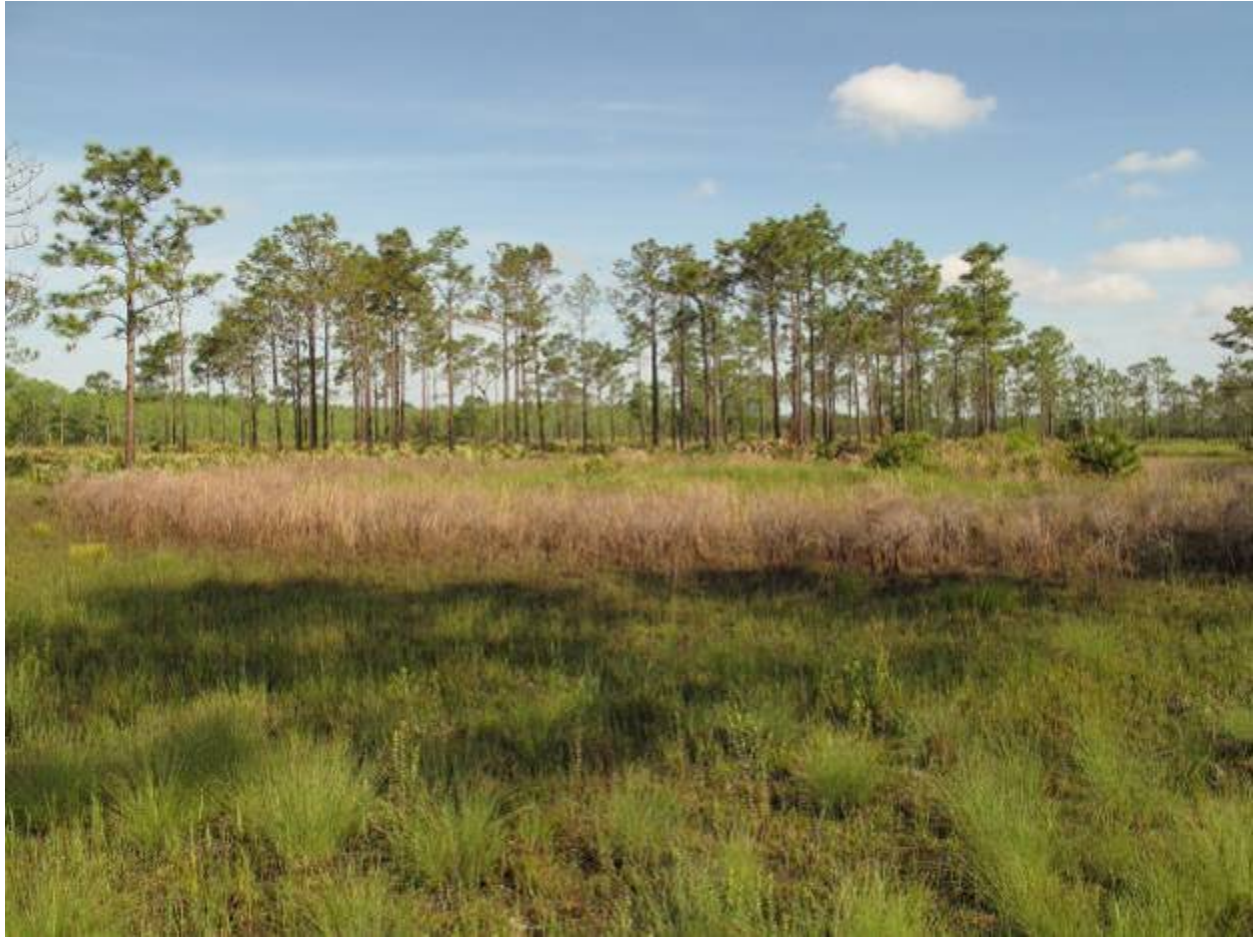
**Wetland ID: 66-03**

**Description:** This wetland is a 0.2 ha ephemeral marsh. There is no tree canopy or midstory cover. *Hypericum* grows in a thin ring around the wetland center. Maidencane grows in the wetland interior, and sedges/grasses grow in a ring around the wetland. The herbaceous vegetation covers >75% of the basin. Small fish were present on the day of our visit. The adjacent uplands are mesic flatwoods and pasture created by past cattle grazing.

**Wetland Concerns:** Upland condition

**Restoration Action Recommended:** Continue providing regular fire to the landscape - in order to restore the full ecological function of the wetland, the uplands will need to be restored.

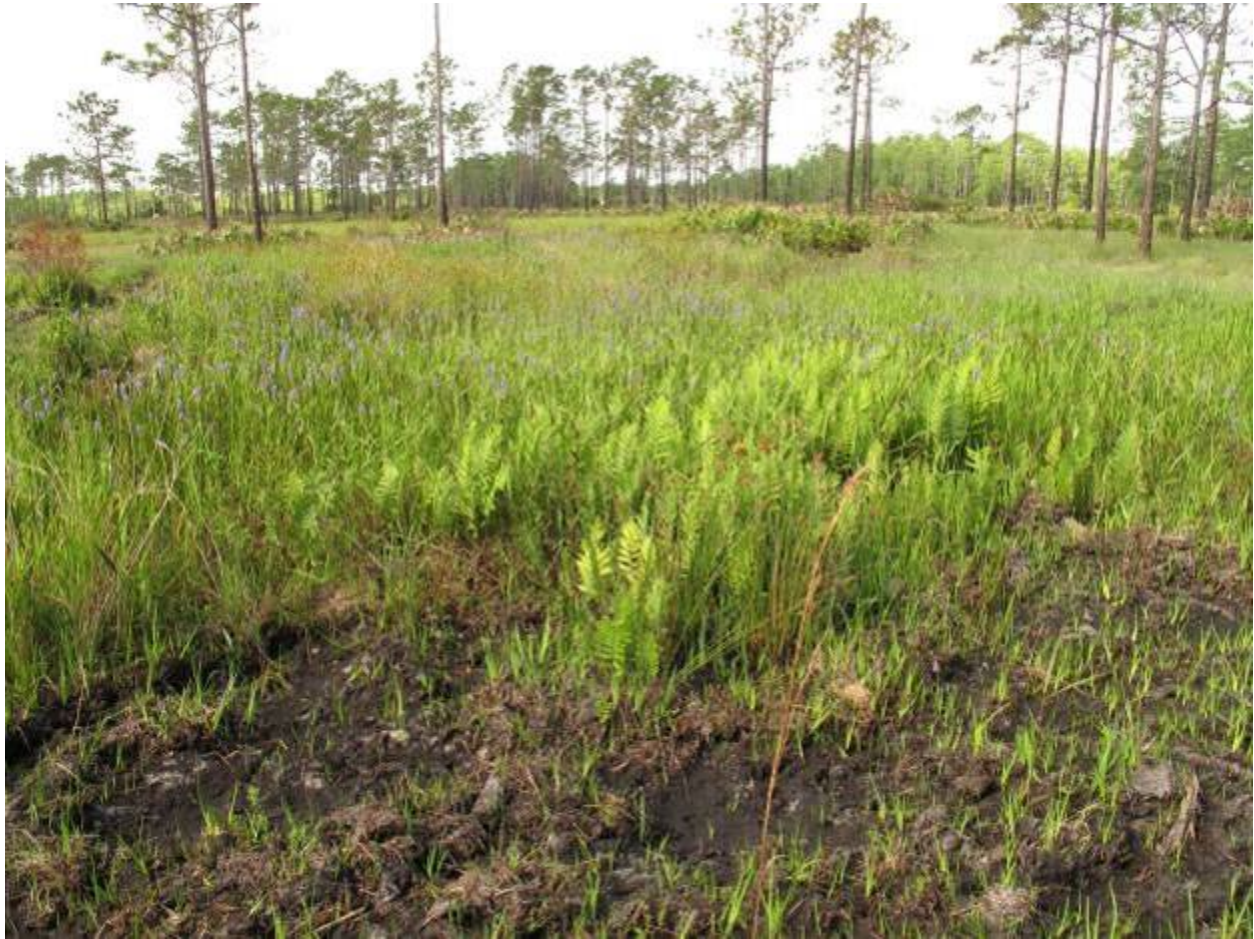
**Wetland ID: 66-04**

**Description:** This wetland is a <0.1 ha ephemeral marsh. There is no tree canopy or midstory cover. Maidencane and pickerelweed grow throughout the wetland, and cover >75% of the basin. There is a distinct ring of feral hog damage around the wetland. The adjacent uplands are mesic flatwoods and pasture created by past cattle grazing.

**Wetland Concerns:** Feral hog damage, Upland condition

**Restoration Action Recommended:** Continue providing regular fire to the landscape - in order to restore the full ecological function of the wetland, the uplands will need to be restored.

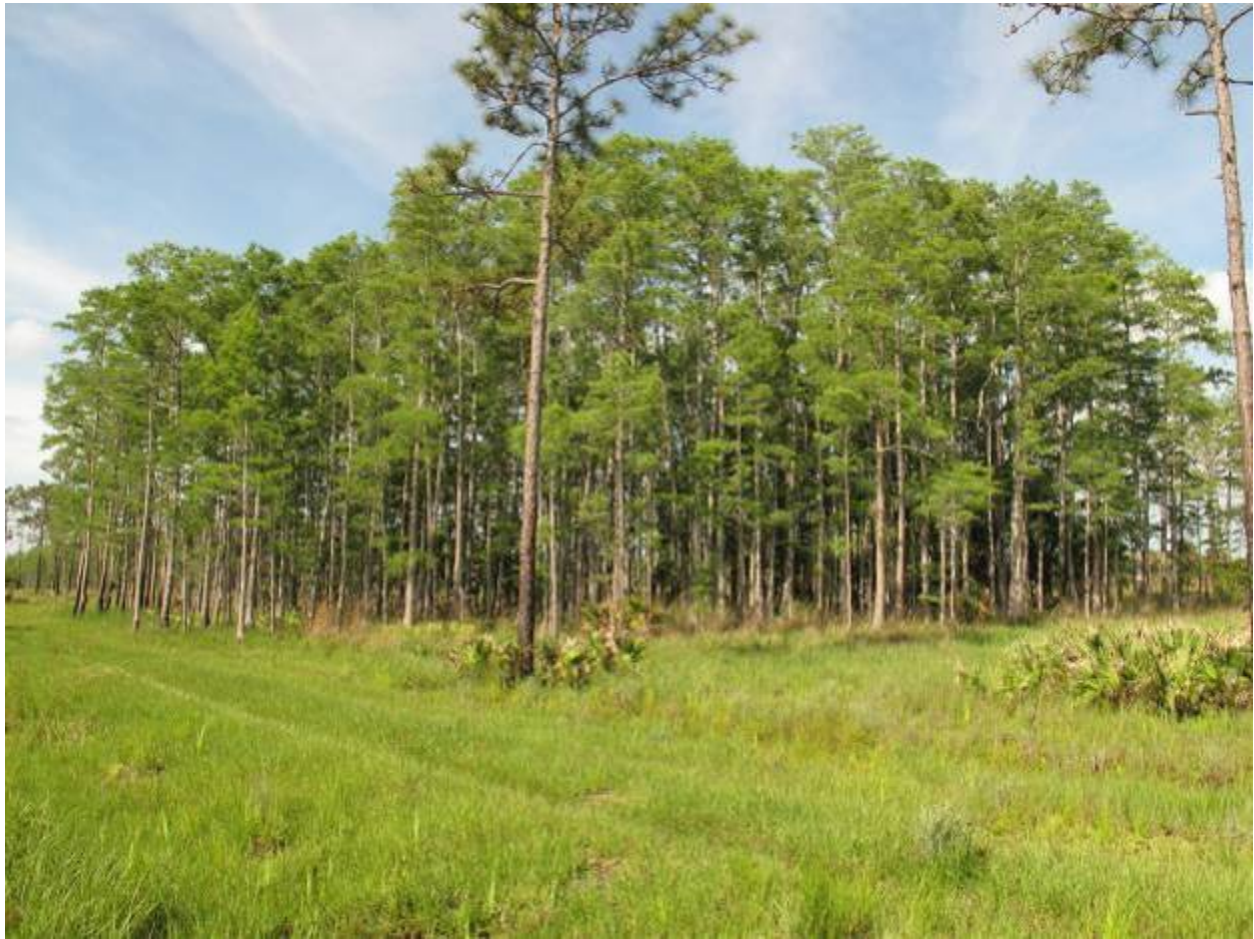
**Wetland ID: 67-01**

**Description:** This wetland is a 0.3 ha ephemeral forested swamp. Cypress trees dominate the canopy, and cover >75% of the basin. There is no midstory cover. Sedges/grasses and fern grow throughout the wetland, and cover >75% of the basin. A grass, possibly torpedograss, is abundant in the wetland interior. Feral hog damage is minor and patchy. The adjacent uplands are mesic flatwoods and pasture created by past cattle grazing.

**Wetland Concerns:** Feral hog damage, Invasive species, Upland condition

**Restoration Action Recommended:** Continue providing regular fire to the landscape - in order to restore the full ecological function of the wetland, the uplands will need to be restored.

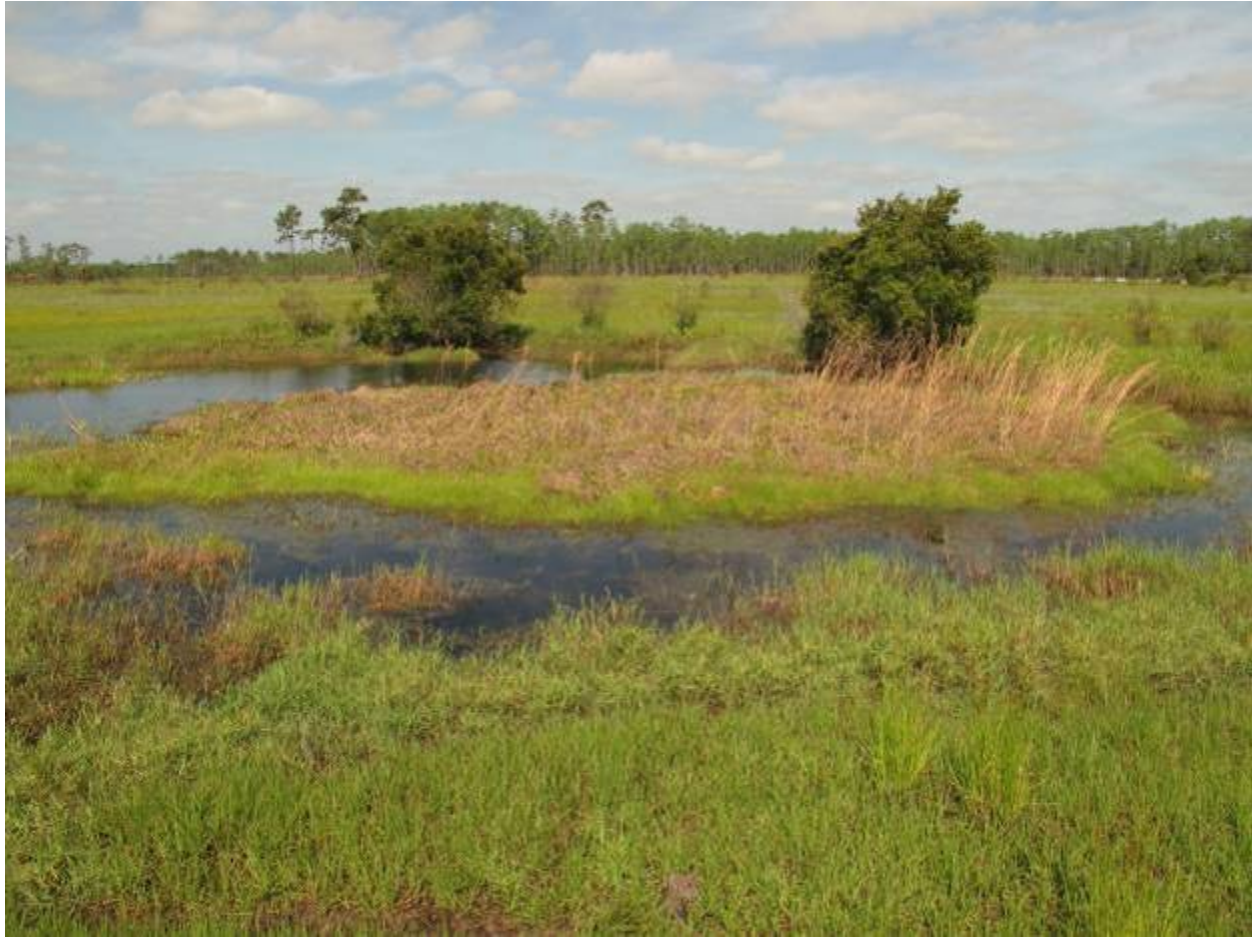
**Wetland ID: 67-02**

**Description:** This wetland is a 0.1 ha semi-permanent marsh. We could not discern whether this wetland was modified or created from the uplands. It is currently functioning as an ephemeral wetland. There is no tree canopy or midstory cover. Emergent vegetation and sedges/grasses grow throughout the wetland, and cover >75% of the basin. The adjacent uplands are pasture created by past cattle grazing. Pasture grasses, including torpedograss, have encroached into the wetland edges.

**Wetland Concerns:** Dug-out, Invasive species, Upland condition

**Restoration Action Recommended:** Continue providing regular fire to the landscape - in order to restore the full ecological function of the wetland, the uplands will need to be restored.

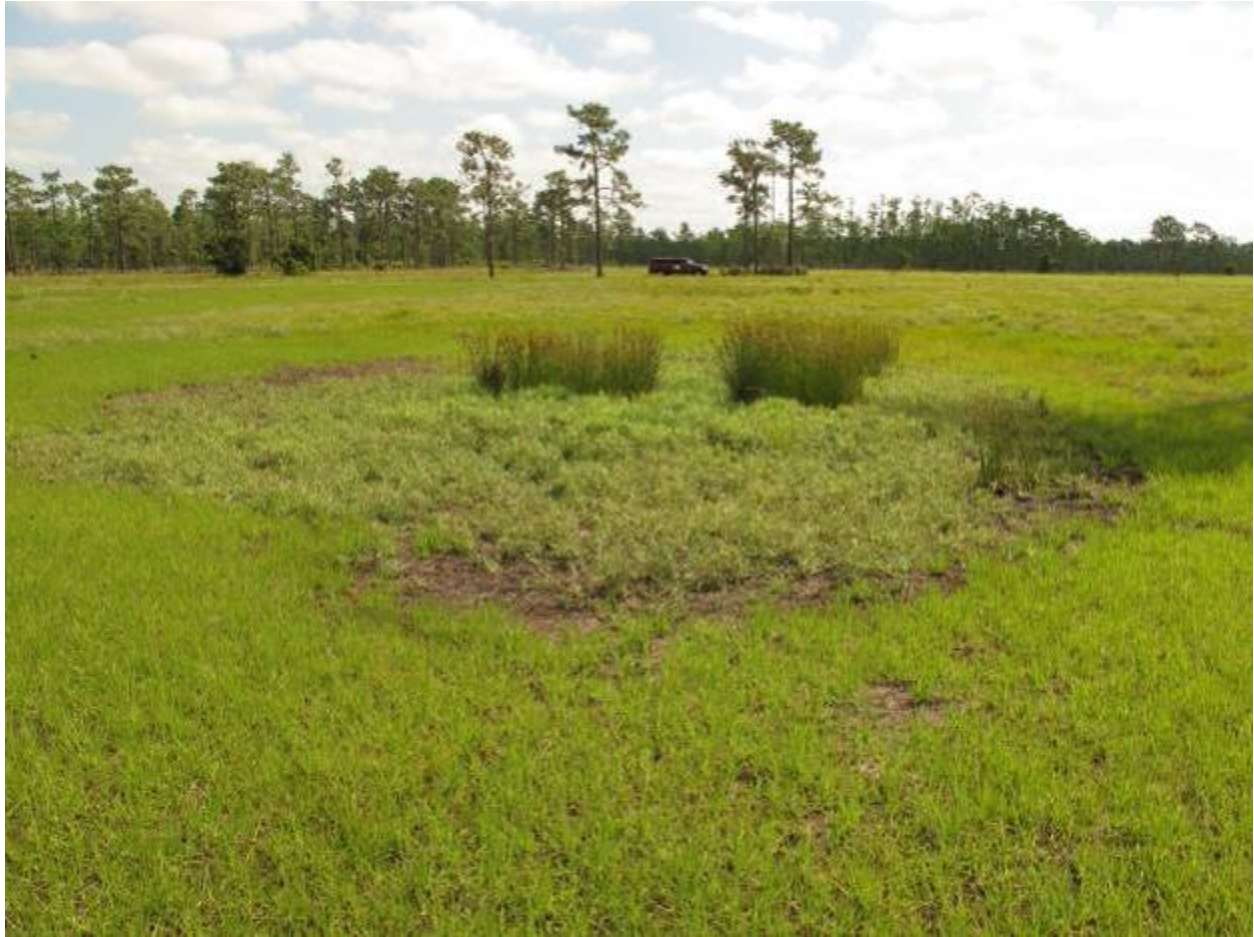
**Wetland ID: 67-03**

**Description:** This wetland is a <0.1 ha ephemeral marsh. There is no tree canopy or midstory cover. Bahia grass grows around the outer edge and torpedograss grows in the wetland center. The herbaceous vegetation covers >75% of the basin. The adjacent uplands are pasture created by past cattle grazing. Pasture grasses have encroached into the wetland.

**Wetland Concerns:** Invasive species, Upland condition

**Restoration Action Recommended:** Continue providing regular fire to the landscape - in order to restore the full ecological function of the wetland, the uplands will need to be restored.

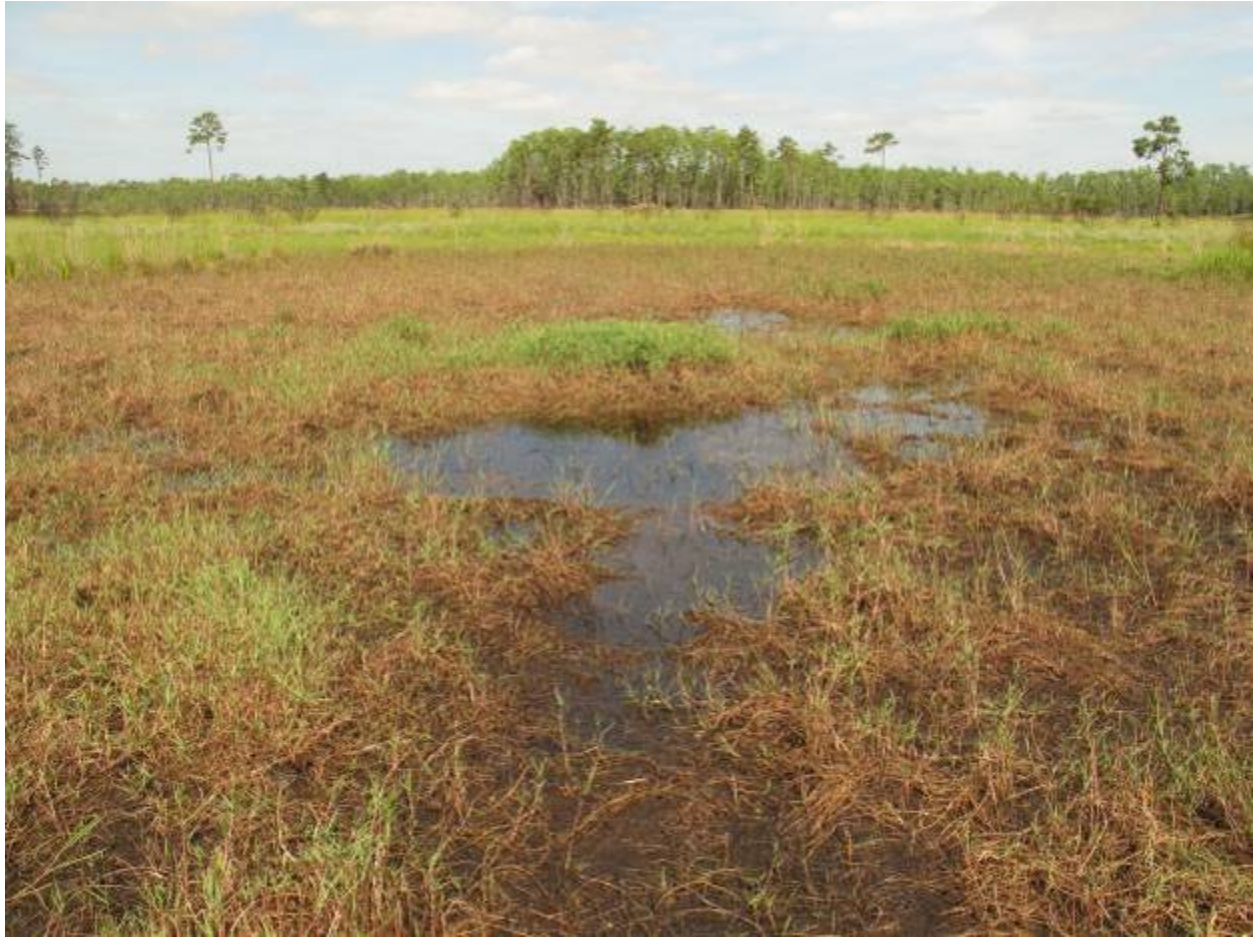
**Wetland ID: 67-04**

**Description:** This wetland is a 0.3 ha ephemeral marsh. There is no tree canopy or midstory cover. Sedges/grasses, including torpedograss, grow throughout the wetland, and cover >75% of the basin. The adjacent uplands are pasture created by past cattle grazing. Pasture grasses have encroached into the wetland.

**Wetland Concerns:** Invasive species, Upland condition

**Restoration Action Recommended:** Continue providing regular fire to the landscape - in order to restore the full ecological function of the wetland, the uplands will need to be restored.
