# **Inventory, Assessment, and Restoration Potential of Ephemeral Wetlands on FFWCC Wildlife Management Areas**

## **Triple N Ranch WMA Final Report**

Submitted by: Rebecca P.M. Means<sup>1</sup>, Ryan C. Means<sup>1</sup>, Steven A. Johnson<sup>2</sup>

15 May 2010 – 15 August 2010

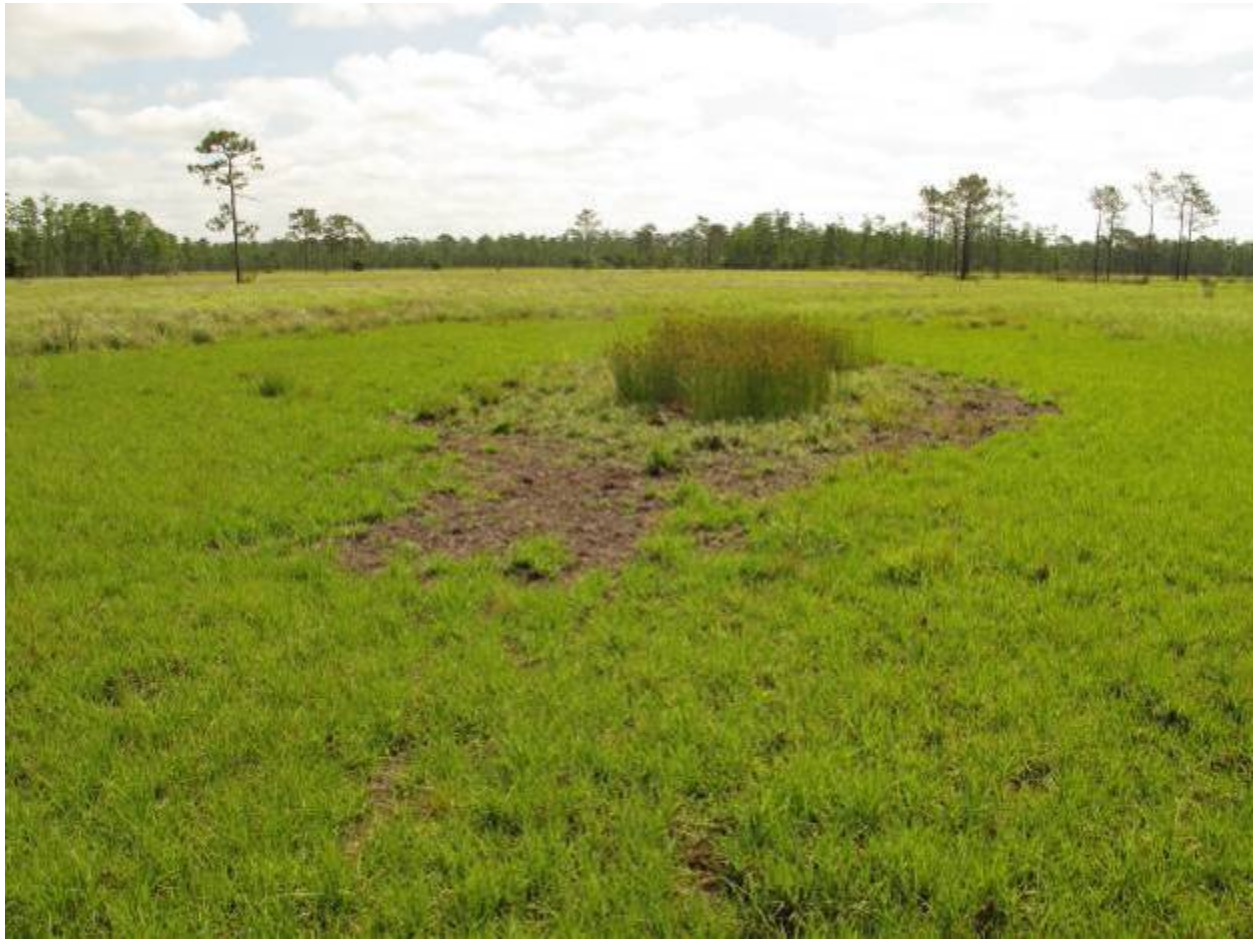
**Wetland ID: 67-05**

**Description:** This wetland is a <0.1 ha ephemeral marsh. There is no tree canopy or midstory cover. Bahia grass grows around the outer edge of the wetland, and torpedograss and rush grow in the wetland center. The herbaceous vegetation covers >75% of the basin. The adjacent uplands are pasture created by past cattle grazing. Pasture grasses have encroached into the wetland.

**Wetland Concerns:** Invasive species, Upland condition

**Restoration Action Recommended:** Continue providing regular fire to the landscape - in order to restore the full ecological function of the wetland, the uplands will need to be restored.

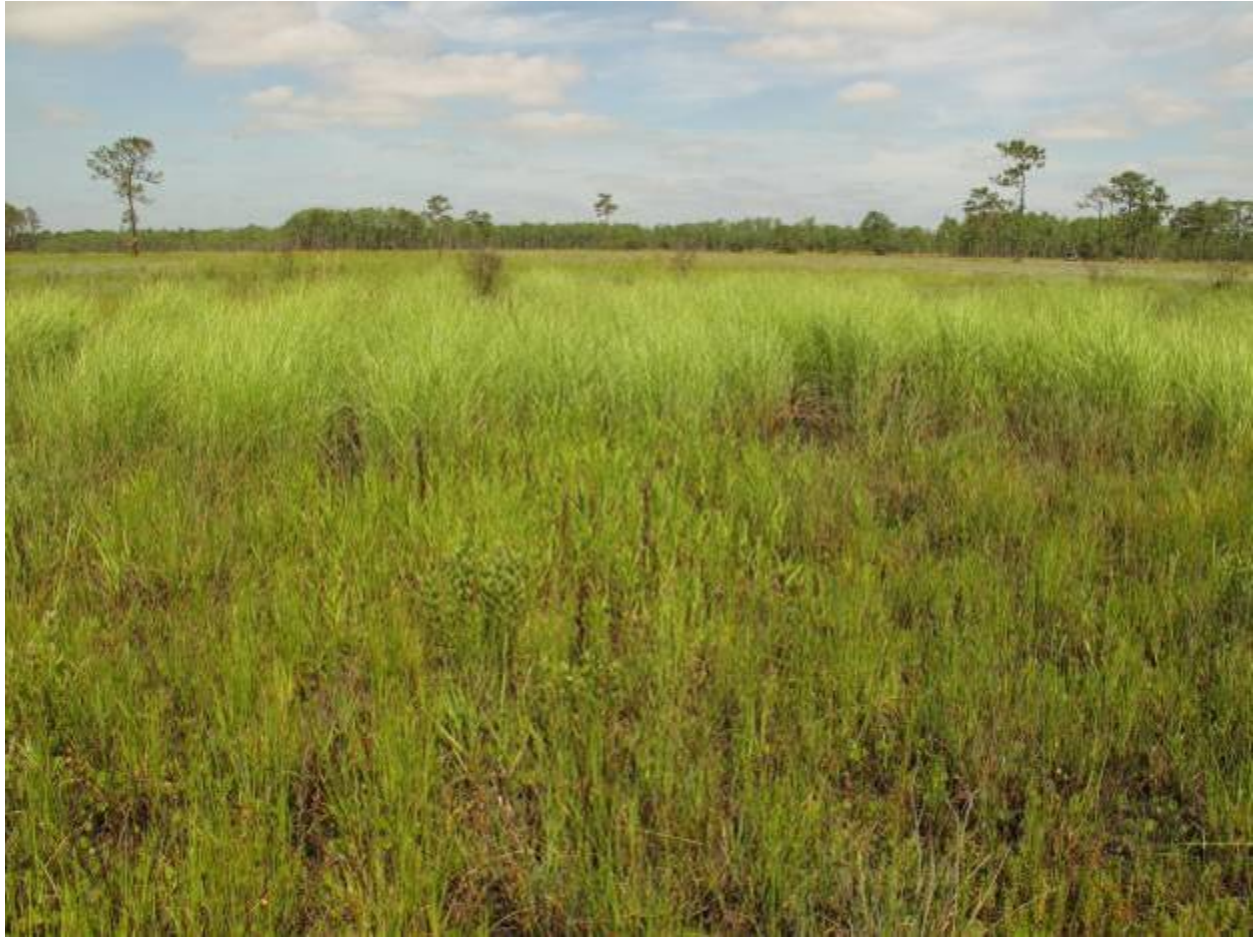
**Wetland ID: 67-06**

**Description:** This wetland is a <0.1 ha ephemeral marsh. There is no tree canopy or midstory cover. Sedges/grasses, including torpedograss, grow throughout the wetland, and cover >75% of the basin. The adjacent uplands are pasture created by past cattle grazing. Pasture grasses have encroached into the wetland.

**Wetland Concerns:** Invasive species, Upland condition

**Restoration Action Recommended:** Continue providing regular fire to the landscape - in order to restore the full ecological function of the wetland, the uplands will need to be restored.

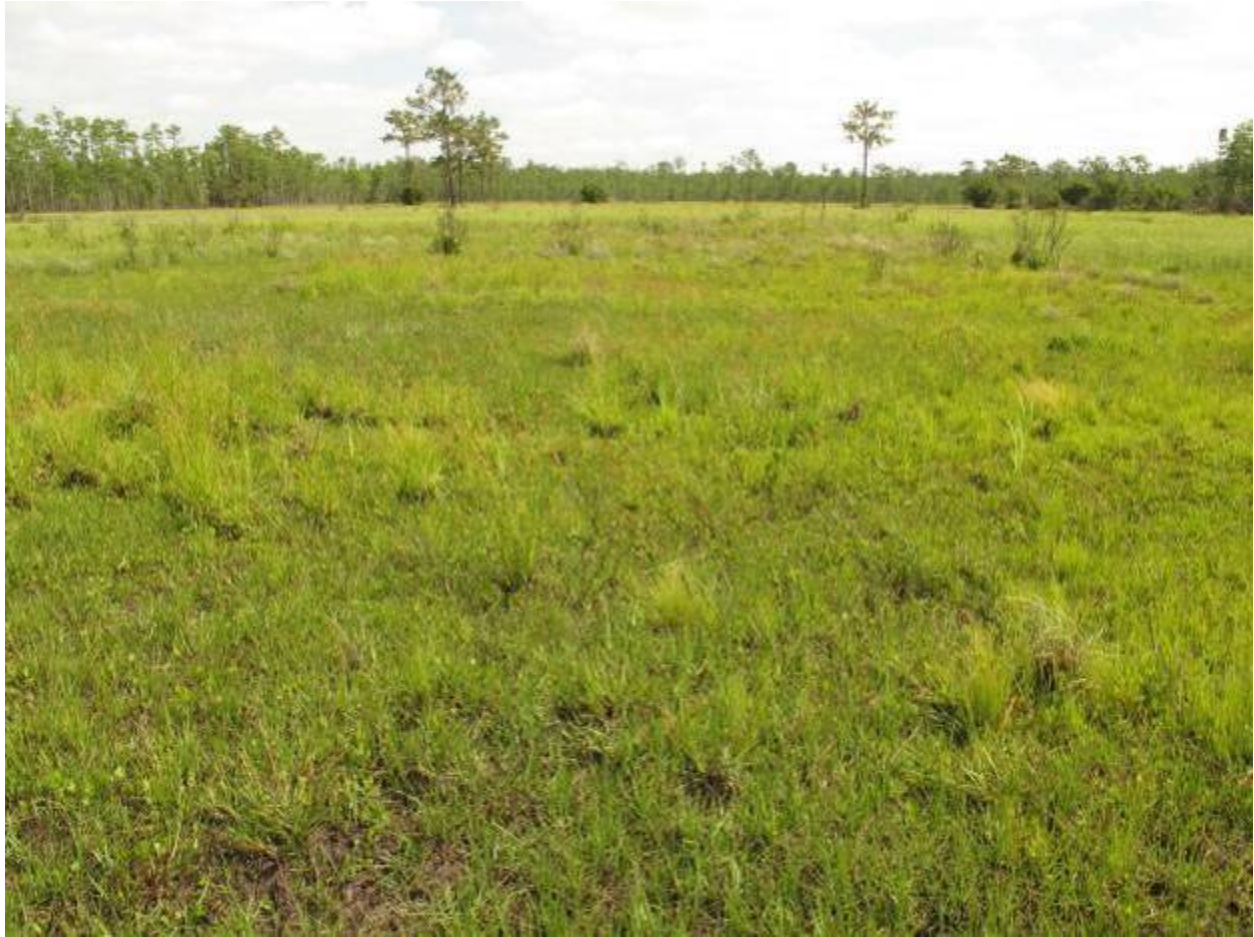
**Wetland ID: 67-07**

**Description:** This wetland is a <0.1 ha highly ephemeral marsh. There is no tree canopy or midstory cover. A diversity of native and non-native grasses, including bahia grass and torpedograsses, grows throughout the wetland, and covers >75% of the basin. The adjacent uplands are pasture created by past cattle grazing. Pasture grasses have encroached into the wetland.

**Wetland Concerns:** Invasive species, Upland condition

**Restoration Action Recommended:** Continue providing regular fire to the landscape - in order to restore the full ecological function of the wetland, the uplands will need to be restored.

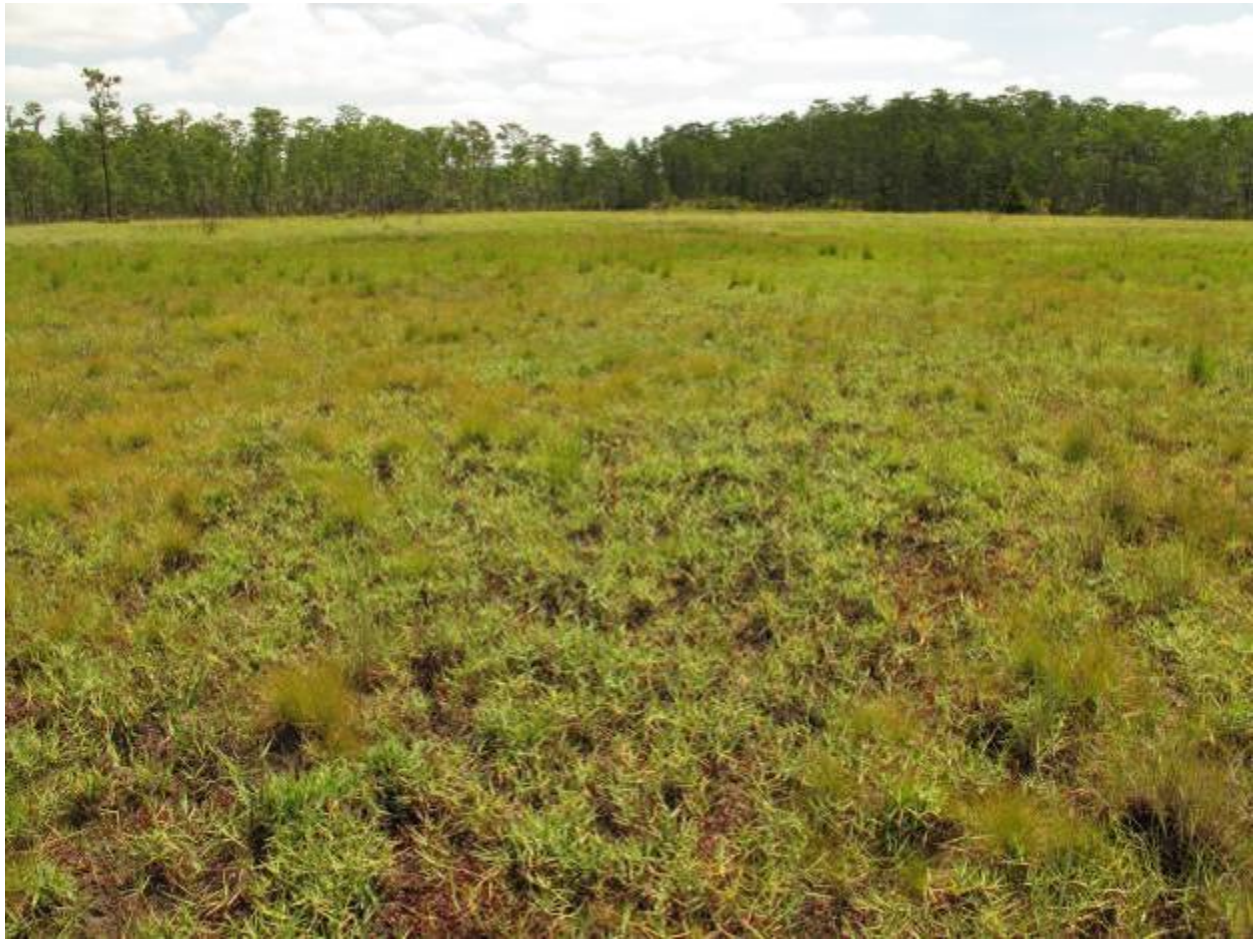
**Wetland ID: 67-08**

**Description:** This wetland is a 0.1 ha ephemeral marsh. There is no tree canopy or midstory cover. A diversity of native and non-native grasses, including torpedograsses, grows throughout the wetland, and covers >75% of the basin. The adjacent uplands are pasture created by past cattle grazing. Pasture grasses have encroached into the wetland.

**Wetland Concerns:** Invasive species, Upland condition

**Restoration Action Recommended:** Continue providing regular fire to the landscape - in order to restore the full ecological function of the wetland, the uplands will need to be restored.

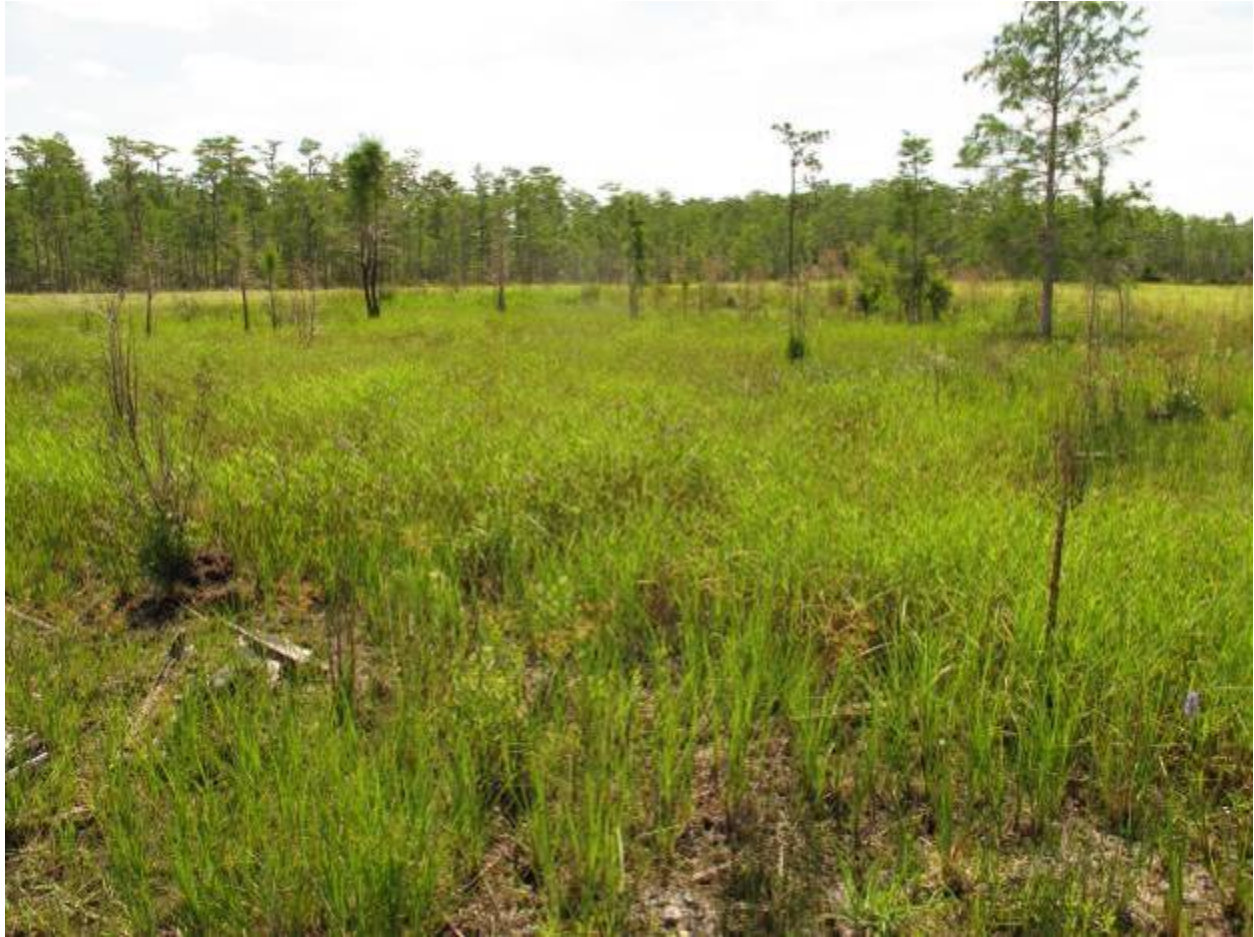
**Wetland ID: 67-09**

**Description:** This wetland is a 0.1 ha ephemeral marsh. There is no tree canopy or midstory cover. Maidencane grows throughout the wetland, and covers >75% of the basin. There are old cypress stumps in the wetland, signifying this wetland was once a cypress dome. A small dirt berm was created on the south side of the wetland. The adjacent uplands are pasture created by past cattle grazing.

**Wetland Concerns:** Upland condition

**Restoration Action Recommended:** Continue providing regular fire to the landscape - in order to restore the full ecological function of the wetland, the uplands will need to be restored.

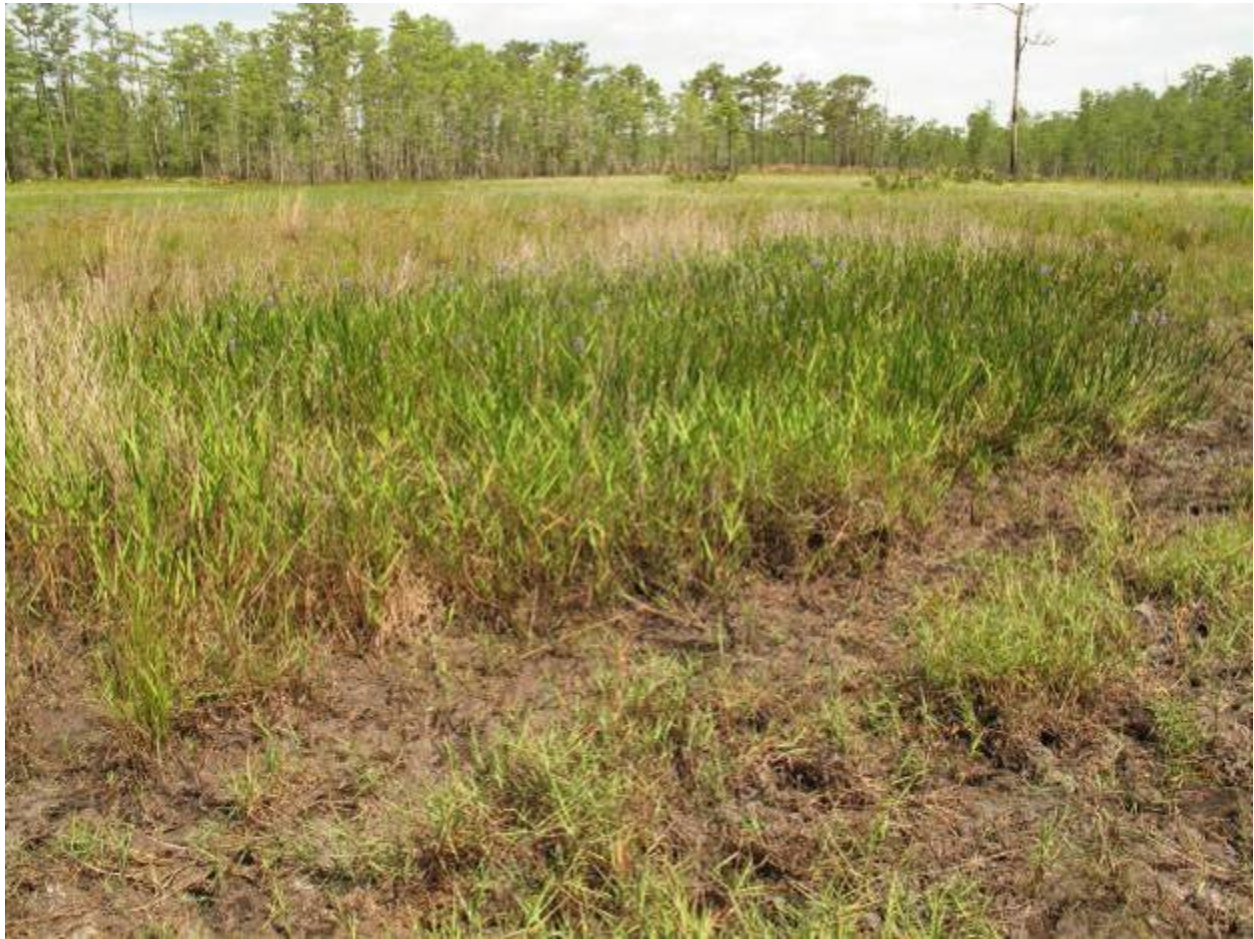
**Wetland ID: 67-10**

**Description:** This wetland is a 0.3 ha ephemeral marsh. There is no tree canopy or midstory cover. Maidencane and torpedograsses are the dominant herbaceous vegetation, and pickerelweed grows in the wetland center. The herbaceous vegetation covers >75% of the basin. Feral hog damage is minor. The adjacent uplands are pasture created by past cattle grazing. Pasture grasses have encroached into the wetland.

**Wetland Concerns:** Feral hog damage, Invasive species, Upland condition

**Restoration Action Recommended:** Continue providing regular fire to the landscape - in order to restore the full ecological function of the wetland, the uplands will need to be restored.

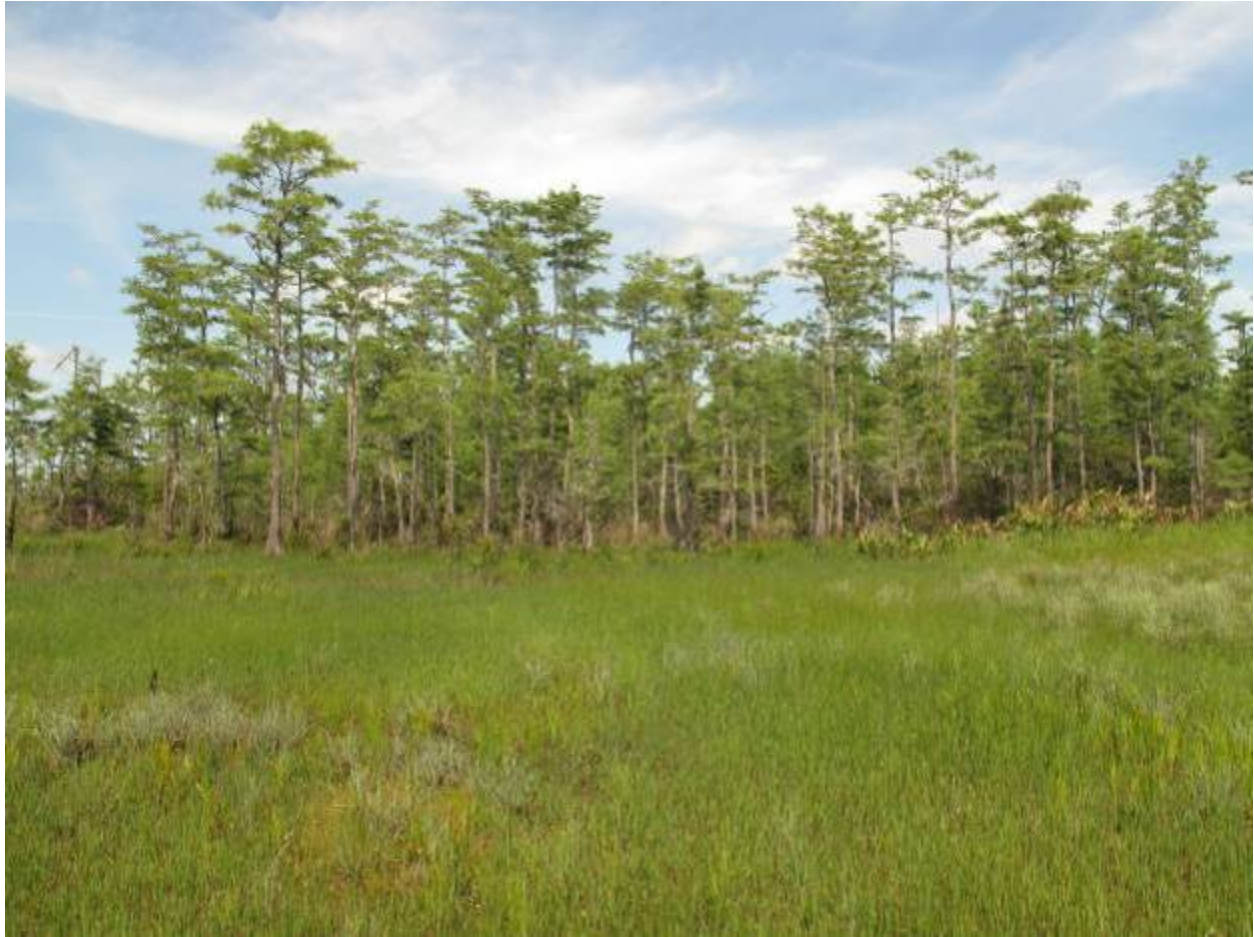
**Wetland ID: 67-11**

**Description:** This wetland is a 0.9 ha ephemeral forested swamp. Cypress trees dominate the canopy, and cover 50-75% of the basin. The midstory is dominated by fetterbush and young cypress trees, and covers 5-25% of the wetland. Maidencane and *Sphagnum* grow throughout the wetland, and cover >75% of the basin. The west half of the wetland has dense brush and appears to be a fire shadow. The east half of the wetland shows evidence of fire. There is feral hog damage in the wetland. This wetland may connect to 67-10 during times of high water. The adjacent uplands are pasture created by past cattle grazing.

**Wetland Concerns:** Feral hog damage, Upland condition

**Restoration Action Recommended:** Continue providing regular fire to the landscape - in order to restore the full ecological function of the wetland, the uplands will need to be restored.

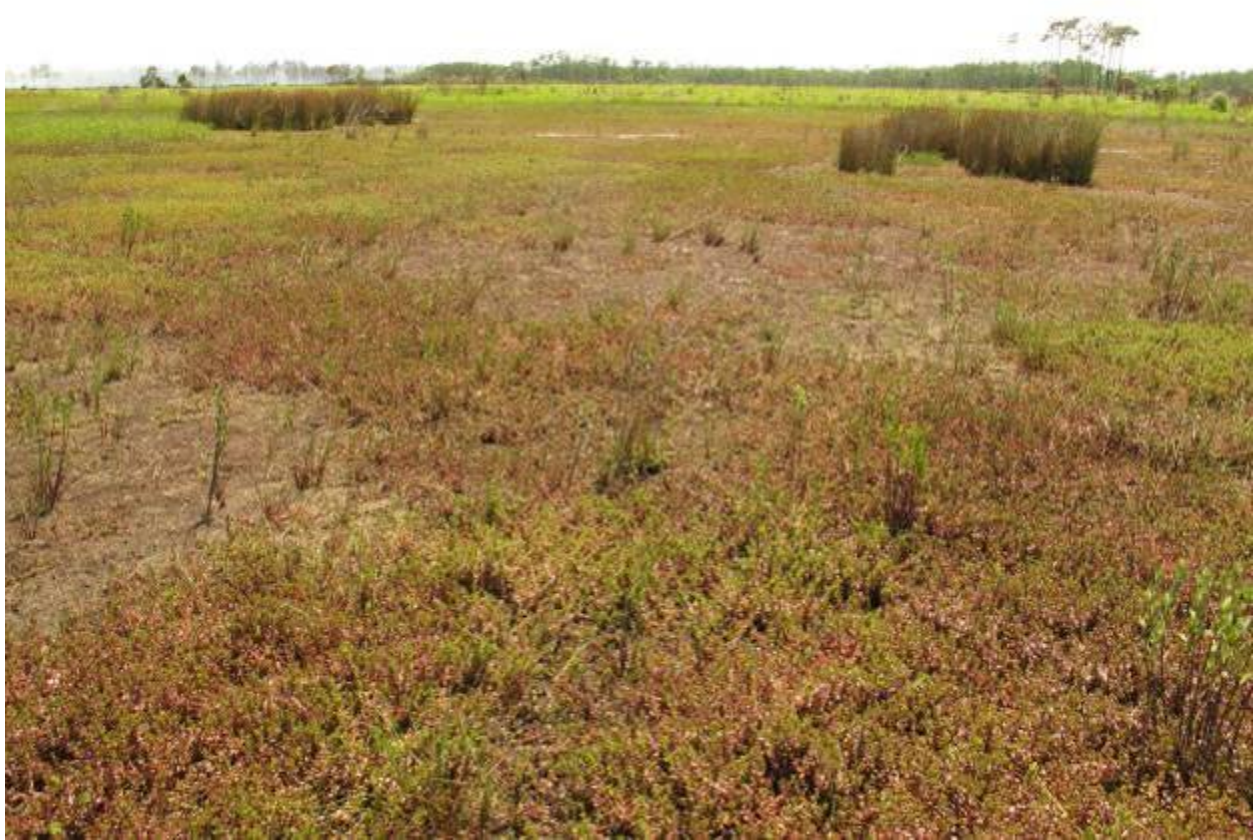
**Wetland ID: 68-01**

**Description:** This wetland is a 0.5 ha ephemeral marsh. There is no tree canopy or midstory cover. Emergent vegetation and sedges/grasses grow throughout the wetland basin, and cover >75% of the basin. Although cattle are no longer allowed on this MU, evidence of past grazing is present in the wetland. The adjacent uplands are pasture with widely scattered pine trees and shrubs.

**Wetland Concerns:** Upland condition

**Restoration Action Recommended:** Continue providing regular fire to the landscape - in order to restore the full ecological function of the wetland, the uplands will need to be restored.

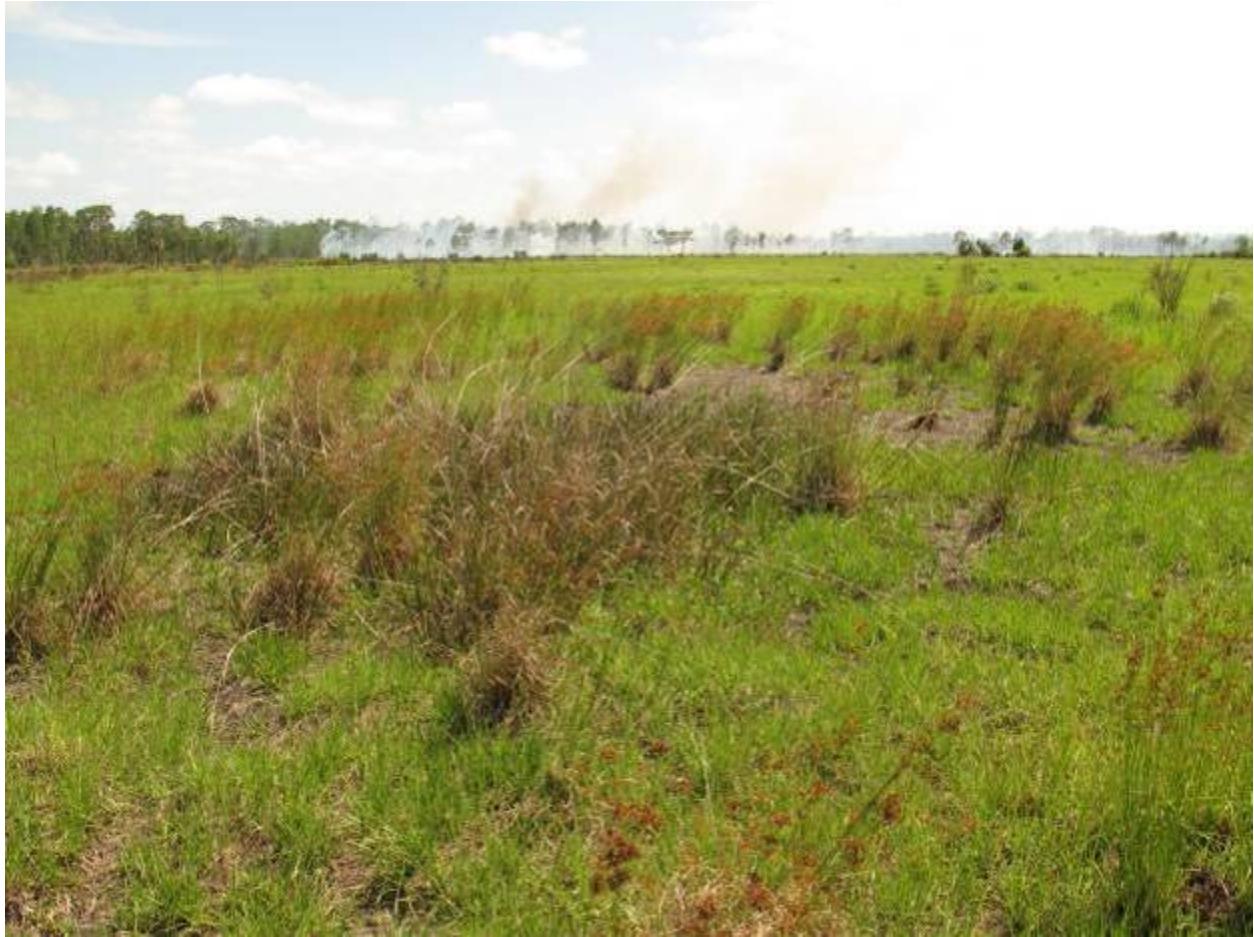
**Wetland ID: 68-02**

**Description:** This wetland is a 0.1 ha ephemeral marsh. There is no tree canopy or midstory cover. Sedges/grasses, including bahia grass, grow throughout the wetland, and cover >75% of the basin. The adjacent uplands are pasture with widely scattered pine trees and shrubs. Pasture grasses have encroached into the wetland.

**Wetland Concerns:** Invasive species, Upland condition

**Restoration Action Recommended:** Continue providing regular fire to the landscape - in order to restore the full ecological function of the wetland, the uplands will need to be restored.

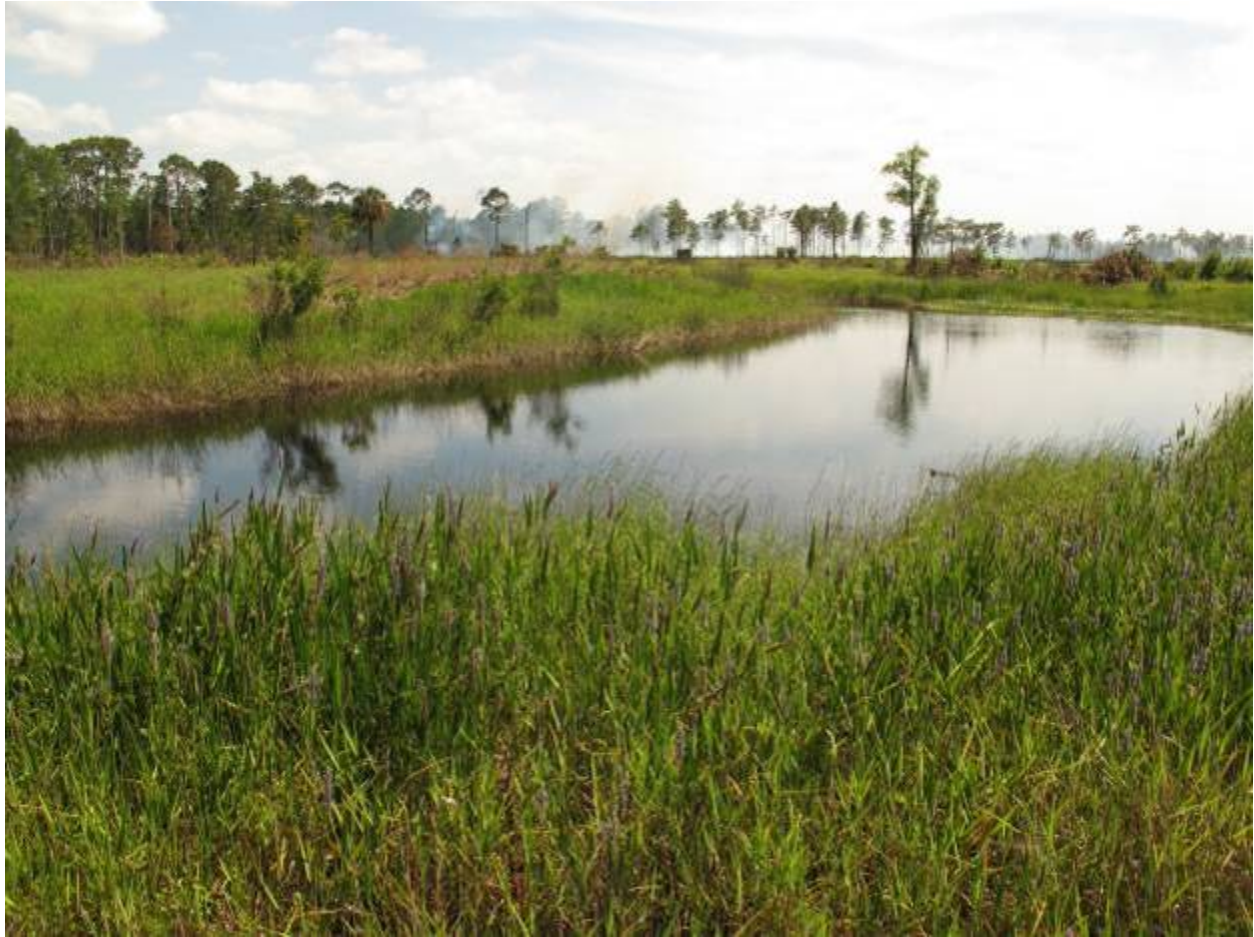
**Wetland ID: 68-03**

**Description:** This wetland is a 0.4 ha semi-permanent marsh. There is no tree canopy or midstory cover. Maidencane and emergent vegetation grow in scattered patches, and cover 50-75% of the basin. This marsh has been deeply dug-out in a semi-circle and a 2 m tall earthen mound was created in the wetland center. Fish were present on the day of our visit. The adjacent uplands are pasture with widely scattered pine trees and shrubs.

**Wetland Concerns:** Dug-out, Upland condition

**Restoration Action Recommended:** Fill the wetland with the earthen berm in order to restore the natural hydrology. Continue providing regular fire to the landscape - in order to restore the full ecological function of the wetland, the uplands will need to be restored.

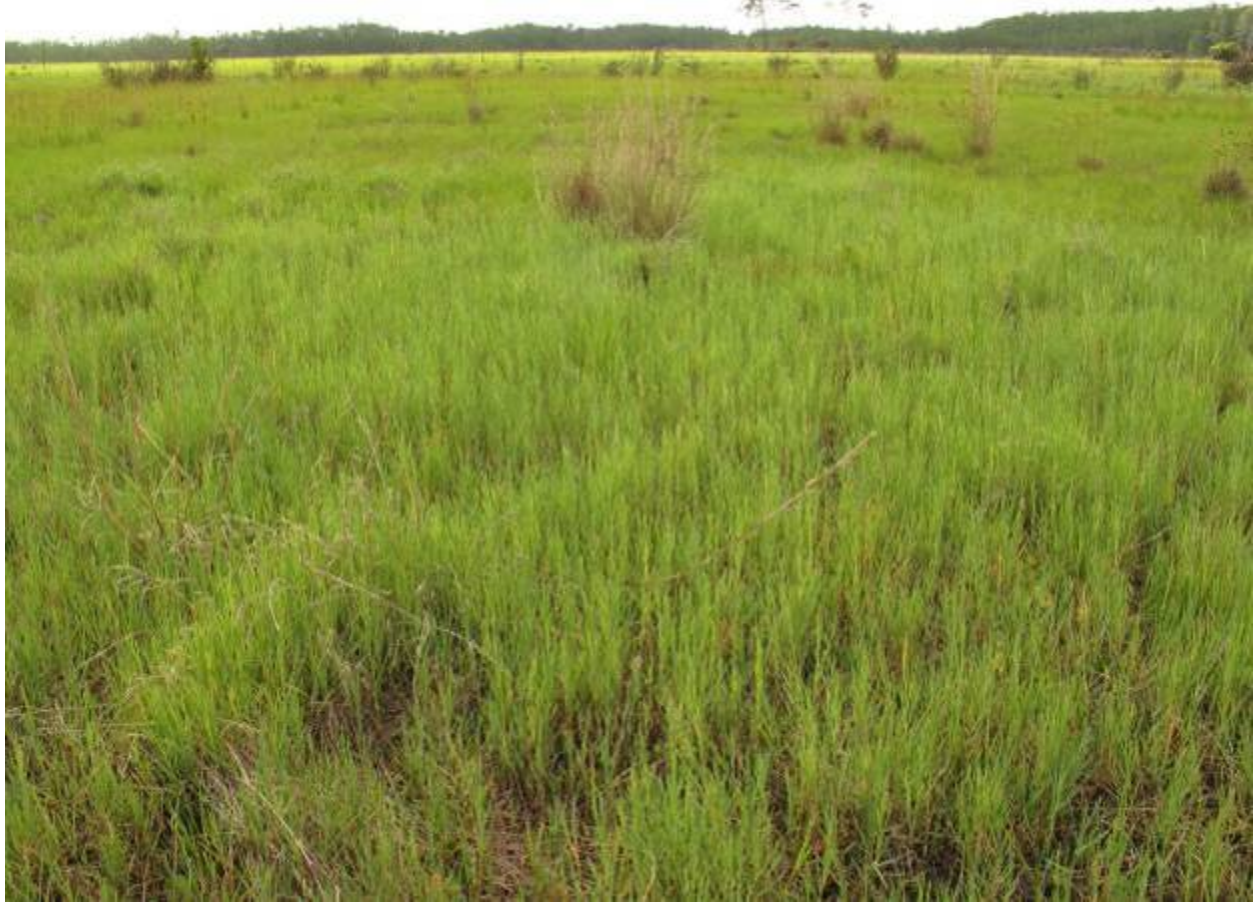
**Wetland ID: 68-04**

**Description:** This wetland is a 0.2 ha highly ephemeral marsh. There is no tree canopy or midstory cover. Sedges/grasses, including bahia grass and possibly torpedograsses, grow throughout the wetland, and cover >75% of the basin. The adjacent uplands are pasture with widely scattered pine trees and shrubs. Pasture grasses have encroached into the wetland basin.

**Wetland Concerns:** Invasive species, Upland condition

**Restoration Action Recommended:** Continue providing regular fire to the landscape - in order to restore the full ecological function of the wetland, the uplands will need to be restored.

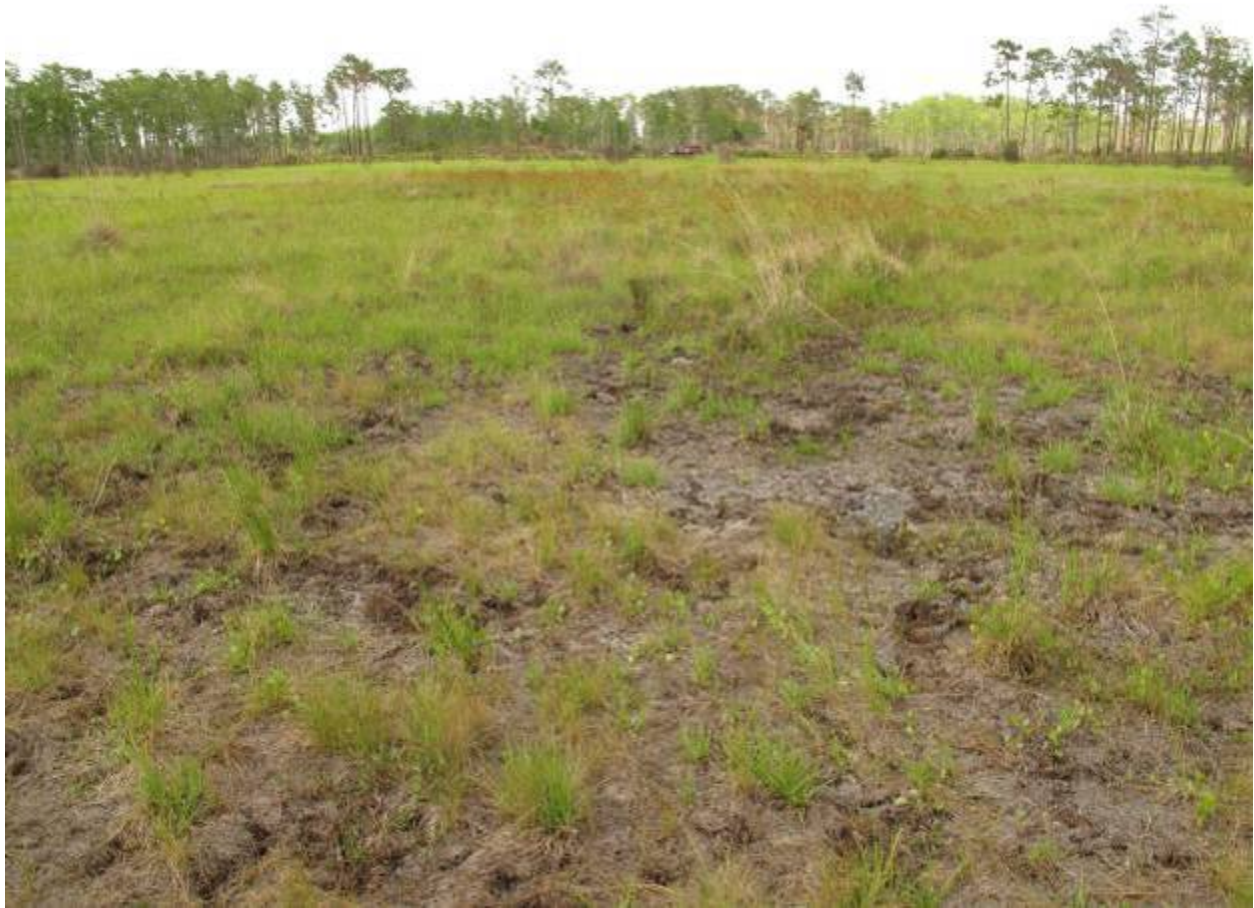
**Wetland ID: 68-05**

**Description:** This wetland is a 0.3 ha ephemeral marsh. There is no tree canopy or midstory cover. A high diversity of sedges/grasses, including bahia grass, grow throughout the wetland, and cover >75% of the basin. The adjacent uplands are pasture with widely scattered pine trees and shrubs. Pasture grasses have encroached into the wetland basin.

**Wetland Concerns:** Invasive species, Upland condition

**Restoration Action Recommended:** Continue providing regular fire to the landscape - in order to restore the full ecological function of the wetland, the uplands will need to be restored.

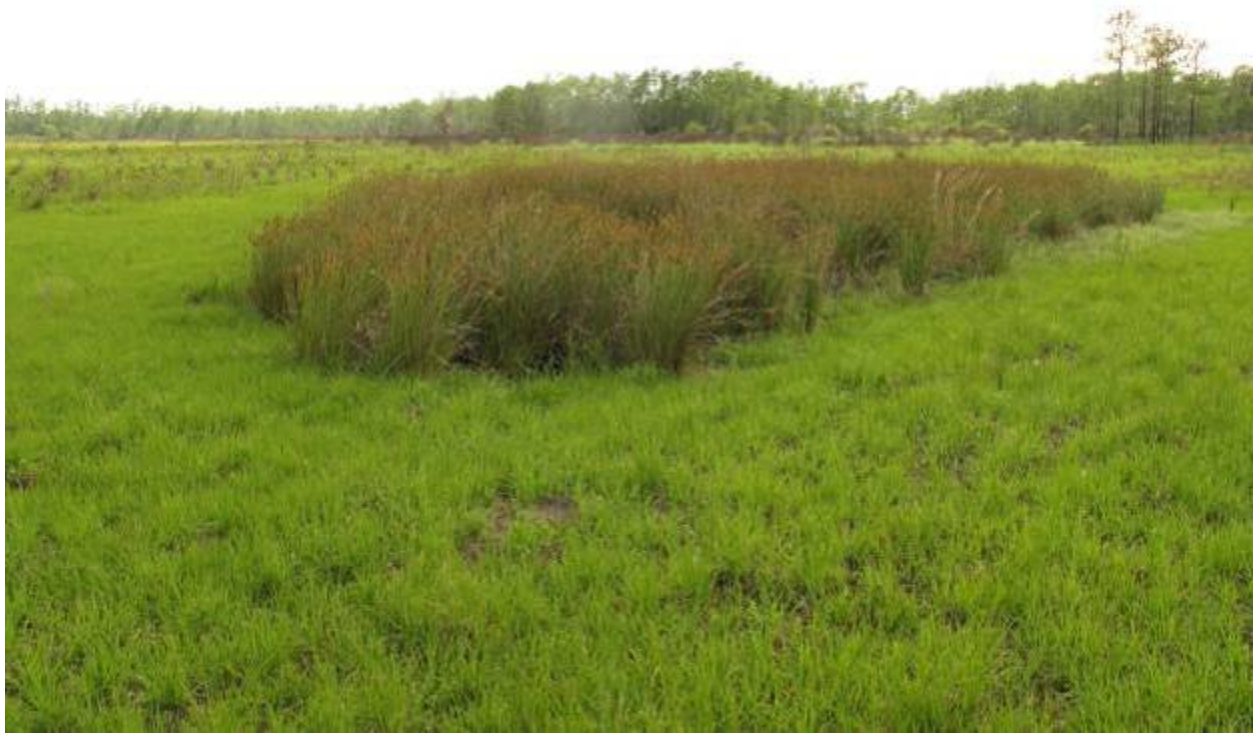
**Wetland ID: 68-06**

**Description:** This wetland is a 0.1 ha ephemeral marsh. There is no tree canopy or midstory cover. Rush grow in the deeper wetland center, sedges/grasses, including bahia grass, grow around the wetland perimeter. A grass, possibly torpedograsses, is abundant in the wetland interior. The herbaceous vegetation covers >75% of the basin. The adjacent uplands are pasture with widely scattered pine trees and shrubs. Pasture grasses have encroached into the wetland basin.

**Wetland Concerns:** Invasive species, Upland condition

**Restoration Action Recommended:** Continue providing regular fire to the landscape - in order to restore the full ecological function of the wetland, the uplands will need to be restored.

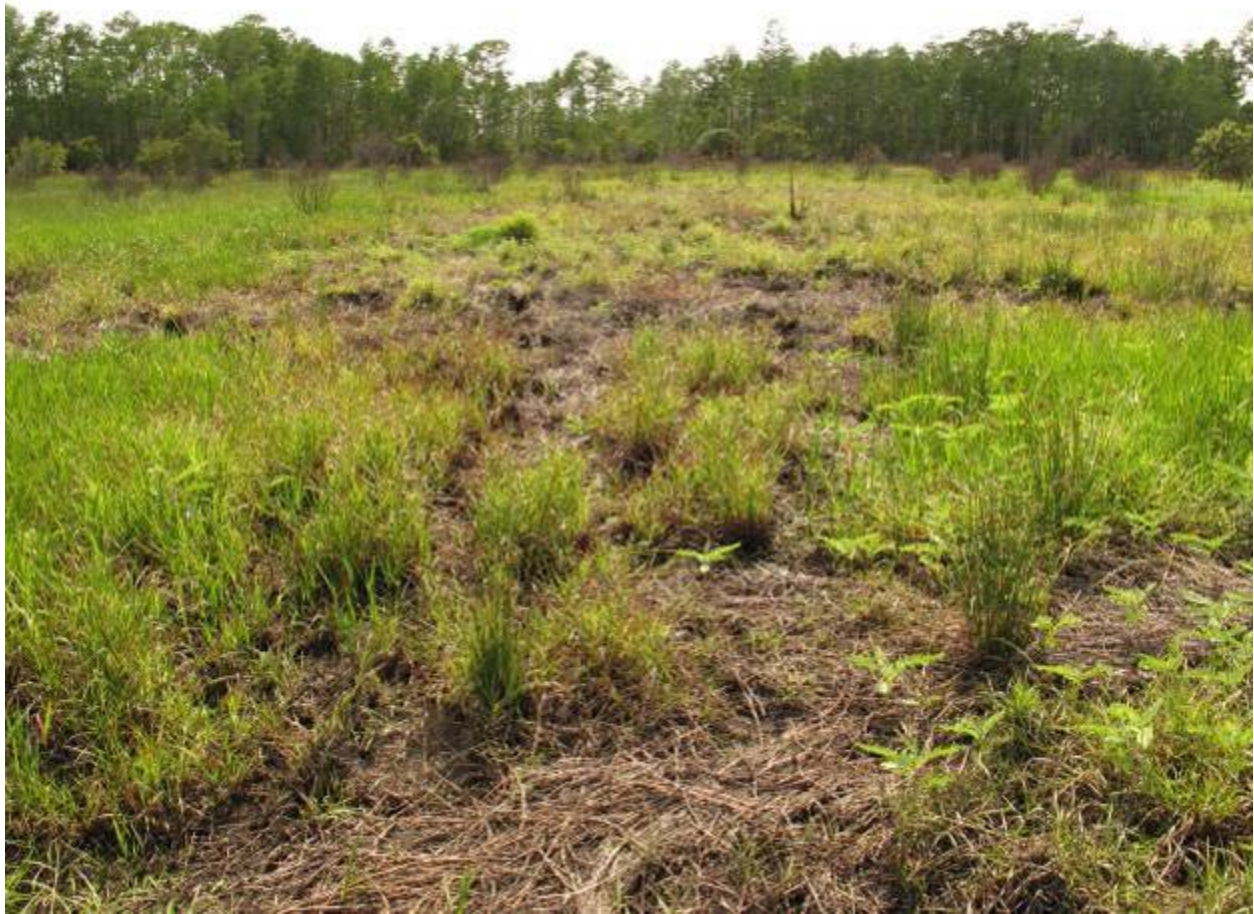
**Wetland ID: 68-07**

**Description:** This wetland is a 0.1 ha ephemeral marsh. There is no tree canopy or midstory cover. A grass, possibly torpedograsses, and a small legume are common in the wetland, and maidencane grows in scattered patches. The herbaceous vegetation covers >75% of the basin. There is evidence of fire throughout the wetland basin. The adjacent uplands are pasture with widely scattered pine trees and shrubs. Pasture grasses have encroached into the wetland.

**Wetland Concerns:** Invasive species, Upland condition

**Restoration Action Recommended:** Continue providing regular fire to the landscape - in order to restore the full ecological function of the wetland, the uplands will need to be restored.

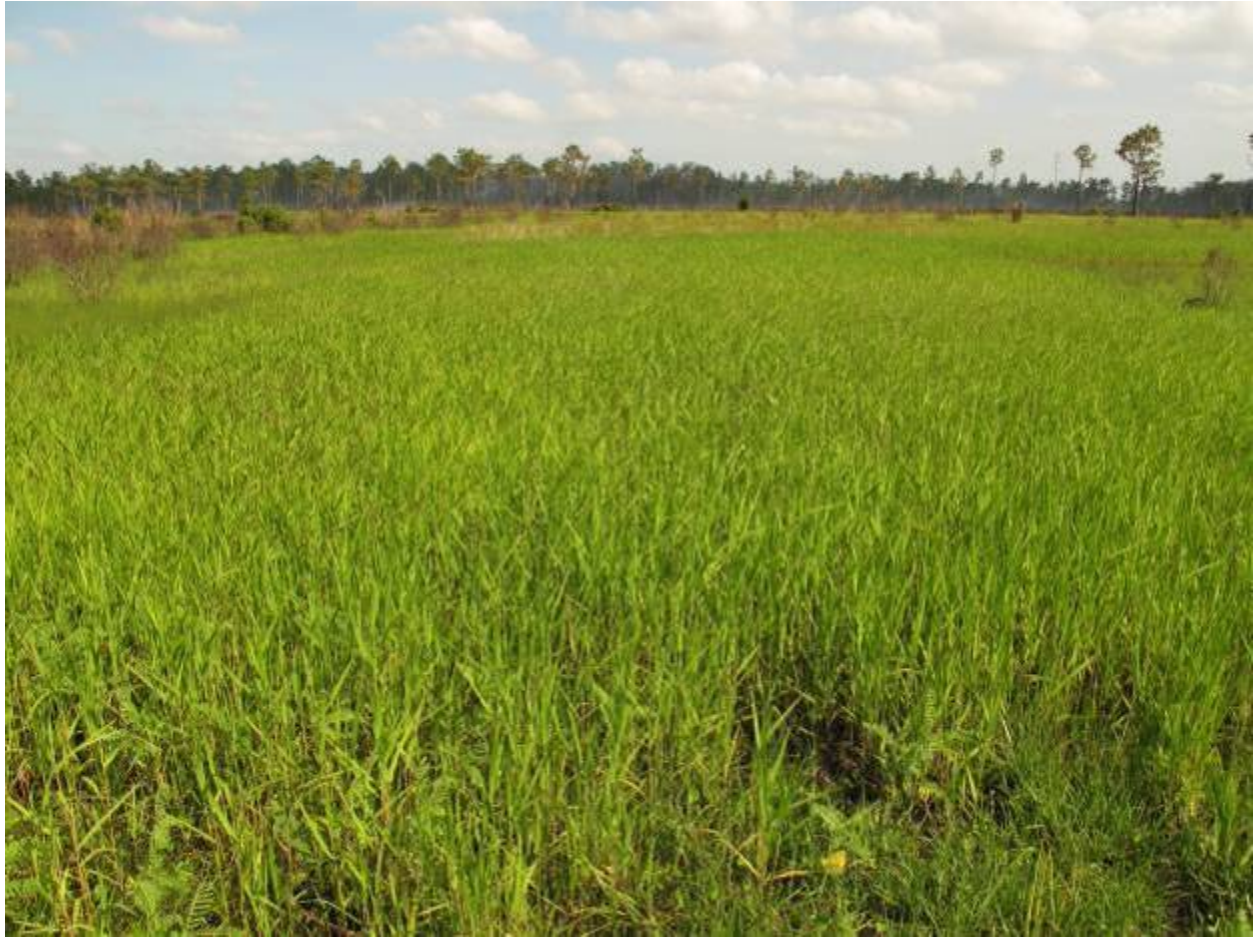
**Wetland ID: 68-08**

**Description:** This wetland is a 0.2 ha ephemeral marsh. There is no tree canopy or midstory cover. Maidencane grows throughout the wetland, and covers >75% of the basin. There is fire evidence throughout the wetland interior. The adjacent uplands are pasture with widely scattered pine trees and shrubs. Pasture grasses have encroached into the wetland.

**Wetland Concerns:** Invasive species, Upland condition

**Restoration Action Recommended:** Continue providing regular fire to the landscape - in order to restore the full ecological function of the wetland, the uplands will need to be restored.

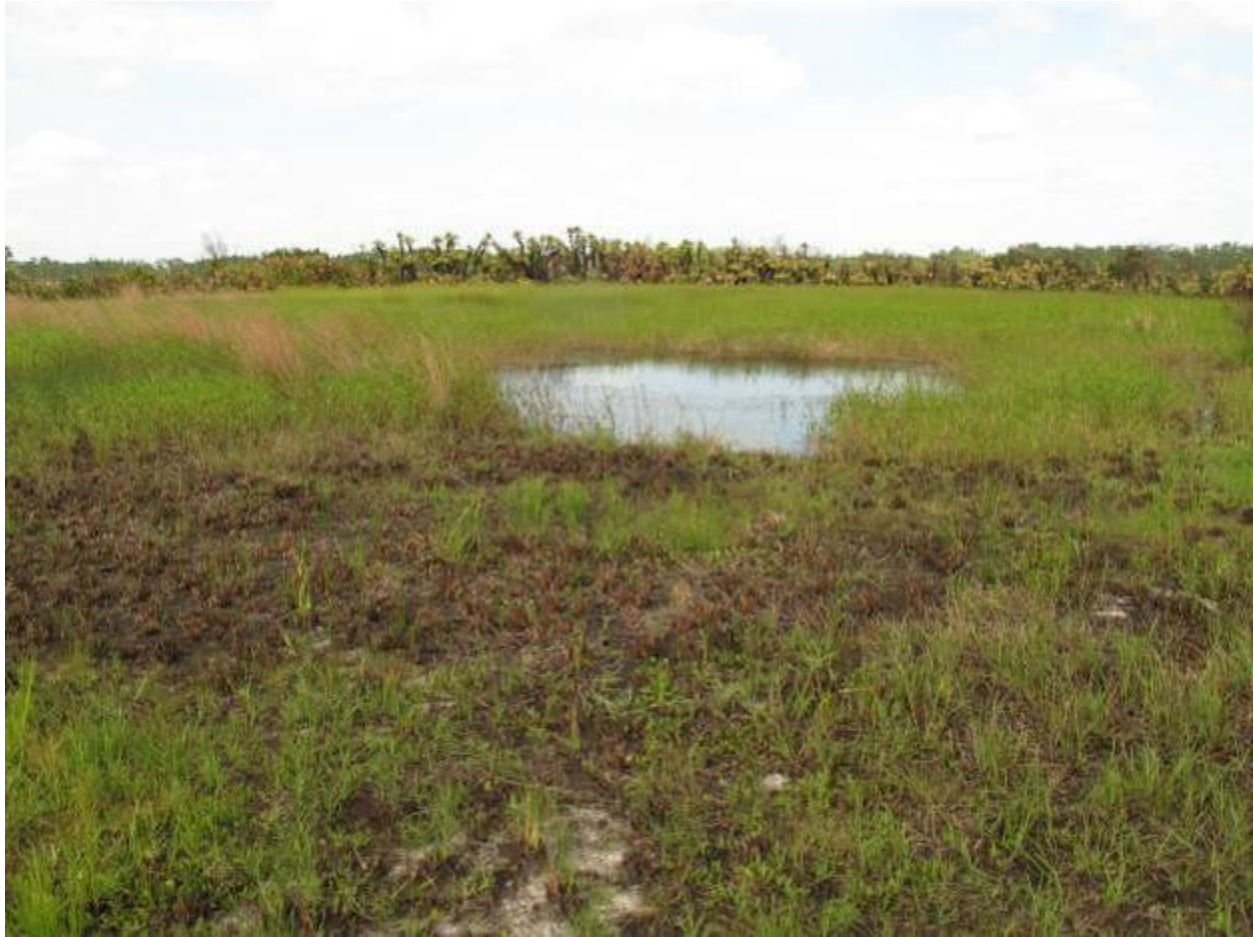
**Wetland ID: 68-09**

**Description:** This wetland is a 0.5 a ephemeral marsh. There is no tree canopy or midstory cover. Maidencane and emergent vegetation grow throughout the wetland basin, and bahia and possibly torpedograsses grow in the south end of the wetland. It appears a hole has been dug in the wetland center, creating a longer hydroperiod. Fish were present in the deeper hole on the day of our visit. A recent fire burned into the wetland edges. The adjacent uplands are pasture with widely scattered pine trees and shrubs. Pasture grasses have encroached into the wetland.

**Wetland Concerns:** Dug-out, Invasive species, Upland condition

**Restoration Action Recommended:** Fill the dug-out hole to restore wetland hydroperiod. Continue providing regular fire to the landscape - in order to restore the full ecological function of the wetland, the uplands will need to be restored.

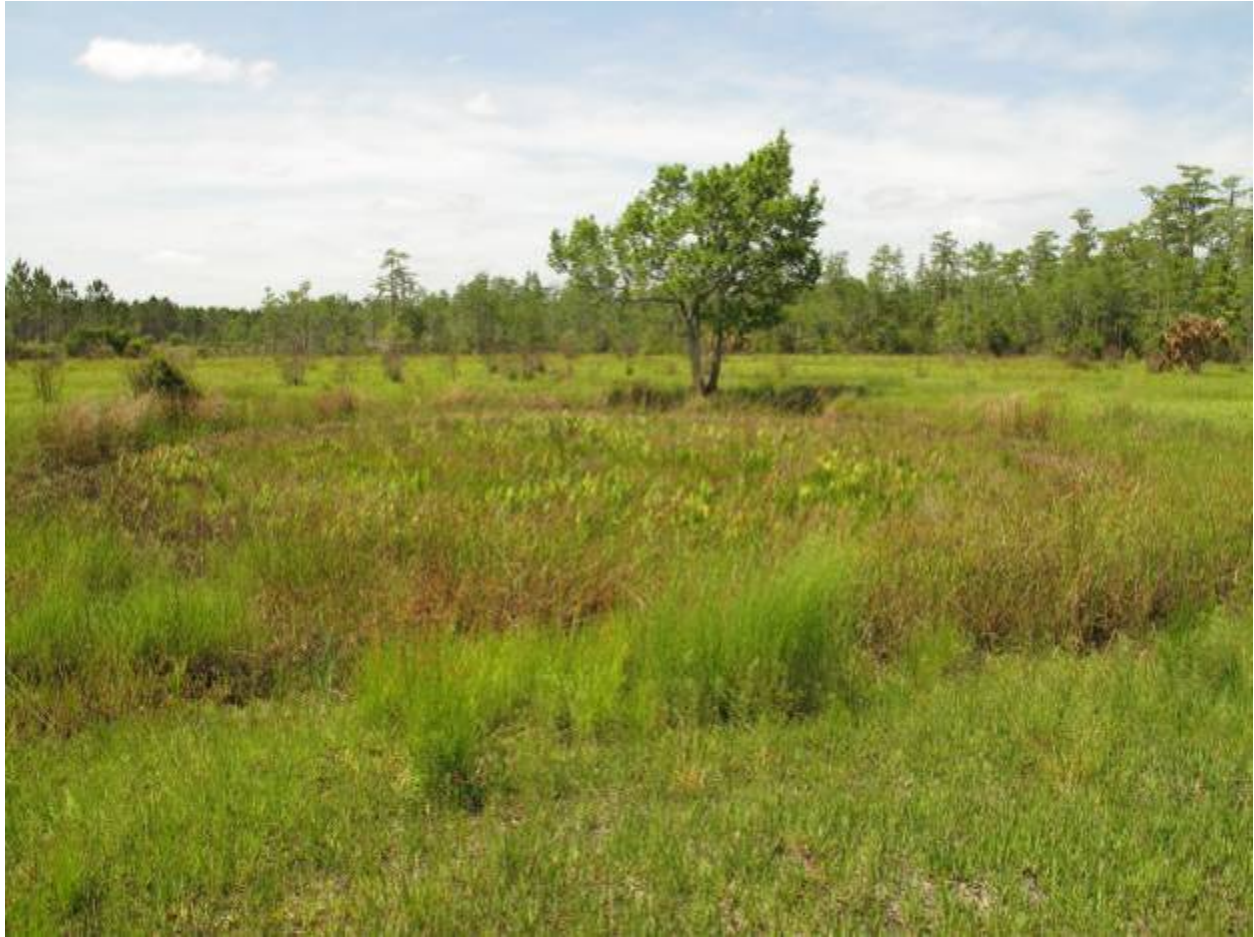
**Wetland ID: 70-01**

**Description:** This wetland is a 0.1 ha ephemeral marsh. There is no tree canopy or midstory cover. A high diversity of herbaceous vegetation, including fern, redroot, emergent vegetation, rush, and sedges/grasses, grows throughout the wetland and covers >75% of the basin. A short earthen berm surrounds the wetland, indicating this wetland was likely created for cattle. The adjacent uplands are pasture with widely scattered pine trees and shrubs.

**Wetland Concerns:** Berm, Upland condition

**Restoration Action Recommended:** The wetland is functioning as a healthy, ephemeral wetland so we do not recommend altering the berm. Continue providing regular fire to the landscape - in order to restore the full ecological function of the wetland, the uplands will need to be restored.
