# **Inventory, Assessment, and Restoration Potential of Ephemeral Wetlands on FFWCC Wildlife Management Areas**

## **Triple N Ranch WMA Final Report**

Submitted by: Rebecca P.M. Means<sup>1</sup>, Ryan C. Means<sup>1</sup>, Steven A. Johnson<sup>2</sup>

15 May 2010 – 15 August 2010

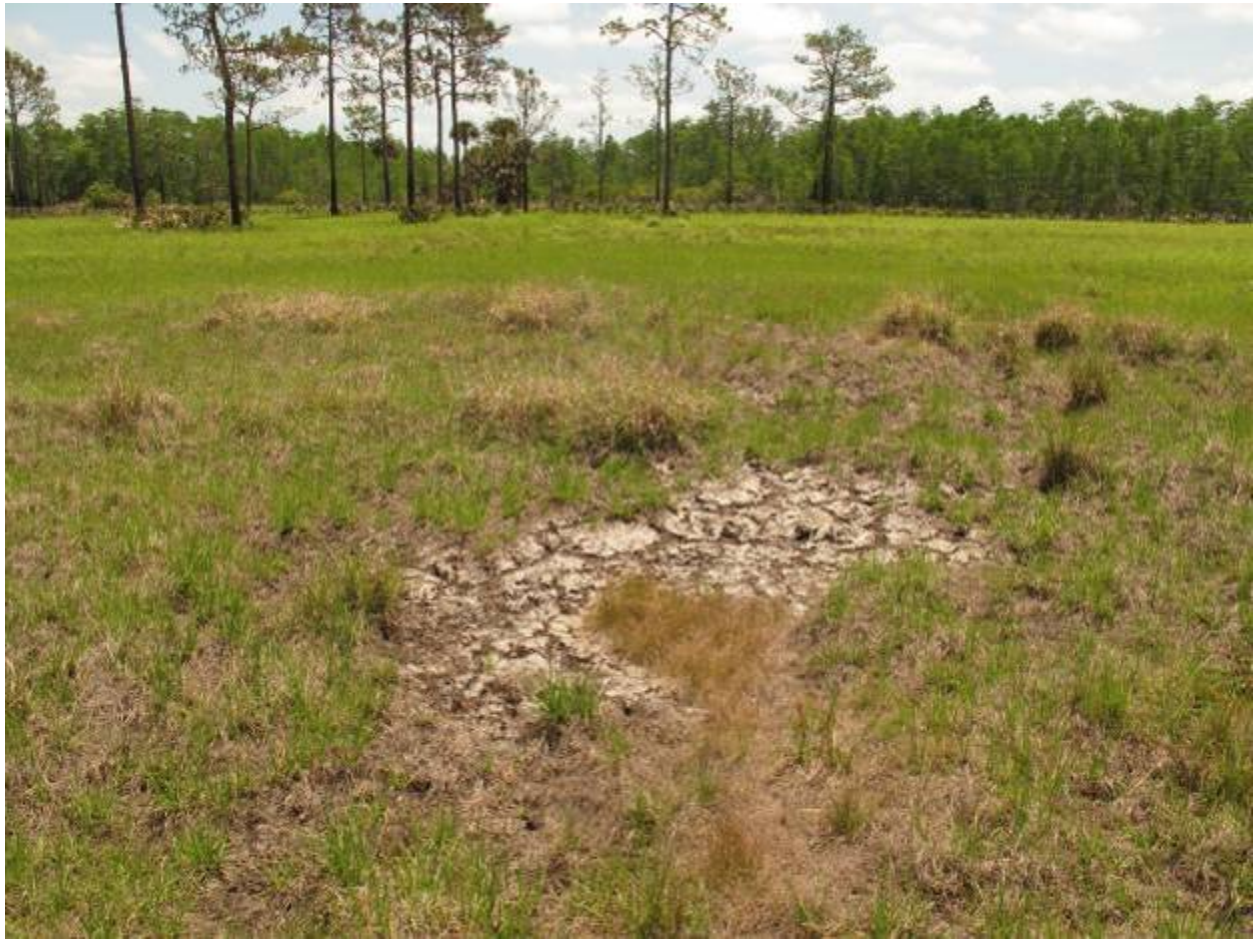
**Wetland ID: 71-01**

**Description:** This wetland is a 0.1 ha ephemeral marsh. There is no tree canopy or midstory cover. Sedges/grasses, including bahia grass, grow throughout the wetland, and cover >75% of the basin. Even though cattle are no longer allowed on this MU, cattle trails and grazing are still evident throughout the wetland. The adjacent uplands are pasture with widely scattered pine trees and shrubs. Pasture grasses have encroached into the wetland basin.

**Wetland Concerns:** Invasive species, Upland condition

**Restoration Action Recommended:** Continue providing regular fire to the landscape - in order to restore the full ecological function of the wetland, the uplands will need to be restored.

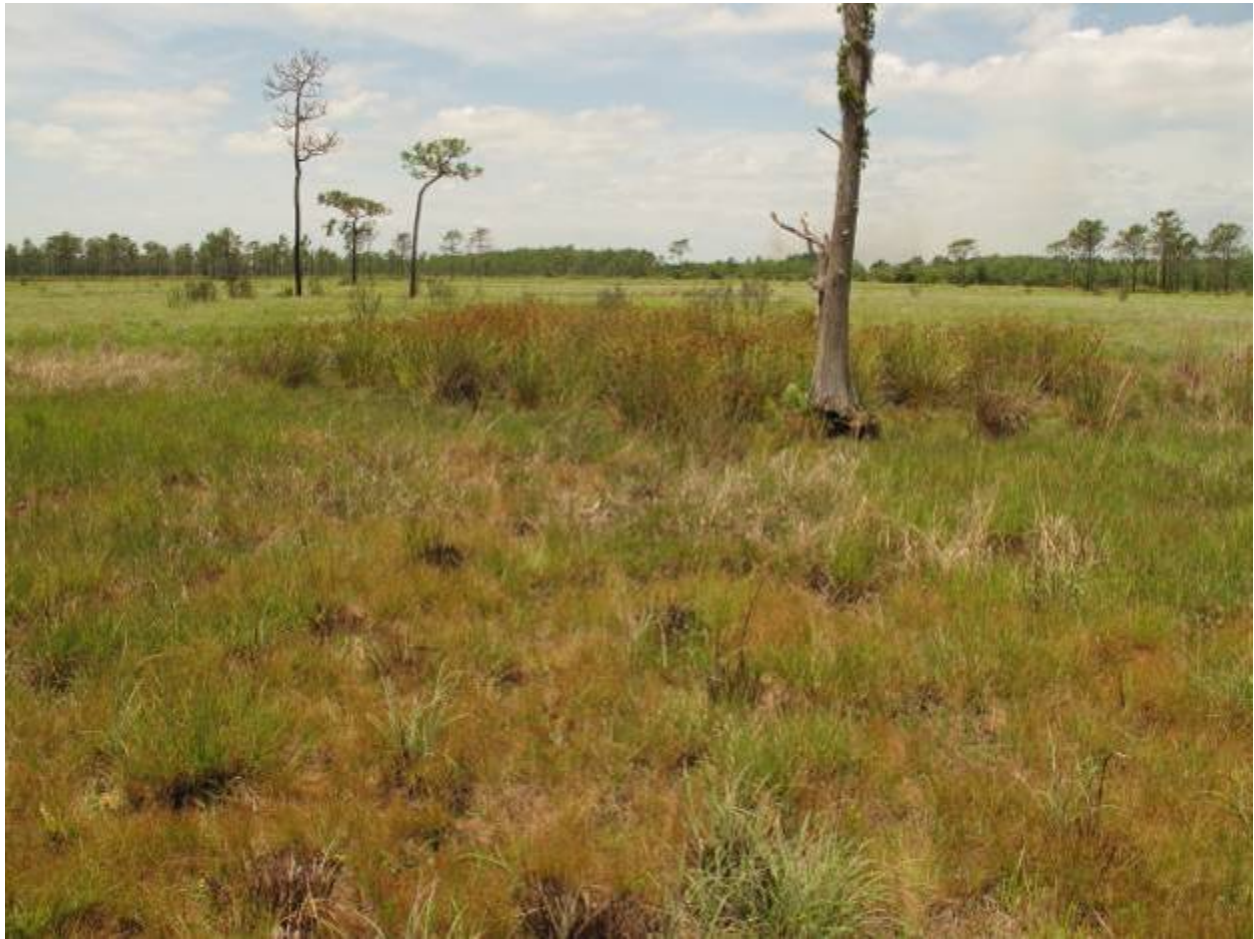
**Wetland ID: 71-02**

**Description:** This wetland is a 0.1 ha ephemeral marsh. There is no tree canopy or midstory cover. Rush and emergent vegetation grow in the deeper wetland center, and sedges/grasses grow around the edges of the wetland. The herbaceous vegetation covers >75% of the basin. Even though cattle are no longer allowed in this MU, grazing effects are still evident throughout the wetland. The adjacent uplands are pasture with widely scattered pine trees and shrubs.

**Wetland Concerns:** Upland condition

**Restoration Action Recommended:** Continue providing regular fire to the landscape - in order to restore the full ecological function of the wetland, the uplands will need to be restored.

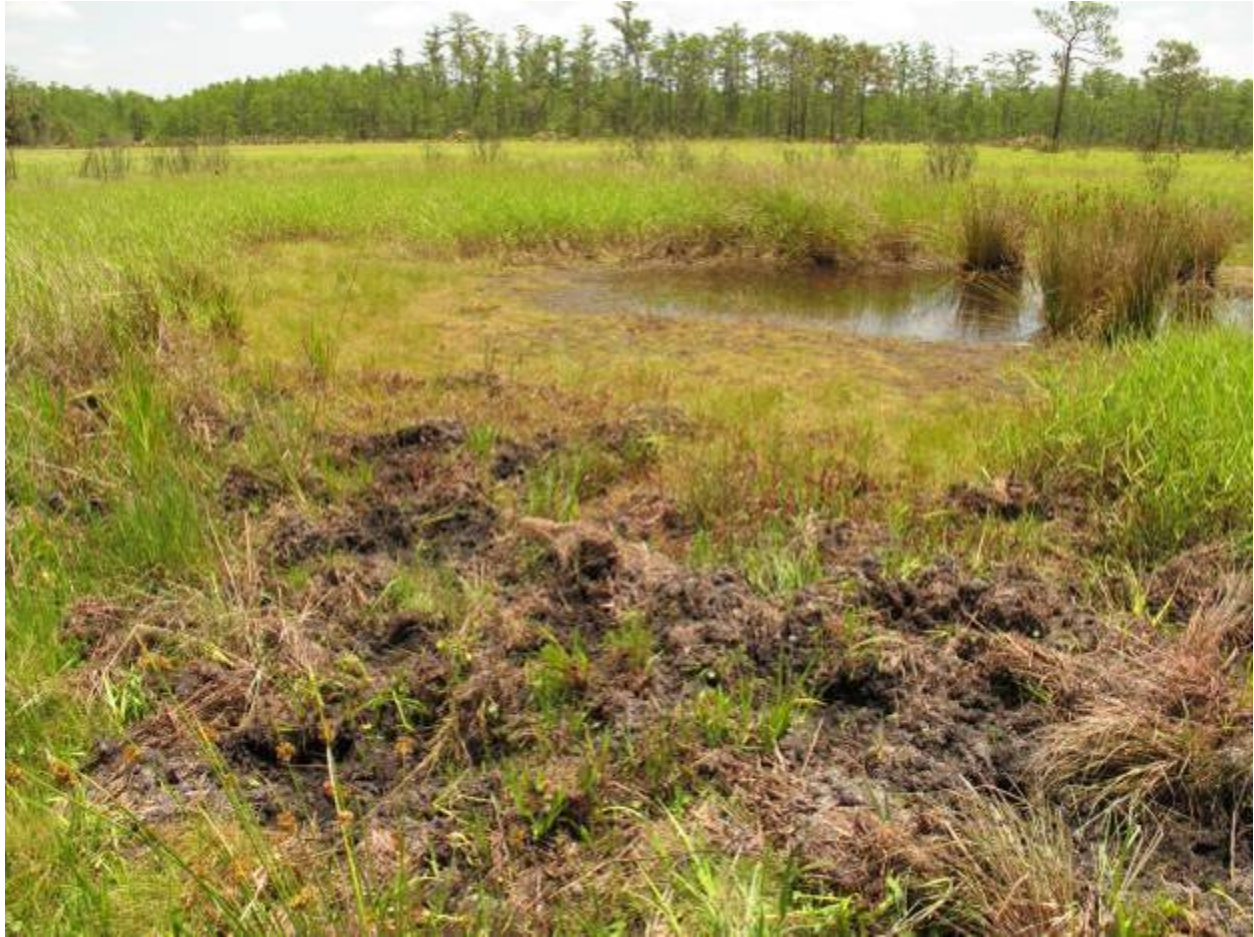
**Wetland ID: 71-03**

**Description:** This wetland is a 0.1 ha ephemeral marsh. There is no tree canopy or midstory cover. Rush grow in the deeper wetland center, and maidencane and sedges/grasses grow in a ring around the wetland center. The herbaceous vegetation covers >75% of the basin. A shallow ditch leads out of the south end of the wetland. There is moderate feral hog damage on the southern edge of the wetland. Even though cattle are no longer allowed in this MU, damage from past grazing is still evident. The adjacent uplands are pasture with widely scattered pine trees and shrubs.

**Wetland Concerns:** Ditching, Feral hog damage, Upland condition

**Restoration Action Recommended:** Fill ditch to restore the wetland's isolation. Continue providing regular fire to the landscape - in order to restore the full ecological function of the wetland, the uplands will need to be restored.

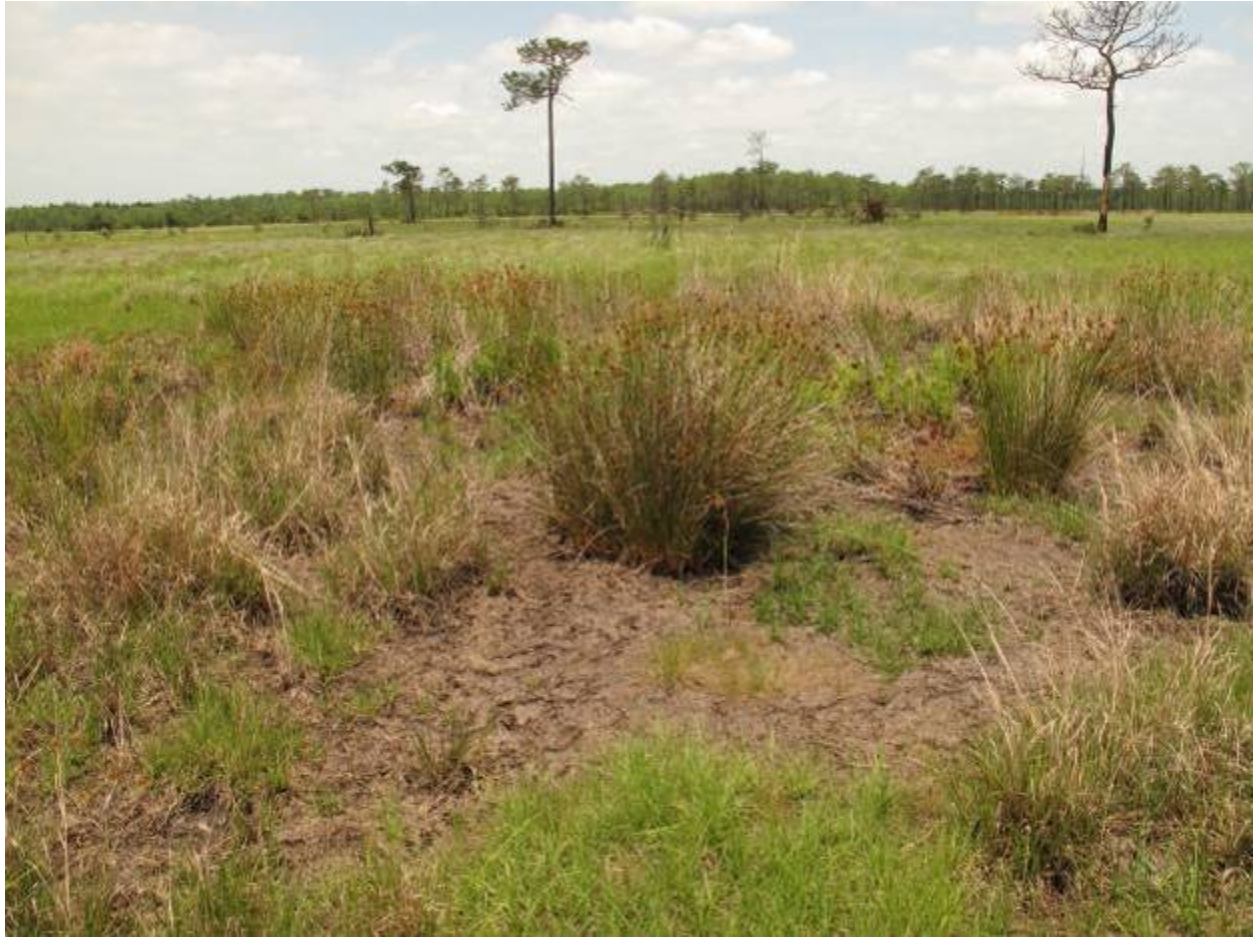
**Wetland ID: 71-04**

**Description:** This wetland is a <0.1 ha ephemeral marsh. There is no tree canopy or midstory cover. Rush grow in the deeper wetland center, and bahia grass is common within the shallower areas of the wetland. The herbaceous vegetation covers >75% of the basin. A shallow ditch bisects the eastern edge of the wetland. The adjacent uplands are pasture with widely scattered pine trees and shrubs. Pasture grasses have encroached into the wetland basin.

**Wetland Concerns:** Ditching, Invasive species, Upland condition

**Restoration Action Recommended:** Fill the ditch to restore the wetland's isolation. Continue providing regular fire to the landscape - in order to restore the full ecological function of the wetland, the uplands will need to be restored.

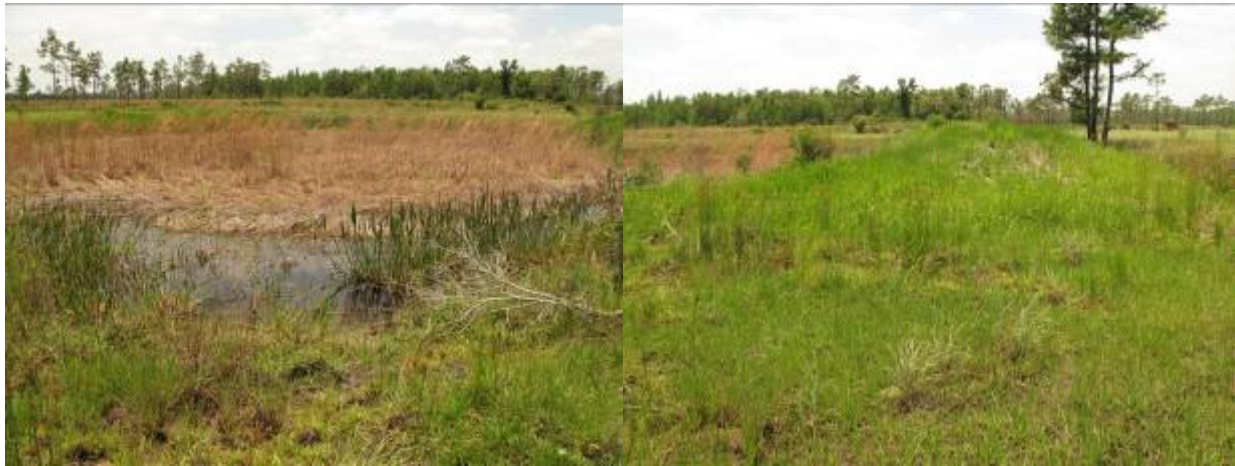
**Wetland ID: 71-05**

**Description:** This wetland is a 0.1 ha semi-permanent marsh. Cypress trees grow in the northeast corner of the wetland, and cover 5-25% of the basin. There is no midstory cover. Emergent vegetation grows in the deeper wetland center, sedges/grasses grow around the wetland edges, and maidencane is patchy throughout. The herbaceous vegetation covers >75% of the basin. There is a 2 m earthen berm on the northeast side of the wetland and a section of the wetland was dug deeper, presumable for cattle. A ditch leads from the south side of the wetland. Fish were present on the day of our visit. The adjacent uplands are pasture with widely scattered pine trees and shrubs.

**Wetland Concerns:** Berm, Ditching, Dug-out, Upland condition

**Restoration Action Recommended:** Fill ditch to restore the wetland's isolation. When the wetland is dry, fill the dug-out with the earthen mound and flatten the bottom. Continue providing regular fire to the landscape - in order to restore the full ecological function of the wetland, the uplands will need to be restored.

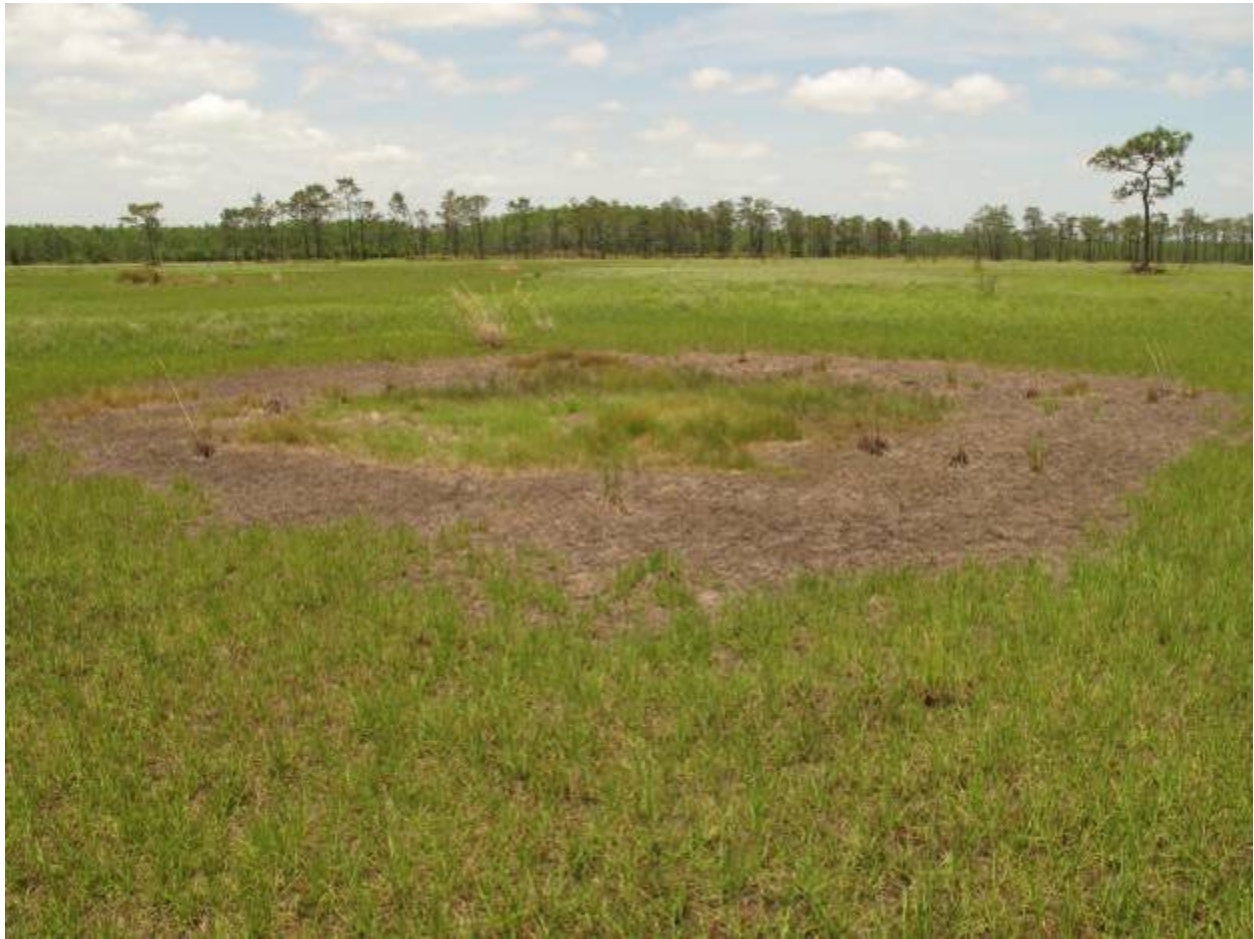
**Wetland ID: 71-06**

**Description:** This wetland is a <0.1 ha ephemeral marsh. There is no tree canopy or midstory cover. Native sedges/grasses grow in the wetland center, and grazed bahia grass grows around the wetland edge. The herbaceous vegetation covers >75% of the basin. The adjacent uplands are pasture with widely scattered pine trees and shrubs.

**Wetland Concerns:** Invasive species, Upland condition

**Restoration Action Recommended:** Continue providing regular fire to the landscape - in order to restore the full ecological function of the wetland, the uplands will need to be restored.

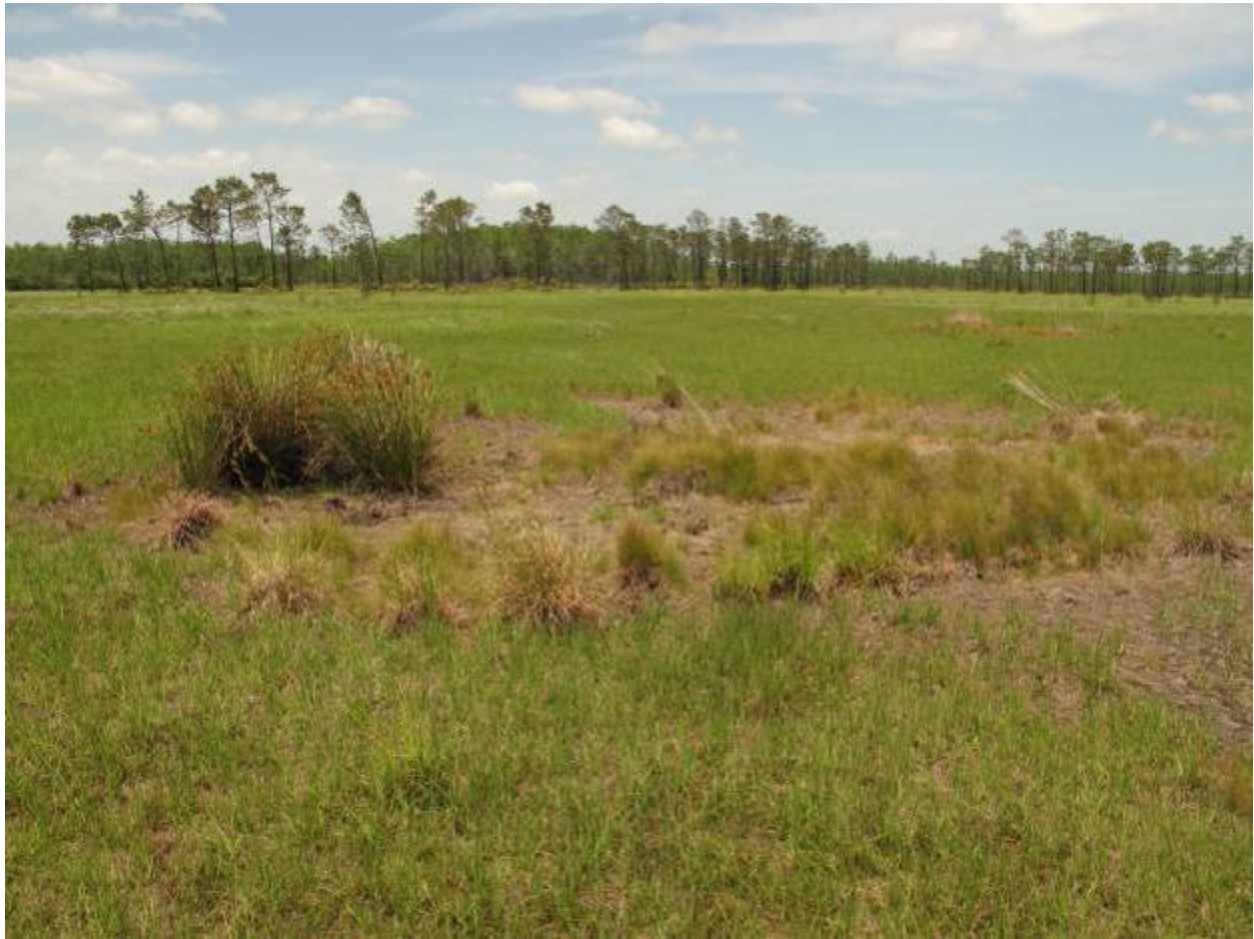
**Wetland ID: 71-07**

**Description:** This wetland is a 0.1 ha ephemeral marsh. There is no tree canopy or midstory cover. Rush grow in the deeper wetland center, and grazed bahia grass grows around the wetland edge. The herbaceous vegetation covers >75% of the basin. Even though cattle are no longer allowed on this MU, trampling damage is still evident in the wetland. The adjacent uplands are pasture with widely scattered pine trees and shrubs. Pasture grasses have encroached into the wetland basin.

**Wetland Concerns:** Invasive species, Upland condition

**Restoration Action Recommended:** Continue providing regular fire to the landscape - in order to restore the full ecological function of the wetland, the uplands will need to be restored.

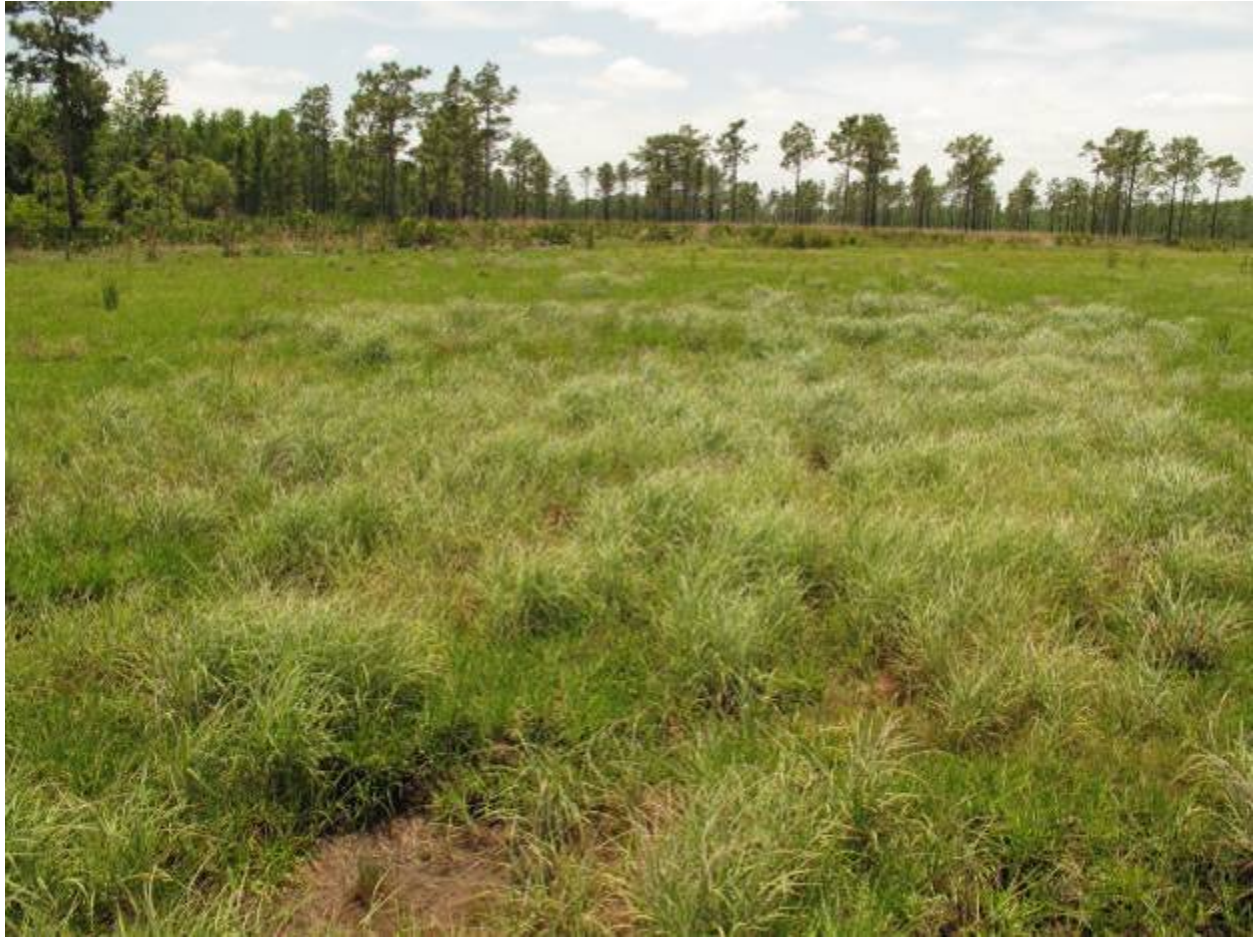
**Wetland ID: 71-08**

**Description:** This wetland is a <0.1 ha highly ephemeral marsh. There is no tree canopy or midstory cover. Bahia grass and broomsedge are the dominant herbaceous vegetation, and cover >75% of the basin. Old feral hog damage is extensive and has grown over with vegetation. The adjacent uplands are pasture with widely scattered pine trees and shrubs. Pasture grasses have encroached into the wetland basin.

**Wetland Concerns:** Feral hog damage, Invasive species, Upland condition

**Restoration Action Recommended:** Continue providing regular fire to the landscape - in order to restore the full ecological function of the wetland, the uplands will need to be restored.

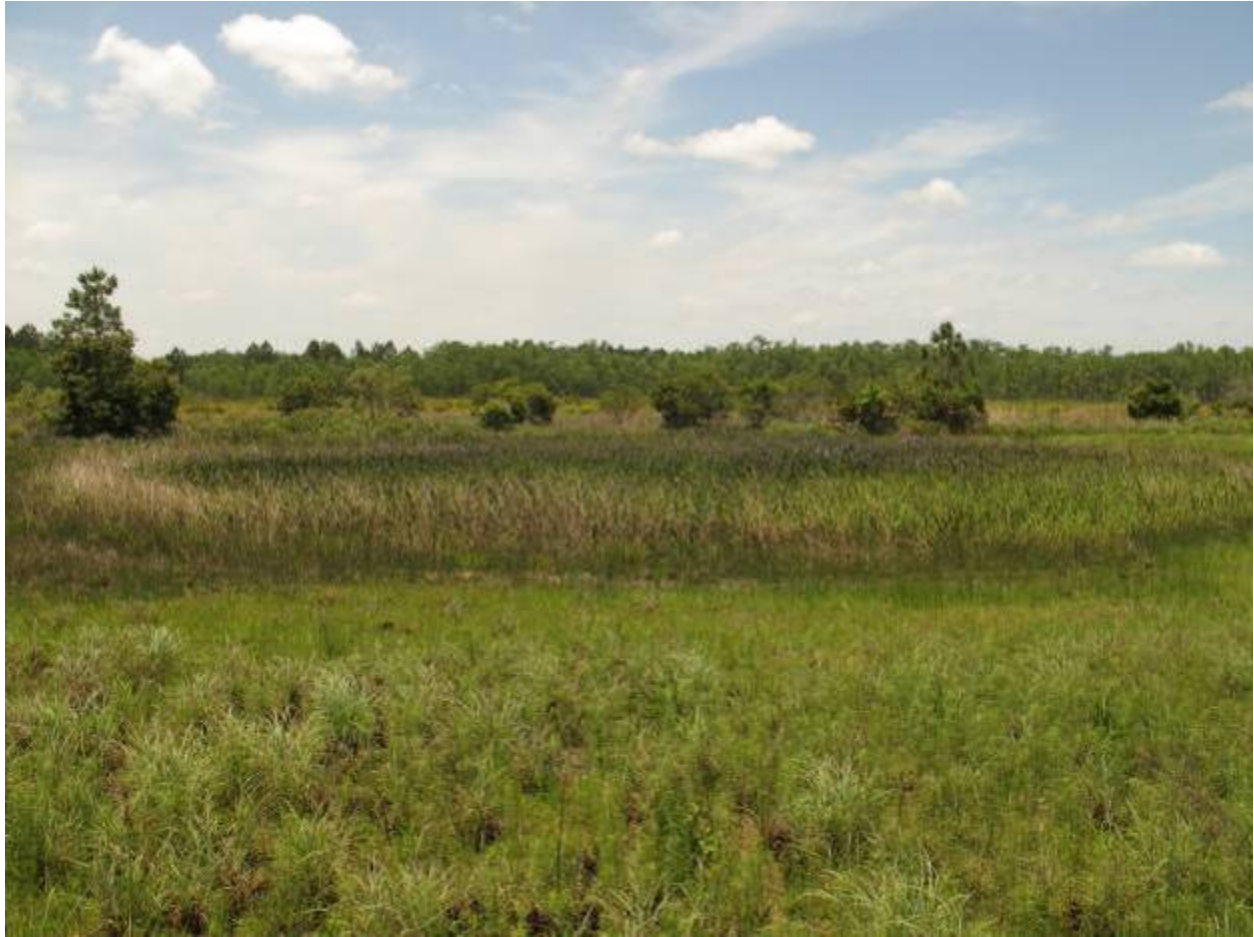
**Wetland ID: 71-09**

**Description:** This wetland is a 0.1 ha ephemeral marsh. There is no tree canopy or midstory cover. Pickerelweed and maidencane grow throughout the wetland, and cover >75% of the basin. A fireline/property boundary and fence line runs along the west edge of the wetland. A vehicular track is forming around the wetland perimeter, likely a result of driving the fireline and avoiding the wet, western side of the pond. Even though cattle are no longer allowed in this MU, damage from past grazing is still evident around the wetland edges. The adjacent uplands are pasture with widely scattered pine trees and shrubs.

**Wetland Concerns:** Fireline, Invasive species, Upland condition, Vehicular damage

**Restoration Action Recommended:** Re-route the track 10m into the pasture uplands on the north, east, and south sides of the wetland. Continue providing regular fire to the landscape - in order to restore the full ecological function of the wetland, the uplands will need to be restored.

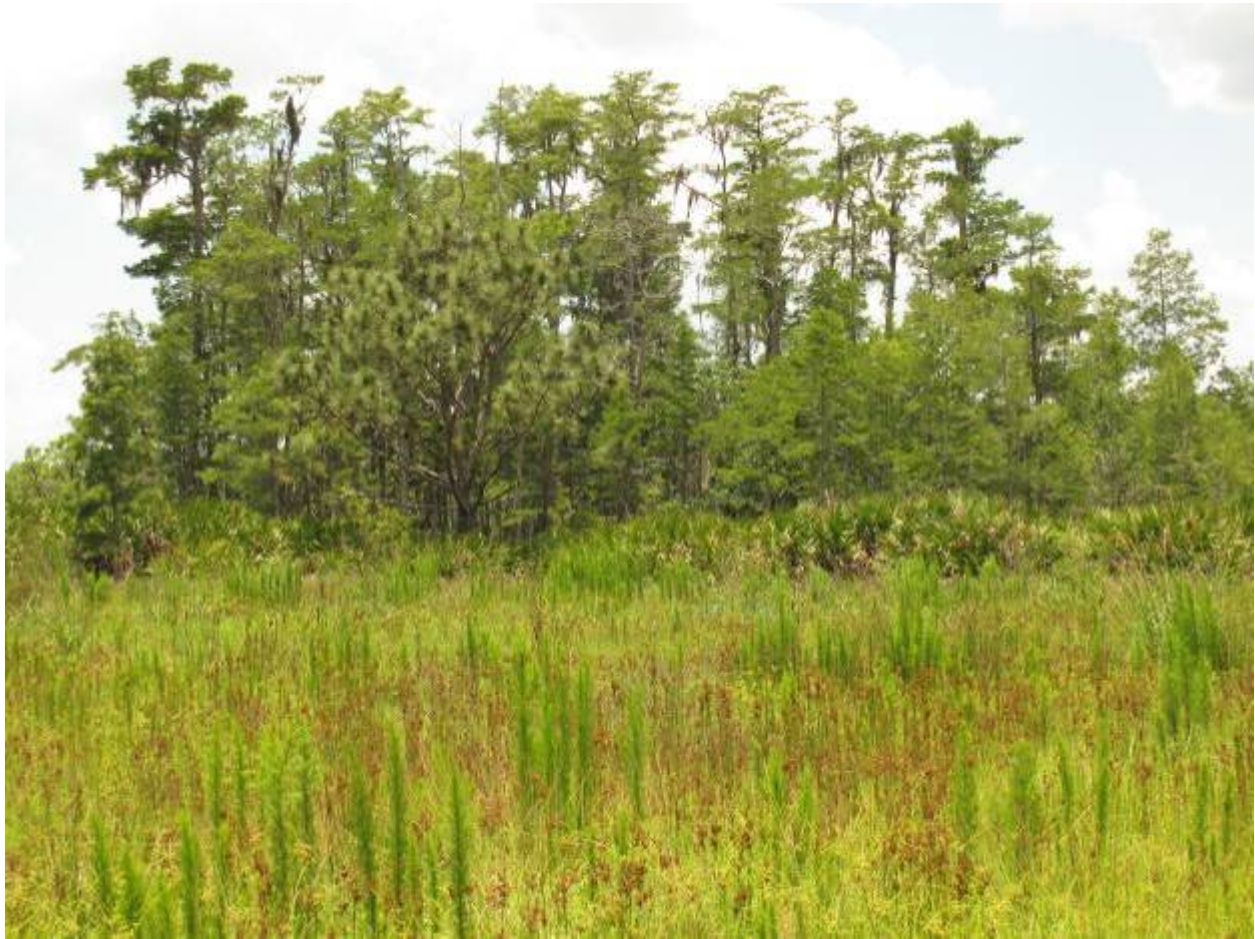
**Wetland ID: 79-01**

**Description:** This wetland is a 0.5 ha ephemeral forested swamp. Cypress trees dominate the canopy, and cover >75% of the basin. There is no midstory cover. Sedges/grasses grow throughout the wetland, and cover >75% of the basin. There is evidence of past fire throughout the wetland. The adjacent uplands are an old citrus grove with cogongrass present.

**Wetland Concerns:** Upland condition

**Restoration Action Recommended:** Continue providing regular fire to the landscape - in order to restore the full ecological function of the wetland, the uplands will need to be restored.

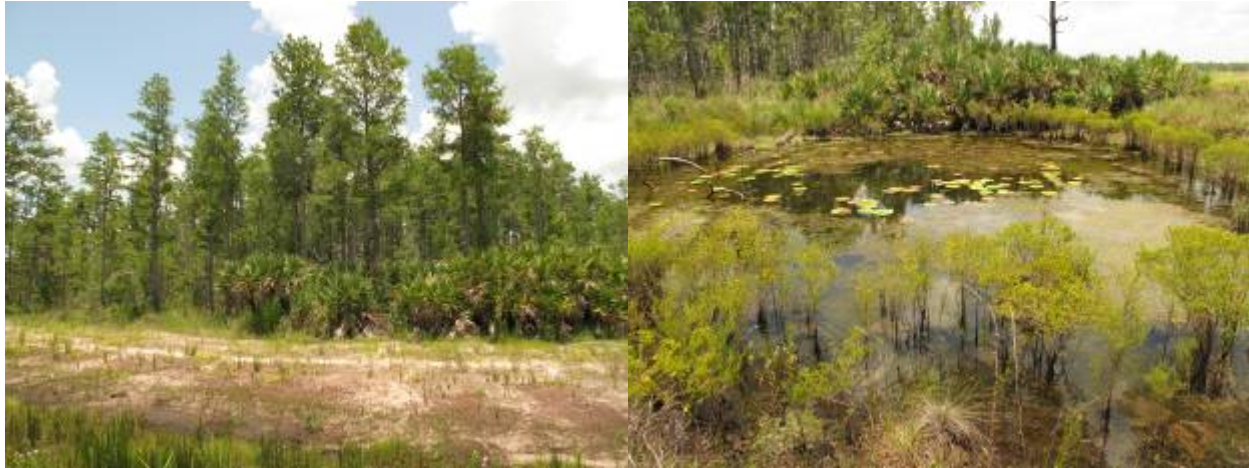
**Wetland ID: 79-02**

**Description:** This wetland is a 1.2 ha ephemeral forested swamp. Cypress trees dominate the canopy, and cover >75% of the basin. The midstory is dominated by fetterbush, wax myrtle, and various other hardwood species, and covers 5-25% of the wetland. Sedges/grasses, including what appears to be torpedograss, and fern grow throughout the wetland, and cover >75% of the basin. Two drainage channels were constructed on the east and south side of the wetland and a deeper ditch runs along the south end inside the wetland. A deep, circular pond, likely human-constructed, is on the southeast corner of the wetland. The adjacent uplands are an old citrus grove with cogongrass present.

**Wetland Concerns:** Ditching, Dug-out, Invasive species, Upland condition

**Restoration Action Recommended:** Fill ditches to restore the wetland's isolation. If the pond is human-constructed, fill the pond to restore the wetland hydroperiod. Continue providing regular fire to the landscape - in order to restore the full ecological function of the wetland, the uplands will need to be restored.

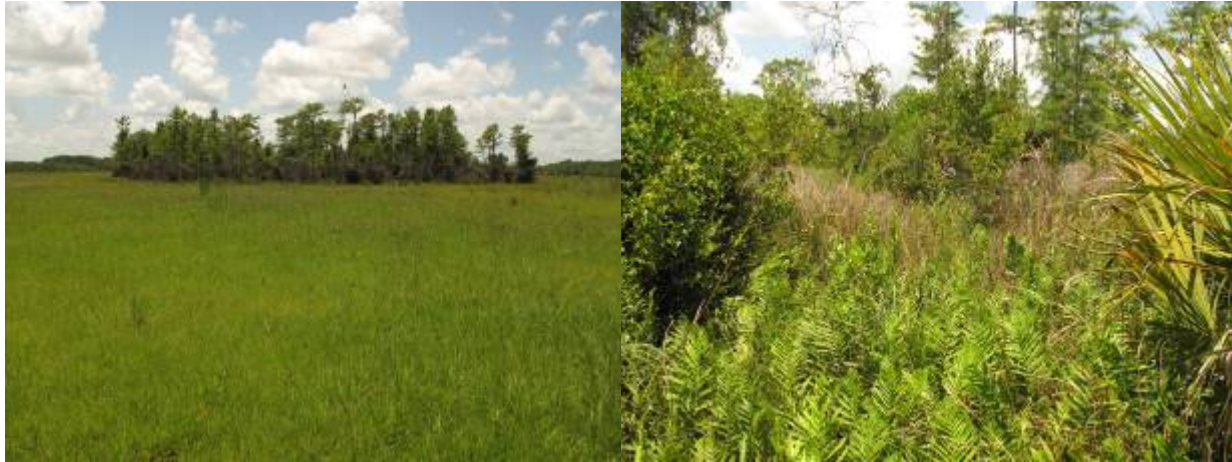
**Wetland ID: 81-01**

**Description:** This wetland is a 1.2 ha ephemeral shrub swamp. It appears to be a brushy marsh succeeding to a mixed swamp. Cypress trees dominate the canopy, and cover 5-25% of the basin. The midstory is dominated by wax myrtle, and covers 50-75% of the wetland. Sedges/grasses and fern grow throughout the wetland, and cover >75% of the basin. A deep ditch drains the south end of the wetland and the wetland shows signs of desiccation. There is evidence of past fire around the wetland edges. The adjacent uplands are pasture created by past grazing. Bahia grass and torpedograss are present in the uplands and appear to have encroached into the wetland as well.

**Wetland Concerns:** Ditching, Invasive species, Upland condition, Woody encroachment

**Restoration Action Recommended:** Fill ditch to restore the wetland hydroperiod. Continue providing regular fire to the landscape - in order to restore the full ecological function of the wetland, the uplands will need to be restored.

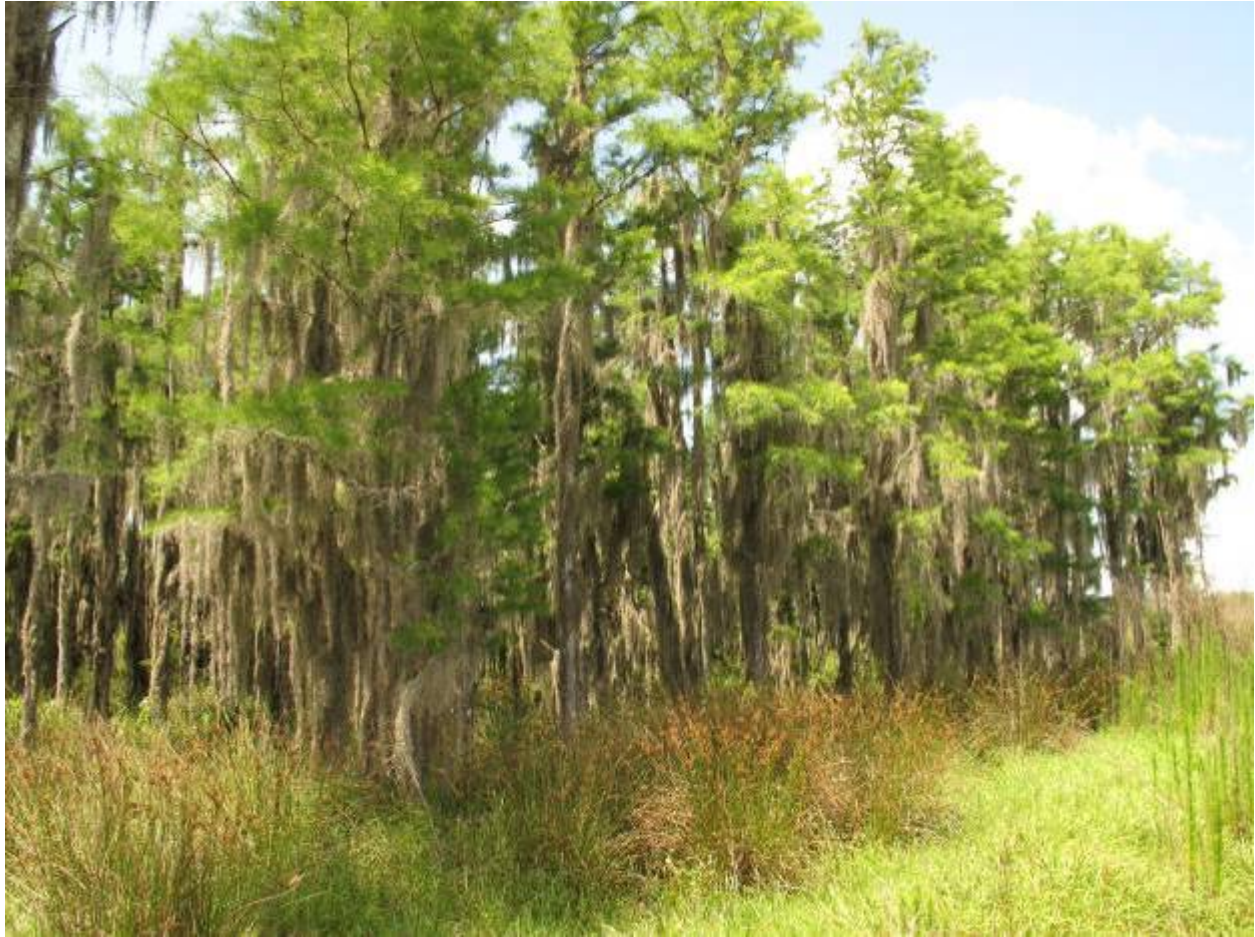
**Wetland ID: 85-01**

**Description:** This wetland is a 0.9 ha ephemeral forested swamp. Cypress trees dominate the canopy, and cover 50-75% of the basin. There is no midstory cover. Sedges/grasses, rush, and emergent vegetation grow throughout the wetland. The herbaceous vegetation covers >75% of the basin. Old cypress stumps provide evidence that this wetland has been a cypress dome for a long time. The adjacent uplands are pasture created by past grazing. Pasture grasses appear to have encroached into the wetland as well.

**Wetland Concerns:** Invasive species, Upland condition

**Restoration Action Recommended:** Provide regular fire to the landscape - in order to restore the full ecological function of the wetland, the uplands will need to be restored.

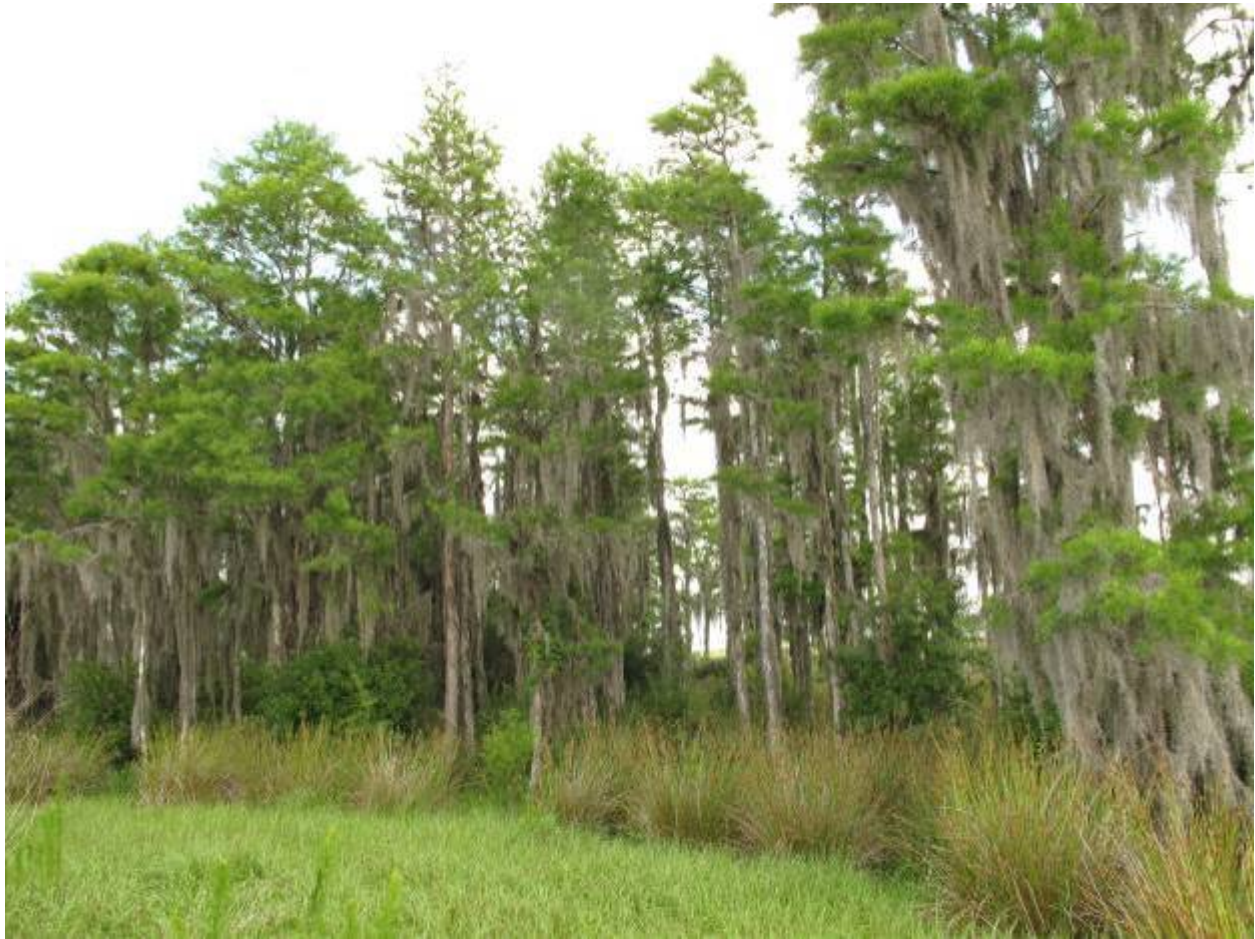
**Wetland ID: 86-01**

**Description:** This wetland is a 0.5 ha ephemeral forested swamp. Cypress trees dominate the canopy, and cover >75% of the basin. The midstory is dominated by wax myrtle, and covers 5-25% of the basin. Sedges/grasses, rush, and emergent vegetation grow throughout the wetland. The herbaceous vegetation covers >75% of the basin. Old cypress stumps provide evidence that this wetland has been a cypress dome for a long time. The adjacent uplands are pasture created by past grazing. Pasture grasses appear to have encroached into the wetland as well.

**Wetland Concerns:** Invasive species, Upland condition

**Restoration Action Recommended:** Provide regular fire to the landscape - in order to restore the full ecological function of the wetland, the uplands will need to be restored.

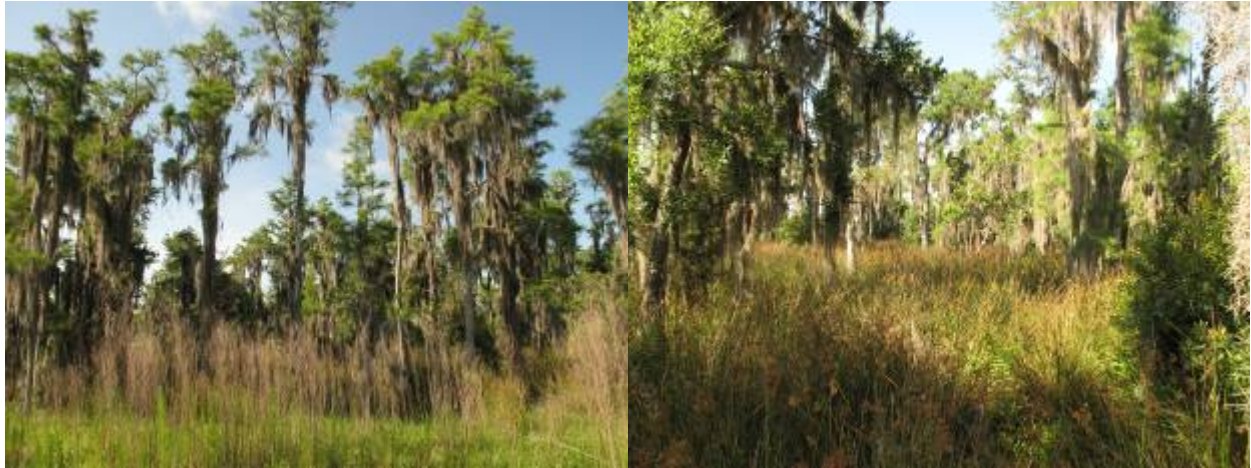
**Wetland ID: 87-01**

**Description:** This wetland is a 0.4 ha ephemeral forested swamp. It appears to be a marsh succeeding to a swamp. Cypress trees dominate the canopy, and cover 25-50% of the basin. There is no midstory cover. Sedges/grasses, rush, and emergent vegetation grow throughout the wetland. The herbaceous vegetation is dense and covers >75% of the basin. The adjacent uplands are pasture created by past grazing. Pasture grasses appear to have encroached into the wetland as well.

**Wetland Concerns:** Invasive species, Upland condition, Woody encroachment

**Restoration Action Recommended:** Provide regular fire to the landscape - in order to restore the full ecological function of the wetland, the uplands will need to be restored.

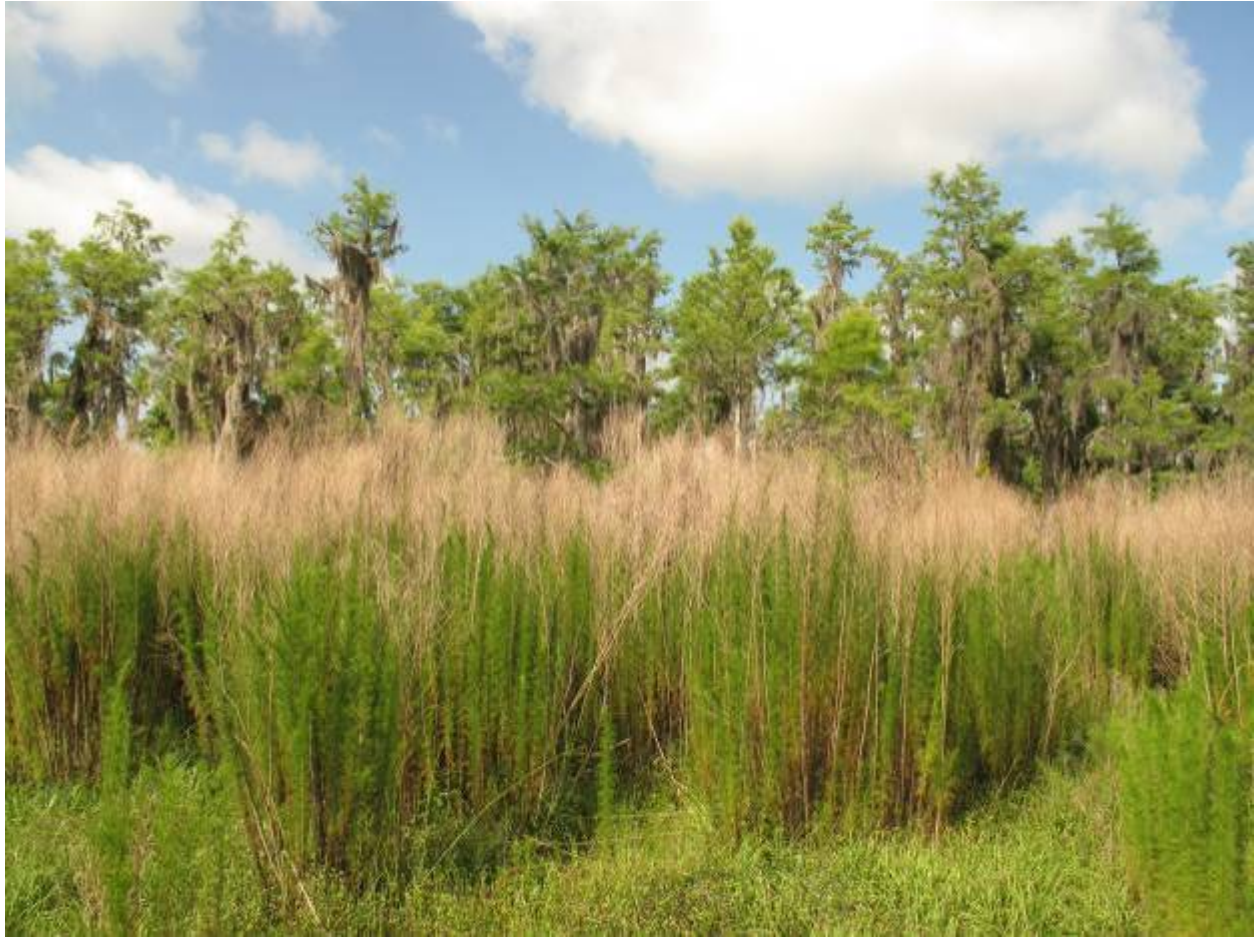
**Wetland ID: 87-02**

**Description:** This wetland is a 1.2 ha ephemeral forested swamp. Cypress and gum trees dominate the canopy, and cover 25-50% of the basin. The midstory is dominated by wax myrtle, and covers 5-25% of the wetland. A diversity of sedges/grasses, rush, emergent vegetation, and other herbaceous vegetation grow throughout the wetland. The herbaceous vegetation is dense and covers >75% of the basin. At first glance, this wetland appears to be a marsh succeeding to a swamp. However, old cypress stumps provide evidence that this marsh was once a cypress swamp. Therefore, this wetland is returning to its original state as a cypress swamp. The adjacent uplands are pasture created by past grazing. Pasture grasses appear to have encroached into the wetland as well.

**Wetland Concerns:** Invasive species, Upland condition

**Restoration Action Recommended:** Provide regular fire to the landscape - in order to restore the full ecological function of the wetland, the uplands will need to be restored.

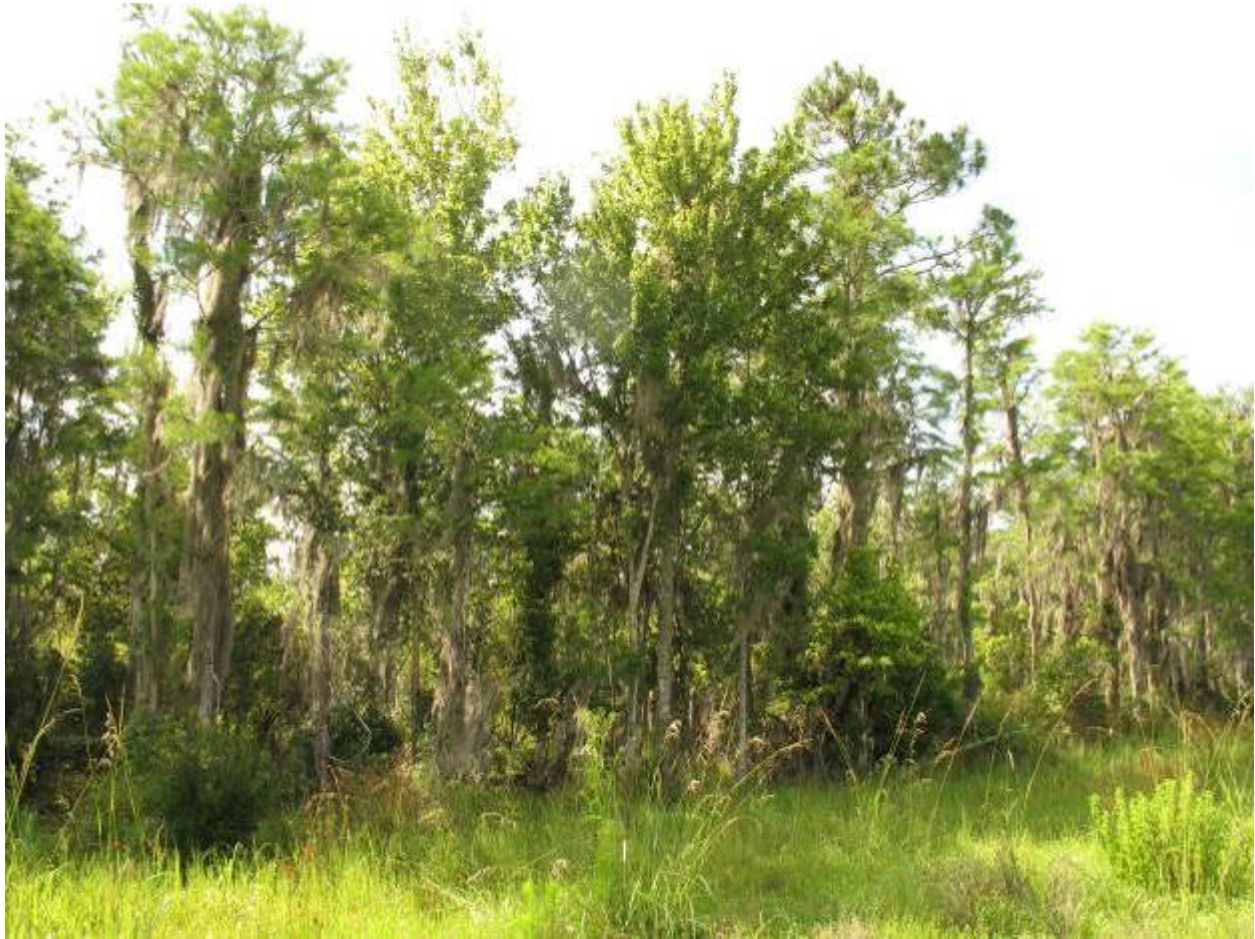
**Wetland ID: 87-03**

**Description:** This wetland is a 1.0 ha ephemeral mixed swamp. It appears to be a marsh succeeding to a swamp. Cypress and maple trees dominate the canopy, and cover 25-50% of the basin. The midstory is dominated by wax myrtle, and covers 25-50% of the wetland. A diversity of sedges/grasses, rush, and emergent vegetation grow throughout the wetland. The herbaceous vegetation is dense and covers >75% of the basin. The adjacent uplands are pasture created by past grazing. Pasture grasses appear to have encroached into the wetland as well.

**Wetland Concerns:** Invasive species, Upland condition, Woody encroachment

**Restoration Action Recommended:** Provide regular fire to the landscape - in order to restore the full ecological function of the wetland, the uplands will need to be restored.
